# Application Form for a Resource Consent

Removal of a Registered Tree T358

Street Address of Site: 27 Cranston Street, Anderson's Bay, Dunedin. 9013

Greentrees Report concerning a  
Small Leafed Lime Tree - T358  
at 27 Cranston St, Dunedin

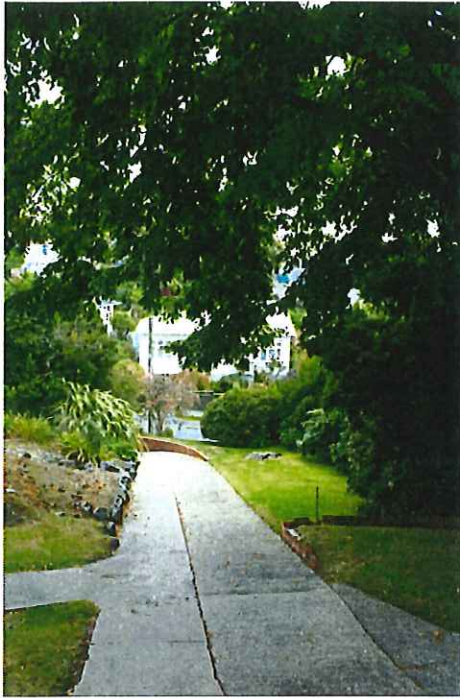
Tree overshadowing driveway (looking down hill)

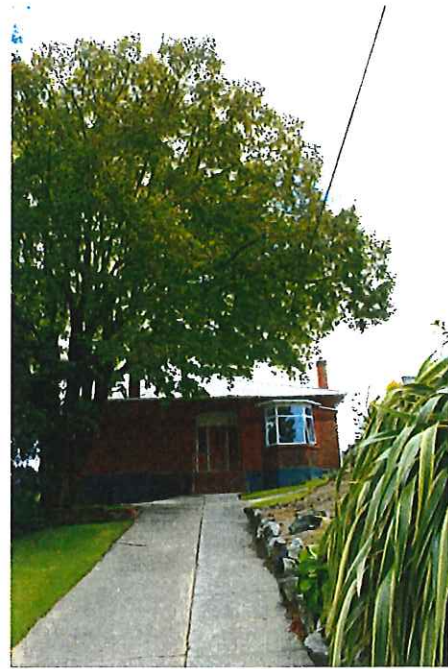
Tree overshadowing driveway (looking up hill)

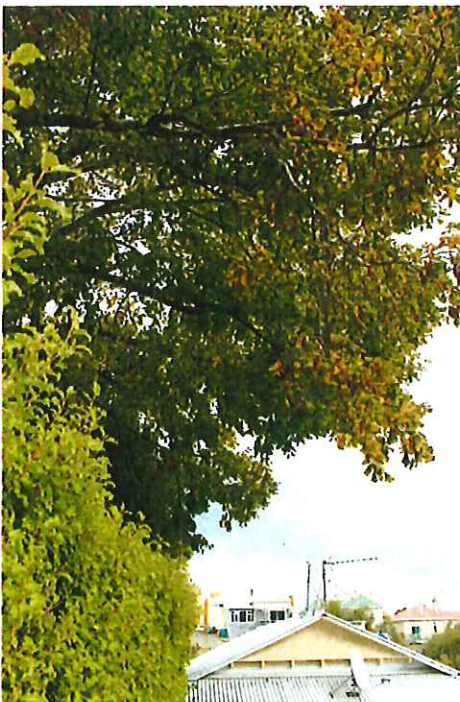
Most of the above points also relate to our immediate neighbours home. The tree completely covers one corner of their house and they have the same issues with gutters, roof corrosion, moss and algae growth.

The potential risk of damage to their house is far greater than ours because their house is situated approx 2.5m below the level of our property. If the tree happened to fall on their house probably 3/4 of it would be destroyed.

Tree overshadowing neighbor's house

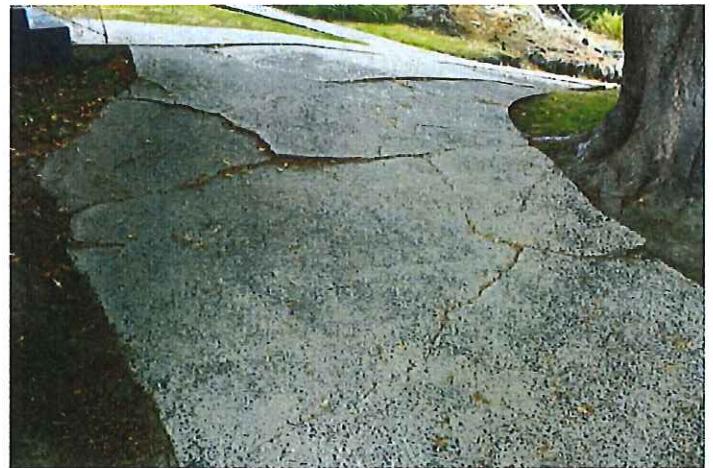
The effect of the tree roots is evident on the driveway and along the side of the house. Implication in time will be destabilization of the house foundations and a potential impact on the cost to continued insurance for our home. If the tree happened to fall against our house there may be limited damage due to its very close proximity but the chimney would be very much at risk and being tall and brick a very real danger to anyone in the bedroom directly below it.

Broken concrete on driveway and car park area.

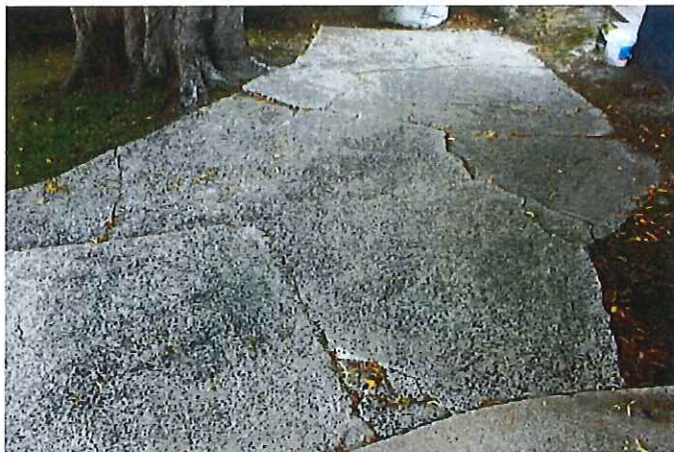
The constant maintenance required especially to clear the guttering is a serious safety issue. The access is only by extension ladder and the ground is sloping and adjacent car park area and driveway is broken and uneven because of the tree roots have lifted the concrete. Various methods (mesh and brushes) have been tried to keep gutters clear but the petals from the blossom clog the mesh and the seed pods clog the brushes

Sloping car park area and footing for extension ladder to access gutter (1 ¾ stories high)

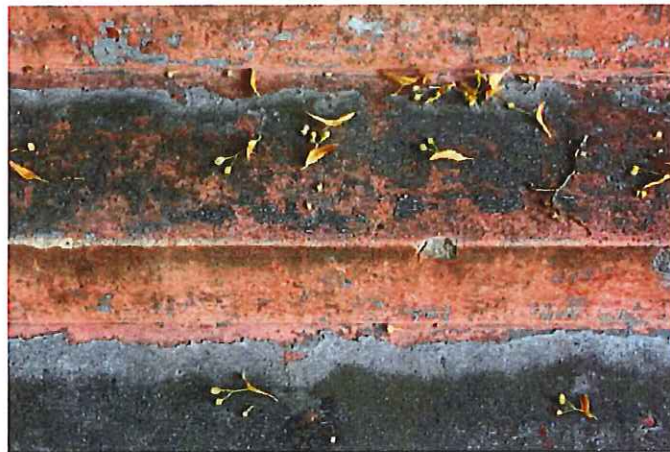
Seed pods on steps that dry out hard like marbles

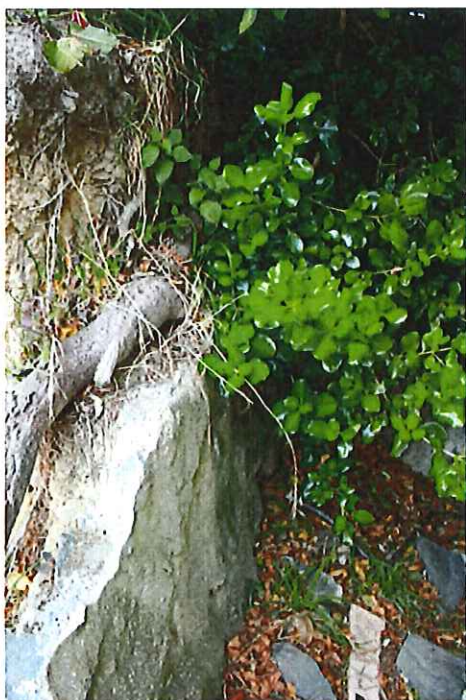
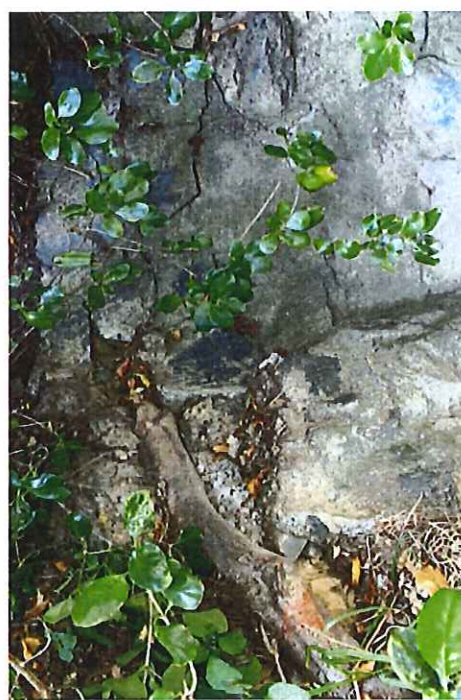
The tree roots have broken the rock and concrete retaining wall between our 2 properties and become a danger to their young grand children to the extent they no longer use that part of their property. The tree roots have also caused damage to their plumbing pipes in the recent past and will likely cause more damage in the future.

Tree roots grown through retainer wall in neighbours section

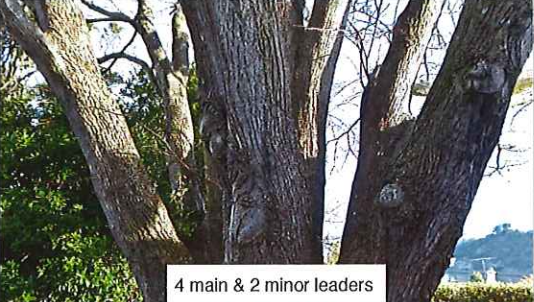
| Risk Categories | | | | | | | | | | | | | | | | | | | | | | | | | | |
|---|---|---|---|---|---|---|---|---|---|---|---|---|---|---|---|---|---|---|---|---|---|---|---|---|---|---|
| Potential structural weakness is evident in the upper right photo showing 6 main leaders arising from the same point on the trunk near the base. Each leader being 15m+ in length acts as long lever-arm on the junction/fulcrum with the trunk. The forces generated when such big leaders sway in gales are exponential. These joints do fail very occasionally without any internal rot being present within the stem. Major nuisance factors are roots causing damage to a neighbour's retaining wall, leaf/twig litter blocking gutters & accumulated honeydew making the drive slippery on approach to the front of the house. | | | | | | | | | | | | | | | | | | | | | | | | | | |

| Risk Categories | | | | | | | | | | | | | | | | | | | | | | | | | | |
|---|---|---|---|---|---|---|---|---|---|---|---|---|---|---|---|---|---|---|---|---|---|---|---|---|---|---|
| 1. Prune to reduce end-weight & install cable support system to mitigate potential failure risks associated with tree | | | | | | | | | | | | Residual Risk | Low | | | | | | | | | | | | | |
