# Memorandum

**TO:** Laura Mulder – Planner, Resource Consents  
**FROM:** Mark Roberts – Arborist, Roberts Consulting Ltd  
**DATE:** May 4, 2026  
**SUBJECT:** LUC-2026-113. 4 Cemetery Road East Taieri (East Taieri Presbyterian Church)

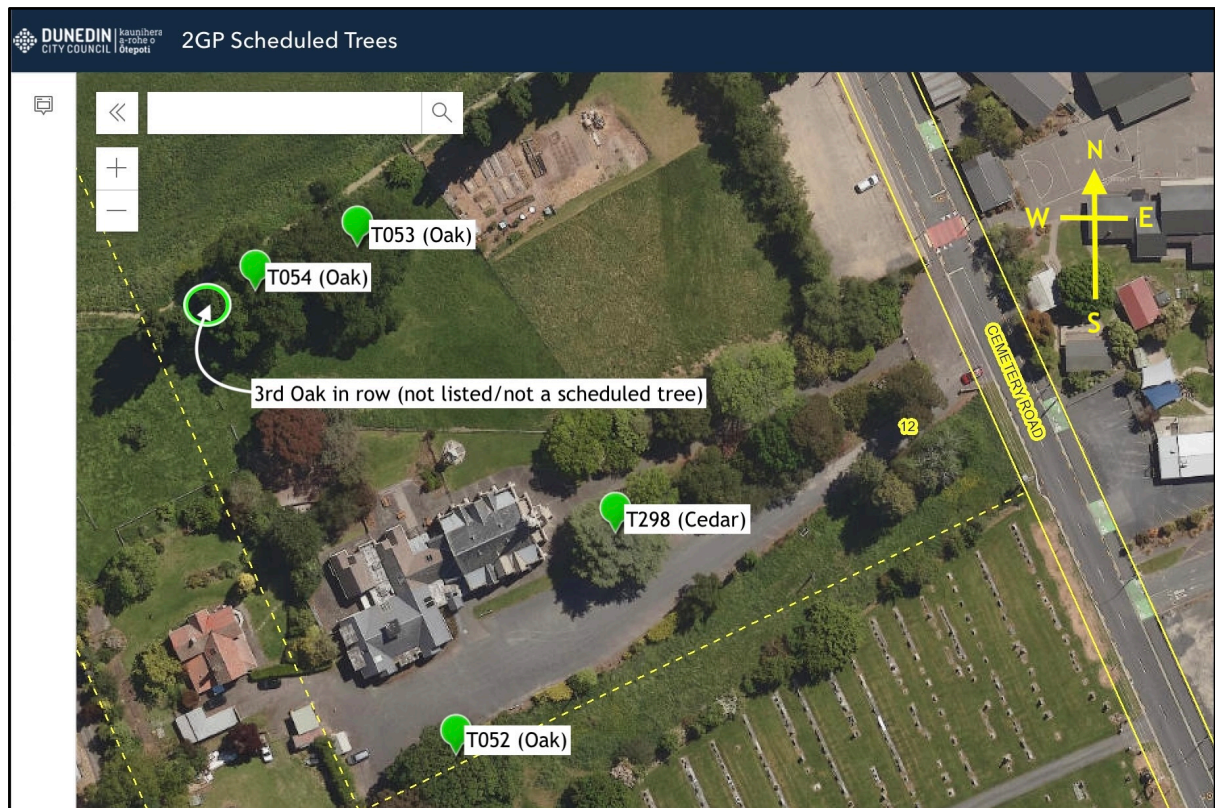
I undertook a site visit on Wednesday, April 29, and met with the applicant, Leeanne McKinlay. I was shown three trees, all of which were to the north of the church, and all exhibited storm damage. Those trees were scheduled tree T053, scheduled tree T054, and a third oak tree to the west of T054 that does not appear to be a scheduled tree (image one). I assessed the condition of those three trees on the afternoon of April 29.

**Image one:** Image showing the location of the 2GP Scheduled trees at 4 Cemetery Road East Taieri as seen on the DCC Dunedin Maps ArcGIS page (May 4, 2026). The three trees discussed in the consent application LUC-2026-113 can be seen in the top of the image. T052 is at the bottom of the image – completely separated from T053 and T054.

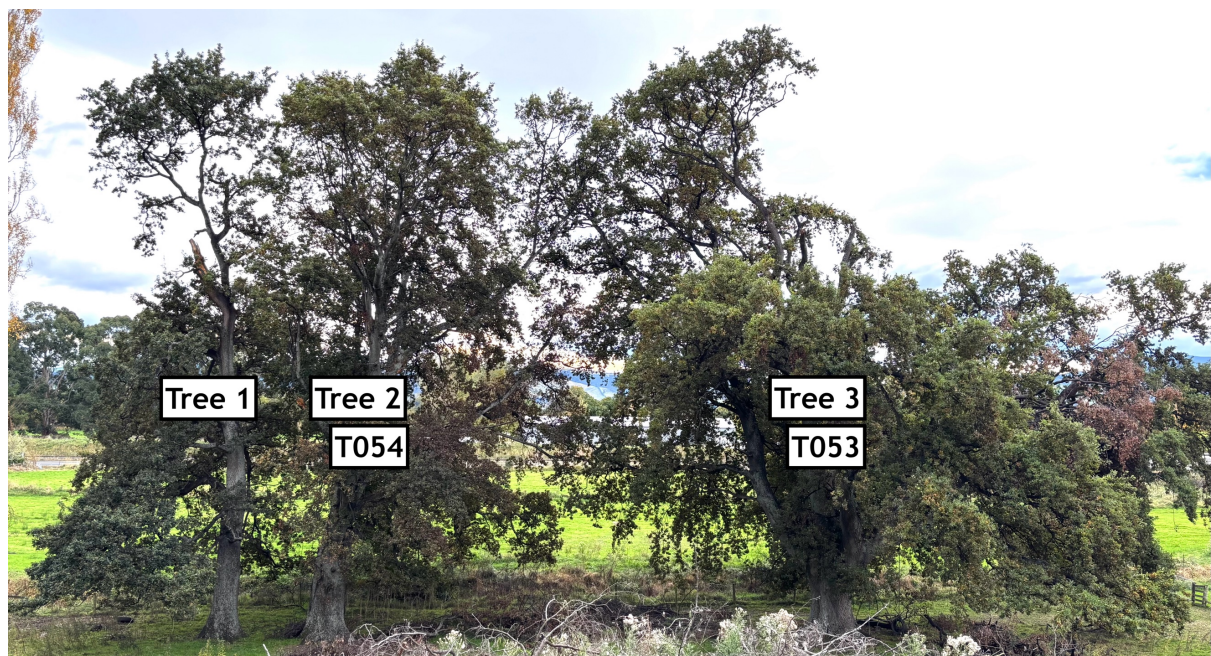
- The canopies of the three trees touch, the row extends for about 50m and runs basically from the south-west to the north-east.
- Each of the three trees had suffered significant storm damage. The damage wasn't fresh.
- Due to the distance from the church and the occupancy of the field, it is unlikely that trees could pose a risk to parishioners and/or property. But the current state of the trees prevents safe use and full access to the land under them.

General observations of the three trees in the field to the north of the church (image two)

- The western-most tree is a free-standing specimen and there is no indication that it is, or has ever been, a scheduled tree. Although the tree has sustained storm damage, I do not believe that the Council has authority over this tree as it falls outside the scheduling regime.

**Image two:** Photo of the three storm damaged oak trees in field to the north of the (the western-most tree is tree 1)

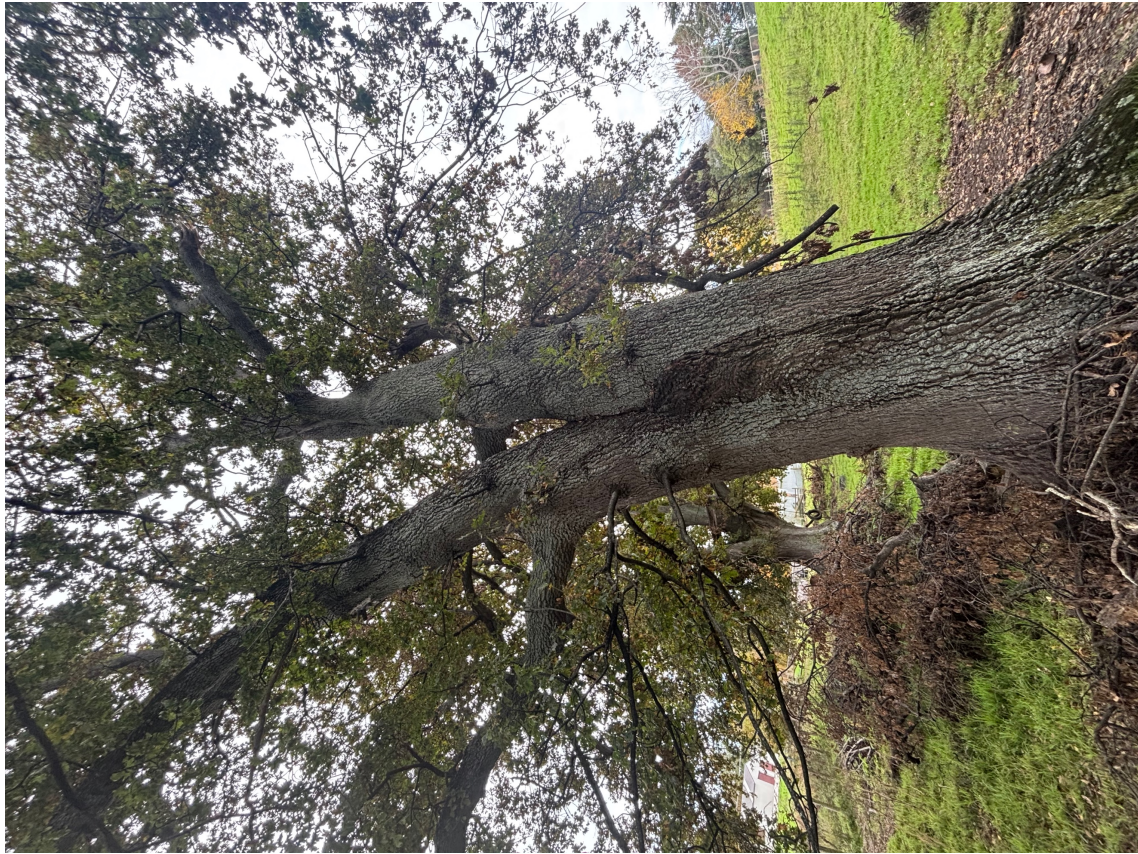
- The middle tree (T054) had some broken and damaged limbs. It had a phototrophic lean towards the north and bark inclusions on both sides of the trunk from about 2.5m down to ground level (image three). This tree is not in terminal decline.

**Image three:** Photo of T054 (the centre tree) shown the bark inclusion and the lean towards the north

- I recommend the removal of scheduled trees T053 and T054 as they pose a significant risk to personal/public safety [Policy 7.2.1.2]

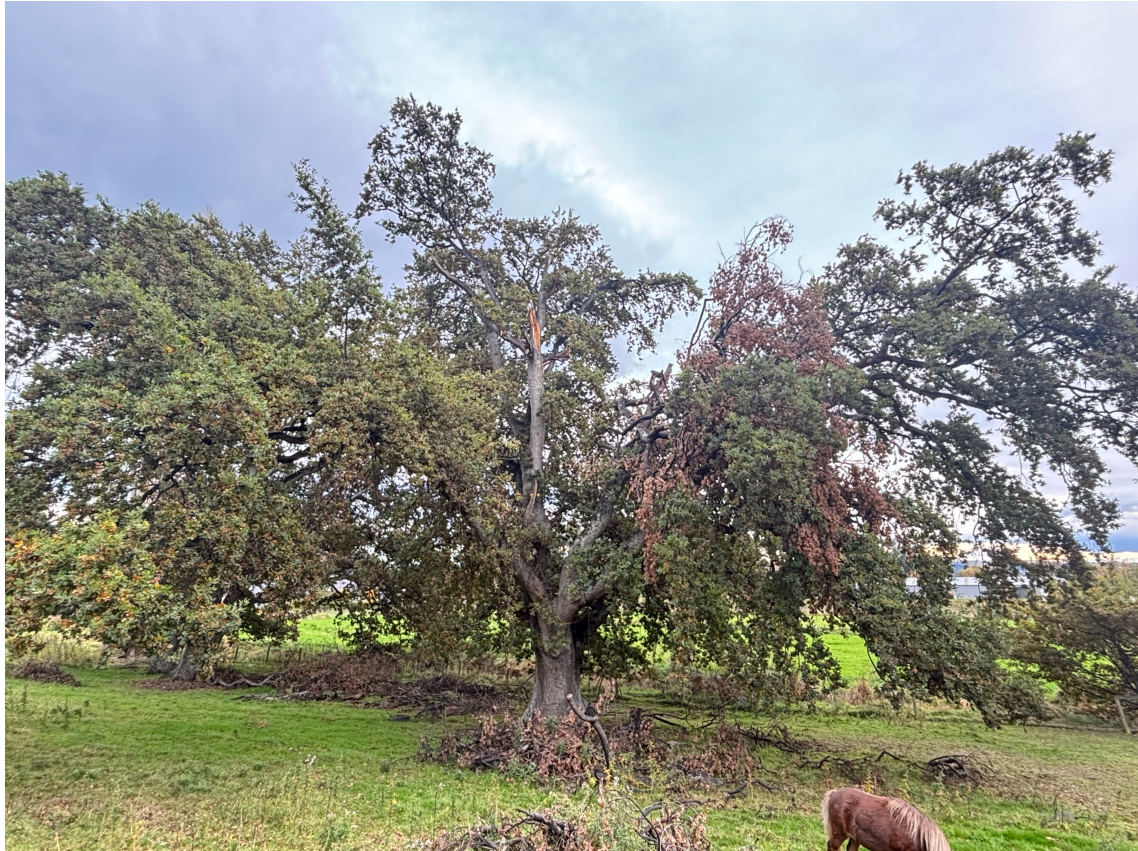
- The eastern-most tree (T053) had considerable damage and had possibly lost 40 to 50% of its upper canopy (image four). This tree is not in terminal decline.

**Image four:** Photo of T053 (the eastern-most tree) showing the extent of the damage (the lost upper canopy)
