# **SECOND GENERATION DISTRICT PLAN**

## **Variation 2 – Additional Housing Capacity Part 3 – Sites Proposed for Rezoning**

## **Appendix D.2**

### **Evidence on Hazards**

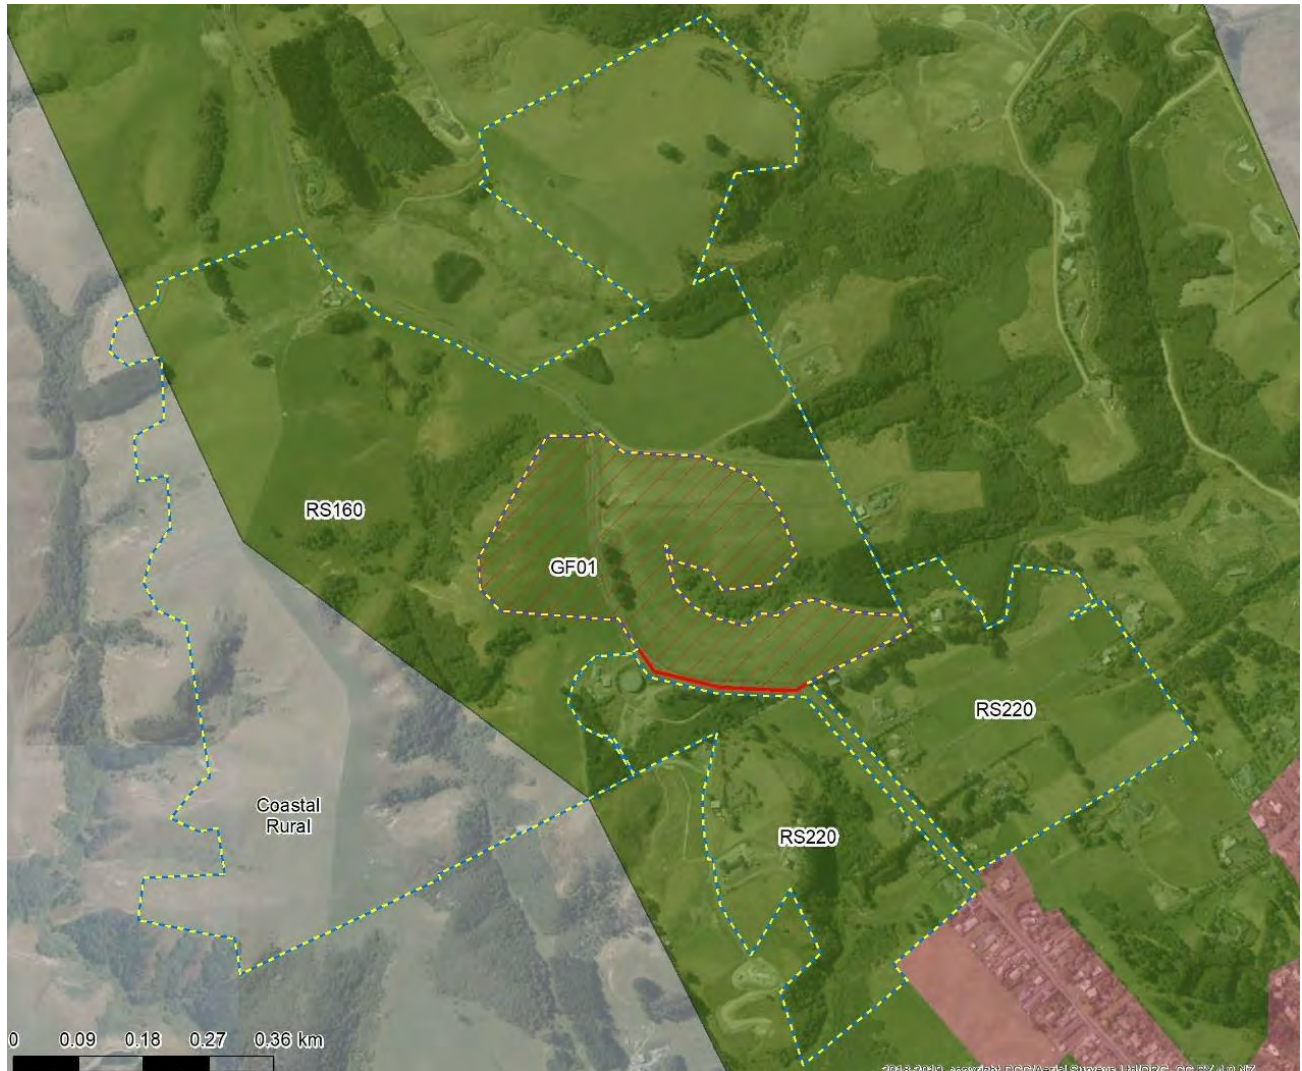
Figure 1 – RS220: 53, 64, 73, 74, 80, 85, 86, 92, 100, 103, 103A, 123, 127 SCROGGS HILL ROAD

The site consists of multiple landslide hazards relating to potential instability of the steep banks and gullies within the site area.

These land stability hazards does not exclude this site from development, but engineering assessments of these steep areas is definitely required to permit development and confirm the extents of the proposed site.

We consider that this site is a **medium level hazard**. This decision is based on the following summary of information:

- There are **medium level hazards** associated with slope instability on the site
  - o Global stability of steeper parts of the site appears to be governed by stormwater management and steepness/aspect of the slopes.
  - o Geotechnical advice will be required prior to subdivision of this site to confirm the extents of instability and ensure it will not affect any potential lots/structures. This may also identify any offsets that might be required from unstable areas.

Geotechnical assessment will be required to confirm the stability of proposed lots near steep portions of the site. Provided the site is found to be globally stable, some specific earthworks and stormwater management requirements would be applicable for lots on the site. It is likely that removal of trees from the gully areas will exacerbate instability.

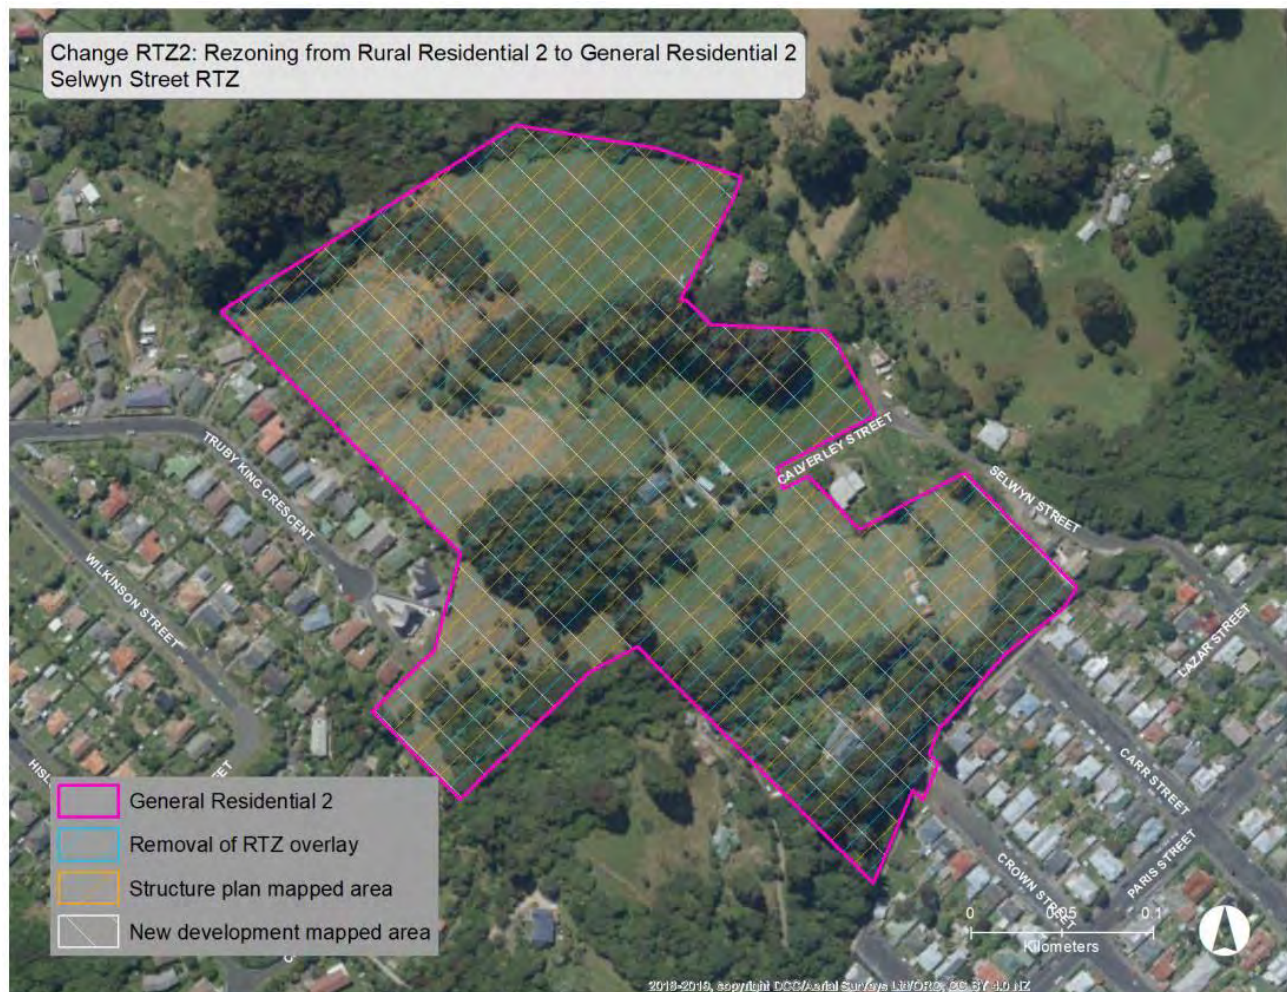
Figure 2 – RTZ2: 87 SELWYN STREET

There are no hazards identified within the hazards register for the proposed area, however there has been historic slips associated with rain events on nearby similar slopes.

We consider that this site is a **high level hazard**. This decision is based on the following summary of information:

- There are **high level hazards** associated with slope instability on the site
  - o The majority of the site consists of steep land over 15 degrees, and half the site is over 20 degrees
  - o There is previous history of land instability nearby within similar geology and slope angles.
  - o Some of the site is within typical stability limits, however there are significant areas of possible instability

Geotechnical assessment will be required to confirm the general stability of the site, especially for the steeper areas. Provided the site is found to be globally stable, requirements for earthworks consent would be normal for the lower lying land sloping by less than 12 degrees within this site.

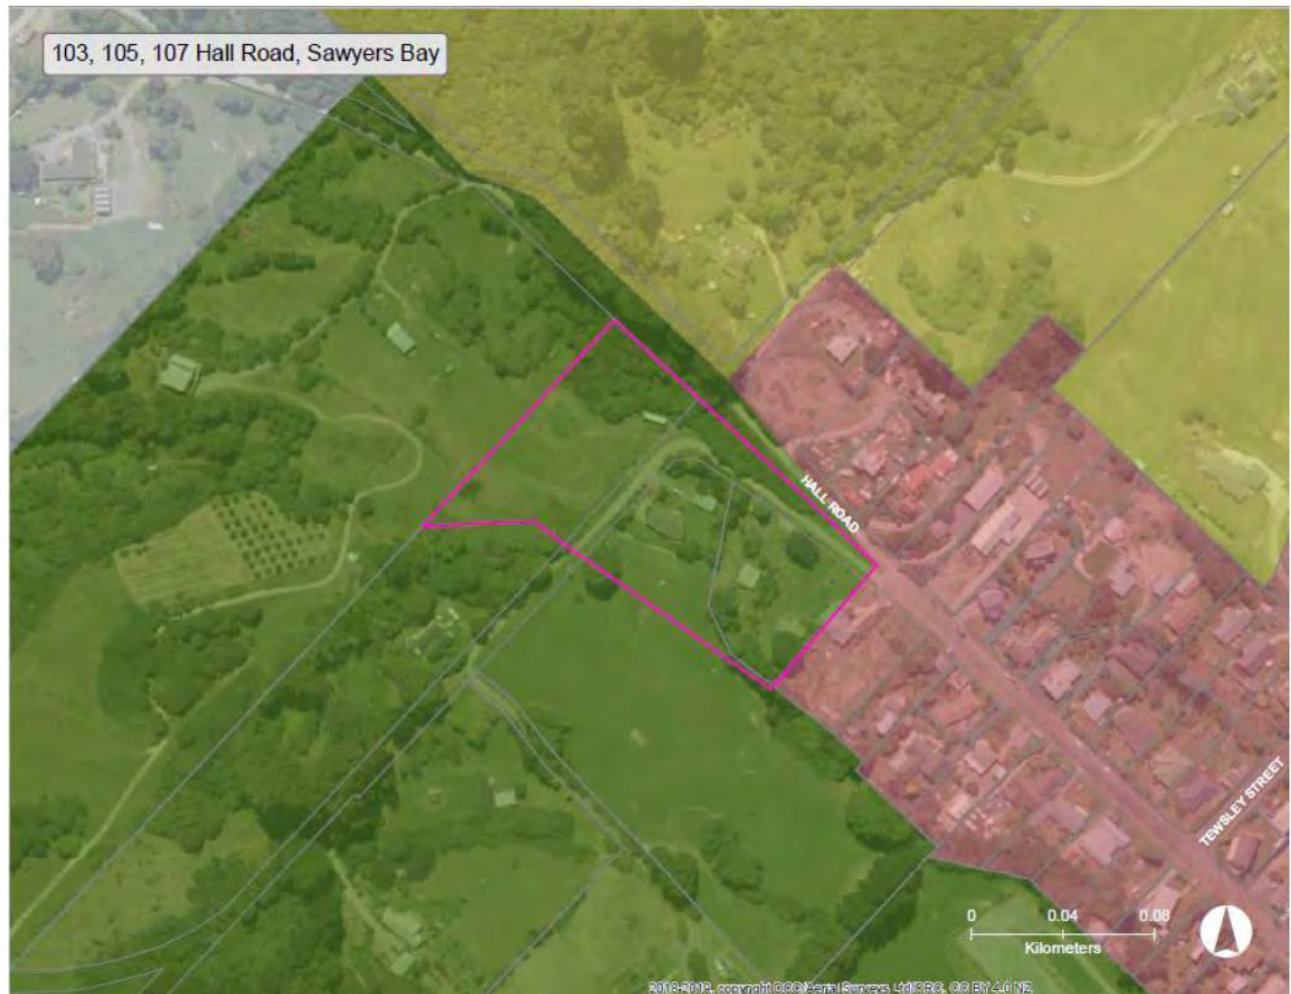
Figure 3 – RS170: PART 103, 105, 107 HALL ROAD, SAWYERS BAY

The land stability hazards above appear to be minor and related to alluvial deposition from flood events. This hazard affects the entire of Sawyers Bay. There are no other hazards on adjacent land that may affect this site.

We consider that this site is a **low hazards level**. This decision is based on the following summary of information:

- There are **no hazards** associated with slope instability
- There are no other listed natural hazards on the site which would affect development

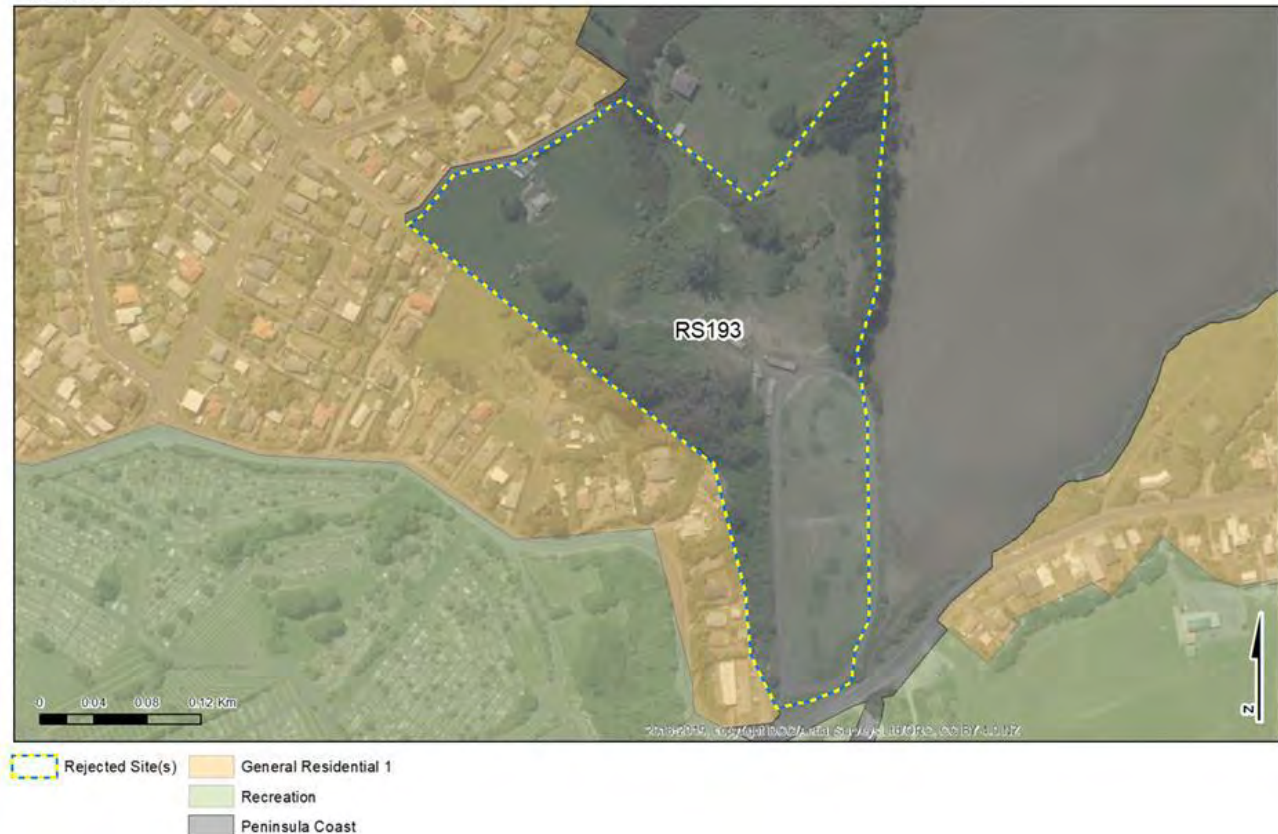
Figure 4 – RS193: 177 TOMAHAWK ROAD

- Hazard ID 10945: Land Stability – Subsidence (Landfill)  
The flat portion of the site adjacent to Tomahawk Lagoon is comprised of a landfill hazard zone. It is unclear whether this is related to landfill or unengineered earth fill.

The liquefaction and landfill hazard zones cover the flat portion of the site adjacent to Tomahawk Lagoon.

Although not listed as a hazard, the slopes are very steep and are likely to present land stability risks with such a dense format such as GR1.

We consider that this site is a **high level hazard** site. This decision is based on the following summary of information:

- There are several **high level hazards** associated with slope instability in the steep portion of the site:
  - o Much of the steeper slopes are sloping by over 20 degrees and global stability of the site could be affected by development, especially from earthworks and/or groundwater changes. Any global instabilities would affect multiple potential lots.
  - o Geological investigations are required to determine the suitability of the site.
- There is a **high level hazard** associated with liquefaction and landfill on the flat portion of the site
  - o The low lying land is unlikely to be suitable for development due to the low-lying nature of the land, potential for liquefaction/lateral spreading into the lagoon, and landfill.

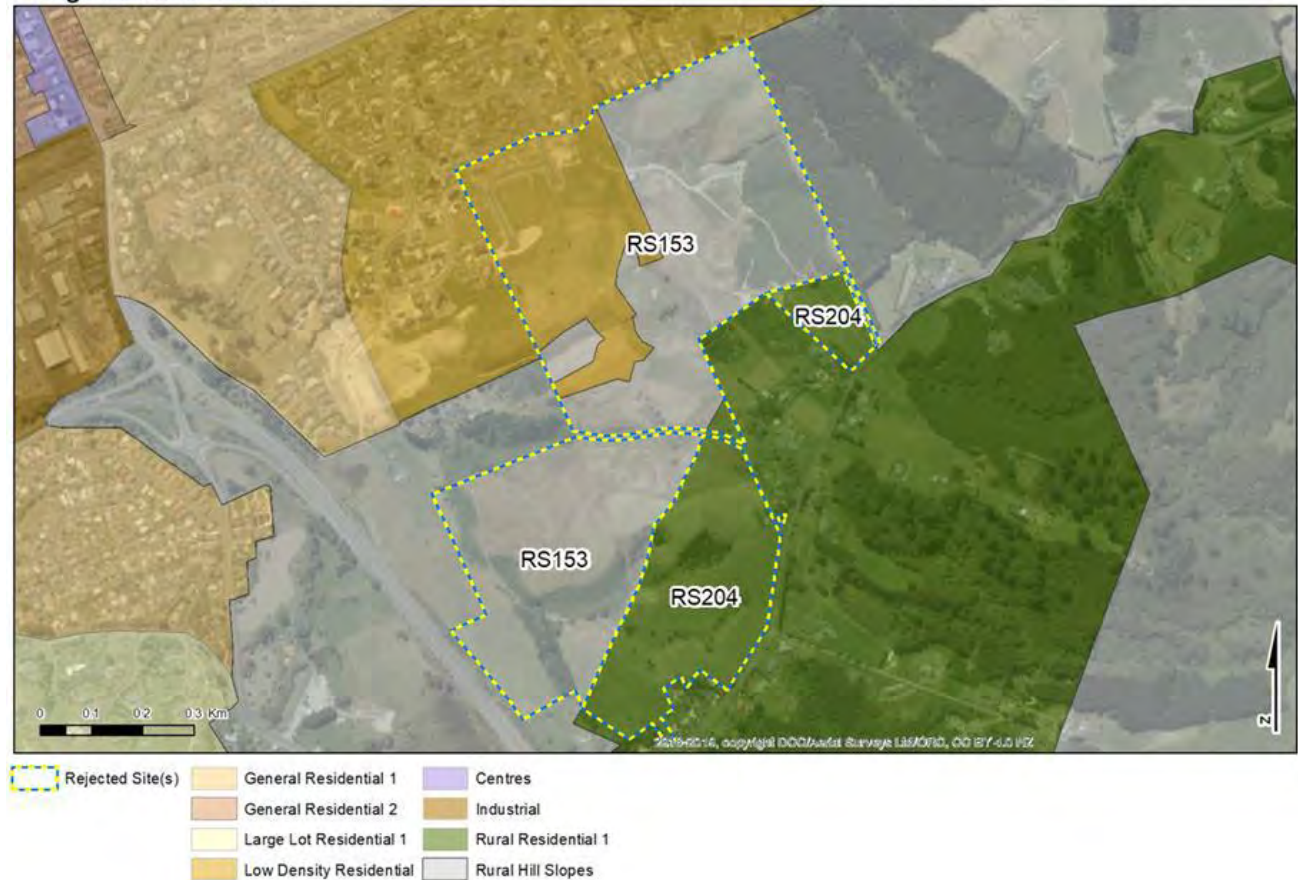
Figure 5 – RS204: 21, 43, 55, 65, 75, 79, AND 111 CHAIN HILLS ROAD

There are land instability hazards within the site and mapped historic landslides within nearby slopes. These are typically within steeper slopes of the same geology. Although the risk of land stability hazard is not excluded from this site, it is likely to be localized to steep slopes around gullies.

We consider that this site is a **low to medium level hazard**. This decision is based on the following summary of information:

- There are **low level hazards** associated with slope instability on the site in slopes less than 12 degrees adjacent to Chain Hills Road:
  - o Much of the site itself is within typical stability limits.

- There are **medium level hazards** associated with slope instability within gully features:
  - o Stability of steeper parts of the area appears to be uncertain (on slopes greater than 15 degrees). In some areas, the site is steep and with prehistoric landslide features that require geotechnical assessment.

Geotechnical assessment will be required to confirm the stability of the gullies across the site. Provided the site is found to be globally stable, requirements for earthworks consent would be normal for low angled lots (<15 degrees) within this area.

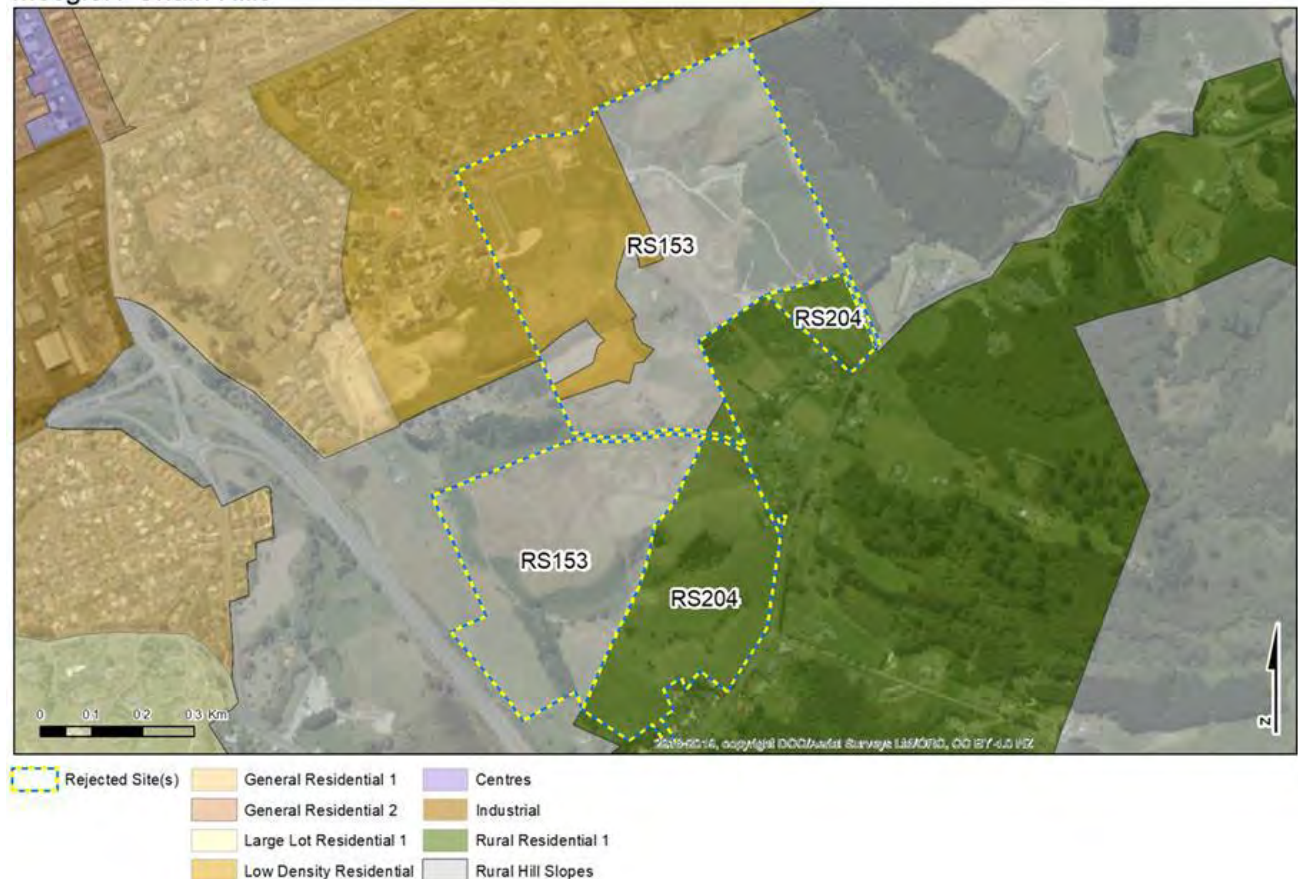
Figure 6 – RS153: 77 and 121 Chain Hills Road and 100 Irwin Logan Drive

There are land instability hazards within the site and mapped historic landslides within nearby slopes. There are also obvious locations of localized surface movement/erosion evident in the aerial photographs. Some of these appear to have been planted out to prevent further erosion/land movement.

We consider that this site is a **medium level hazard**. This decision is based on the following summary of information:

- There are **medium level hazards** associated with slope instability:
  - o Most of the site consists of undulating terrain with steep slopes over 15 degrees. In some areas, the site is steep and with prehistoric landslide features that require geotechnical assessment.
  - o Geotechnical advice will be required prior to subdivision of this site to confirm the extents of any instabilities and ensure the proposed subdivision layout will not limit the ability to address these hazards. This may also identify any offsets that might be required from unstable slopes

Geotechnical assessment will be required to confirm the stability of the gullies across the site. Provided the site is found to be globally stable, requirements for earthworks consent would be normal for low angled lots (<15 degrees) within this area.

We do not anticipate that this site will be generally unstable, though much of it will be unsuitable for structures. Geotechnical advice will need to identify building platforms and lot layouts/sizes that will work with the terrain features and not confuse the ability to address these hazards.

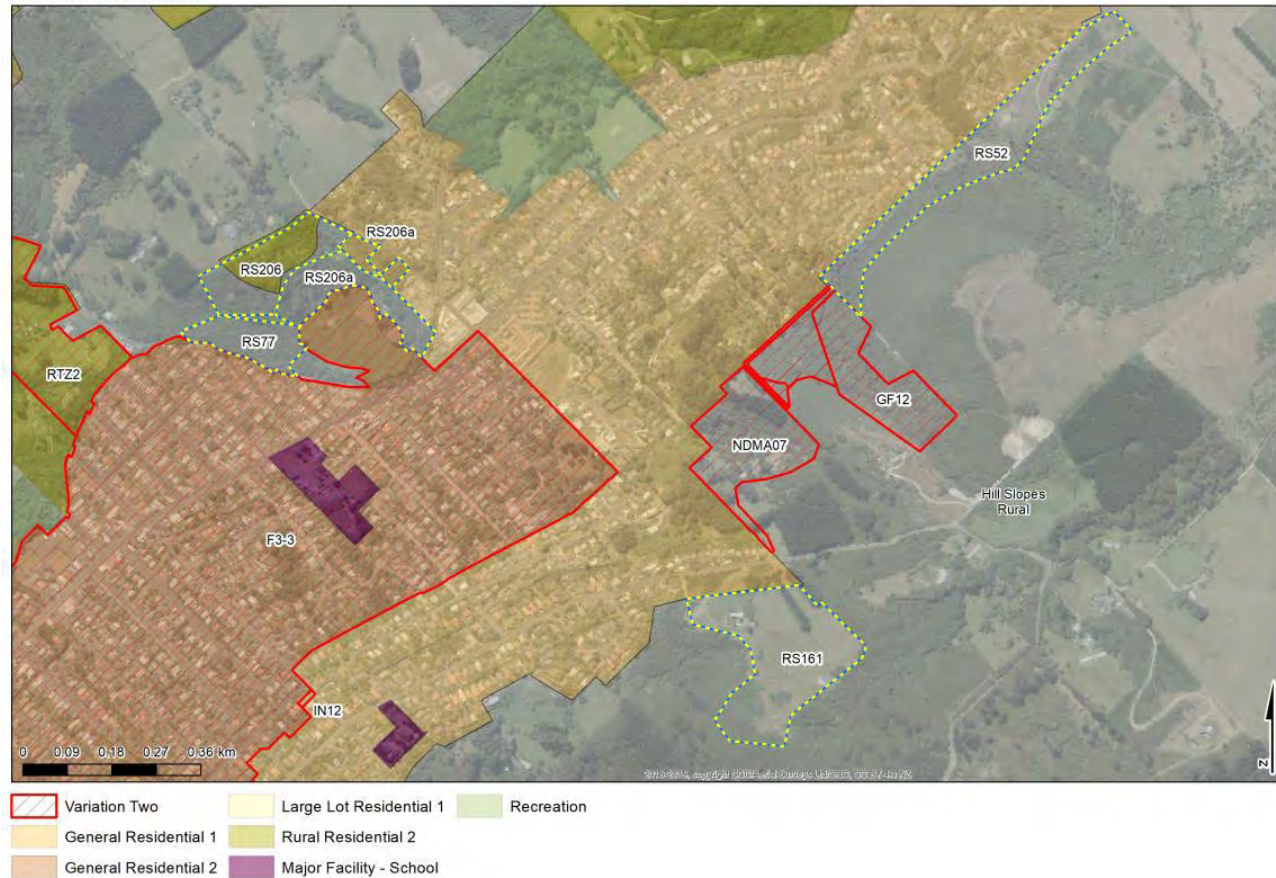
Figure 7 – RS161: PART 210 SIGNAL HILL ROAD

There are no hazards on this site or adjacent land that may affect this site within the hazards register.

We consider that this site is a **low hazard level**. This decision is based on the following summary of information:

- There are **low hazards** associated with slope instability within the proposed area. The area appears to have been explicitly chosen to avoid the steeper slopes surrounding the site.

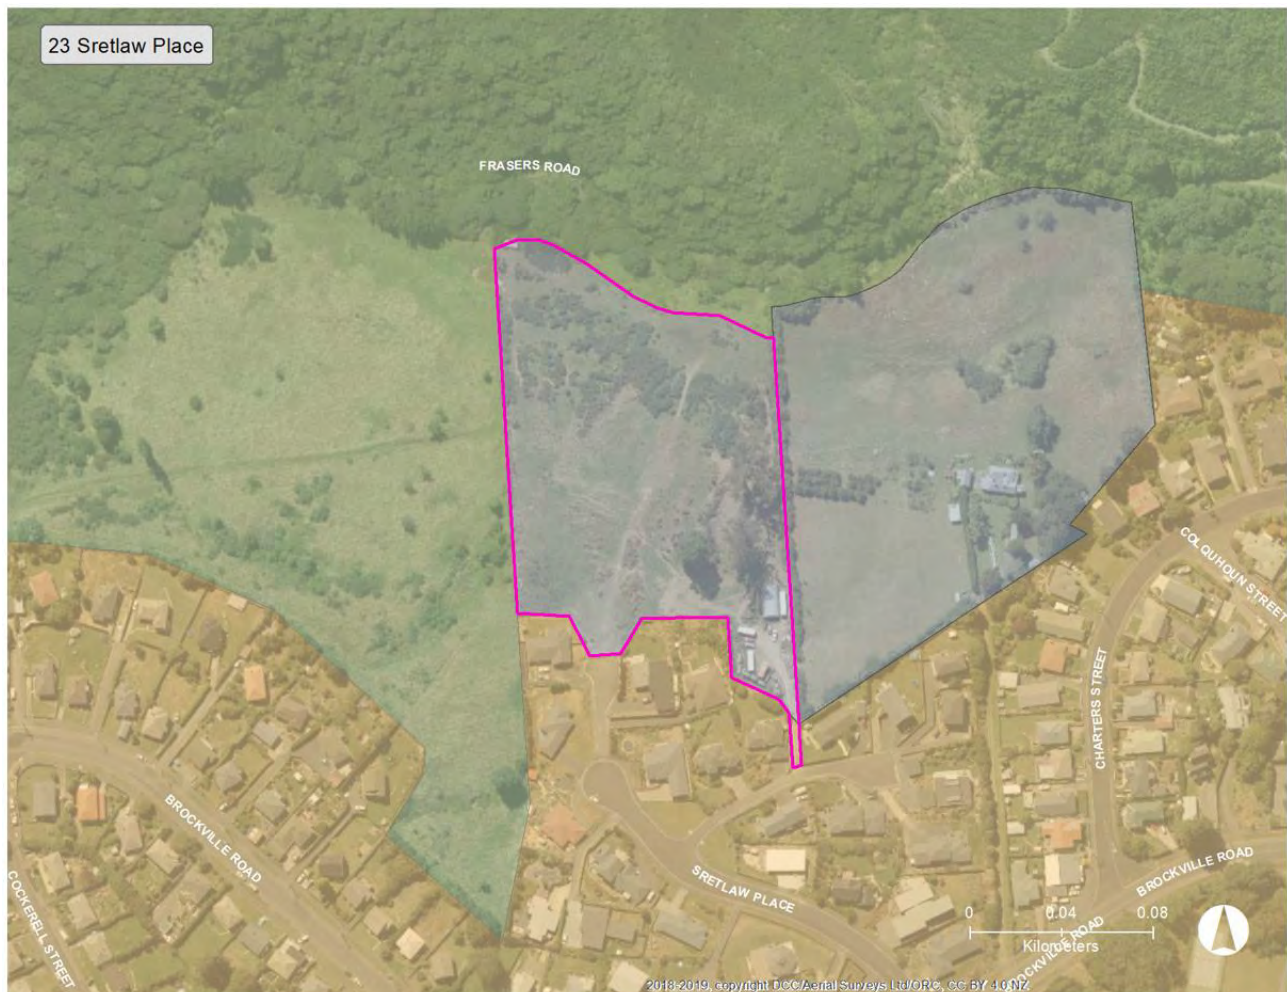
Figure 8 – RS110: 23 SRETLAW PLACE

The above land stability hazards indicate that the site has some landslide debris from an ancient uphill landslide. There are also nearby slopes on adjacent lots with existing land instability. We found historical maps with land stability awareness zones that extend into the site.

We consider that this site is a **low to medium level hazard**. This decision is based on the following summary of information:

- The site slope angles are moderate, and there appears to be no significant landslides on the site. However,
- There are several sources of information to suggest the site has been inundated with landslide debris and affected by landslides from other lots. We consider the site to have **medium level hazards** associated with slope instability.
- Geotechnical advice will be required prior to subdivision of this site to confirm the extents of any instabilities and ensure the proposed subdivision layout will not limit the ability to address these hazards. This may also identify any offsets that might be required from unstable slopes or landslide debris.

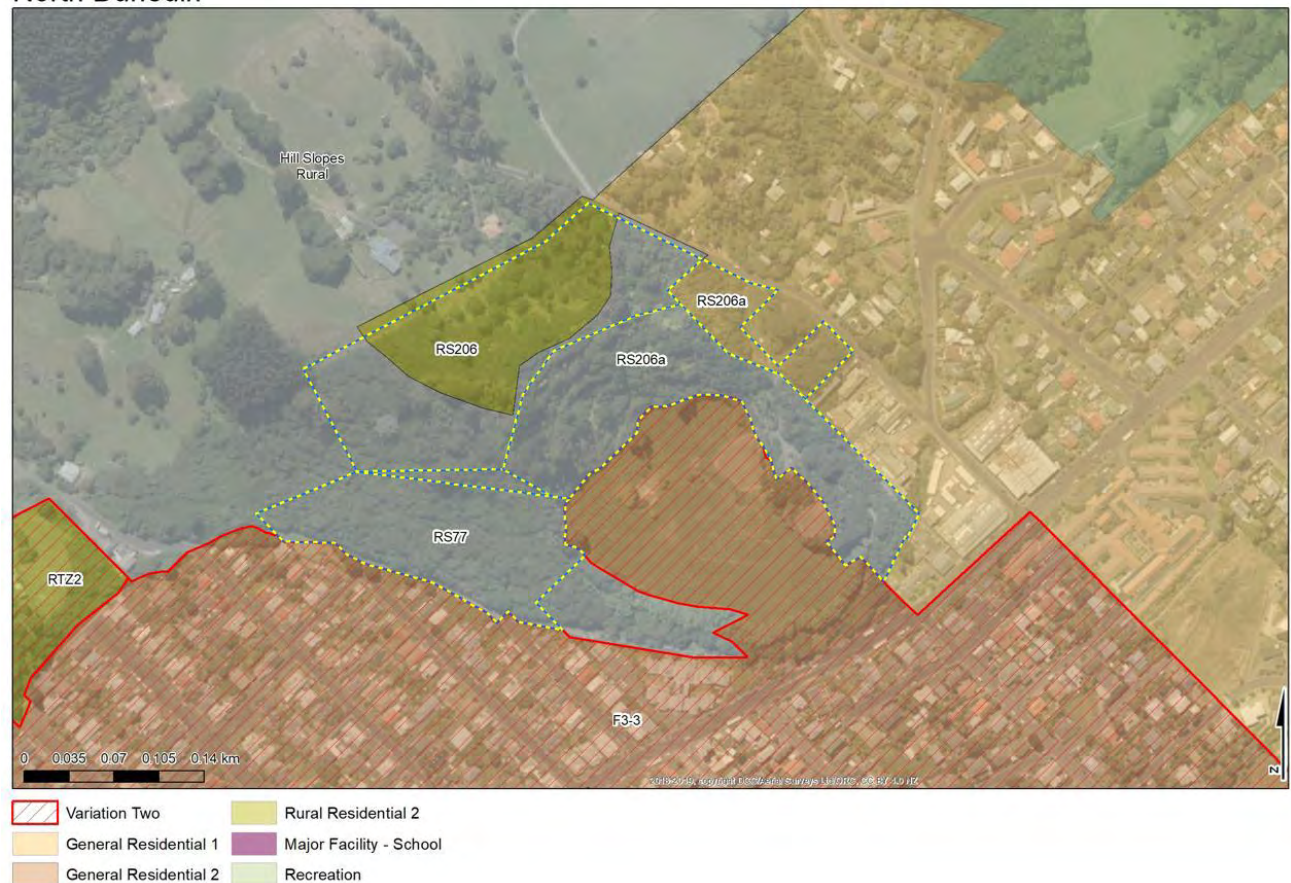
Figure 9 – RS206, RS206a, RS77: Part 35 and 43 Watts Road, Part 109 North Road

Both hazards on the site are associated with the eastern boundary of the site to Watts Rd. There was a historic slip associated with a rain event on the bank of this site.

There is also a large hazard associated with the historic quarry activity in the middle of the sites.

We consider that this site is a **high level hazard**. This decision is based on the following summary of information:

- There are **high level hazards** associated with slope instability on the site
  - o Most of the site consists of steep land over 20 degrees
  - o There is previous history of noted land instability on the eastern slopes of the site
  - o Some of the site is within typical stability limits (there is a small flat area on 43 Watts Rd), however the majority of the land has significant areas of possible instability

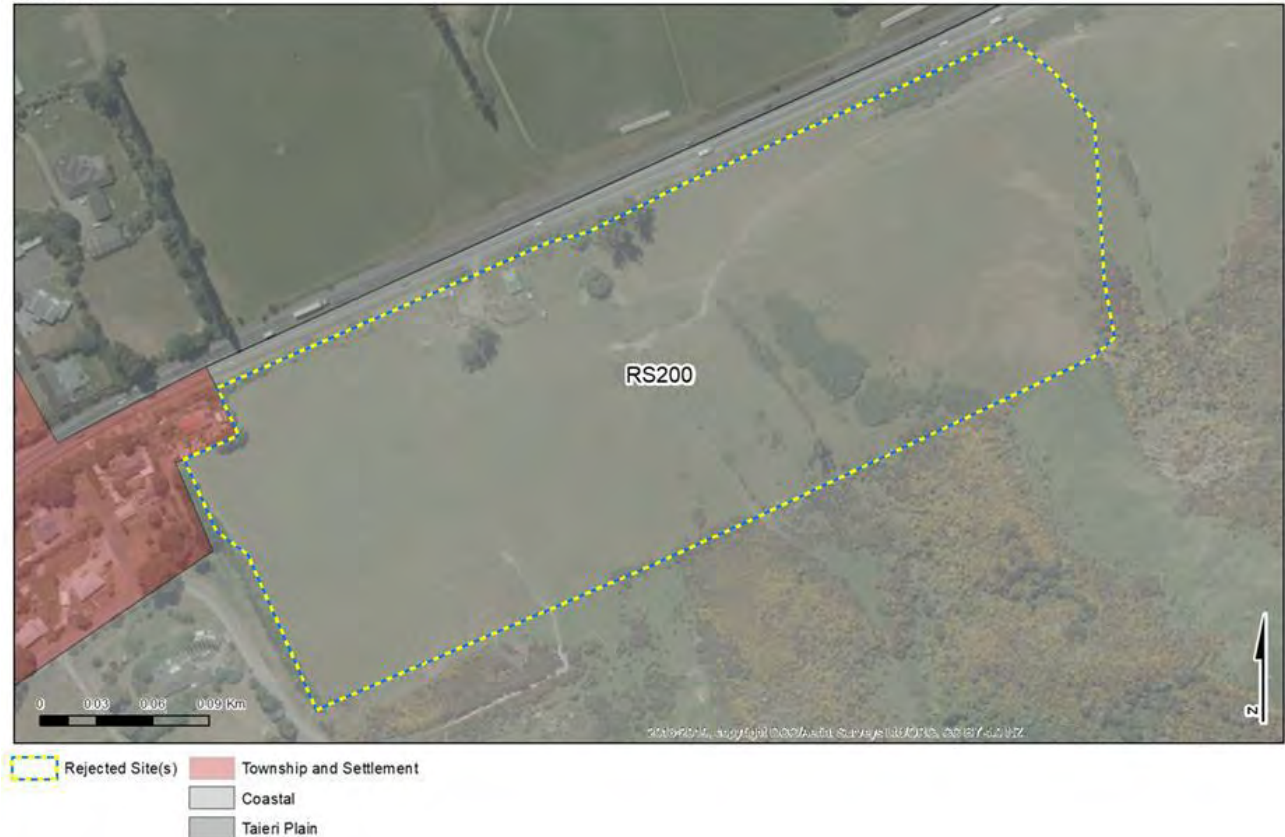
Figure 10 – RS200: 489 EAST TAIERI-ALLANTON ROAD

All the hazards are relating to flood and liquefaction associated with weak floodplain alluvium on the lower lying portion of the site. This is no different than many other locations within Allanton and is controlled using engineering design for foundations and guidelines for minimum floor levels.

We consider that this site is a **low hazard level**. This decision is based on the following summary of information:

- There are **low level hazards** associated with flood hazard on the site:
  - o The site lies within flood hazard overlays that are typically mitigated through minimum floor levels implemented at the time of subdivision.
  - o The site contains a important watercourse that are more than minor and affect neighboring land. It is unlikely that anyone will build on the lowest portion of the site, however, further assessments of stormwater management and offsets from the watercourse would be required to ensure any development does not have adverse effects.

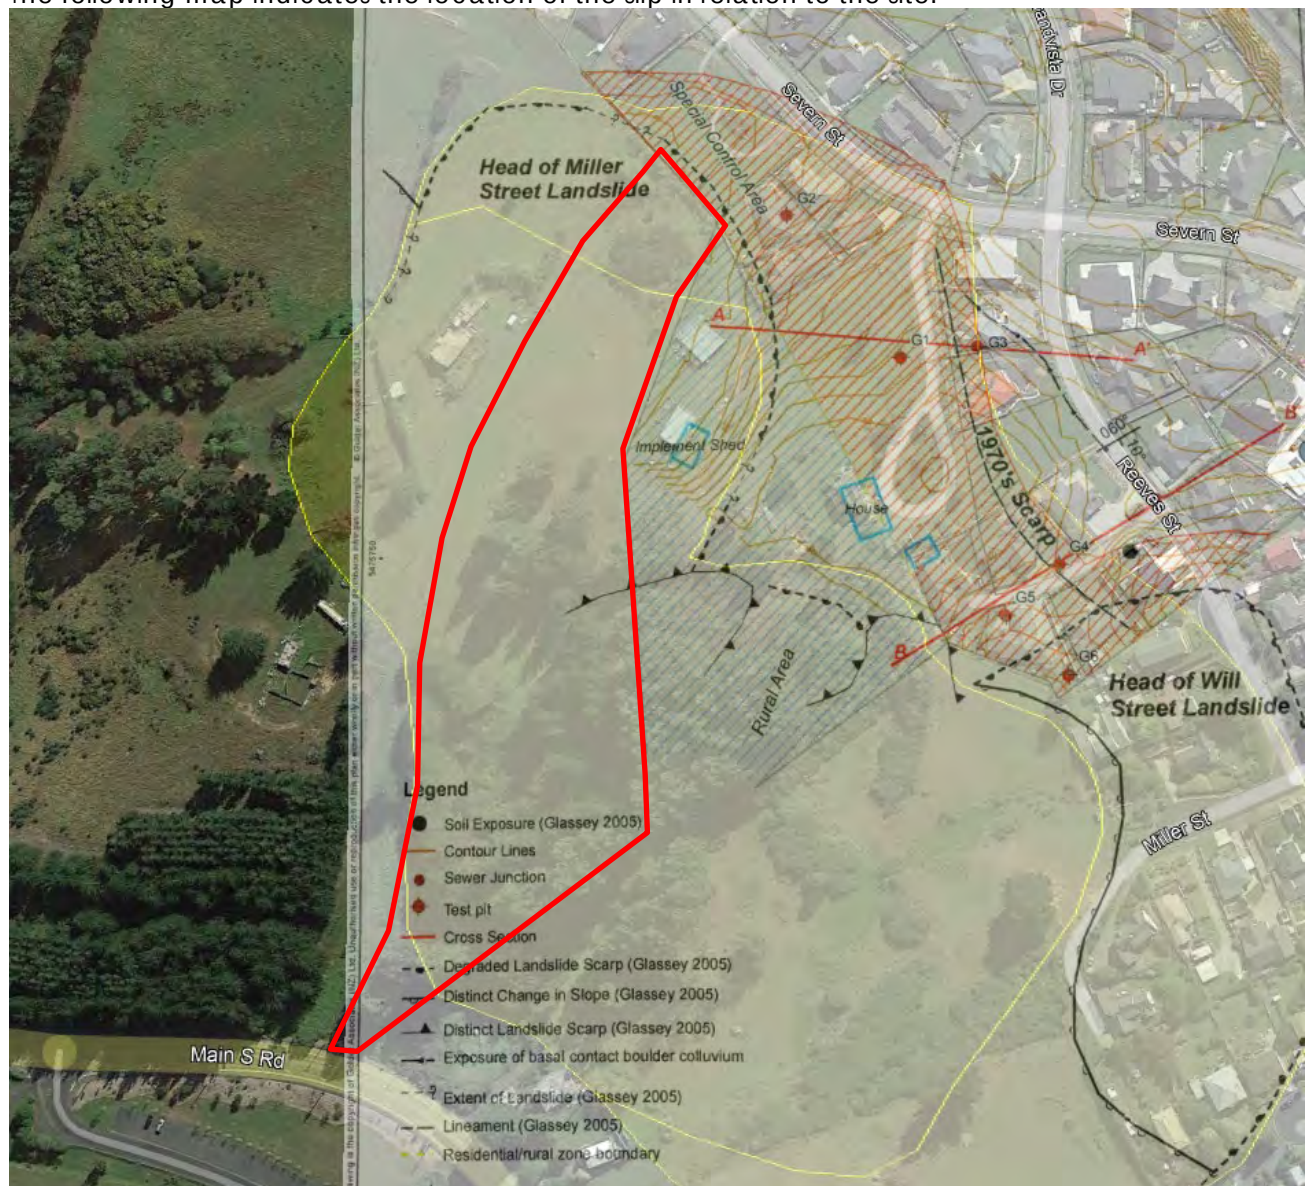
The following map indicates the location of the slip in relation to the site.

We recommend that specific geotechnical advice is sought before any zone changes in this area. From our desktop assessment, the site appears to be unsuitable for any subdivision or reduction in lot sizes where there are massive landslips present. Detailed site investigations would need to be undertaken to support any development proposals in this area.
