## BEFORE THE COMMISSIONERS APPOINTED BY THE DUNEDIN CITY COUNCIL

**AND** Variation 2 to the Dunedin

BETWEEN GTJM PROPERTY

## BRIEF OF EVIDENCE OF JAMES MOLLOY DATED 5 AUGUST 2022

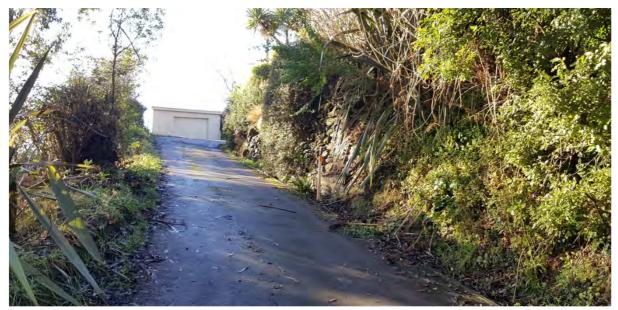
replacement of the existing stacked rock retaining wall in the northwest area of the site. The current access within the DCC Road Reserve area is a narrow roadway with a number of old retaining walls and over steep slopes, so consideration should be given to improving this to a more modern and reliable accessway, including developing appropriate sight distances for approaching and departing traffic off Portobello Road.

Plate 1: View of the driveway entrance with stacked rock retaining wall in the background.

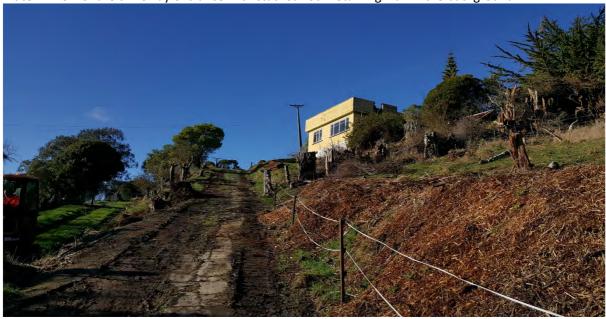
Fills were encountered at 0.3m to 0.7m depth in the lower northwest area of the site and 0.4m depth below the existing house building platform, which will also have thicker layers of fills used to form the outer slopes of the platform. The fills comprised of what appeared to be locally excavated soil with minor gravel and cobbles throughout. All fills are noted to be soft and are overlying the original topsoil.

**Plate 2:** View of the mid area of the site looking up at the existing house.

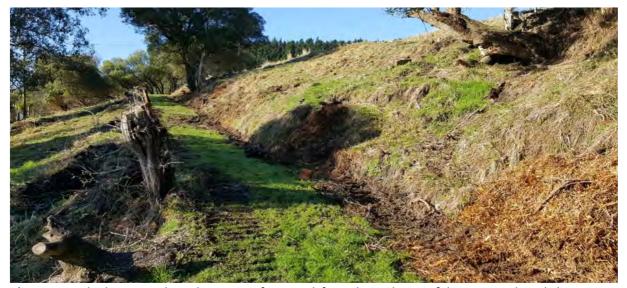
Plate 3: View looking east along the existing farm track from the midpoint of the proposed road alignment.

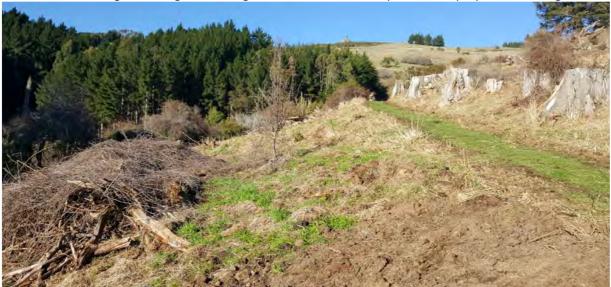
Plate 4: View looking southeast over the eastern area of the site.

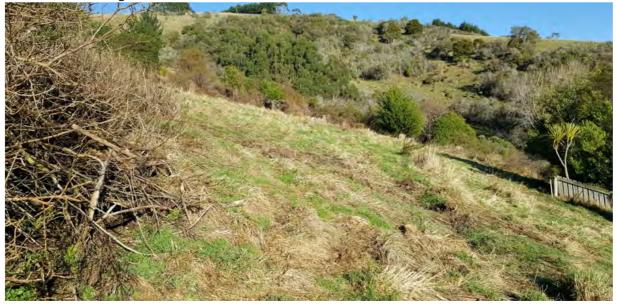
**Plate 5:** View looking southwest over the western area of the site.

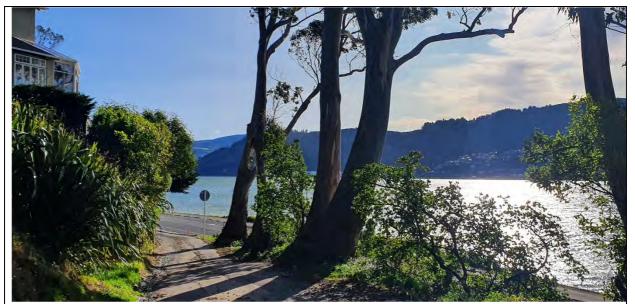
Plate 1: - Weller St entry off Portobello Rd, noting the leaning gums trees with preferential pruning to the hill side

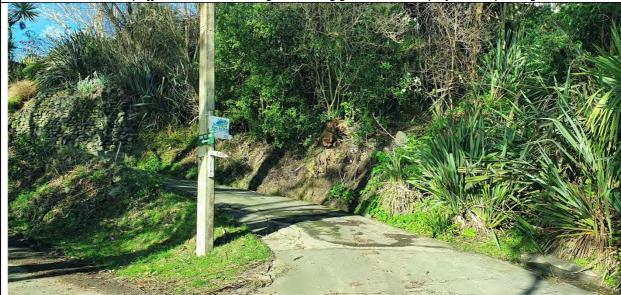
Plate 2: View further up Weller St at single lane accessway to the site with random rubble rock wall in upper area.

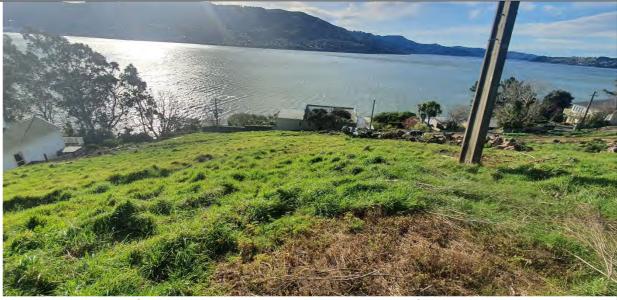
Plate 3: Panorama view from Lot 10 boundary, noting no obvious evidence of historical land slide instability

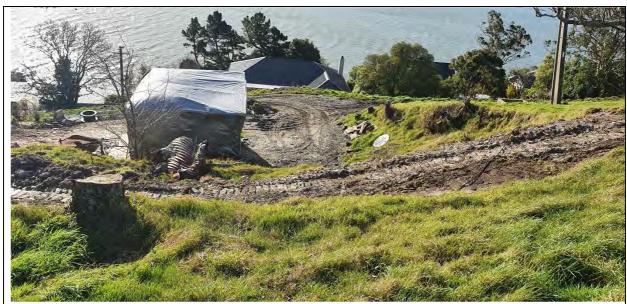
Plate 4: Looking down on demolished house site with over steep formed slopes and non-engineered fills at front.

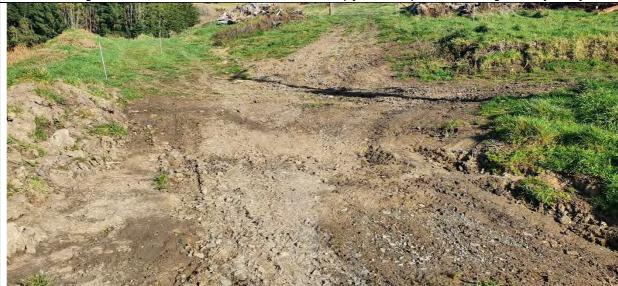
Plate 5: View at intended upper roundabout location where three farms track intersect, with little erosion noted.

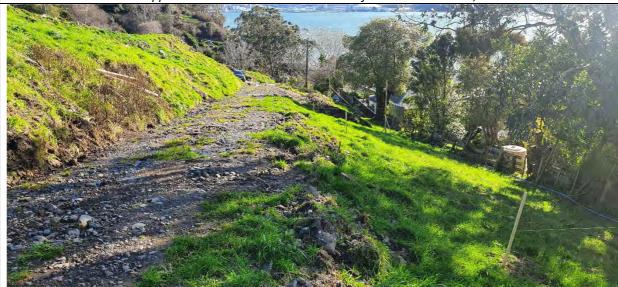
Plate 5: Looking down the lower farm track (GHD ch250) with existing steep non-engineered fills on side slopes
