30 June 2021
Terra MDC Limited
82 Bond Street,
Central City
Dunedin 9016
New Zealand

Project Reference: 202106304

RE: Preliminary Geotechnical Assessment of Land for the Proposed Subdivision at 336 Portobello Rd, Dunedin

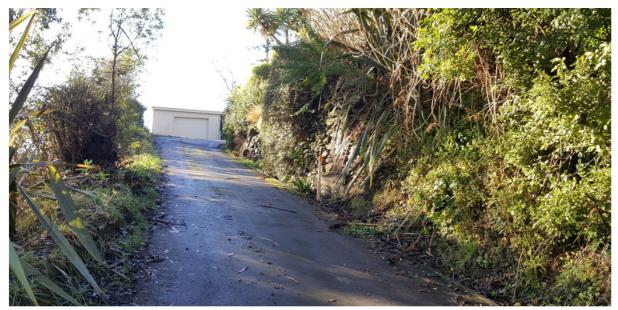
There is a number of section of over steepened slopes above the driveway in the northwest area of the site that has slumped and is undermining the fence posts above. The slippage is likely due to the steep bank suffering ongoing erosion and wetting causing the soils to become too weak to support the slope angle. The two power poles on the northwest side of the site were noted to be leaning forward. This either due to ongoing soils creep or shallow embedment within the soft upper stratum of loess. As there were no signs of undulating ground surrounding the area, the leaning pole is likely due to shallow embedment.

Plate 1: View of the driveway entrance with stacked rock retaining wall in the background.

replacement of the existing stacked rock retaining wall in the northwest area of the site. The current access within the DCC Road Reserve area is a narrow roadway with a number of old retaining walls and over steep slopes, so consideration should be given to improving this to a more modern and reliable accessway, including developing appropriate sight distances for approaching and departing traffic off Portobello Road.

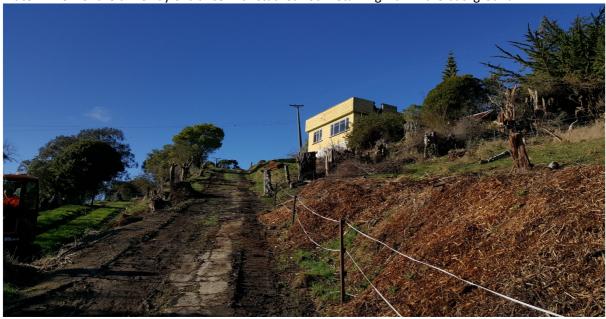
Plate 2: View of the mid area of the site looking up at the existing house.

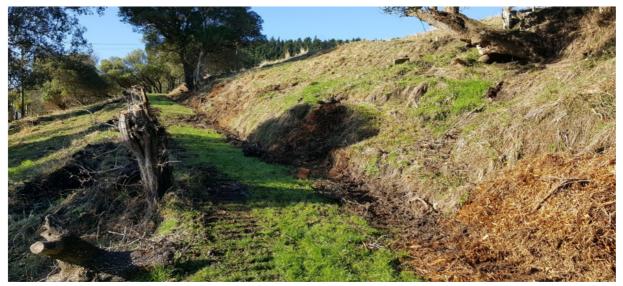
Plate 3: View looking east along the existing farm track from the midpoint of the proposed road alignment.

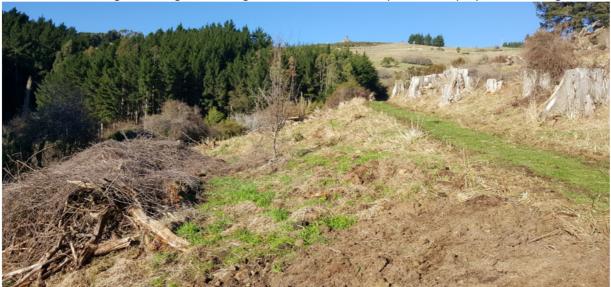
Plate 4: View looking southeast over the eastern area of the site.

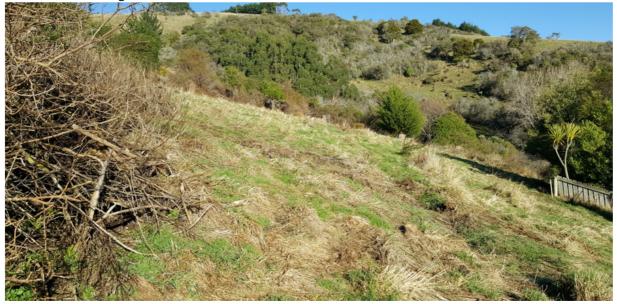
Plate 5: View looking southwest over the western area of the site.
