Talk re stormwater problems in areas near  
NDMA05 + NDMA10 8/13/2021

### Next NDMAIO Stormwater Problems

URBAN CAPABILITY MAP FOR PROPOSED SUBDIVISION- DALZIEL ROAD.

# Appendix B Council Officers Reports

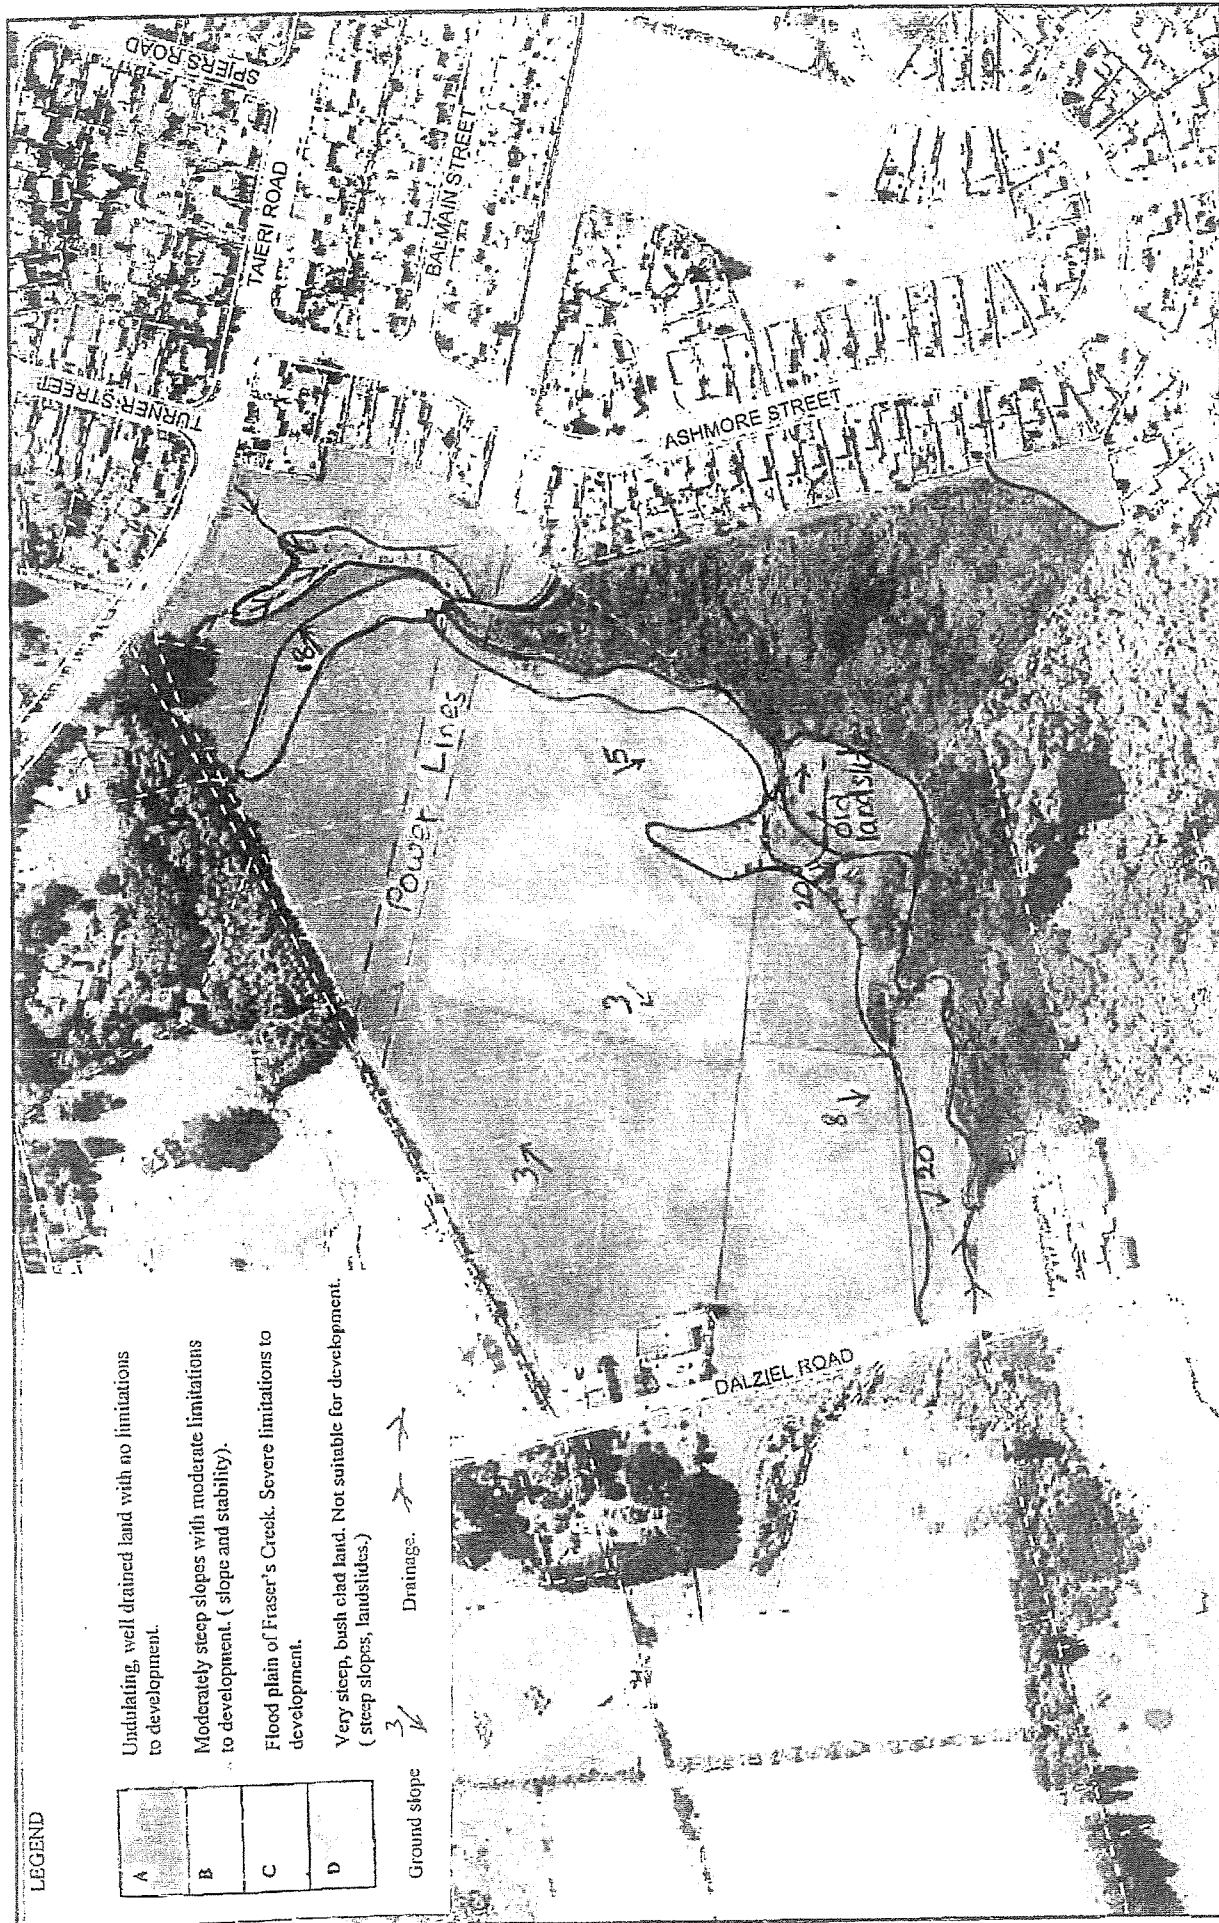
Note Swale drains ~~at~~ the side of Dalziel Rd don't contain continuous rain successfully. At the bottom left-hand corner of NDMA05 there has been

a landslip. This fact is documented on maps. See ref. Appendix B Council Officers Report Feb 2016. Has currently been disregarded since last reported on, and there have been many serious rain events since then. Put houses and concrete above it and that could cause further instability. My comment Another event such as Abbotsford could occur. Alice will speak further on this area and damage caused to walking tracks and flooding in Kaituma Valley.
