Taieri Gorge Rail Corridor Structures Condition Assessment

Revision 2
25 November 2022
145138.31

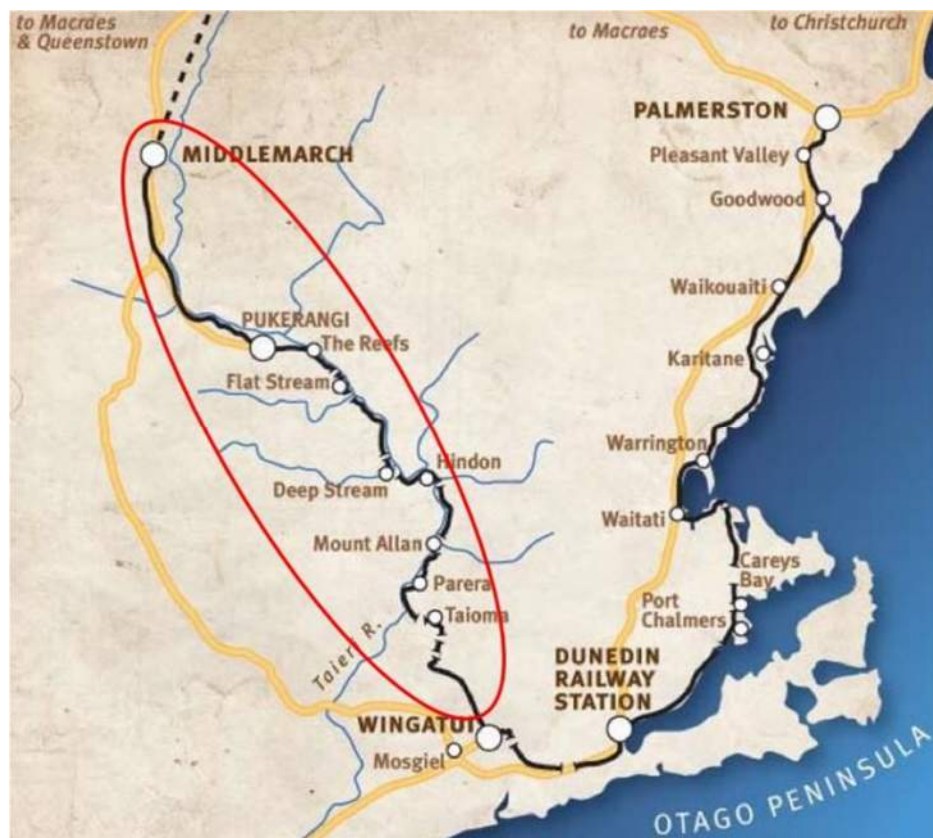
Figure 1 - Location and extent of assessments

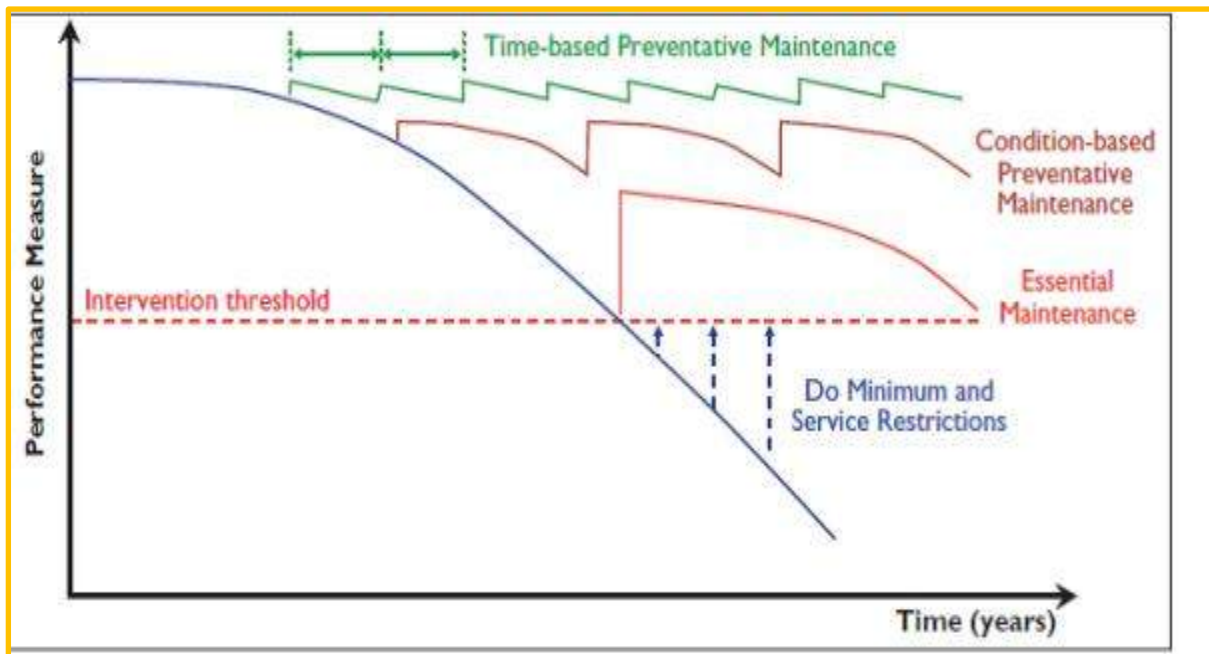
Figure 30 - Asset management strategies
