**KAIKORAI PRESBYTERIAN CHURCH  
CNR TAIERI RD & NAIRN ST  
DUNEDIN**

**SEISMIC ASSESSMENT REPORT**

**DATE:** 09 September 2015

**REFERENCE NO:** 14083

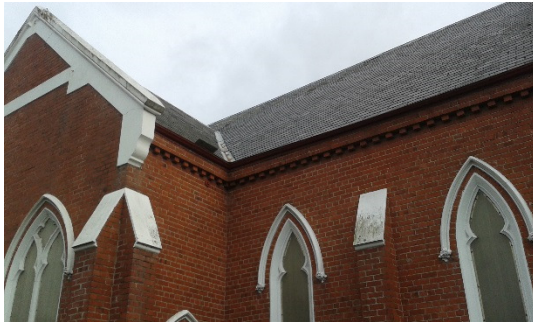
Top of Side walls

- The pointing to the mortar joints is coming out in places, especially higher up the building;
- The mortar behind the pointing is a lime/sand mortar, which is very soft in areas (where it has been exposed to moisture for a long time) and firm in other areas;

So, to ensure the building will behave as assumed in the analysis, all deteriorating mortar joints are to be repaired. This can be done by raking out the very soft mortar with a finger (or some other soft tool) and tooling in new lime sand mortar. All of the affected mortar joints are then required to be repointed with a cement based mortar.

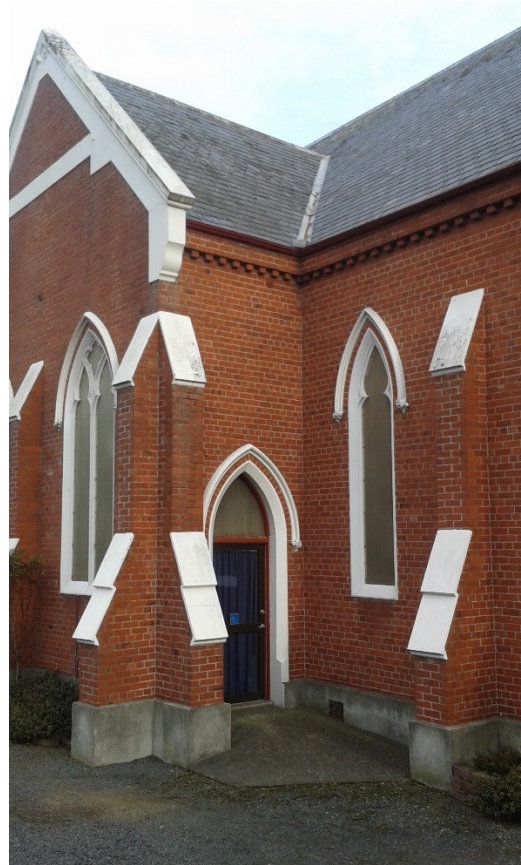
Transept egress door

People exiting the building during an earthquake are at risk of being hit by falling roof slates. This risk can be mitigated by either: replacing the roof slates with a new corrugated steel roof; or by constructing 'protection' verandas over the egress doors located at both ends of the transept and constructing barriers (garden plots perhaps) to keep people clear of the roof slate fall zone.

1. Replace the slate roof with a new corrugated steel roof; or
2. Construct verandas over the transept egress doors (to protect people from falling slates as they exit the building) and plant gardens along the side of the building to prevent people from standing in the fall zone.

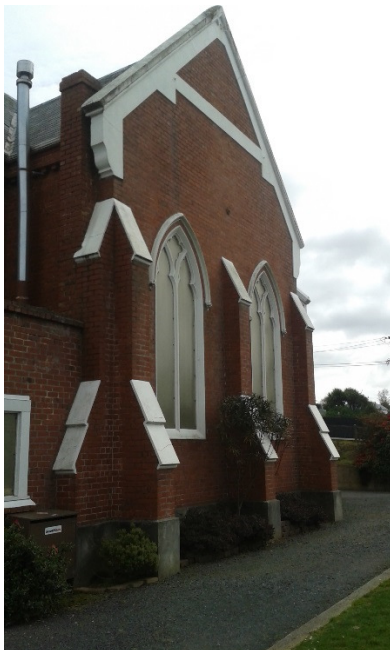
Transept gable end wall

| Item | Building Element | %NBS | Notes to Improve Strength |
|---|---|---|---|
| 13. | Transept Gable walls on gridlines 1 & 5 (out-of-plane capacity of gable above ceiling level) | 40%NBS | Tie the top of the gables more securely into the existing roof structure and install strap bracing within the roof space to transfer the earthquake forces more effectively to the side walls.<br>Note 1. |

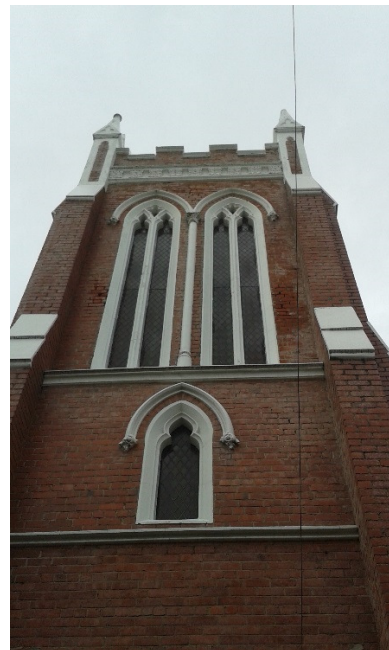
Bell Tower.

| Item | Building Element | %NBS | Notes to Improve Strength |
|---|---|---|---|
| 1. | Tower: Parapets (Out-of-plane response) | 35%NBS | Brace the parapets back to the tower roof.<br>Note 1. |
| 2. | Tower: Pinnacles (Rocking response) | 40%NBS | Brace the pinnacle back to the roof structure to prevent them rocking.<br>Note 1. |
| 3. | Tower: Sidewalls between the buttresses (out-of-plane response) | 35%NBS | Tie the brick walls into the existing belfry floor and roof with orthogonal tie rods and bearing plates.<br>Note 1. |

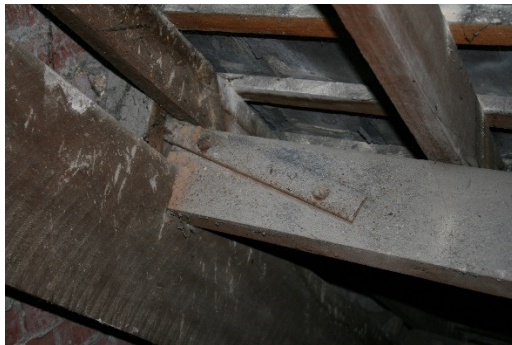
Typ. Underpurlin connection to gable end wall Detail.

- There are bolts fixing the roof structure to the top of the gable end walls. These are showing some surface corrosion, however, they still appear to be fixed firmly in place;

The top of the 3 gable walls are connected into the roof structure at 3 points: one connection at the apex and one half way down on each side of the gable (refer to the drawings in Appendix A). These connections consist of a 20 dia threaded rod welded to a 60x6 steel strap, which is bolted to timber underpurlin with 2 ½" bolts. The capacity of each connection is about 16kN (limited by the ½" bolts).

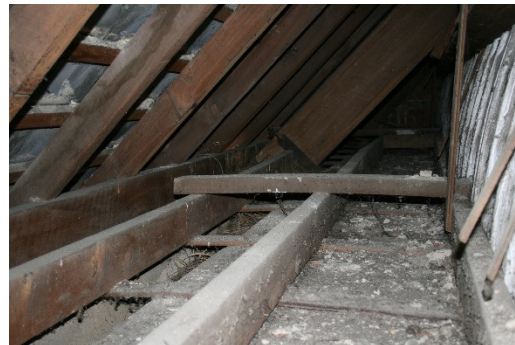
Truss connection to top of brick walls.

- The timber roof trusses are most likely bolted onto a timber jack-post, which is pocketed and secured into the brickwork. Because of access difficulties, the form and condition of this connection could not be confirmed. A more detailed assessment of these connections is required and it to be the subject of further investigation;

- No signs of rot were observed in the roof structure. However, because of access difficulties the connections between the trusses and the walls were unable to be viewed. These should be checked in more detail at some stage as part of any future maintenance work or upgrade;

Because of access difficulties we could not view the connections between the timber roof trusses and the top of the masonry side walls to the nave. However, given the way the building has been constructed each truss is likely to be bolted to a timber jack-post, which is pocketed and bolted into the brickwork. This is an area where timber decay can occur (the result moisture and dampness in the masonry). The construction and condition of these connections is to be checked in more thoroughly as part of any minimum maintenance work required to be done.

Also, the inspection and repair (if necessary) of the roof truss connections at the top of the walls is to be carried out as part of this minimum level of maintenance. See Section 5.3 above.
