## **Dunedin City Holdings Limited**

### **Review of Aurora Energy Limited / Delta Utility Services Limited – Network Safety Concerns**

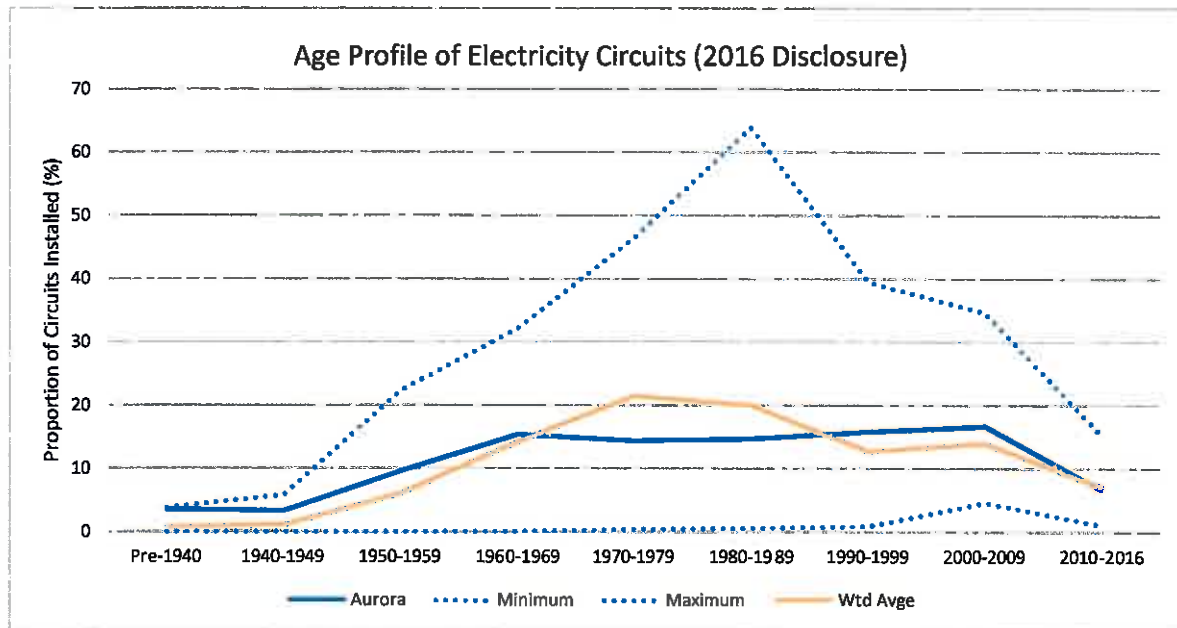
The Aurora network is an aged network. The chart below shows the age profile of electricity circuits installed by decade for Aurora in comparison to the range of profiles and weighted average for the industry.

Higher than average proportions of the Aurora network were constructed at either end of the profile, providing a mixed picture, although the long tail by age is predominantly associated with Dunedin.

- The graph above highlights that the Aurora network is not an outlier with respect to its age profile. The estimated useful lives of the respective components that make up the network are well known from both an industry and company perspective. This should therefore lend itself well to planning for future maintenance and replacement strategies.
