**From:** [Paterson, Lee](#)  
**To:** [Elisabeth Boyle](#)  
**Subject:** RE: LUC-2023-36 - Official peer review for geotech report for 12 Annie Street, Osborne  
**Date:** Friday, 20 December 2024 01:15:45 p.m.  
**Attachments:** [image001.png](#)  
[image002.png](#)

**LUC-2023-36 - Redefined scope, updated site plan, and geotech report for 12 Annie Street**

**From:** Lee Paterson  
**Sent:** Thursday, 9 February 2023 04:28 p.m.  
**To:** Peter Woods; Elisabeth Boyle  
**Subject:** Bradley Road, Osbourne

**Subject:** RE: Emailing: IMG\_4184.jpg, IMG\_4178.jpg, IMG\_4179.jpg, IMG\_4180.jpg, IMG\_4181.jpg, IMG\_4182.jpg, IMG\_4183.jpg

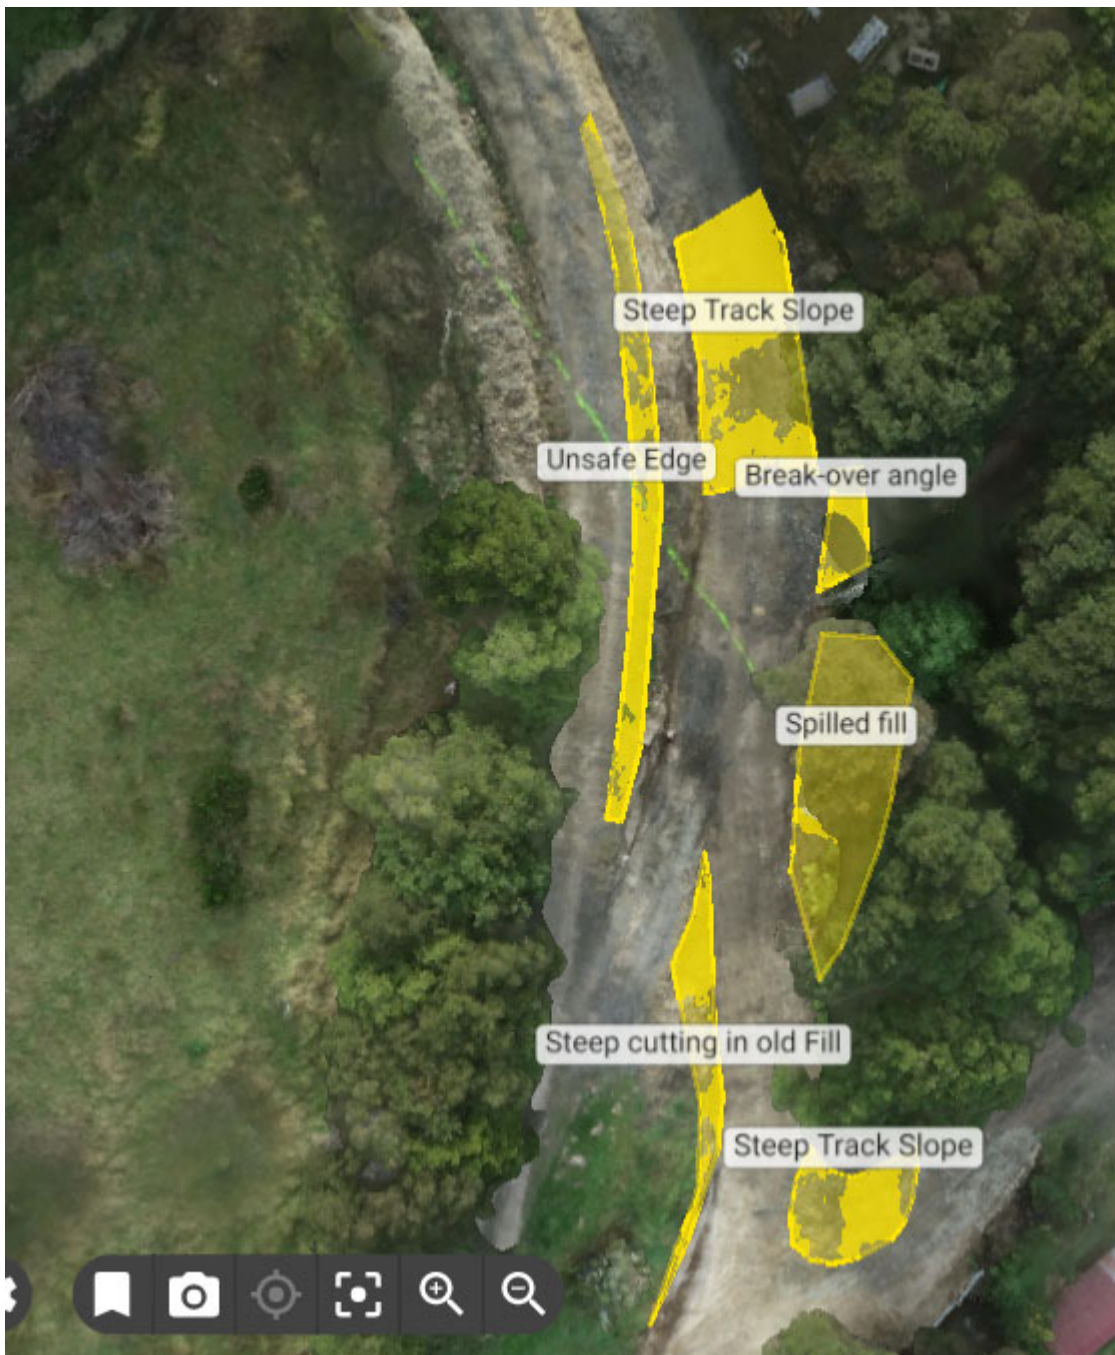
- Although there are many small cut slopes adjacent to roads in Osbourne locally, that are standing up very well at 1:1 or steeper, there appears to be an old filled area that has been cut into by the new lower track.

- My expectation is that this will not support itself, as it is already bulging.
  - This slope should be cut back to 1.5h:1V, or it should be retained.

- Much of the fill is soft on the access track.
  - Mr Napier insists that this work is not finished and will be covered with crushed concrete and asphalt millings

- I can appreciate that in the interim, access for vehicles on this track would be potentially difficult
- Some un-engineered side cast fill has been placed on a steep slope above the paper road to #13

- This material has tumbled and come to rest against a mesh fence
  - Fill should not be placed on slopes steeper than 2h:1v without engineering
  - Mr Napier insists that he intends to complete a rock buttress at the bottom of this slope, and a placed stone facing on the slope to mitigate erosion

- The residual track upslope now has an unsafe edge, with a potential drop of over a m high supported by a steep cut slope.
  - This should not be driven on, and should ideally be removed

- Notwithstanding this, approximately 30 m<sup>3</sup> has been cut on paper road
- There are a number of roading construction issues.
  - The gradient on the initial descent is now significantly steeper than the previous track, at a local grade of 3.5H:1V.

- A neighbour's concrete driveway to #17 has been cut, leaving a significant breakover angle to drive for access
  - The corner access to #13 is very steep and will be un-trafficable to every-day vehicles.

- The fill is soft, and needs time and engineering to firm up.
  - Stormwater drainage has not been diverted

- If it is to be retained, then it is effectively a 1.5m+ wall supporting a sloped fill... and will need to be signed off by an appropriately qualified engineer

- This should be assessed by a professional

- It is not clear if this is to be retained for access to Mr Napier's property.
  - If this is the case, it should be assessed for stability and / or engineering retaining put in place.

However, in it's current geometry, side cast fill would have to be pulled back, and some of the excavated faces supported, as they support driveway accesses above (if this is to be retained)
