# Arboricultural Report

# LUC-2024-297 - Request for comment

Prepared by: Roberts Consulting Ltd

Date: September 9, 2024

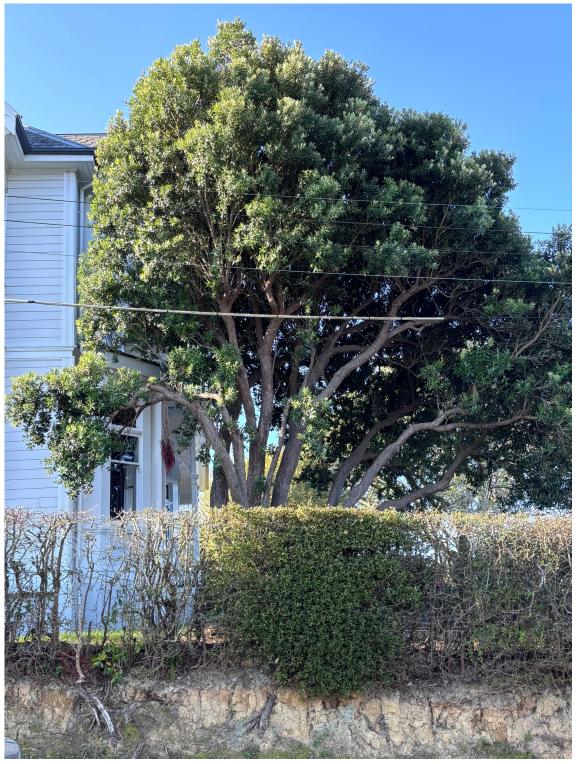
- 1.1 In general, at the time of the visit the tree looked to be in good health and exhibited vigour and vitality consistent for a tree of this species and age (image one).

- 1.2 The tree appears to have had some pruning work undertaken on it in the past which looks to have been carried out in accordance with industry-accepted pruning standards. This includes clearance from the powerlines running along the northern side of the street (image one).

**Image one:** Image showing the Pohutukawa T454 form Fifield Street looking into number 2 Fifield Street. The powerlines and powerline-clearance pruning can be seen (regrowth from adventitious buds along the exposed stems can also be seen).

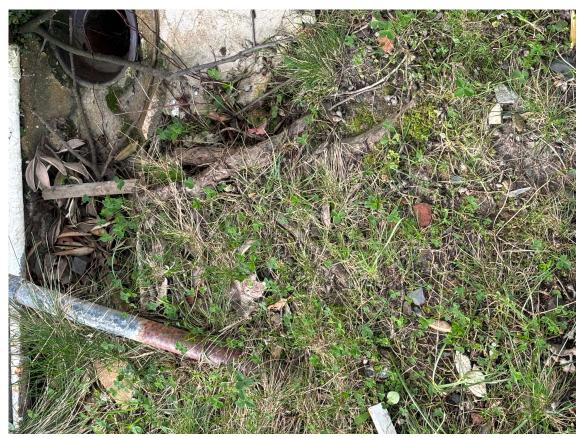
Between the base of the tree and house is an exposed point where the stormwater down-pipe connects with the drainage system. The drain at that point is earthenware piped and there were a number of surface roots in close proximity to these pipes (image two). It is probable that roots from the tree have or will enter the stormwater drainage system at or near this point.

- b) If it hasn't done so already, roots from the tree are likely to enter the stormwater drainage system.
- c) Tree roots are likely to continue to cause damage to the paths and low retaining walls.

**Image two:** Image showing the top of the stormwater pipe where the down-pipe (not visible) connects with the stormwater drainage system. Surface roots can been seen running towards this junction.

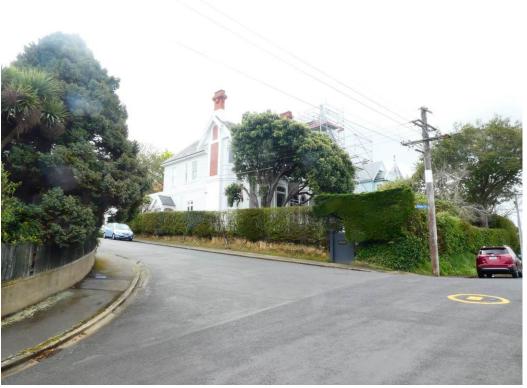
Figure 1. View towards T454 from south of the site on Tweed St.

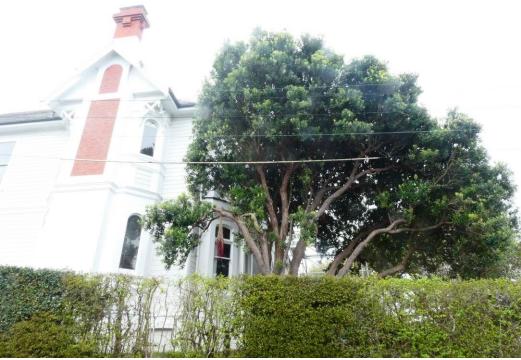
Figure 2. View towards T454 from south of the site on Fifield St.

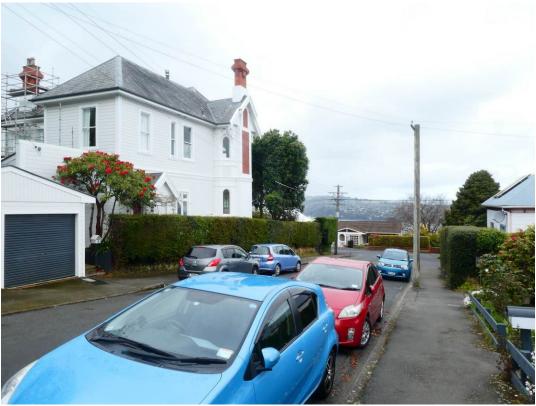
Figure 3. View towards T454 from west of the site on Fifield St.

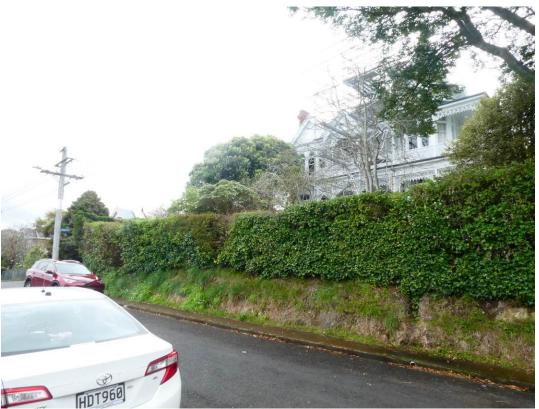
Figure 3. View towards T454 from southeast of the site on Fifield St.

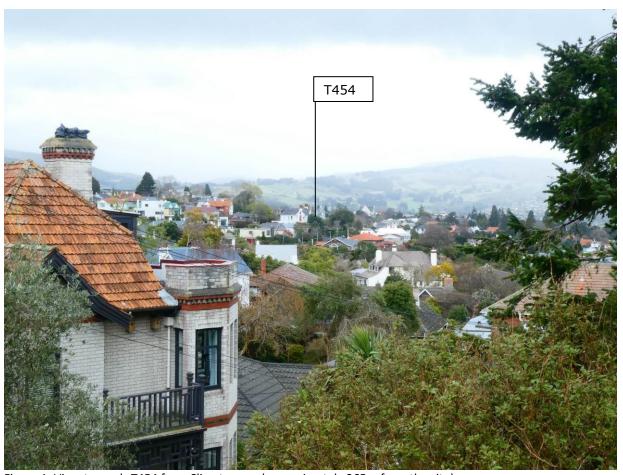
Figure 1: View towards T454 from Sligo terrace (approximately 365m from the site)
