## The New Carisbrook Development

### PRELIMINARY ENVIRONMENTAL SITE ASSESSMENT

- Version01
- 21 December 2006

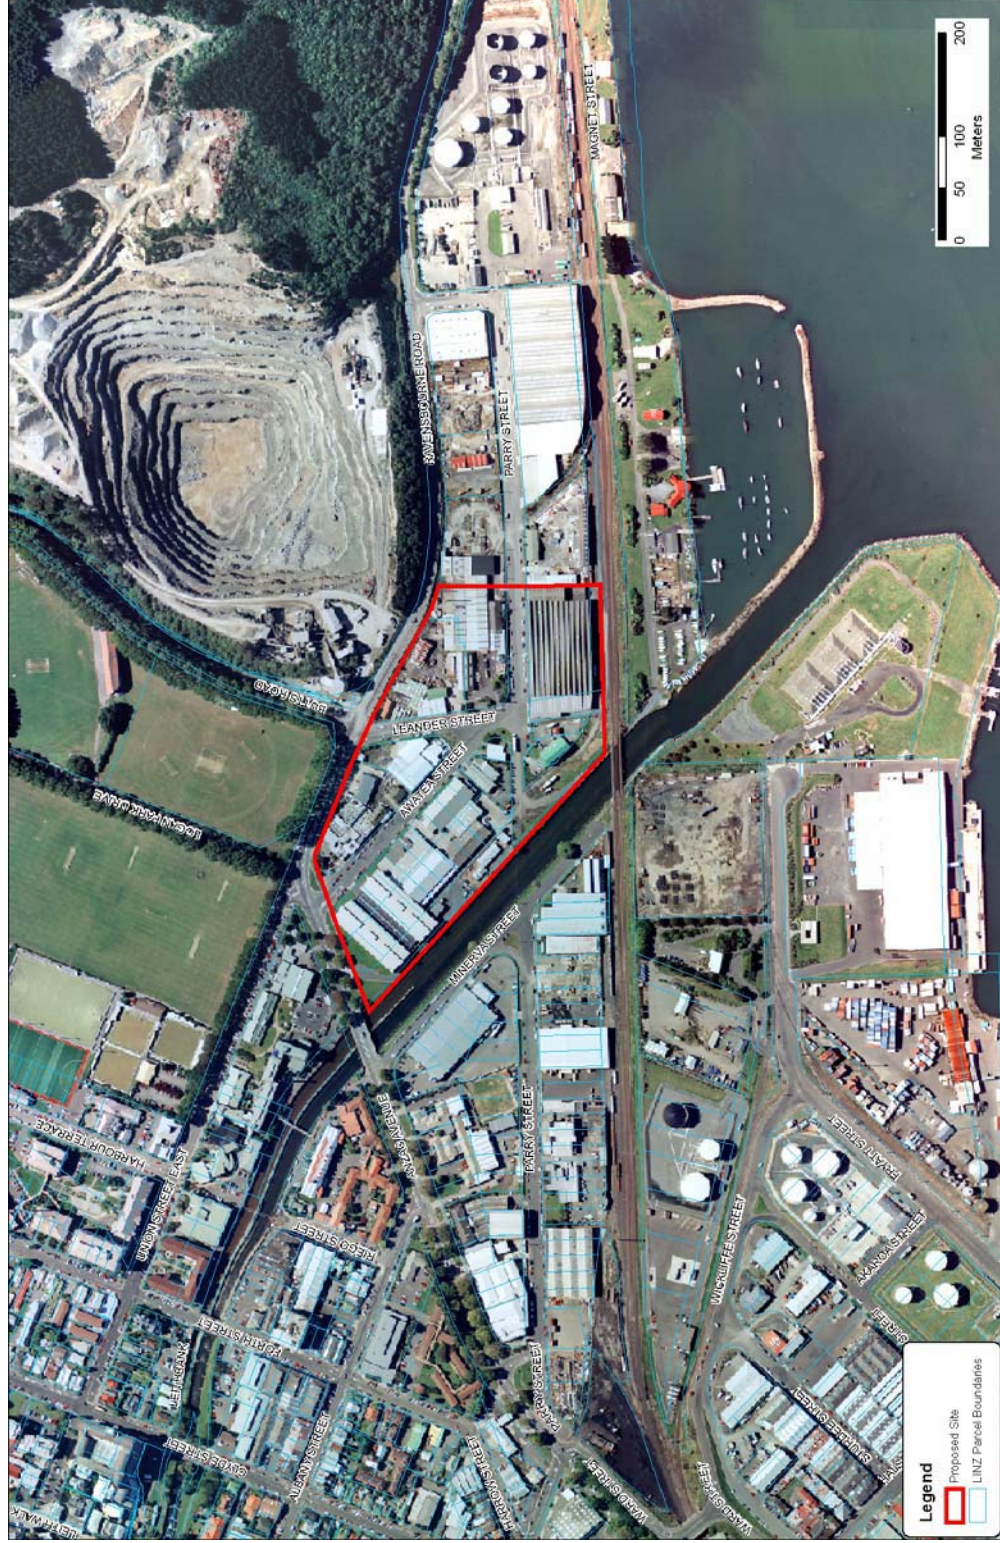
Figure 1: Site location showing development footprint

A new stadium is proposed to be constructed on behalf of the Carisbrook Stadium Trust on land currently occupied by industrial units in Ravensbourne, Dunedin. The proposed stadium site is generally bounded by Union Street East to the north east, Anzac Ave to the north west and the Leith canal to the south west, with the site extending approximately 100 meters east along Parry St. This area can be seen along with the development footprint on the site plan shown in Figure 1.
