# Macraes Phase 4 Consenting

## Project Element 4.3.2: Open Pit Extensions

PSM71-287R Rev 2

15 August 2024

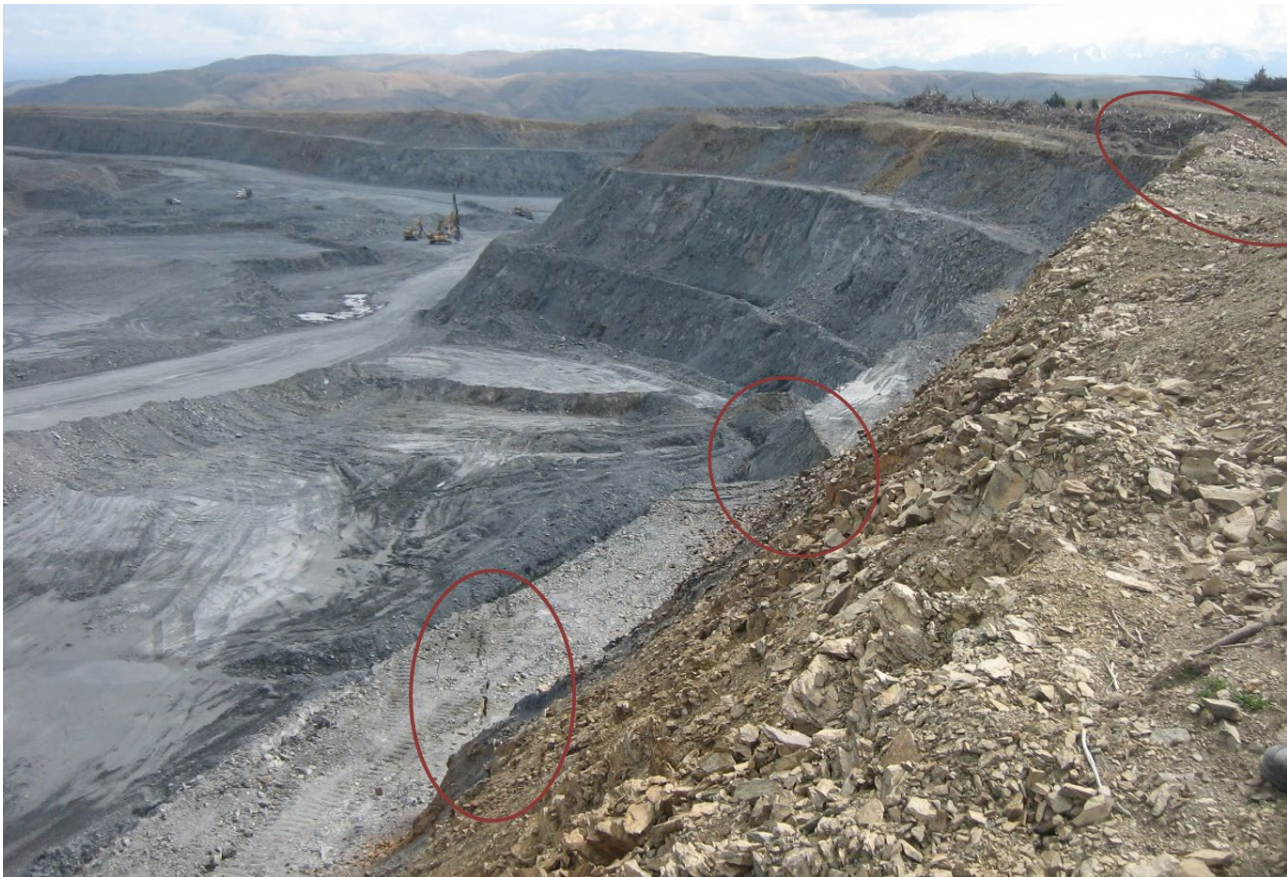
**Photo 3: South-eastern wall of Coronation Pit Stage 1. Wedge failures and cracking have formed along north-south trending, westerly dipping faults, 2015.**

During mining of Stage 1, continuous north-south trending, westerly dipping faults caused cracking along the eastern highwall crest and bench scale failures as shown in Photo 3. It was recommended that these structures be mapped and projected for further cutback designs to better orientate the wall.

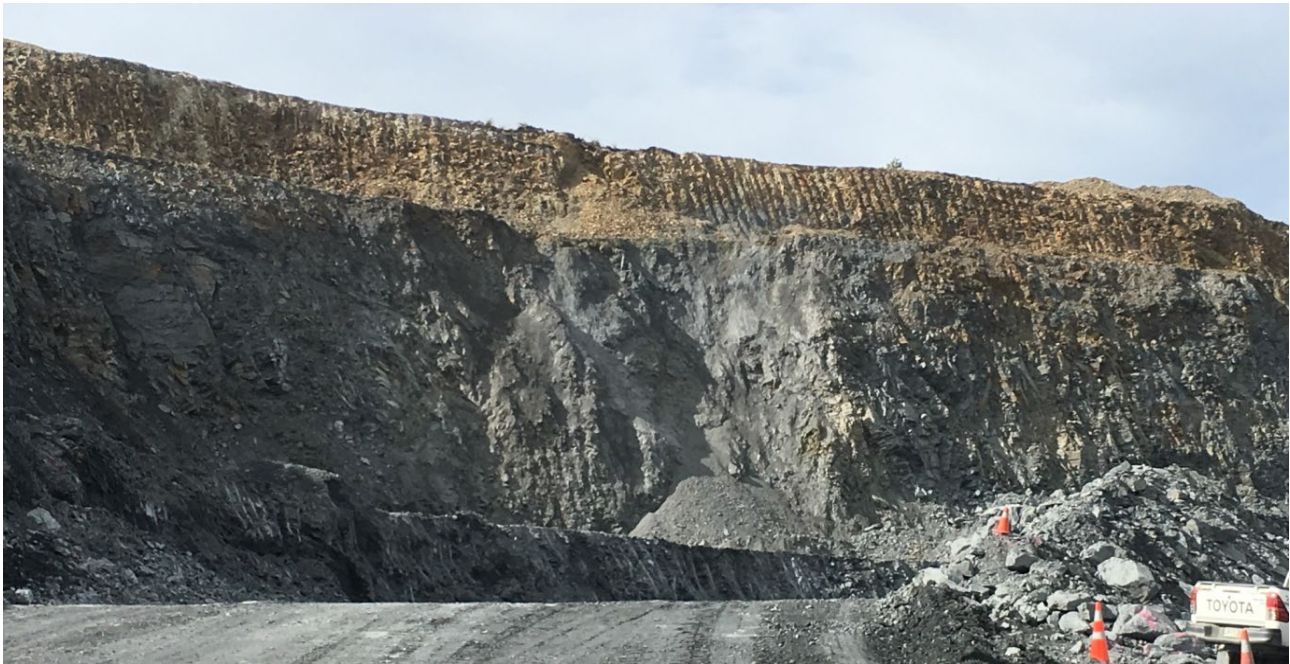
**Photo 5:** Coronation Pit Stage 2 – eastern wall of the ‘southern limb’. The 22.5 m high batters have not performed well in this rock mass.

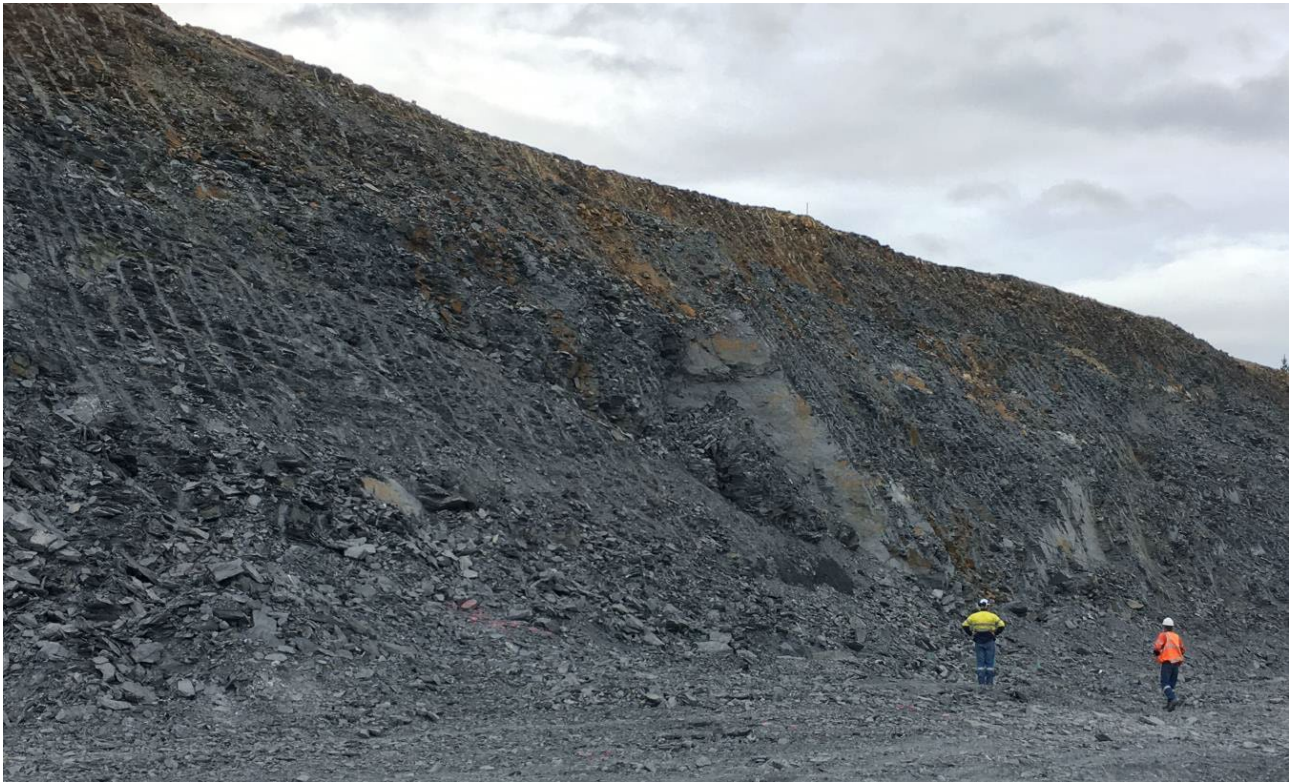
**Photo 6: East wall of Coronation Stage 5 pit. The floor is 675 mRL.**

In 2019 the first two batters had been mined of Stage 5 and performance was favourable considered to be good<sup>27</sup>. Several expected large-scale faults and shears were exposed in the batter. No record of slope performance was captured by PSM after the March 2019 site visit.

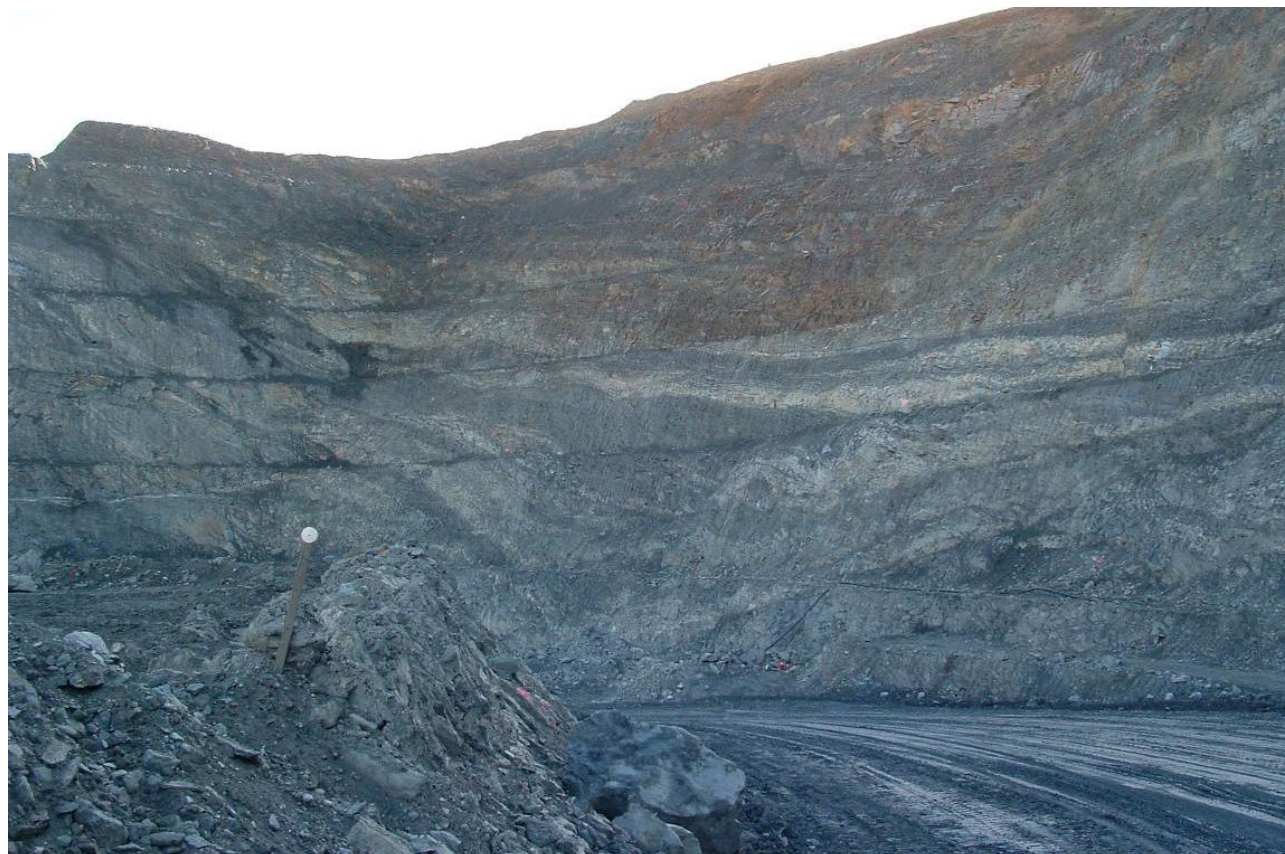
**Photo 7:** View of north-east wall taken July 2005. Notice the depth of weathering, the prominent quartz veins, and the very good performance of the slopes in fresh rock.

In addition to the results in the site visit report, a visual review of final pit walls was completed using photographs from July 2005<sup>32</sup>, April 2022 and photogrammetry survey from July 2022 (Photo 7 – Photo 10). This review supports the observations summarised in Table 7 and little has changed with respect to ongoing slope performance since mining ceased in 2005.

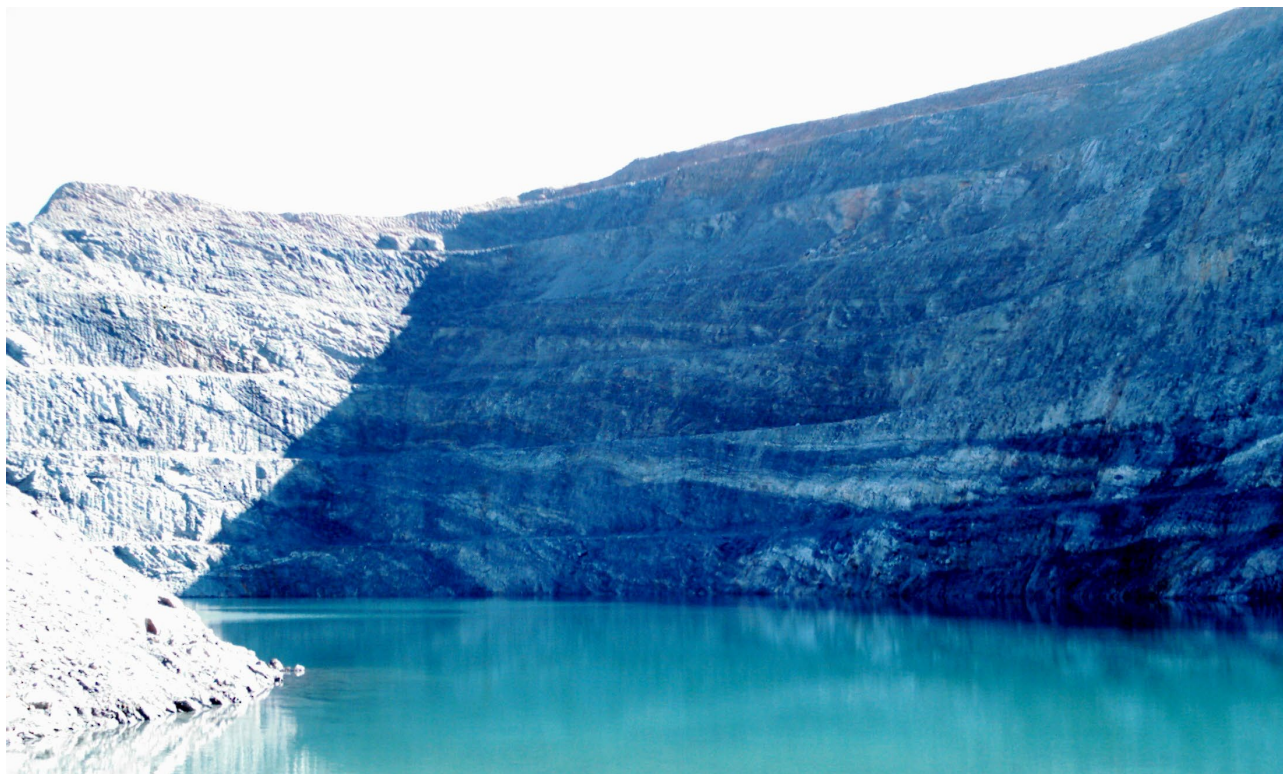
**Photo 8:** North-east wall of Stage 1 in 2005 taken from base of ramp.
