# Addendum

## New Dunedin Hospital – Engineering Assessment of Existing Facades

Blocks 1 to 5 Cumberland Street  
Blocks 3 to 5 Castle Street

Engineering Assessment of Existing Façades  
Blocks 1 to 5 Cumberland Street  
Blocks 3 to 5 Castle Street

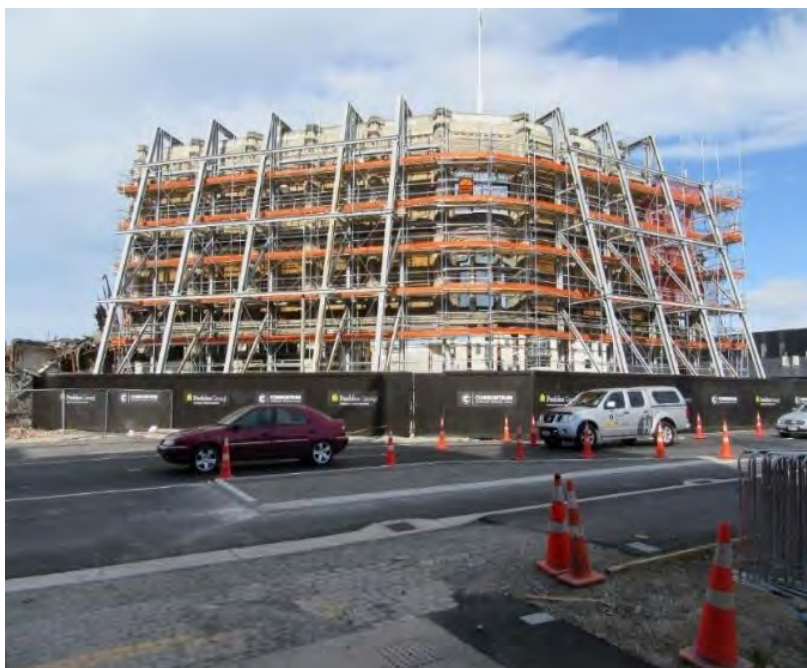
*Figure 1: External view of temporary propping to façade.*

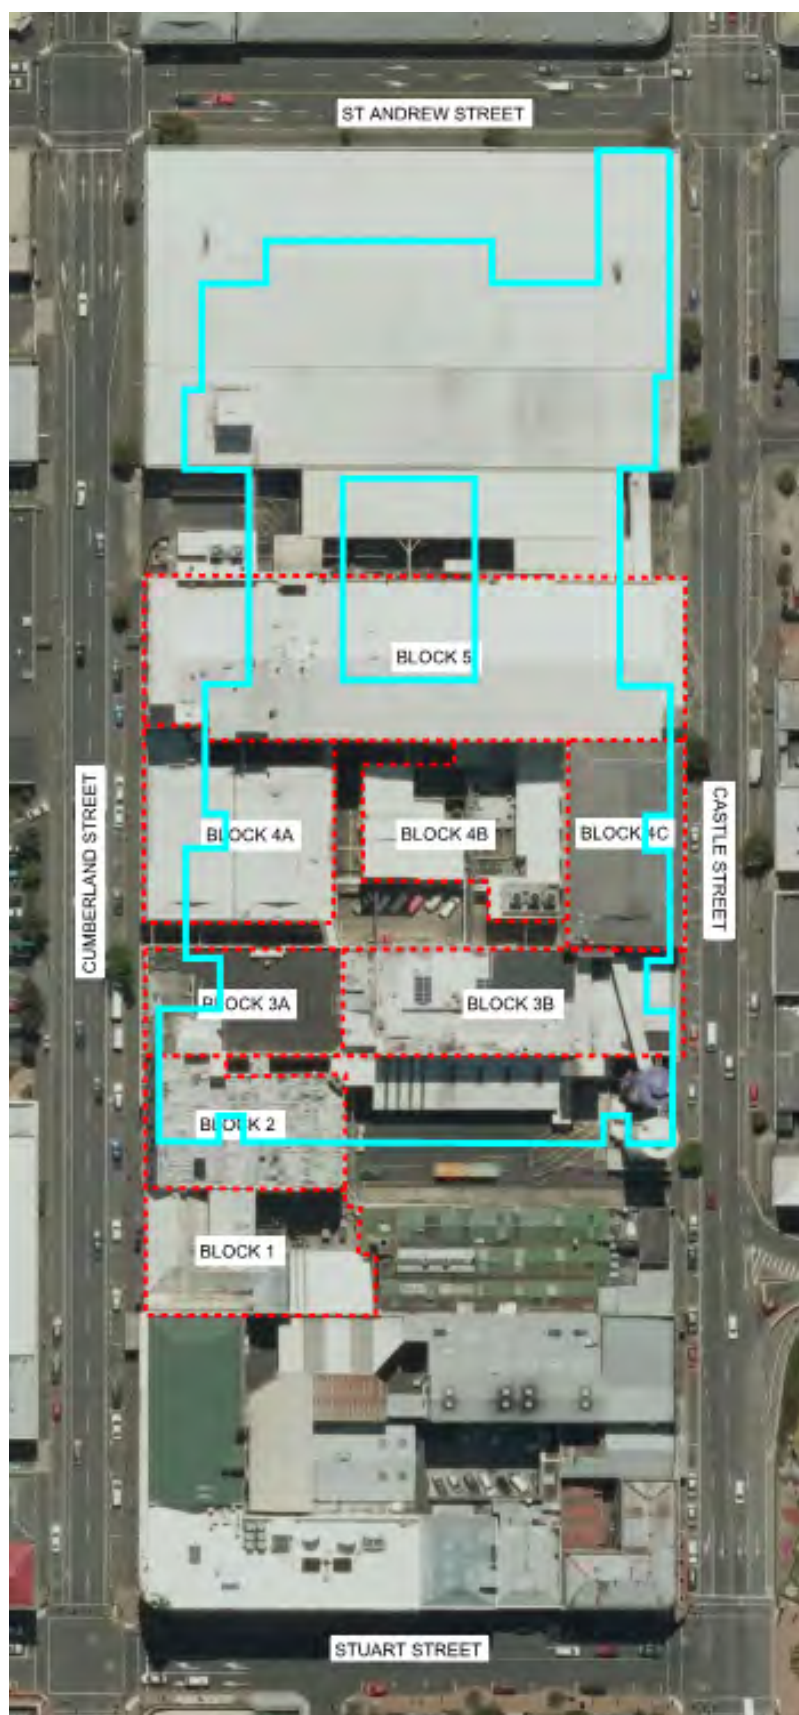
Figure 2: Aerial view of Cadbury block. New hospital outline in blue from the masterplan.

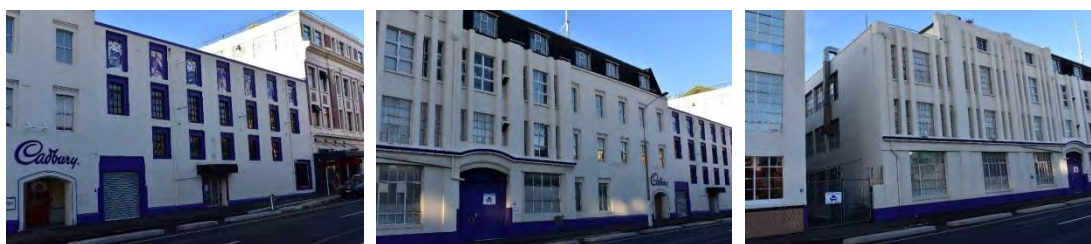
Table 1: Cumberland Street Elevations 1.

| Condition | Rising damp and water ingress, isolated fine cracks | Rising damp | Rising damp with damp in roof and penthouse |

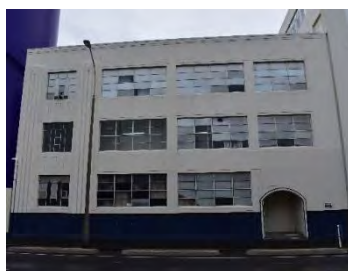
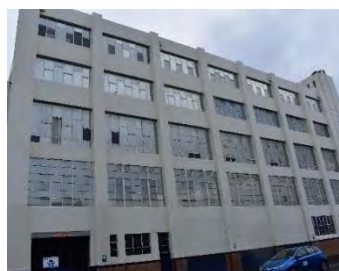
Table 3: Castle Street Elevations.

| Condition | Rising damp and minor cracking | Some wear & tear but no signs of distress | Some wear & tear but no signs of distress |

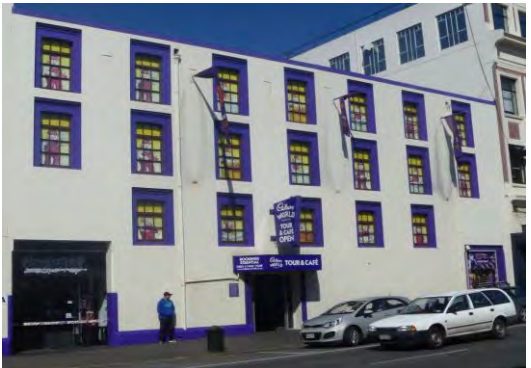
| No. | Block No. | Description | Date Constructed | Construction | Estimated height | Assessment of present condition - see also schedule of photographs | %NBS IL2 from Hanlon IEP (for building) | |
|---|---|---|---|---|---|---|---|---|
| 1 | 1 | Cadbury World Building | Earliest construction 1868 | Solid Brickwork - numerous openings including large doors and window opening at ground floor level. | 11.0m (From Hanlon Alteration Drawings) | Quite poor. Brickwork is damp from water penetration from the roof and also some rising damp at the bottom. Several bricks seem to be soft and the surface can be rubbed off by hand. Rendered externally - some fine to medium cracking noted. | 20% | |

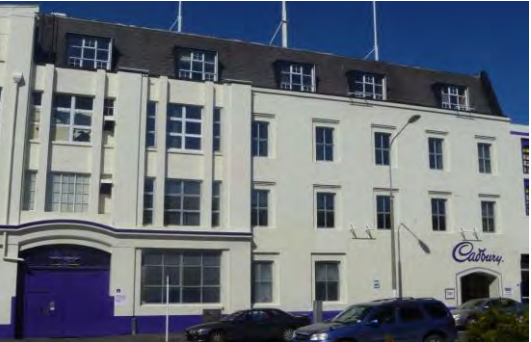
| No. | Block No. | Description | Date Constructed | Construction | Estimated height | Assessment of present condition - see also schedule of photographs | %NBS IL2 from Hanlon IEP (for building) | |
|---|---|---|---|---|---|---|---|---|
| 2 | 2 | Cadbury Reception and Offices | Unknown but a portion thought to have been constructed in 1868 | From the south end (right end of picture) for five windows the construction is solid brickwork. To the north of that the façade has been altered and combined with the front of Block 3A and the link joining the buildings. Probably reinforced concrete circa 1924(?) | 12.0m with the mansard roof section above that | Most of the brickwork cannot be seen as it is plastered inside and rendered outside. Rising damp affecting the plaster is seen at low level. Sign of rising damp also present on the outside. Several fine cracks in the external render. | 20% | |

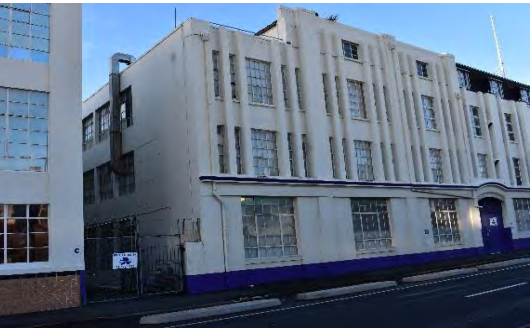
| No. | Block No. | Description | Date Constructed | Construction | Estimated height | Assessment of present condition - see also schedule of photographs | %NBS IL2 from Hanlon IEP (for building) | |
|---|---|---|---|---|---|---|---|---|
| 3 | 3A | Raw Materials | Ground floor constructed 1922, upper floors added 1924. Penthouse added later. | Reinforced Concrete wall. Building is reinforced concrete floor on steel framing. Believed to be on shallow spread footings. | approx15.0m at penthouse. 12.0m to north. | Inside is plastered. Signs of rising damp at the bottom has affected plaster in small areas some minor rust staining. Similar at higher levels where damp either from the windows, operations or the roof have affected the plaster and there are areas where some rust staining is present. Penthouse walls are very damp and internal gutter is cracked and in very poor condition. Top of parapet is brickwork and there is a crack where it sits on the RC wall below. | About 20%. It is thought that the steel frame beam and column joints offer little resistance in the N-S direction | |

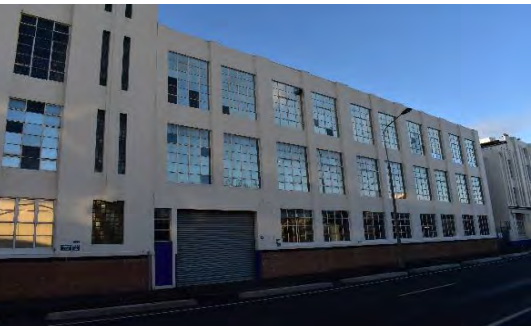
| No. | Block No. | Description | Date Constructed | Construction | Estimated height | Assessment of present condition - see also schedule of photographs | %NBS IL2 from Hanlon IEP (for building) | |
|---|---|---|---|---|---|---|---|---|
| 4 | 4A | Engineering workshop at ground with offices above | 1960 | Reinforced Concrete on piled foundations. Pile 7.60m deep | Approx. 12.0m | The wall is plastered on the inside and rendered and painted on the outside. At the ground floor there are some signs of wear and tear but generally there are no signs of distress or problems. | Hanlons have calculated this to be 100% but it does not appear to have been a full DSA | |

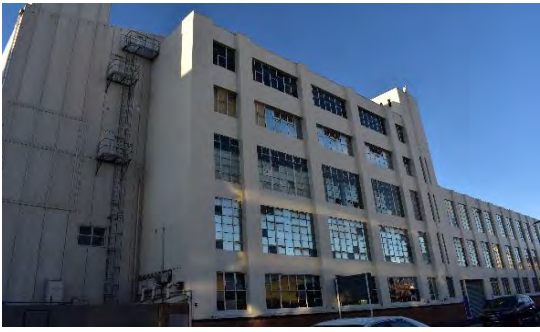
| 5 | 5 | Chocolate manufacture and packaging | 1951, additional storey added 1968. | Reinforced flat slabs on internal columns with external column and beam frames. Foundation is a cellular reinforced concrete ground slab. | Approx. 18.0m - lift tower is higher - circa 21.0m | Rendered and painted inside and out. Some signs of wear and tear but no signs of distress. | 20% NBS | |

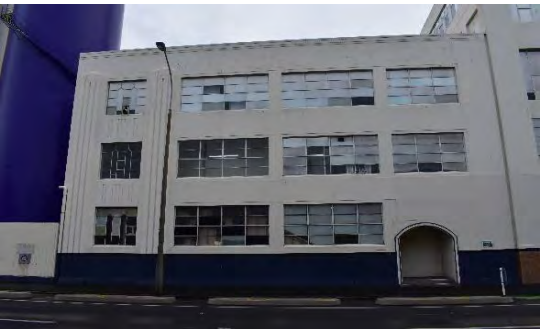
| 6 | 3C | Raw Materials | Building constructed 1924, Castle Street extension 1938 | No drawings for this building. Probably an extension of block 3B | 11.0m | Painted inside and out. Damp penetration at the bottom and at the top from the roof and around some of the windows - mould staining from condensation. Minor cracking noted particularly on the outside. Crack at corner of window at second floor level. | 20% - same issues as 3A | |

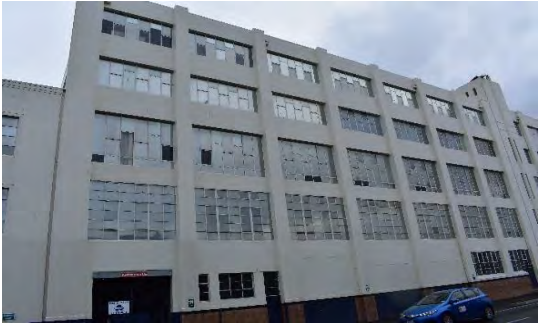
| 7 | 4C | Manufacture, Storage and Packaging | 1951, additional storey added 1968. | Reinforced concrete flat slabs on columns. Exterior reinforced concrete column and beam frames. Foundation cellular reinforced concrete flat slab on ground. Top floor is steel portal frames - some ties to façade. | 18.0m | Painted inside and out. Tiles under windows and ground level. Large openings at ground floor filled in with blockwork. Sign of wear and tear but no particular signs of distress. | 25% due to brittle nature of internal column and beam system. | |

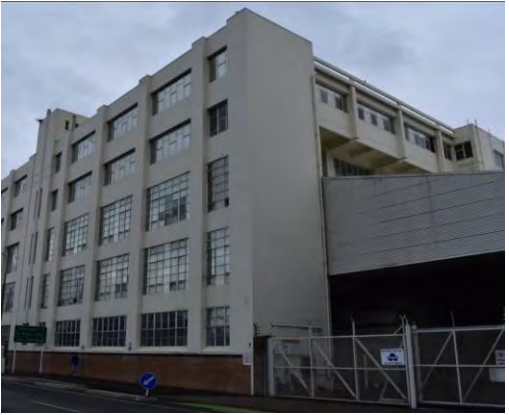
| 8 | 5 | Chocolate manufacture and packaging | 1951, additional storey added 1968. | Reinforced concrete flat slabs on columns. Exterior reinforced concrete column and beam frames. Foundation cellular reinforced concrete flat slab on ground. Lift shaft between blocks 4 and 5. Seismic Gap. | 18.0m | Painted inside and out. Tiles under windows and ground level. Large openings at ground floor filled in with blockwork. Sign of wear and tear but no particular signs of distress. | 20% lack of ductility in internal framing and possible brittle failure. | |

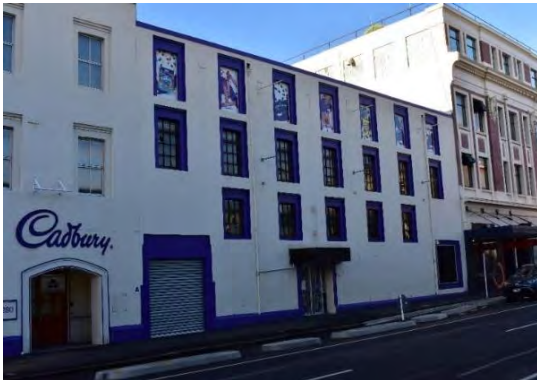
Figure 15: Cumberland Street façade of Block 1.

The building is three and four storeys high and is constructed of unreinforced masonry brick (URM) walls with a concrete slab at ground level. The upper storeys have timber framed floors with a screed finish and a timber framed roof. The ground floor level housed the Cadbury World facility. From this level, the supporting structure of the first floor is visible and consists of double steel RSJ beams which span between and into the URM walls. In general, the floor structure elements are set into the brick walls but were not observed to be mechanically connected to the brickwork.

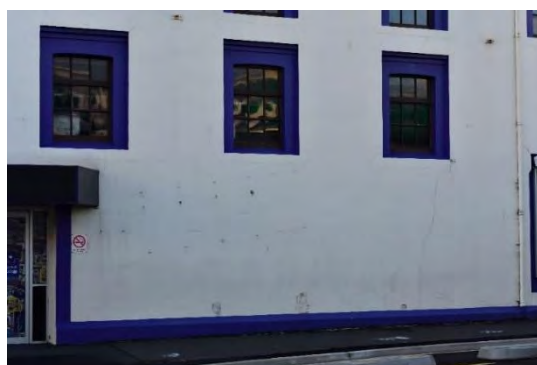
Figure 17: External view of the façade wall to Block 1 showing plaster cracks and damp at pavement level.

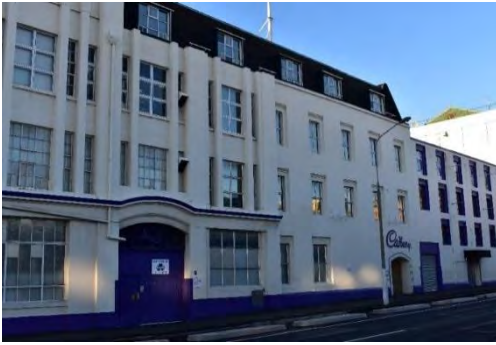
Figure 18: External view of the block 2 façade looking South.

The Cumberland Street façade wall is approx. 12m metres high (not including the mansard section), constructed of URM with regular window openings. It is shown to be 24" (610mm) thick at the first-floor level. The north end of the Block 2 façade wall is distinctively different from the south end. The decorative pattern from the Block 3A façade extends into the façade of Block 2 as a link structure connects the buildings. There is a service entrance on the ground floor level beneath the link. The mansard roof structure extends the full width of the Block. Internally, the façade wall is lined with plaster, and cladding at the higher levels and therefore is not clearly visible. No indicators of distress to the wall materials were observed.

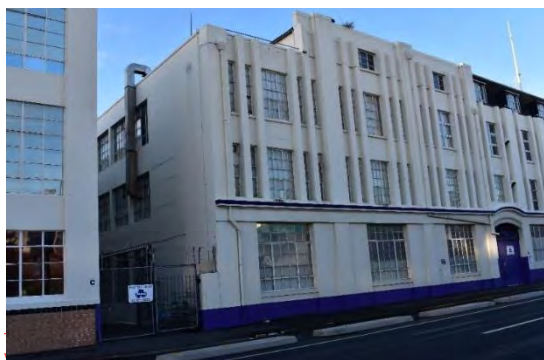
Figure 20: Cumberland elevation of Block 3A.

building but, it would appear that the ground floor was originally constructed in 1922 with the upper floors added in 1924. An extension towards Cumberland Street and an additional penthouse storey were added later.

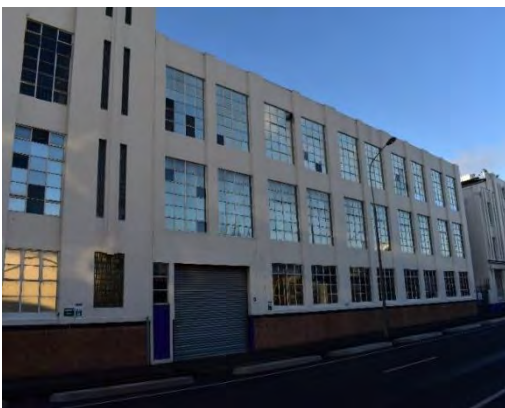
Figure 21: Cumberland Street façade of Block 4A.

Block 4A is situated on the Cumberland Street side of Block 4 and was constructed in 1960. It is predominantly a reinforced concrete frame with reinforced concrete spandrels beneath large windows on the external walls. The building is three storeys high with reinforced concrete floors spanning between reinforced concrete columns at each level. The top level is constructed of steel portal frames which support the roof structure. The steel portal frames span between external concrete walls and are connected at the knee. The ground floor was used for engineering workshops and areas for glucose and melting processes. The first floor was upgraded to an office space in 1994 with timber partition walls. There is a reinforced concrete stair tower on the east side.

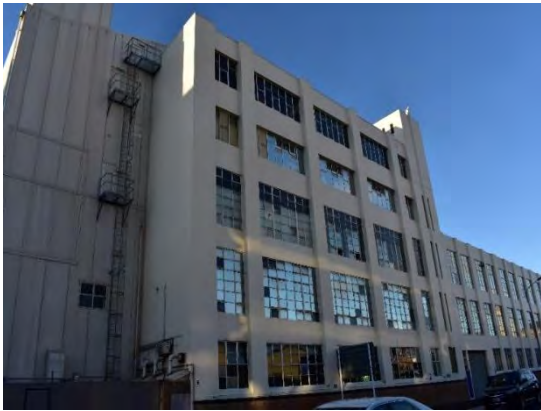
*Figure 22: Cumberland Street elevation of Block 5.*

The building comprises regularly spaced circular concrete columns with cone shaped column heads supporting the first, second and third floor slabs while square concrete columns with concrete beams support the fourth-floor slab. The top storey is constructed of steel portal frames supporting the roof and creating a large open floor area. The external walls are constructed of reinforced concrete columns and concrete infills beneath window openings. There is a seismic gap between Block 4A and Block 5.

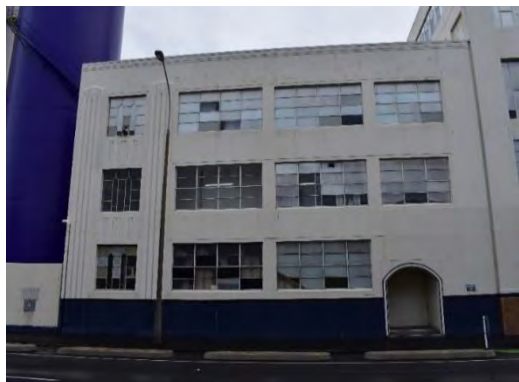
Figure 23: Castle Street elevation of Block 3C.

Block 3C is situated on the Castle Street side of Block 3. It is a three-storey building with a façade on Castle Street. The original building was constructed in 1924. It was extended in 1934 and a third storey was added. According to the drawings, the building was constructed with a temporary end and was extended towards Castle Street with a similar construction type in 1938. This building is often referred to as Block 3B, and the Castle Street extension as Block 3C. The buildings were used for raw materials and manufacturing plant. A staff cafeteria was constructed on the fourth storey of Block 3B in 1938 and was later refurbished in 1989.

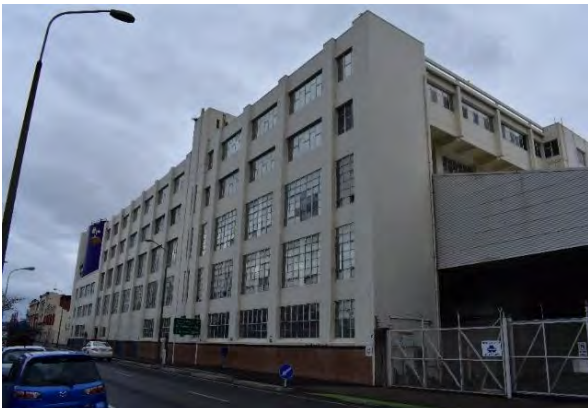
The Castle Street façade is also the same in height (approx. 22m) and construction. Note that at the north end of the building, there is an extended return and the fourth-floor cantilevers over the edge of the floor below. If the building were to be demolished, and the façade retained, this would require further review. Similar to the Cumberland Street elevation there is a service lift at the Block 4 end.

Figure 24: Castle Street elevation of Block 5.

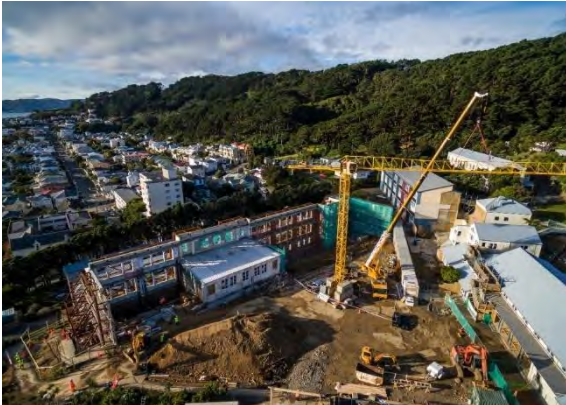
Figure 25: Aerial view of the temporary support.

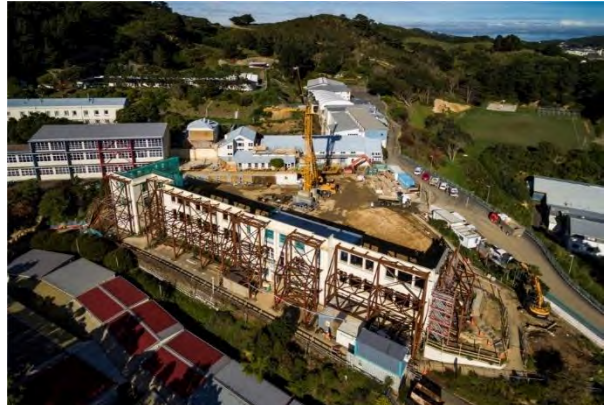
Figure 26: External view of the temporary propping.

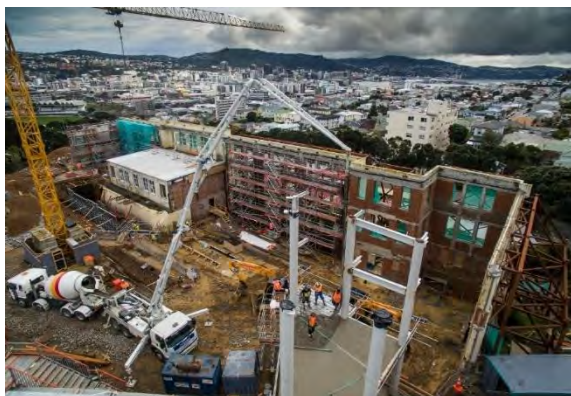
Figure 27: Internal view showing the start of the strengthening works required.

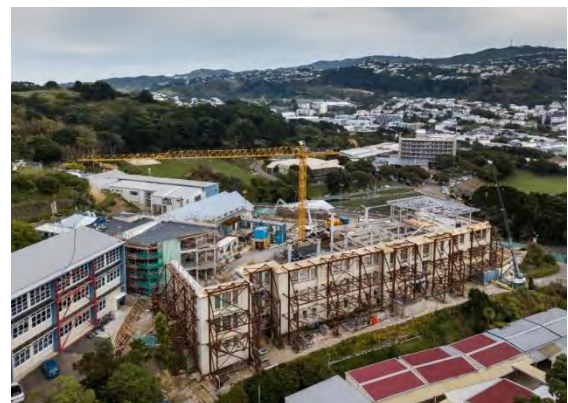
Figure 28: view showing the extent of the temporary propping.

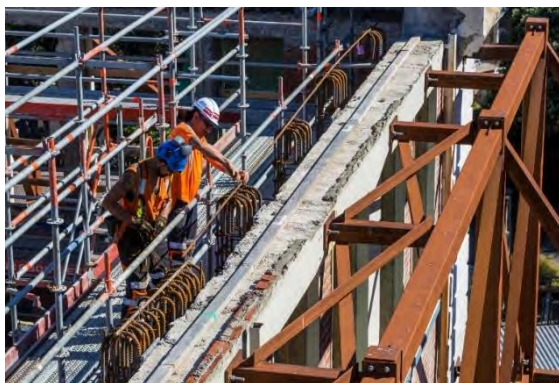
Figure 29: Internal concrete beams to reinforce and support the brickwork.

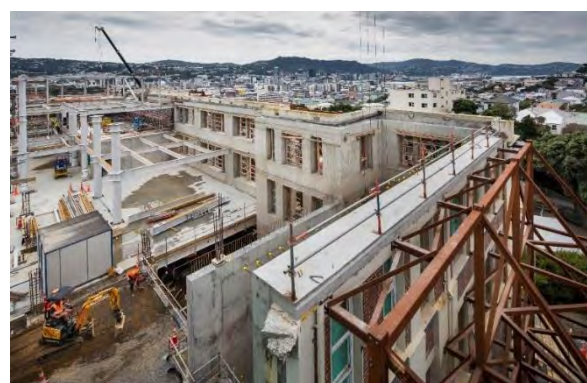
Figure 30: Internal view of the building progressing.

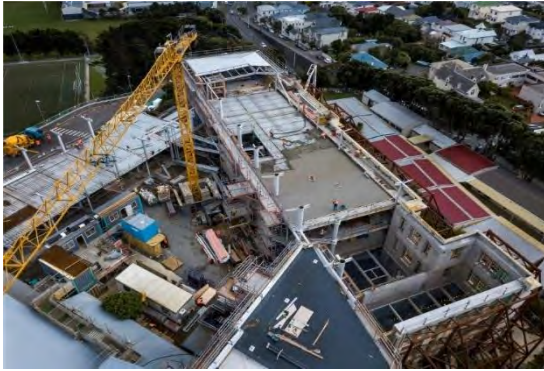
Figure 31: Aerial view showing the construction proceeding.

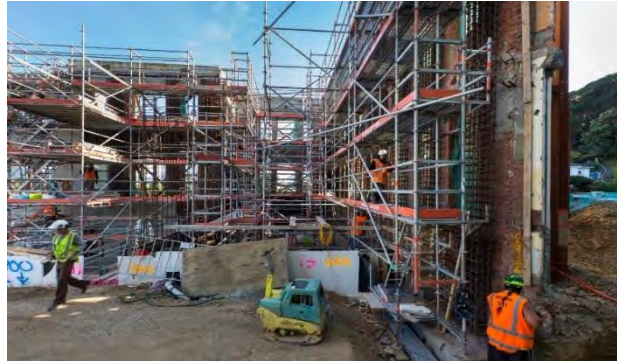
Figure 32: Extent of the strengthening work inside.

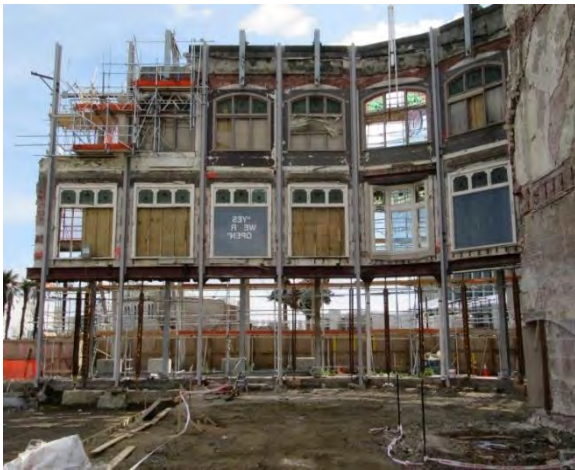
The McKenzie and Willis Store in Christchurch has been rebuilt retaining the original façade. Steel bracing frames were installed on the outside of the building to temporarily hold the façades.

Figure 33: Inside view of the temporary support for the Mackenzie and Willis façade Christchurch.

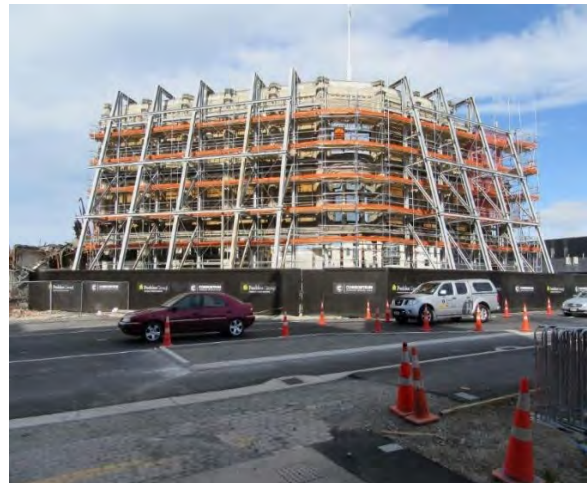
Figure 34: External view of the temporary propping.
