### **REPORT**

**BP Connect Mosgiel  
Detailed Site Investigation  
70-76 Gordon Road, Mosgiel**

J17211\_001a

15 June 2017

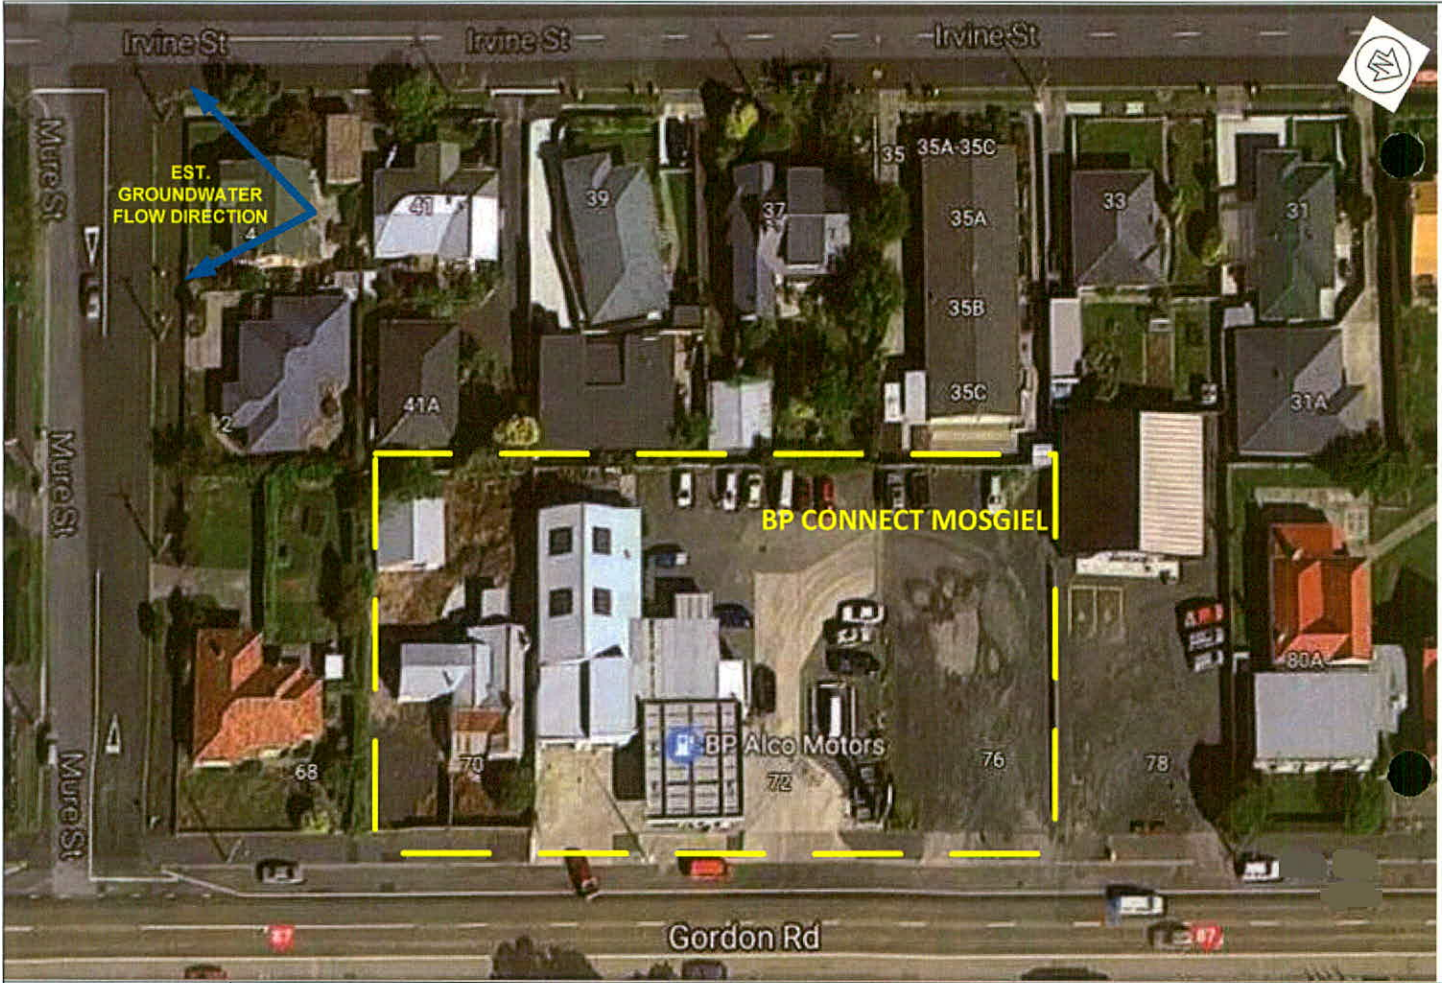
| Separate Phase Ltd<br>Practical Earth Science | CURRENT SITE LAYOUT | | | FIGURE 2<br>BP CONNECT MOSGIEL | SCALE: APPROX. 30 METRES<br>IMAGE SOURCE: GOOGLE MAPS 2017 |

The site has been a service station since at least 1982, and a motor vehicles garage since at least 1979. BP Alco Motors upgraded the tank systems in 1998 and 2005, and it is now proposed for redevelopment into a BP Connect service station. A site location plan is provided in **Appendix A: Figure 1**. A current site layout is provided in **Appendix A: Figure 2**.

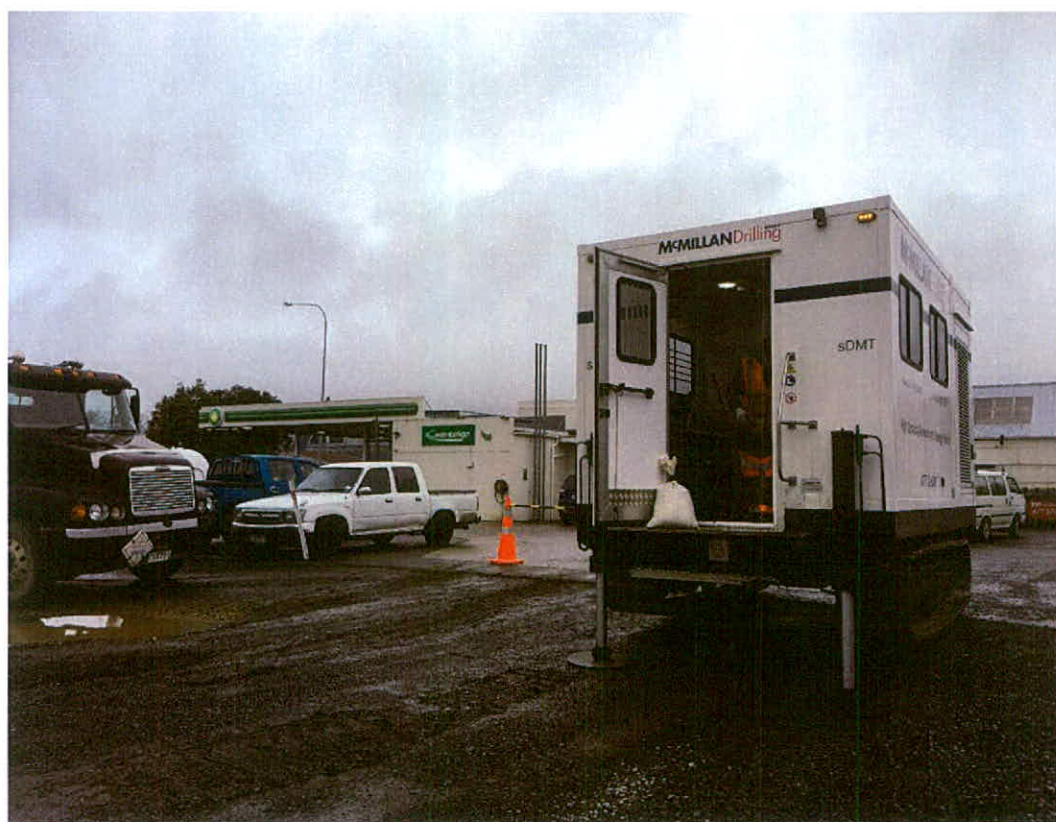
**Site Photograph 2:** McMillan Drilling Group cone penetrometer rig at location CPT001.

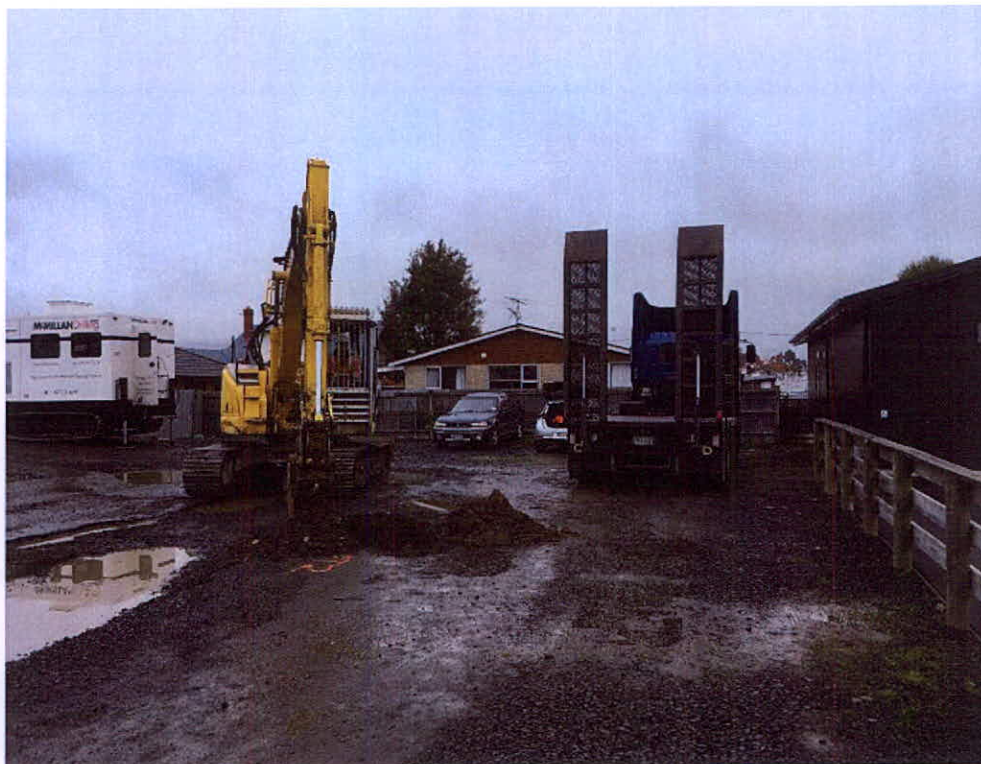
**Site Photograph 3:** Nash & Ross clearing for underground services prior to McMillan Drilling Group's cone penetrometer rig at location CPT002 (taken 01/06/2017).

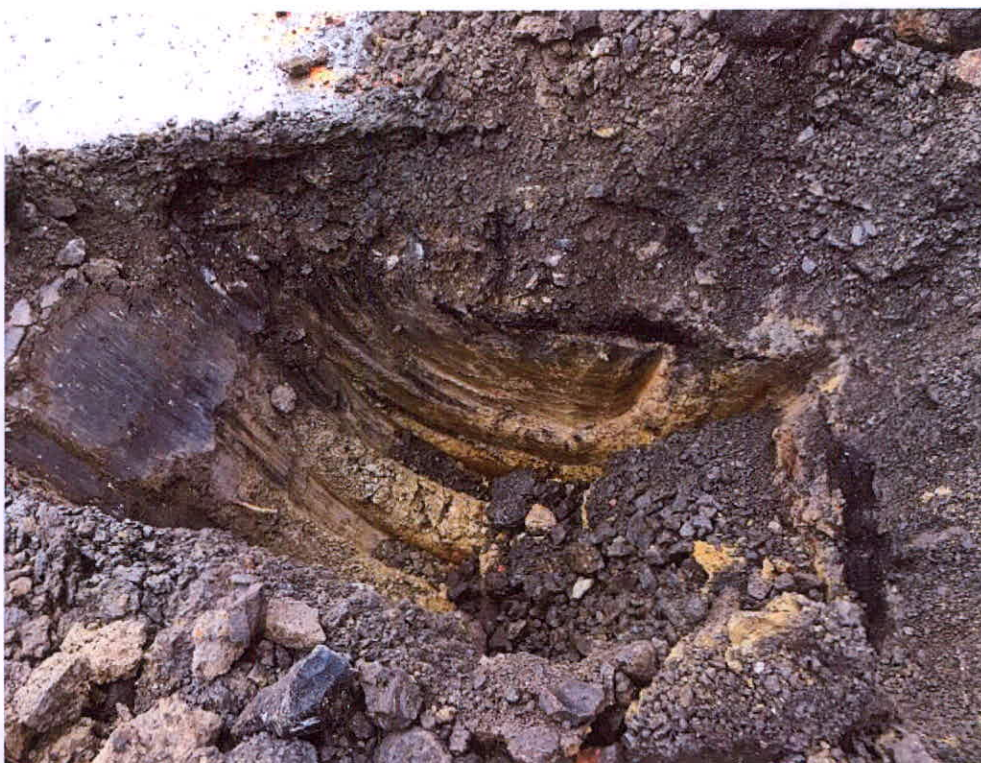
**Site Photograph 4:** CPT002 clearance (taken 01/06/2017).

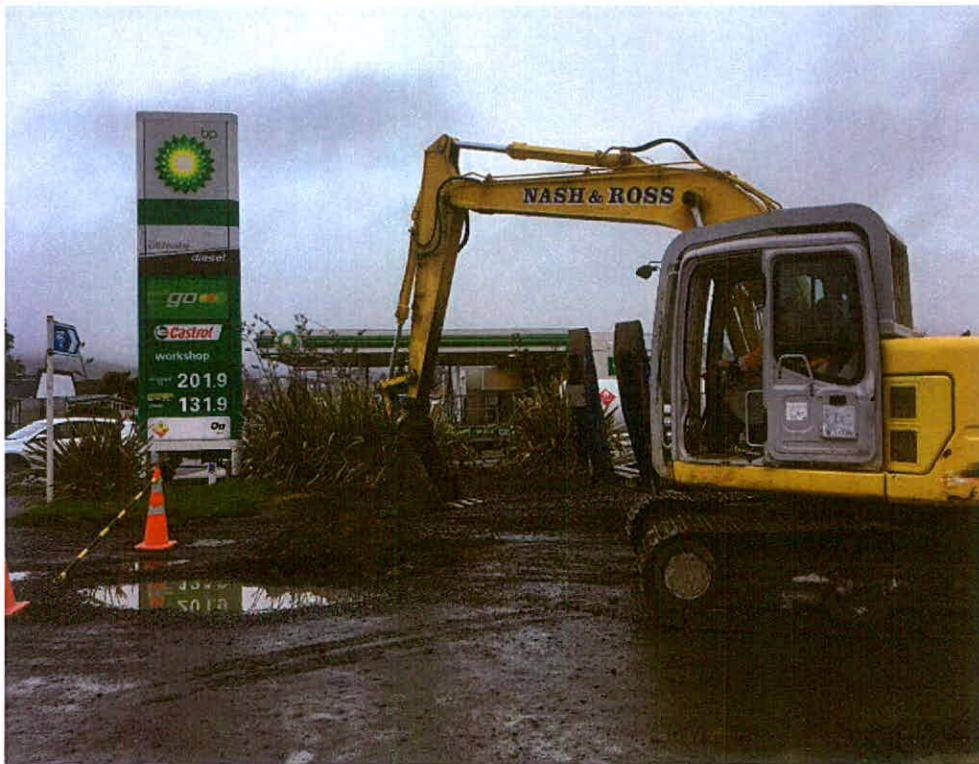
Site Photograph 5: Nash & Ross clearing for underground services prior to McMillan Drilling Group's cone penetrometer rig at location CPT003 (taken 01/06/2017).

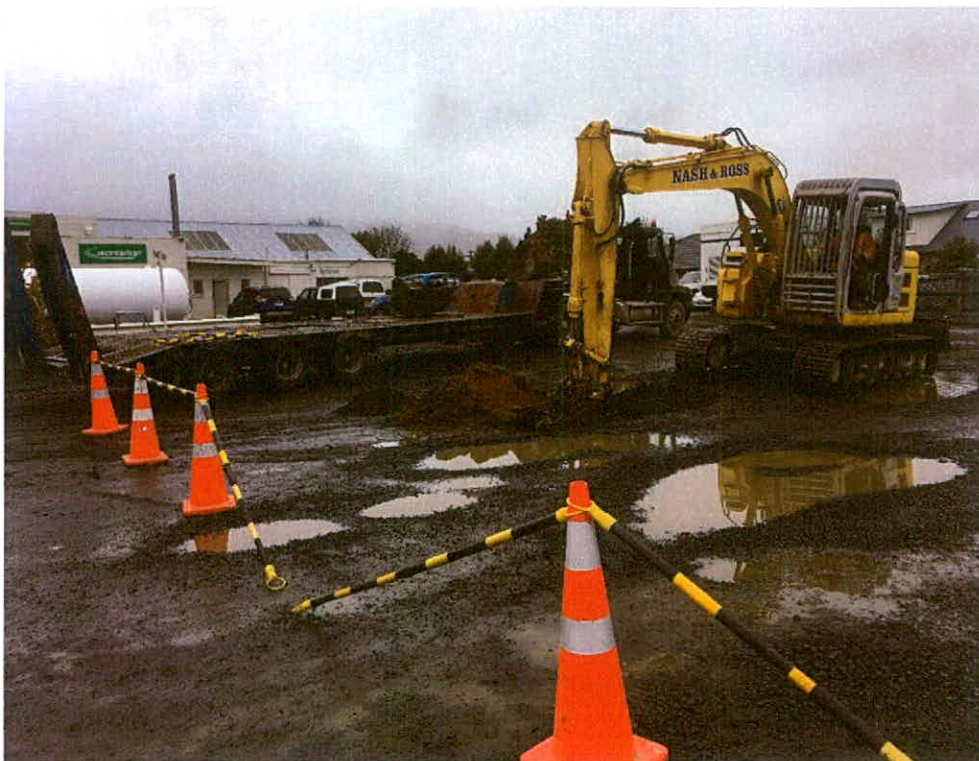
Site Photograph 6: Nash & Ross digging first test pit at location TP004 (taken 01/06/2017).

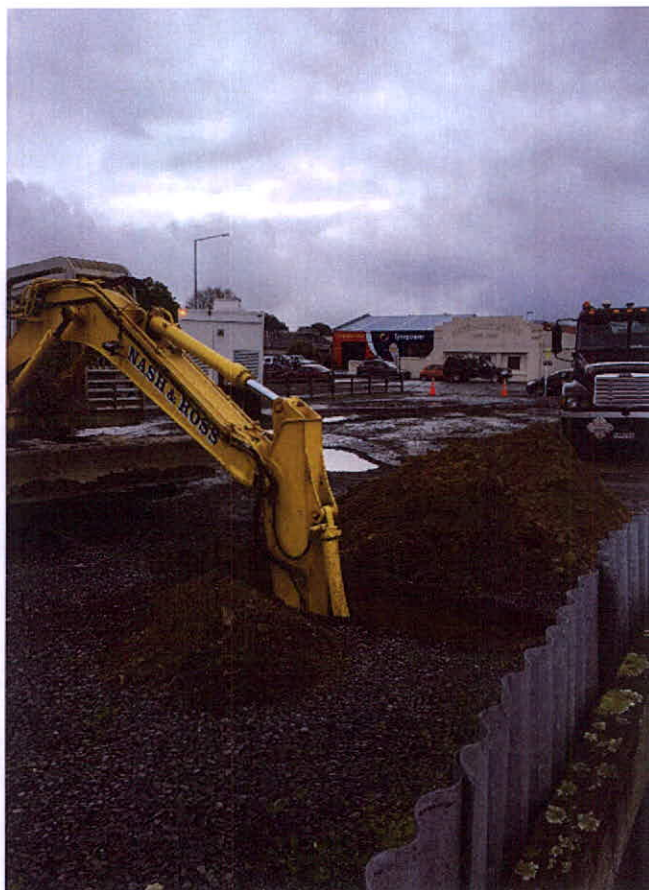
**Site Photograph 7:** Nash & Ross digging second test pit at location TP005 (taken 01/06/2017).
