# Dunedin Hospital Development, Cadbury Confectionary Ltd Buildings

A Heritage Impact Assessment

Report Prepared for Ministry of Health  
Author: Megan Lawrence, Naomi Woods, Dawn Cropper  
and Hayden Cawte  
Reviewed by: Dawn Cropper  
Submitted: May 2020

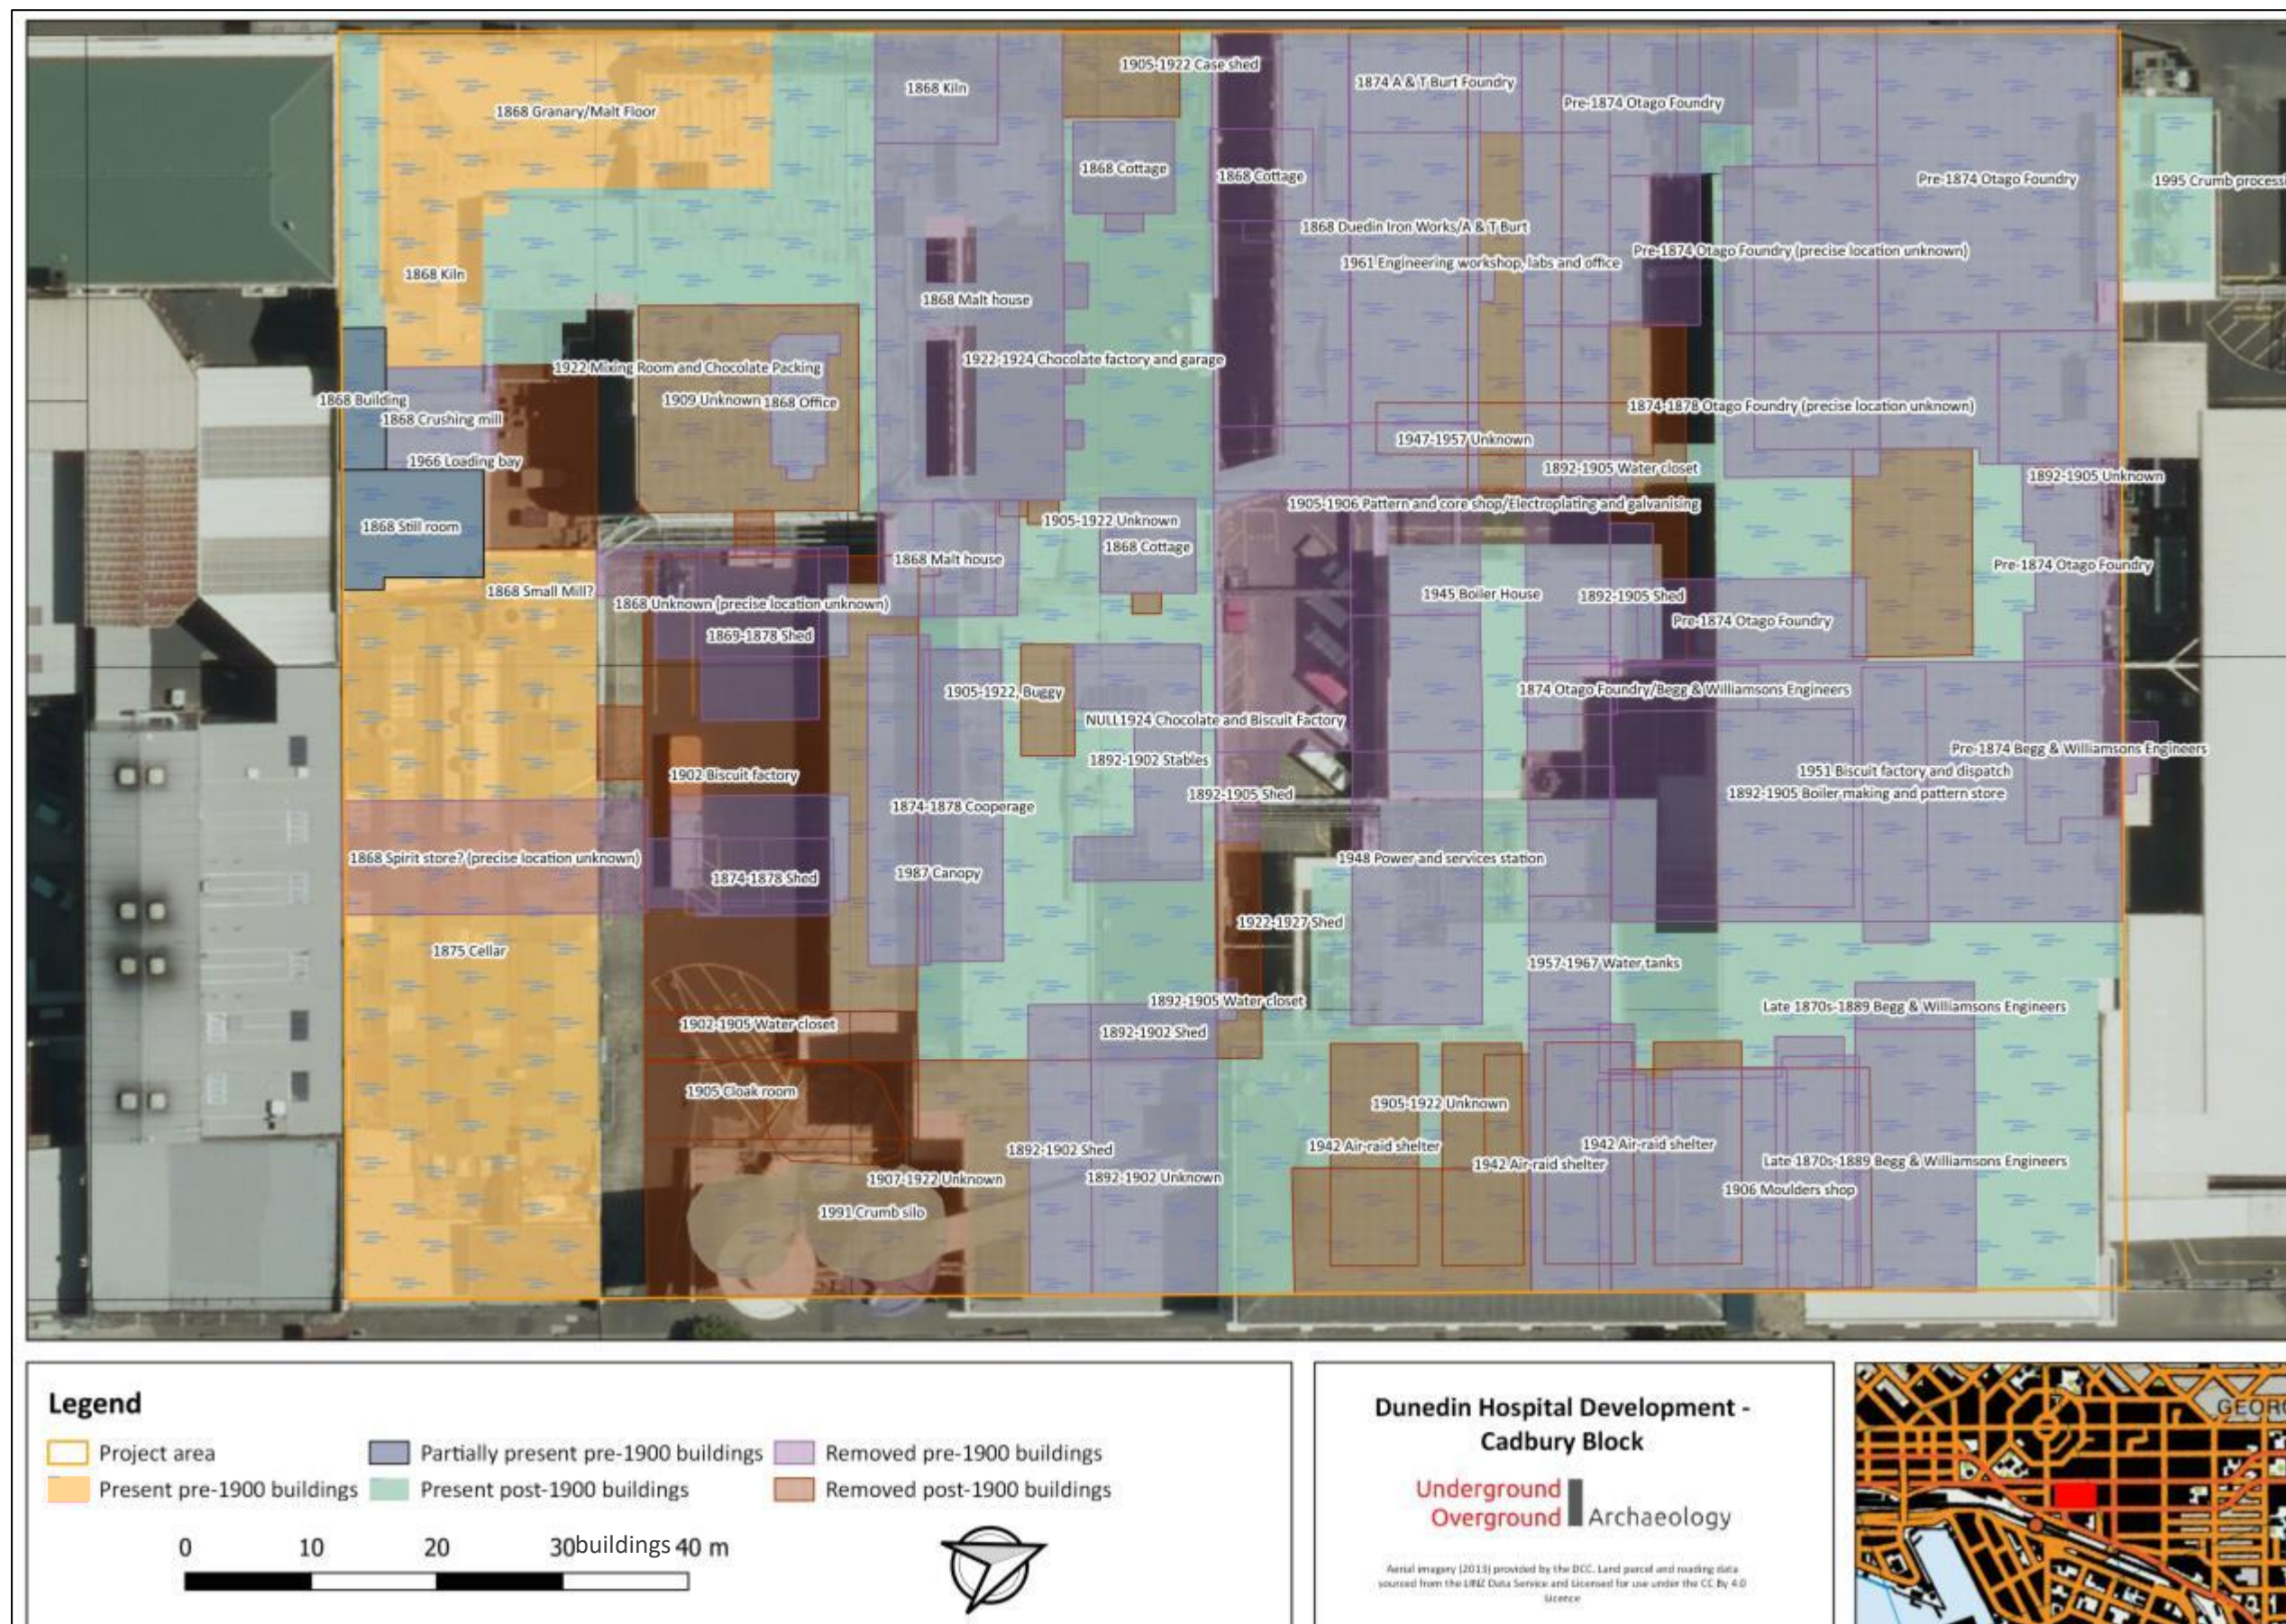
Figure 5-1 Figure showing all known nineteenth and twentieth century buildings and their initial construction dates at the location Cadbury Confectionery Ltd Buildings Site.

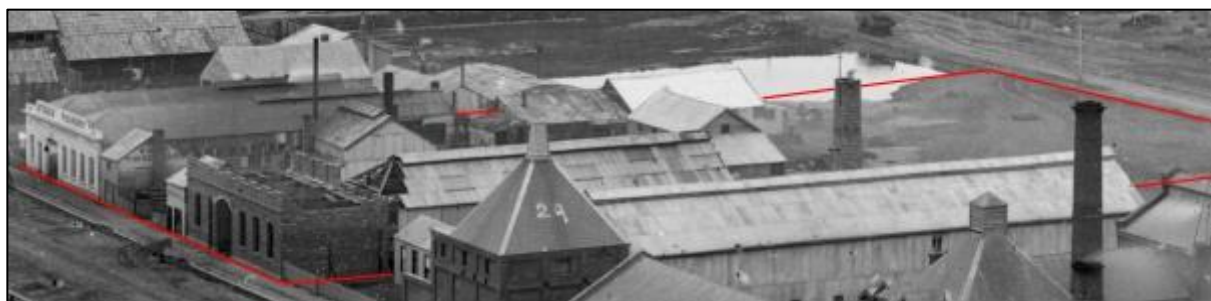
Figure 5-5. Detail from 1874 photograph showing approximate outline of site I44/922 in red (Burton Brothers Studio, 1874). Photograph is looking northeast.

An 1874 photograph (Figure 5-5) of the site shows the building depicted in the c.1868 woodcut as having been recently truncated and a new brick front in the process of construction. Numerous other buildings are present on Sections 58 and 59 to the north, including a small timber building with “Kauri Timber Yard” painted on the side and a larger Otago Foundry building. No buildings are present on the east half of the site. However, the chimney under construction, marks the start of buildings in Section 69.

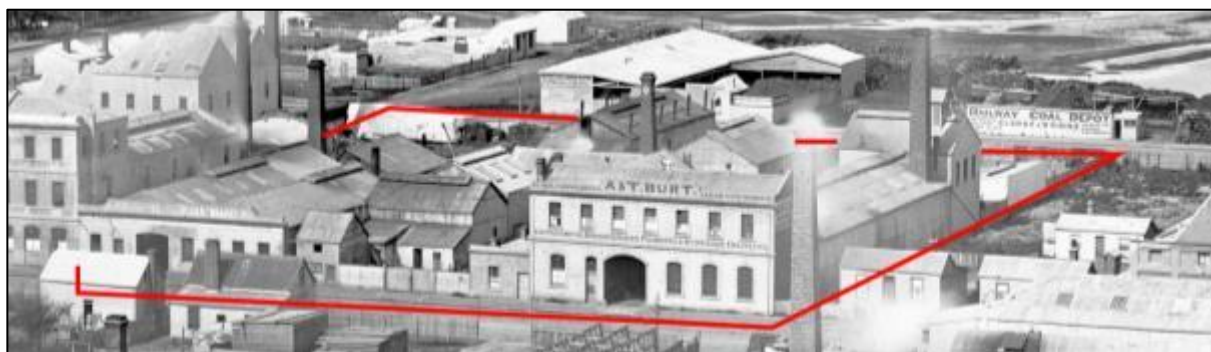
Figure 5-6. Detail from late 1870s photograph showing the approximate outline of site I44/922 in red (Burton Brothers Studio, n.d.). Photograph is looking east.

Another photograph taken at the end of the decade (Figure 5-6) shows the completed front of the two storey iron works building, by this time occupied by engineering firm A & T Burt, and a range of industrial buildings covering most of the site. The 1876 rates records note the owners of Sections 57 and 70 as the NZ Distillery Company and the occupants as A & T Burt, while the remainder of the site was owned by William Wilson and occupied by the Otago Foundry. The foundry had completed chimney and buildings behind in Sections 68 and 69 are also present by the late 1870s. In 1879 a fire that began in the neighbouring McLeod Bros. soap works caused significant damage to the blacksmith shop and three-storey brick building to the north of the Cumberland Street frontage of the site, at the time occupied by the Otago Foundry (Auckland Star, 1879).

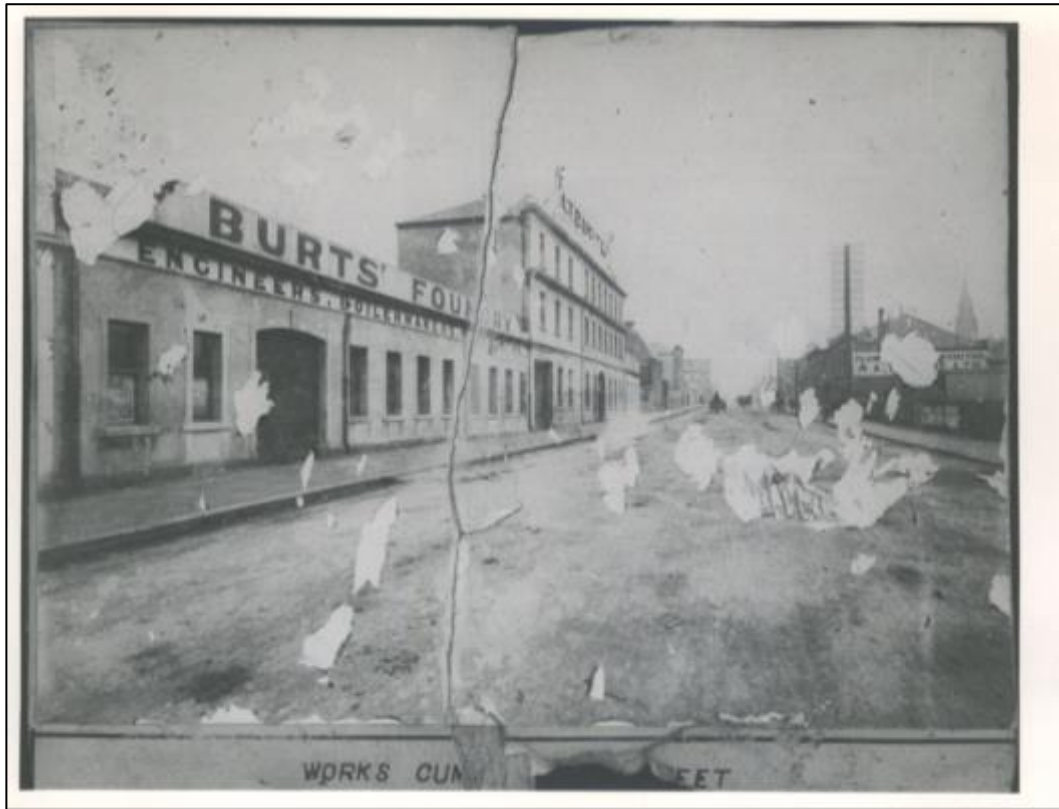
Figure 5-9 1890s-1900s photograph taken sometime looking south at the Cumberland Street façade of the A & T Burt Premises (Anon., n.d.-f).

In 1898 rates records indicate A & T Burt owned and occupied Sections 58 and 59 and by the following year Sections 68 and 69, effectively taking over the whole site. Their buildings including the large three-storey brick structure (visible in Figure 5-9 and Figure 5-8) known as “the works” (Cyclopedia Company Ltd, 1905). A 1905 account of the works (Cyclopedia Company Limited, 1905) gives an idea of the scale and layout of the buildings on site, several of which were previously occupied by the Otago Foundry. This premises held engineering and blacksmithing departments, workman’s store, dressing shop, iron moulding shop, finishing and pattern shop, brass foundry, coppersmith’s shop, boiler house, boiler and fluming pipe shop, warehouse, and a plumbing shop (Figure

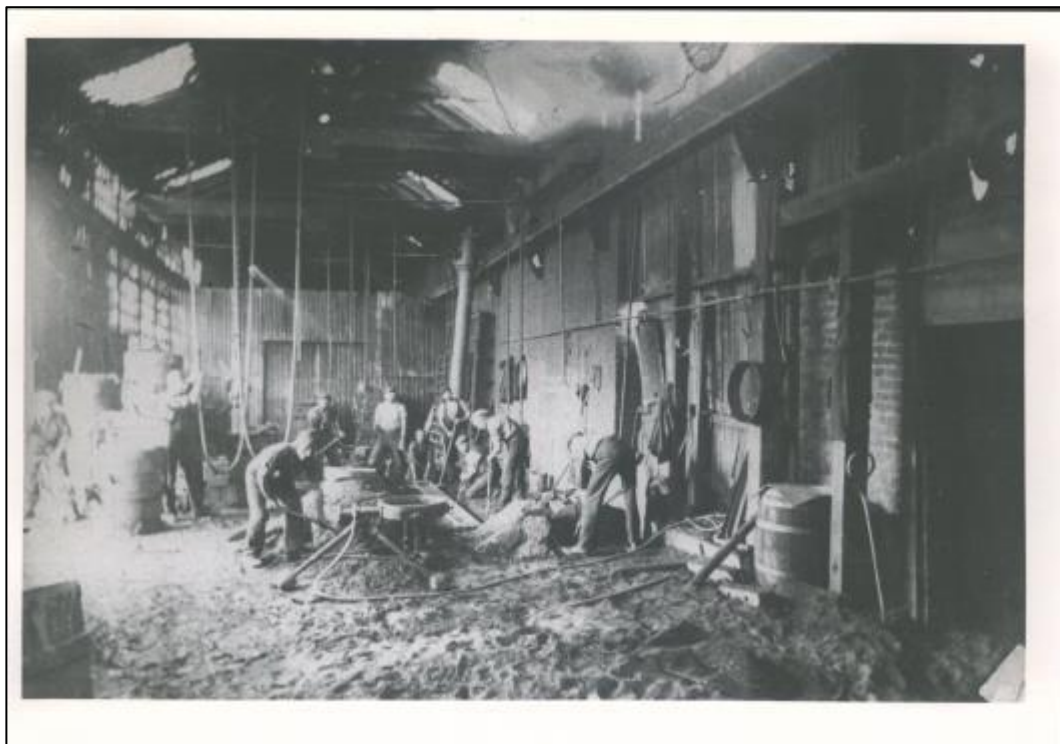
Figure 5-22. Photograph looking east of the iron moulding structure (Anon., n.d.-c).

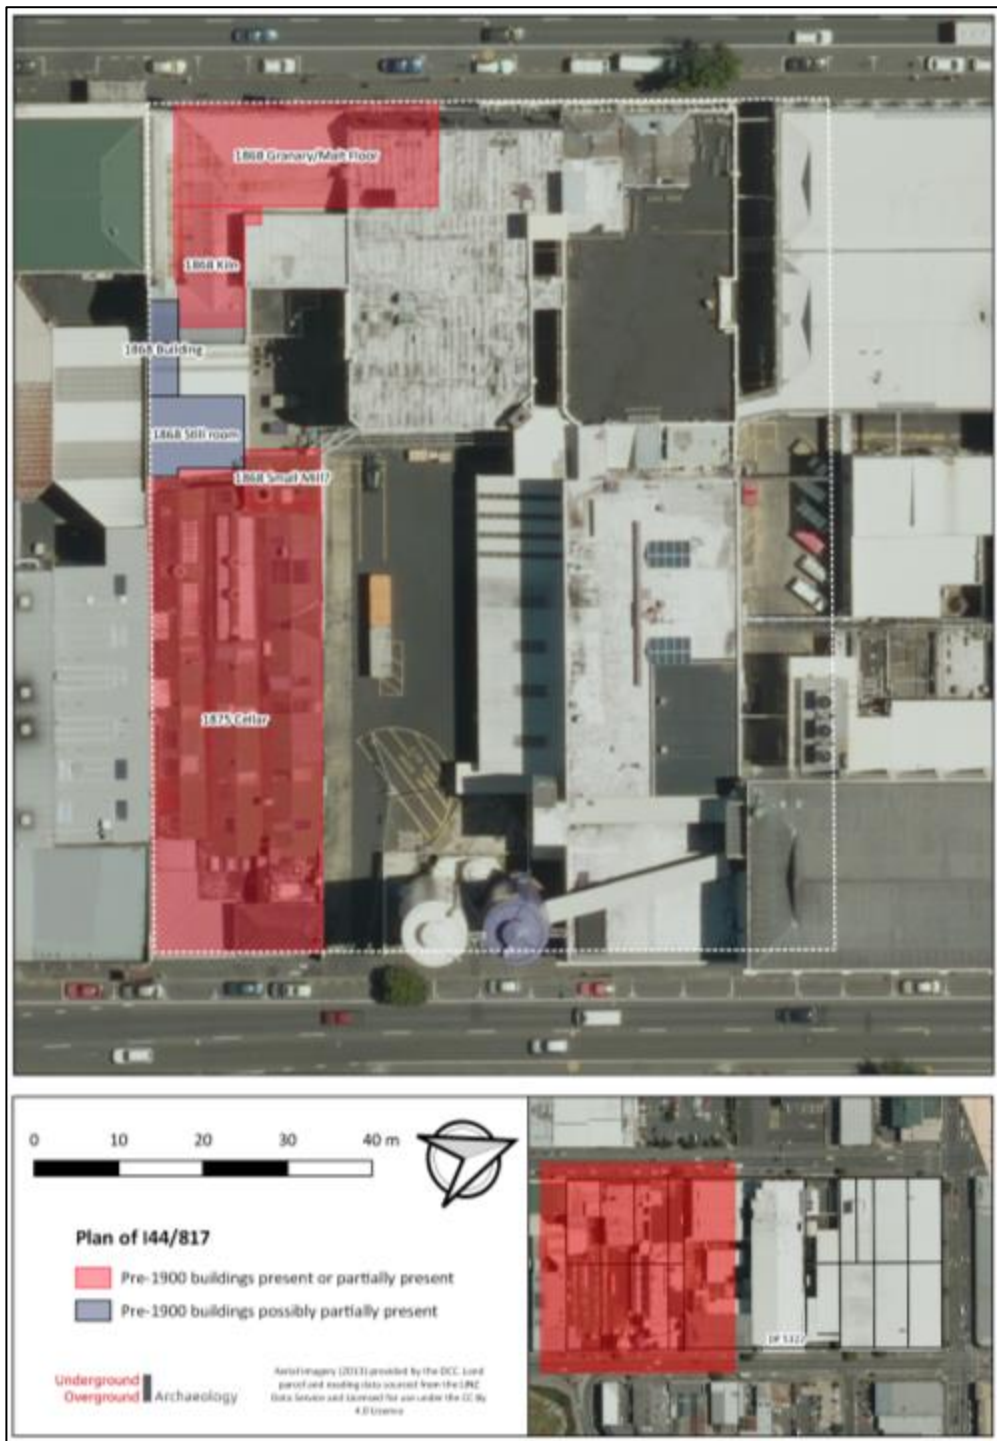
Figure 5-33 Plan of the Cadbury Block showing the location of site I44/817 (dashed white line), the pre-1900 buildings still present today.

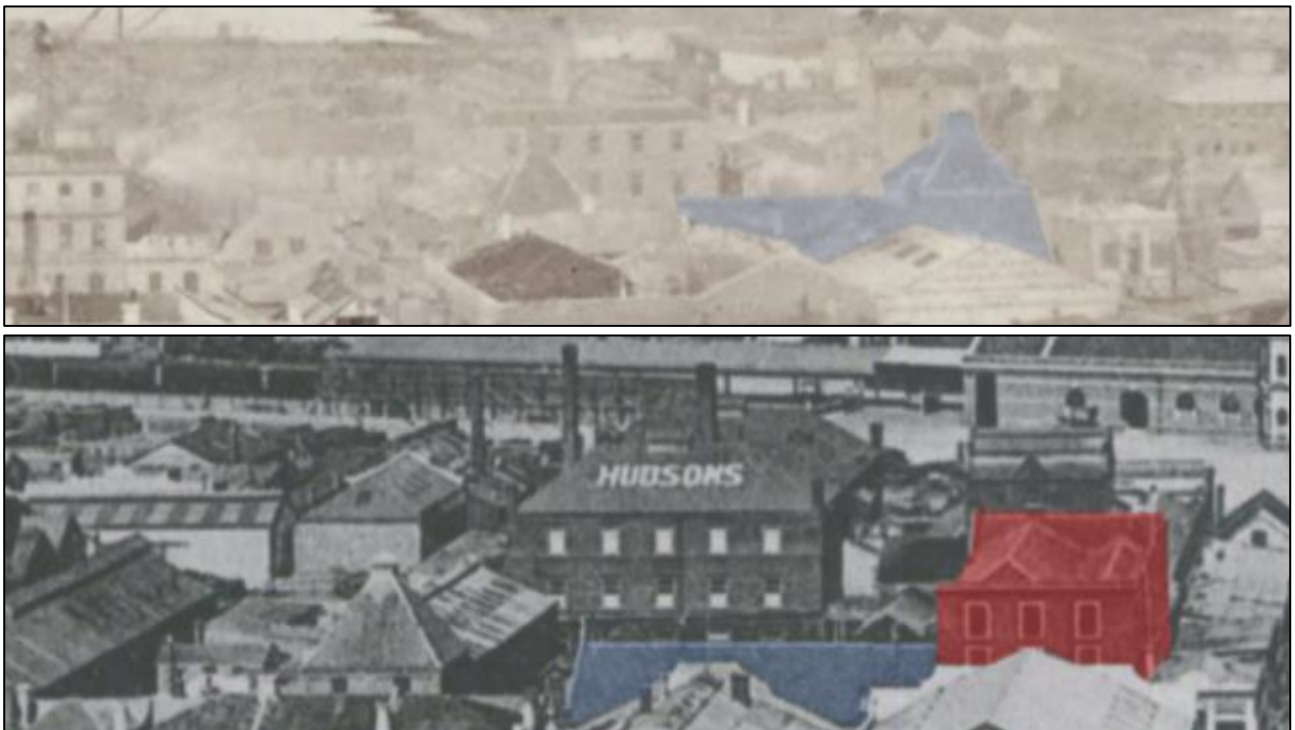
Figure 5-36. April 1901 photograph (top) showing the granary/malt floor building (highlighted blue) prior to the Phase one alterations (Muir and Moodie Studio, 1901). Part of a c. 1905 panoramic view (bottom) showing the 1901 Phase one southern and upper storey extension to the granary/malt floor and kiln buildings (highlighted red) (W Beattie & Co., n.d.). The 1868 central and northern extent of the granary/malt floor building is also visible to the north unaltered (blue). Note the biscuit factory in the background. The top photograph shows the 1901 factory, while the bottom photograph shows the almost identical 1902 building with “Hudsons” advertised on the roof.

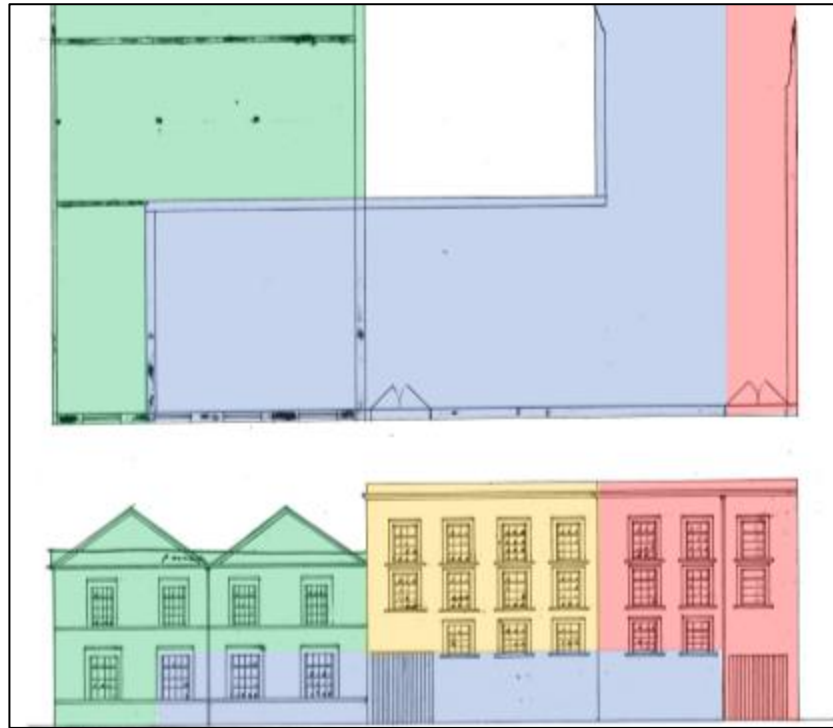
Figure 5-38 1915 plans showing the Cumberland Street façade of the granary/malt floor and kiln buildings (DCC Archive). The original 1868 granary granary/malt floor and kiln buildings are highlighted blue (note that while the mezzanine or first storey of granary/malt floor building is original, the windows were added during Phases one and three). Subsequent alterations are highlighted red for Phase one (1901), yellow for Phase three (1901-1915), and green for Phase four (1915). Phase two (1909) is not visible, even in the plan drawing, as it is immediately out of picture behind Phase four.

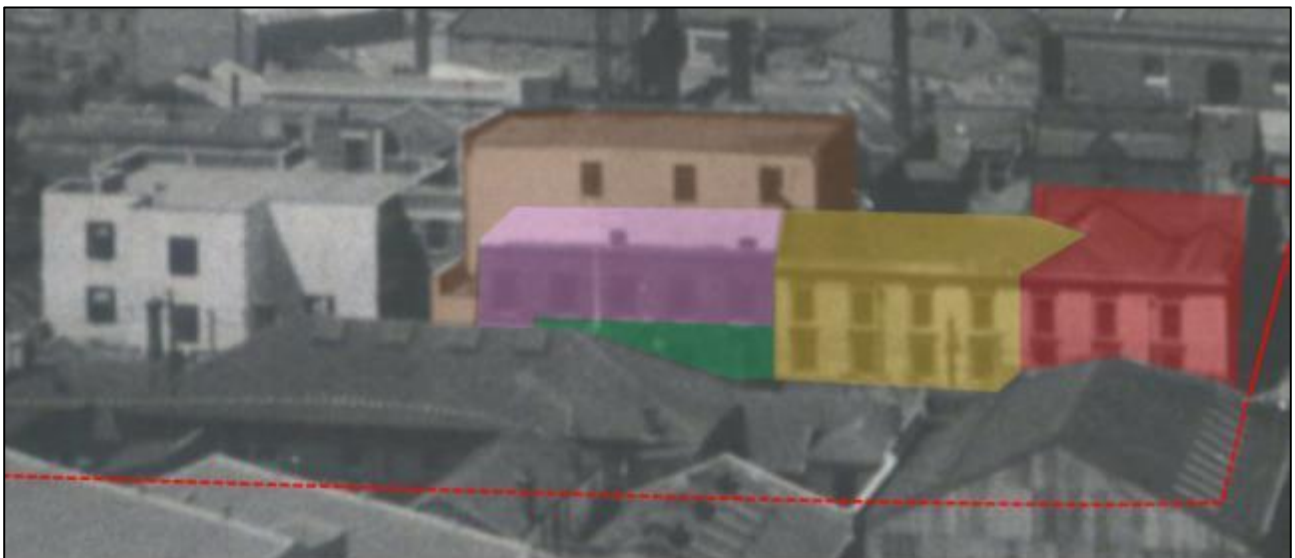
Figure 5-40 Circa 1922-1924 photograph showing buildings the alterations granary/malt floor and Kiln buildings (Frank Duncan and Co. c. 1922-1924). The original 1868 granary granary/malt floor and kiln buildings are not visible; however, subsequent alterations are highlighted red for Phase one (1901), yellow for Phase three (1901-1915), green for Phase four (1915), pink for Phase five (1915-1922), and brown for Phase six (1922).

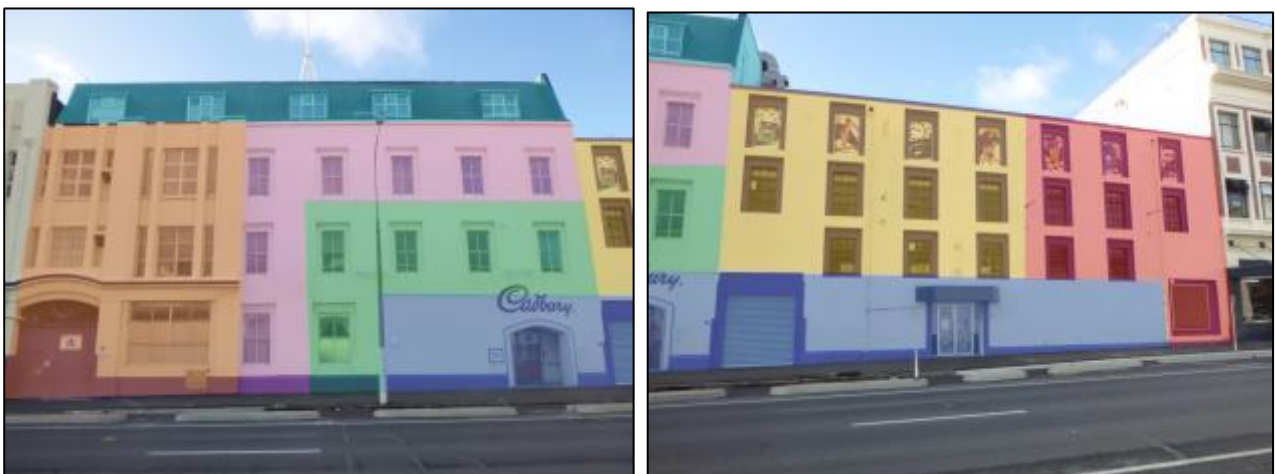
Figure 5-42 Photograph looking east at the Cumberland Street façade showing changes to the original 1868 granary granary/malt floor and kiln buildings are highlighted blue. Subsequent alterations are highlighted red for Phase one (1901), yellow for Phase three (1901-1915), green for Phase four (1915), pink for Phase five (1915-1922), orange for Phase seven (1924) and light blue for Phase eight (1924-1926).

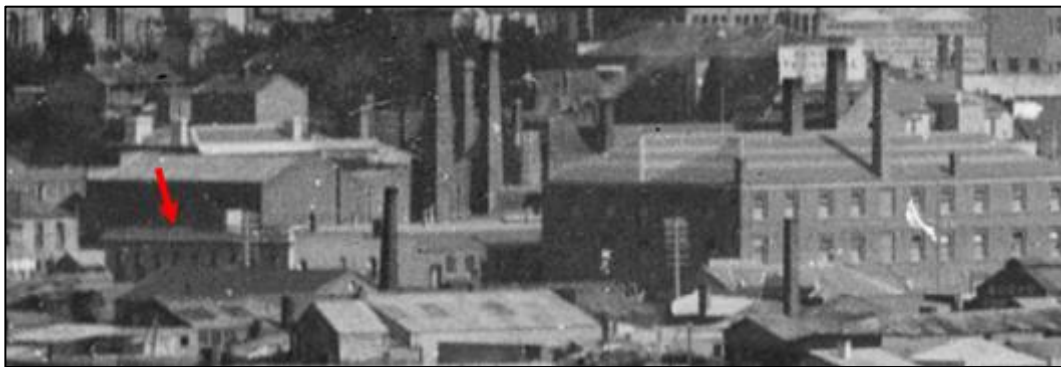
Figure 5-43. Top: 1902 photograph of the cellar building with the office alterations at the front along Castle Street (red arrow) (Muir and Moodie Studio, 1902).

As noted by Farminer (2014) the earliest clear views of the Castle Street frontage are from 1902 and circa 1903-1906 photographs (Figure 5-43 and Figure 5-49). The masonry frontage with a central access way to the more industrial cellar visible is different to those from the late 1870s photographs in which the buildings multi-gable

roof appears to extend all the way to the Castle Street footpath. These early twentieth photographs indicate that the façade had been altered sometime between the late 1870s and 1902. R Hudson and Co. were listed at this address in street directories from 1902 onwards, and by 1910 had converted the Castle Street front of the building into offices. One significant alteration to this building was the façade change in 1918 shown in Figure 5-49 (Brooks & Jacombs, 2010; A Farminer, 2014; Parkinson, 2011). Three windows on the first floor had been removed; an awning, a large doorway and adjacent public double door entranceway installed; and, a redesigned arched parapet with signage was further added. The brick work was exposed, and relief rusticated plasterwork used for the ground floor façade. The central portion of the cellar building itself would become home to a finished goods store and dairy, housing a milk condensing plant. It is unclear when this change occurred except that it was early in Hudson's ownership of the property (Brooks & Jacombs, 2010; A Farminer, 2014; Parkinson, 2011). Plans from 1922 show that a covered bridge was constructed from the second floor of the central cellar building through to the 1902 biscuit factory, providing easy access to the dairy and finished goods store. These same plans show that the pre-1900 possible small mill, now with a second storey added sometime after 1889, had been converted into engine house and it opened to connect through into the cellar building (Figure 5-39).

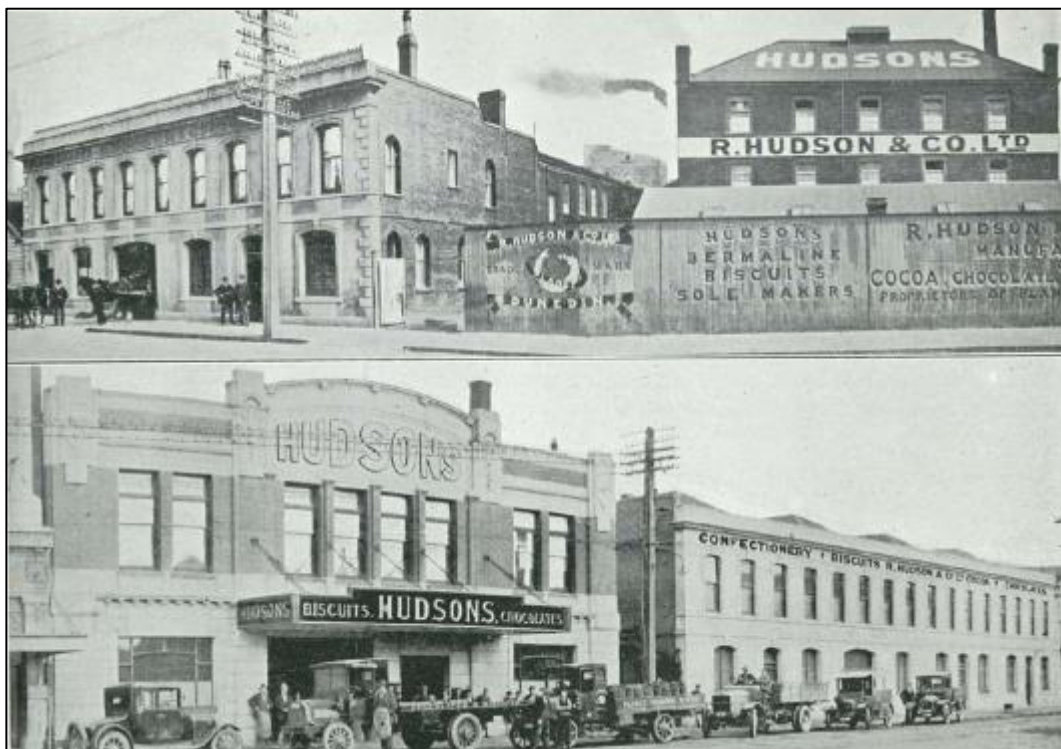
Figure 5-44. Top: 1903-06 photograph of the biscuit factory in Town Sections 72 and 73 to the left of the offices in Town Section 74. Bottom: altered 1918 façade of the Hudson building in 1928 (Figure 12 in Brooks & Jacombs, 2010).

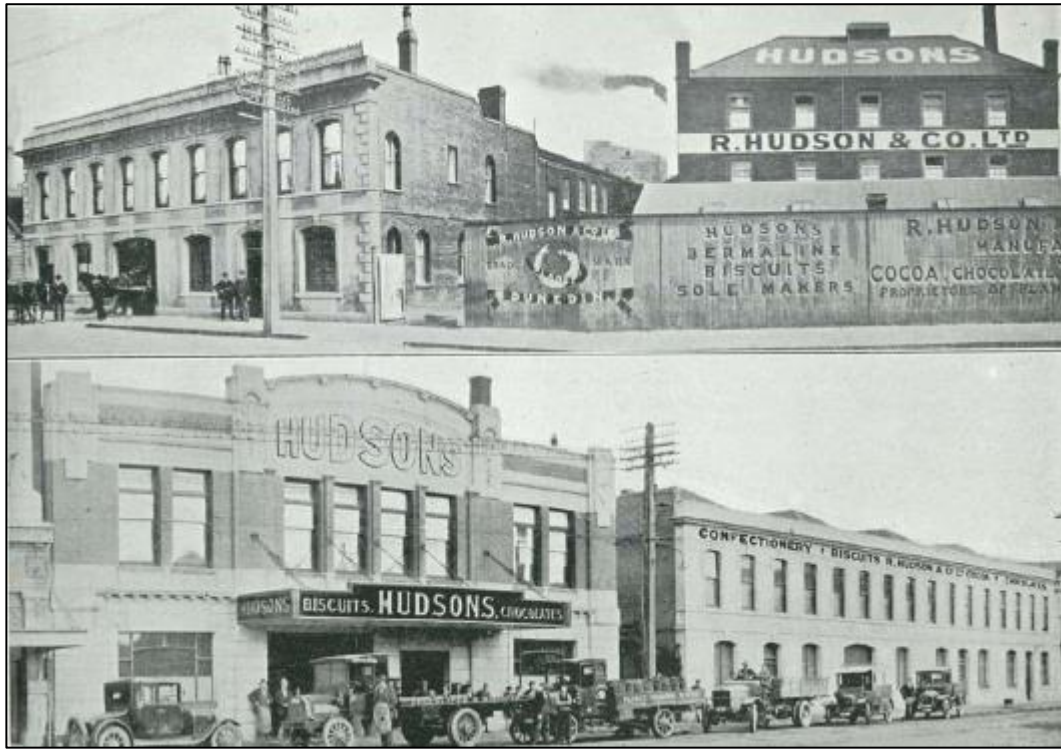
Figure 5-49. Top: 1900s photograph of the Biscuit factory in Town Sections 72 and 73 to the left of the offices in Town Section 74. Bottom: altered façade of the Hudson building in 1928 (Figure 12 in Brooks & Jacombs, 2010).

In 1905 plans were submitted to DCC for a brick cloak room building between Castle Street and the biscuit factory. This building can be seen in Figure 5-49 to Figure 5-52. The two photographs also show a substantial wall in front of the cloak room. This building was replaced between 1907 and 1922 by the much larger building across Sections 72 and 73 (Buildings No. 10 and 14 in Figure 5-45) visible in the 1907 plans (Figure 5-50, Figure 5-51 and Figure 5-52) and the 1928 photograph (Figure 5-49). In the 1922 plan this building is shown to extend north and adjoins the earlier brick building, built sometime between 1892 and 1902 in Section 71 (Building No. 15 in Figure 5-45).

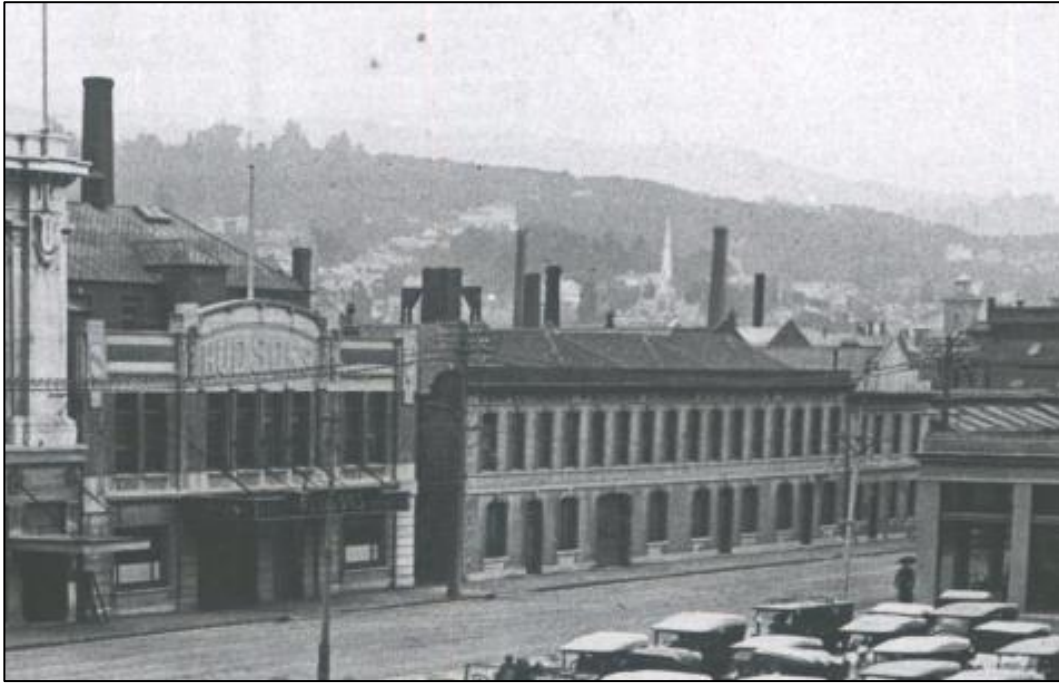
Figure 5-52. 1922 façade of the Dairy and Office Building and Biscuit factory in Town Section 72 and 73 abutting the earlier brick building in Section 71 (Anon., 1922).

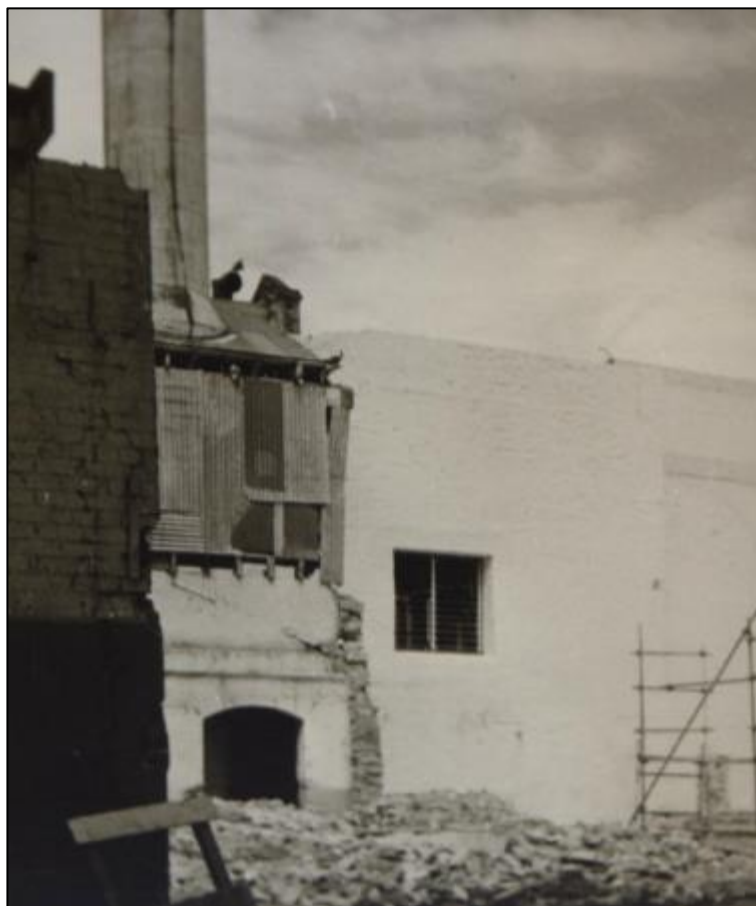
Figure 5-61. Likely early 1960s photo showing the demolition of the old boiler house. The rear wall of the machine or former engine house is visible to the left and the cellar building to the right (Figure 13 in Farminer, 2014). The north return wall of the mill or still room building is visible in the centre of the photo.

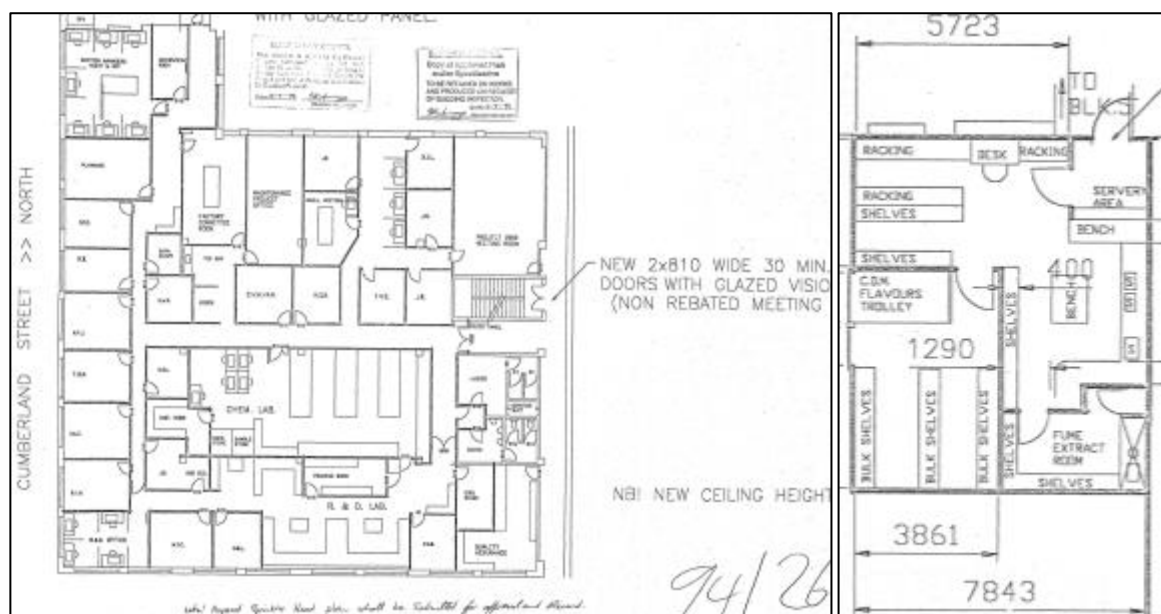
Figure 5-77. 1994 plans of upgrades to offices on first floor (left) and essence room on the second floor (right) of the engineering workshop, labs and offices building.

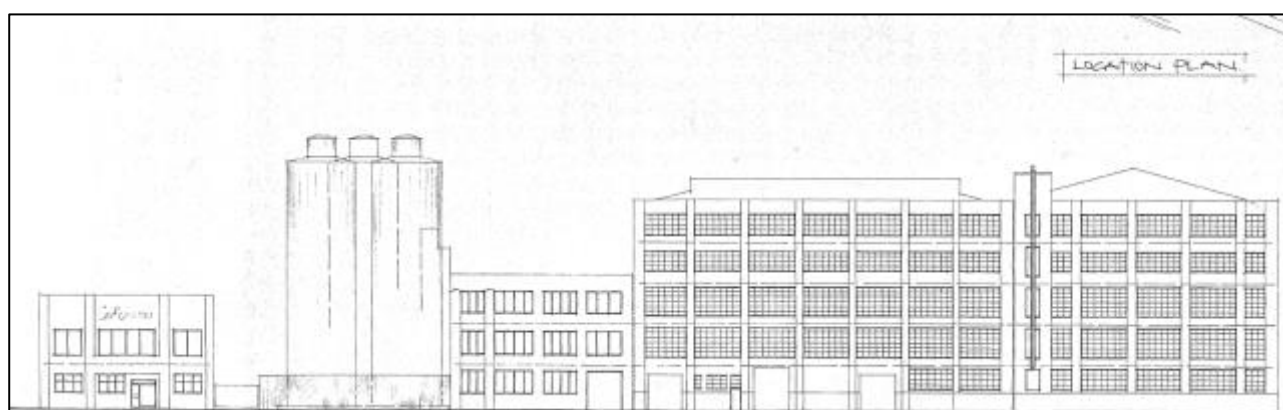
Figure 5-81. 1991 Plan of entire factory façade except for the south of Block A on Castle Street (DCC Archives). The block 2B and 2C buildings have been removed and the crumb silos built.

Between 1985 and 1986 the 1903 biscuit factory and the buildings in front along Castle Street in Block 2B and 2C were demolished (Retrolens), replaced a carpark and eventually 1950s crumb silos transferred to this space from their earlier location on Cumberland Street in 1991, where Countdown is located today (Figure 5-81), while in 1995 a crumb processing plant was added to the north side of the biscuit factory building.

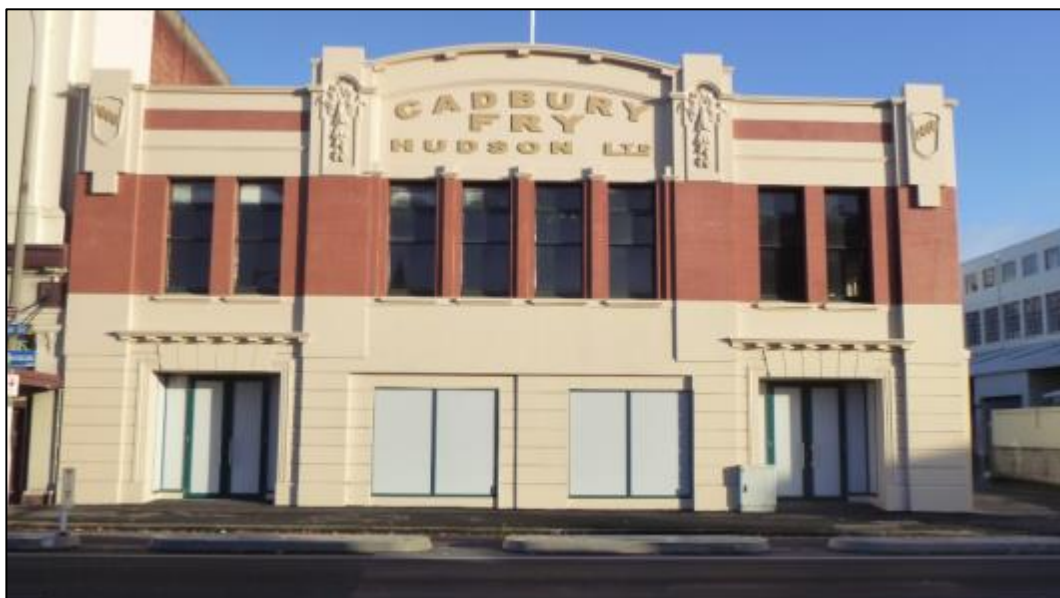
Figure 7-3 Photograph looking west at the Castle Street façade of the Dairy and Machine House Building.

The main elevation of the two-storey brick building faces out onto Castle Street (Figure 7-3). The façade was reconstructed<sup>3</sup> in 2018 to reflect the 1918 façade, rather than its earlier Victorian period frontage. As such the top of the building features an arched parapet with further plasterwork embellishments on the pilasters. The windows on the second floor were restored with timber sills. The ground floor does vary slightly from the 1918 façade as the wide windows are located in the centre of the building, while two double glass doors are situated either side where the windows were previously situated. The doors feature the same plasterwork moulding above as was formerly over the windows in 1918, as is simulated rustication achieved using plaster over cement board along the entire ground floor frontage. Unlike the 1918 façade however, the frontage no longer features an awning over the central portion of the ground floor.

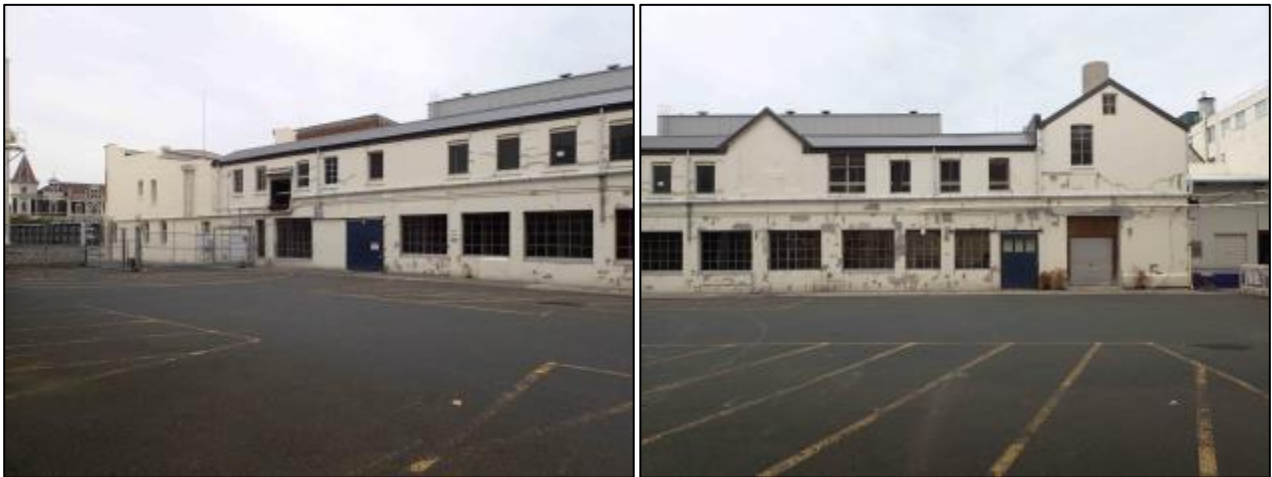
Figure 7-4 Photograph looking southeast (left) and south (right) at the eastern side of building one showing the three distinct portions: the eastern offices, the central dairy, and the western machine house.

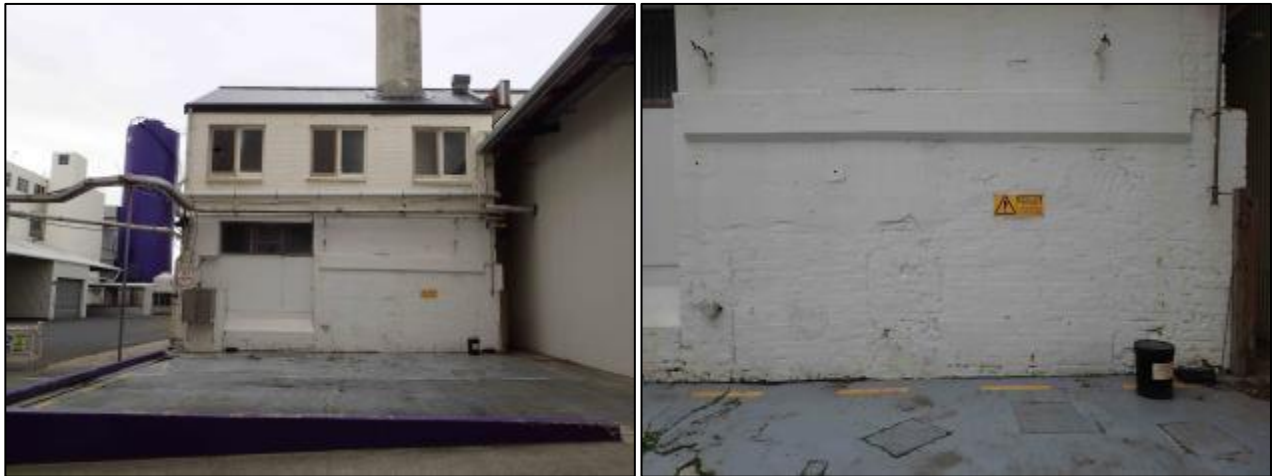
Figure 7-5. Photograph looking east at the western wall of the machine house showing the blocked-in windows. A close-up photograph is shown on the right.

The western extent of the small mill features two bricked-in openings that would have originally led into the machine house from the boiler house (Figure 7-5). Above this is the later twentieth century second floor addition to the small mill building, which had replaced the earlier temporary corrugated iron addition. The central Dairy and Machine House Building, and modern covered loading bay further share the former brick wall that ran between the still room and cellar (Figure 7-6). An archway is visible set back from the machine house along the shared wall, suggesting that there was a door or window situated at this location, yet it too is now blocked in (Figure 7-7). From an aerial view, the office extent of the building has a mono-pitched roof, while the central portion of the building features a multi-gable roof with a cross gable in the centre and a number of skylights adjoining the single-gable roof of the machine house.

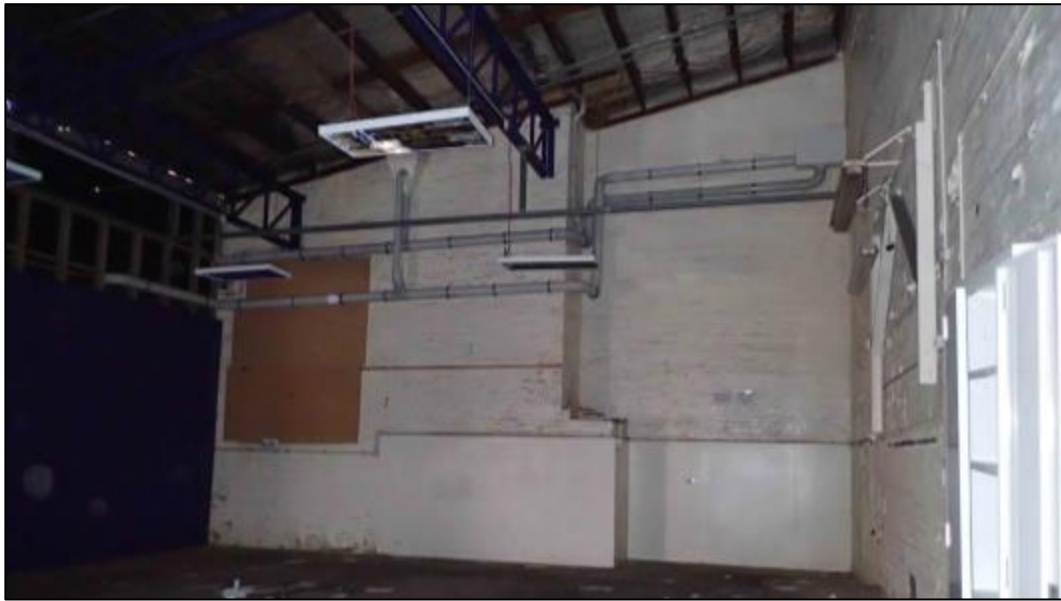
Figure 7-6 Distinct dog-legged wall of the former shared wall between the cellar and the mill (today the Dairy and Machine House Building and covered loading bay).

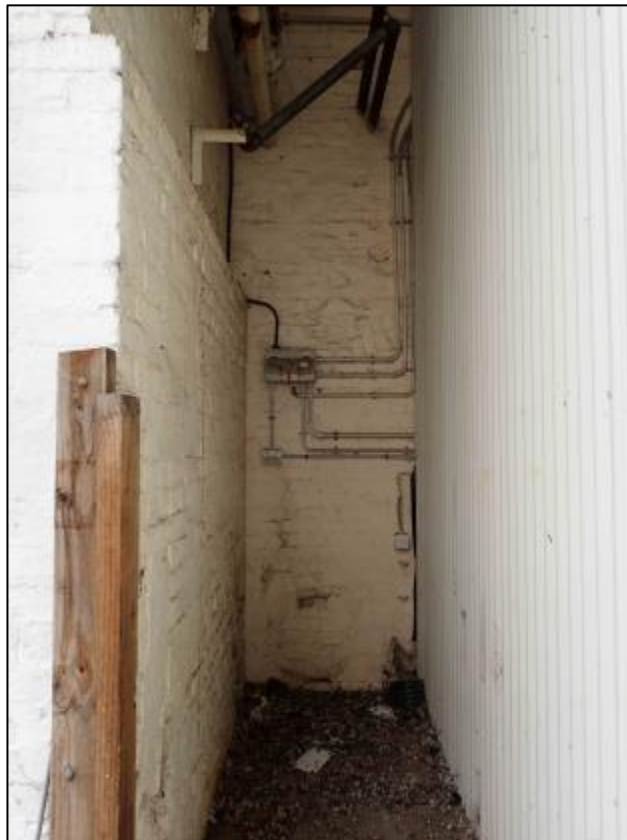
Figure 7-7 Photograph looking east at the former doorway or window arch located on the shared wall between what was once the cellar and mill

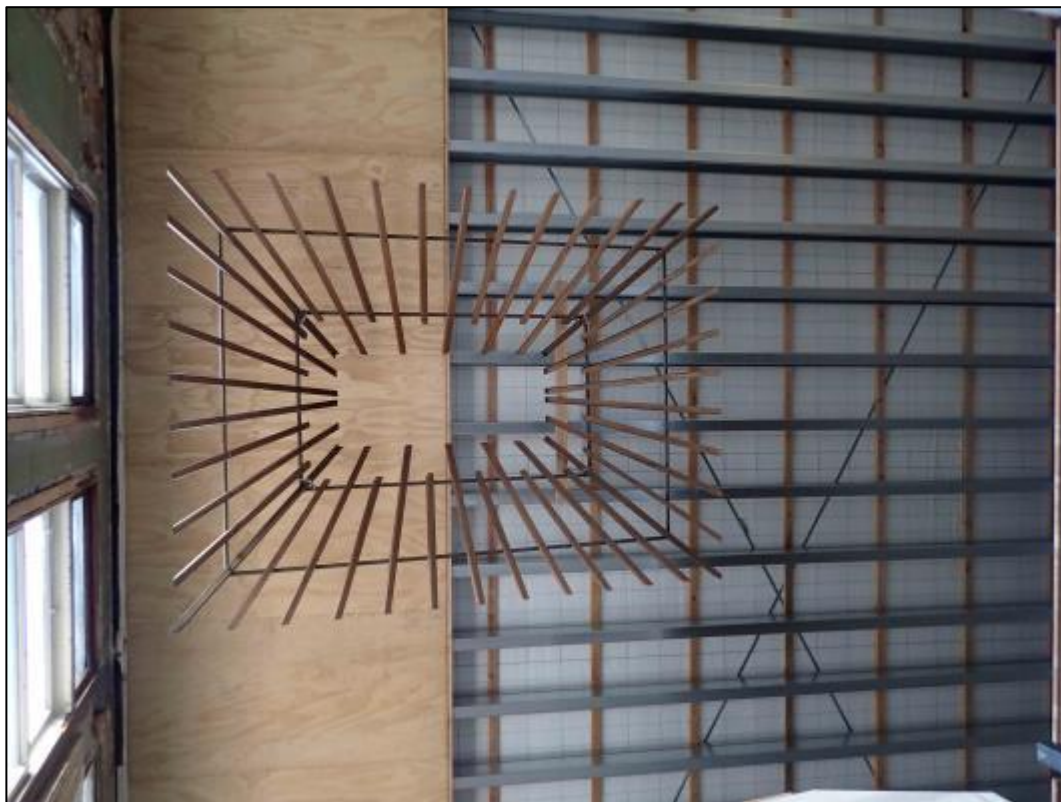
Figure 7-8. Suspended screen visible in the 1966 plans above the stairwell to the second floor.
