# Dunedin Hospital Development, Cadbury Confectionary Ltd Buildings

A Heritage Impact Assessment

Report Prepared for Ministry of Health  
Author: Megan Lawrence, Naomi Woods, Dawn Cropper  
and Hayden Cawte  
Reviewed by: Dawn Cropper  
Submitted: May 2020

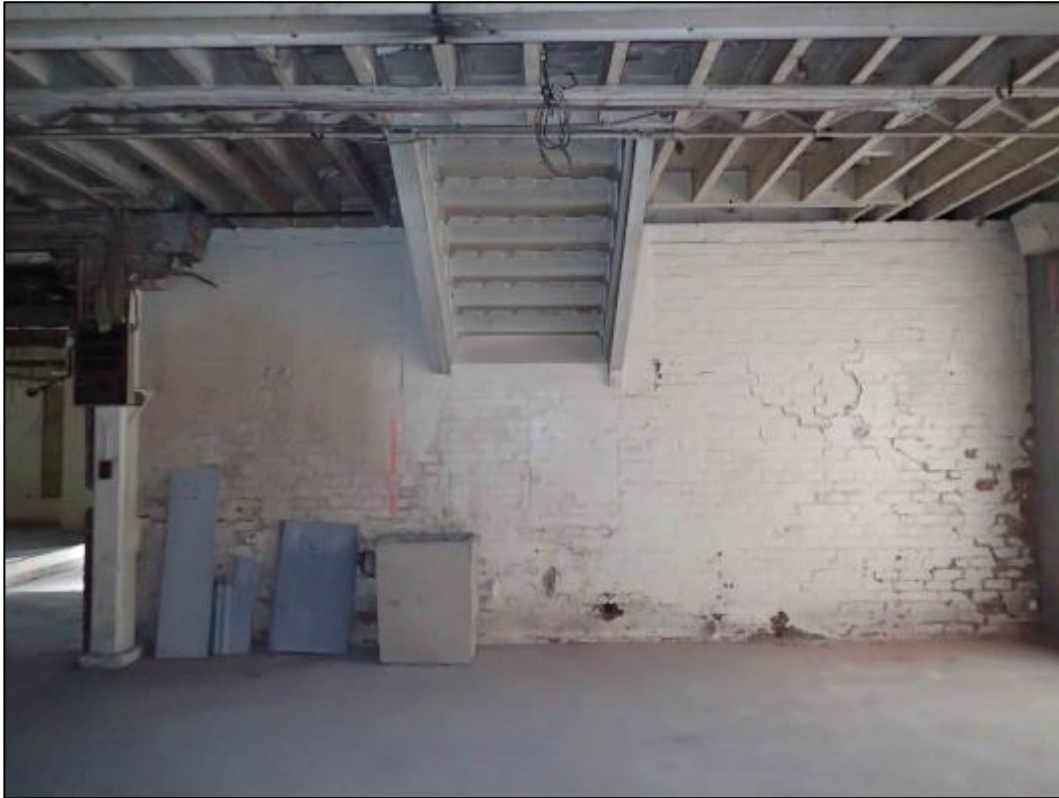
Figure 7-9. Photograph looking north at partition wall with two blocked in windows and the bottom of the stairwell leading from the partitioned area to the first floor.

The interior of the Dairy and Machine House Building has undergone a number of modifications since the 1875 construction of the cellar to accommodate changing functions. The central room is an open space, except for a partitioned stairwell area at the eastern end of the building leading to the second storey. This area was closed off in the 1966 renovations (Figure 5-63 and Figure 5-64). The suspended screen from the second-floor ceiling, visible in the 1966 plans, is still present in the building today (Figure 7-8). The south wall of this partitioned area (Figure 7-9) is formed of brick and may relate to the 1875 construction of the cellar. This wall features two windows that

were blocked prior to 1959, likely when the stair well was installed at this location (Figure 5-60). The location of a former stairwell to the second floor is also visible at the eastern end along the southern wall of the building. There is evidence of a stairwell landing halfway up the stairs (Figure 7-10). These stairs are located further east than the two other stairwells indicated in the 1959 plans suggesting they were used prior to this date (Figure 5-60). At the same height as the landing there are a number of possible joist pockets (Figure 7-10). These ran quite low in comparison to the current floor level, and while the original height of the floor was raised in 1959, it does not appear in older photos of the façade to have been considerably lower than the current level. As such the possible joist pocket locations may have been for a mezzanine level. Later stairs visible on the 1959 plans are located further west (Figure 7-11).

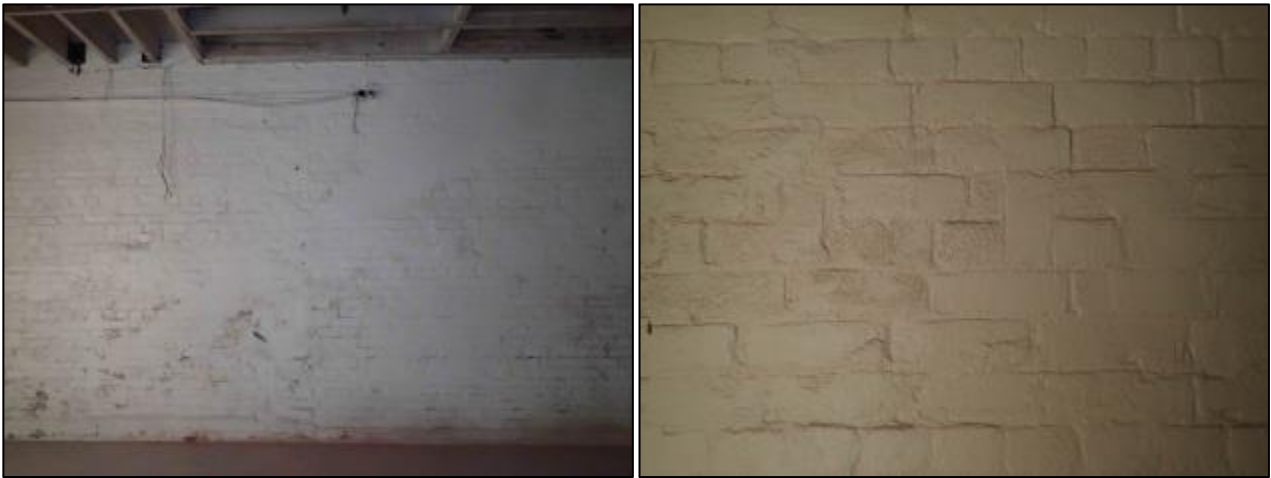
Figure 7-10 On the left is photograph looking south on ground floor of the Dairy and Machine House Building at location of first former staircase. A landing is visible half-way up. On the right is a photograph looking south on ground floor of the Dairy and Machine House Building at possible joist insertion points. These are at the same height as the first former staircase landing and possibly indicate there was a mezzanine floor at this height.

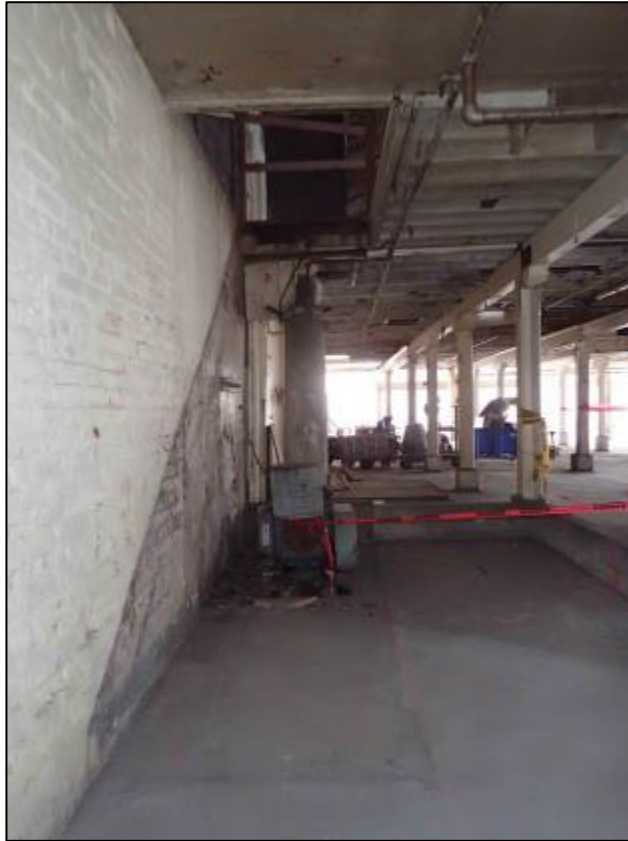
Figure 7-11 Photograph looking west on ground floor of the Dairy and Machine House Building at location of second former staircase visible in 1959 plans.

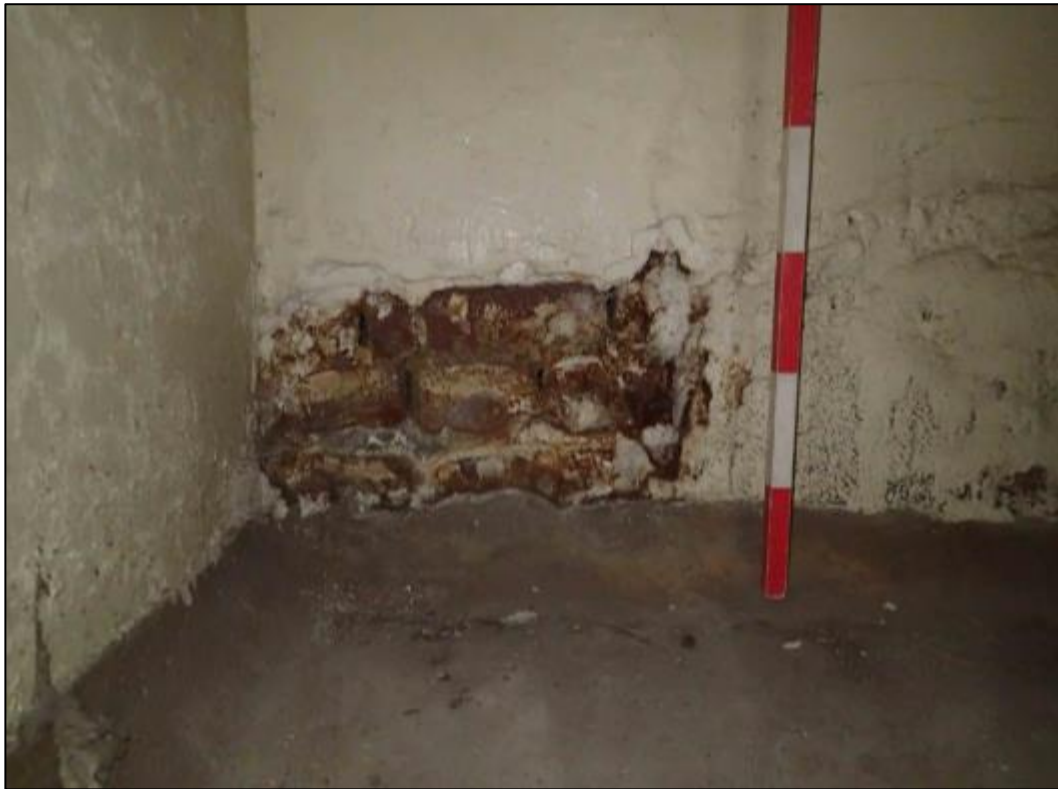
Figure 7-13 Photograph looking west at the plastered brick wall of ground floor in the machine house building.

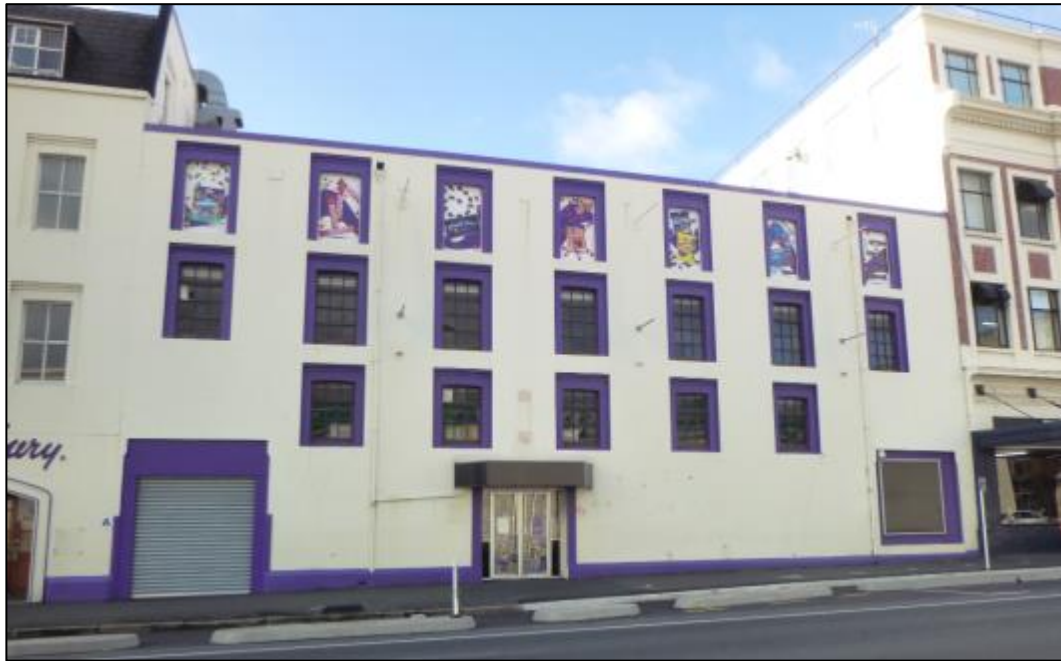
**Figure 7-15 Photograph looking east at the Cumberland Street façade of Cadbury World.**

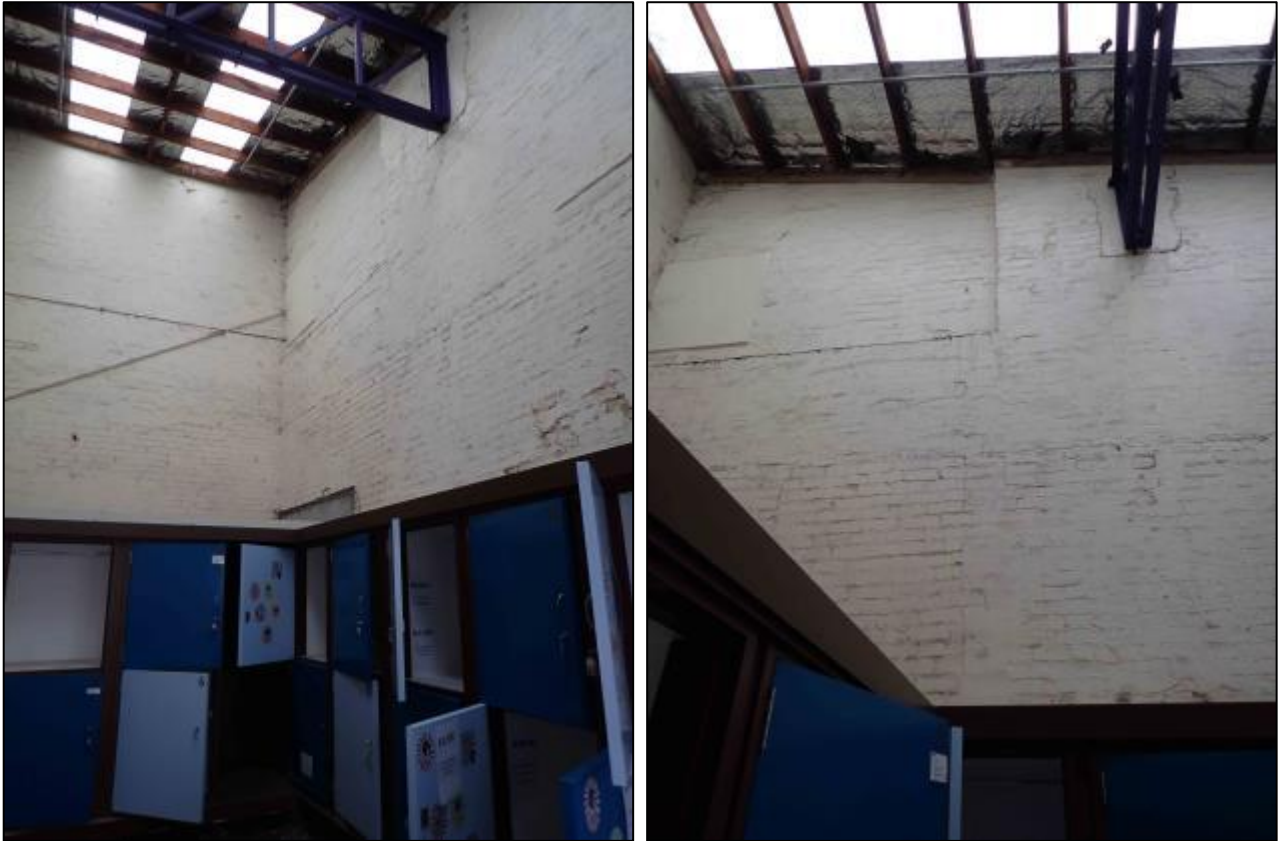
Figure 7-16. Photograph looking southwest (left) and west (right) at the eastern wall of the former kiln and northern wall of the former mill building. Note the jut into the wall is on the second storey. This may be associated with pre-1900 lean-to at the rear of the kiln and mill buildings

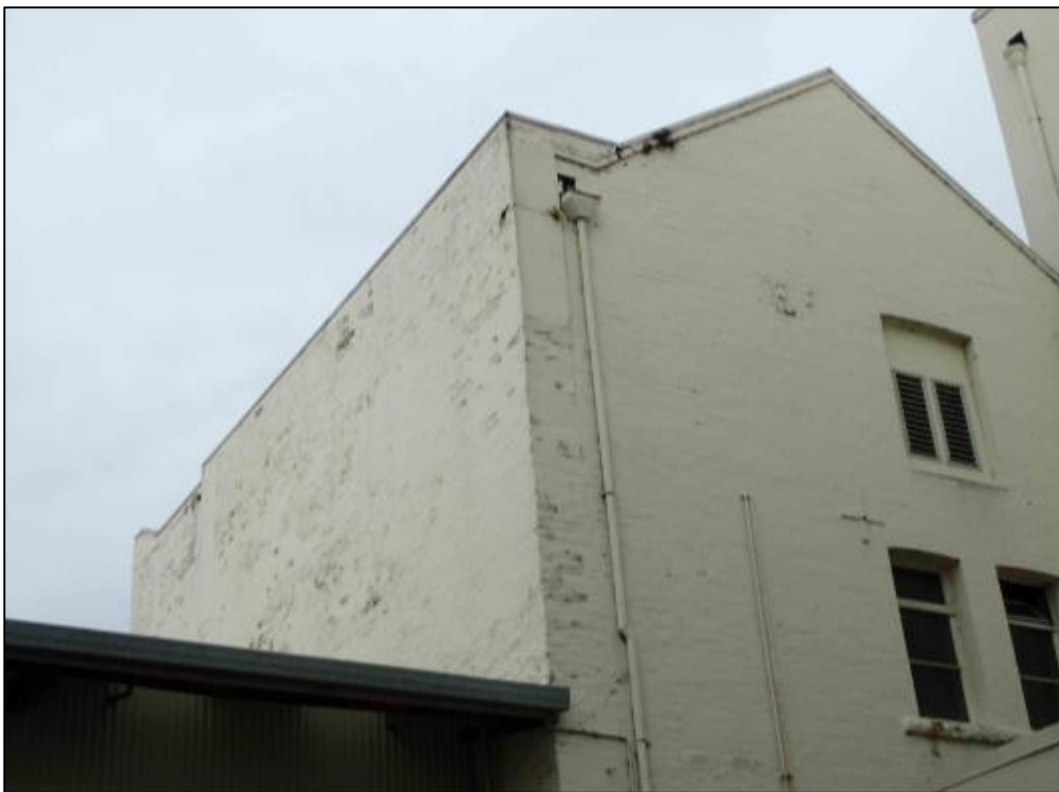
Returning to the Cadbury World building, on the east elevation there are two former bricked-in windows visible as is one more on the northern wall along with two modern windows and one vent along in what was the former kiln building (Figure 7-17). There are two entrances to the building through the café (former granary/malt floor), a shop area (former confectionery factory) or through Cadbury World (former kiln building). The roof of Cadbury World (kiln and granary/malt floor), although it has been reclad in the later twentieth century, matches the early 1902 roof line with a multi-gabled roof with a cross gable at the rear (Figure 5-36). Another gable roof crosses the most northern of these gables and runs north. This is likely associated with the later raising of the central portion of the granary/malt floor building between 1901 and 1915. The 1920s addition to the rear forming the Confectionery factory as well as another post-1950s toilet block addition to the rear feature flat-pitched roofs.

Figure 7-17 Photograph looking southwest at the eastern and northern wall of former smutters and kiln building. The upper floor was added sometime between 1892 and 1901, while the southern extension of 1901 is visible at the rear. There is one blocked in window on the eastern wall and another on the northern wall.

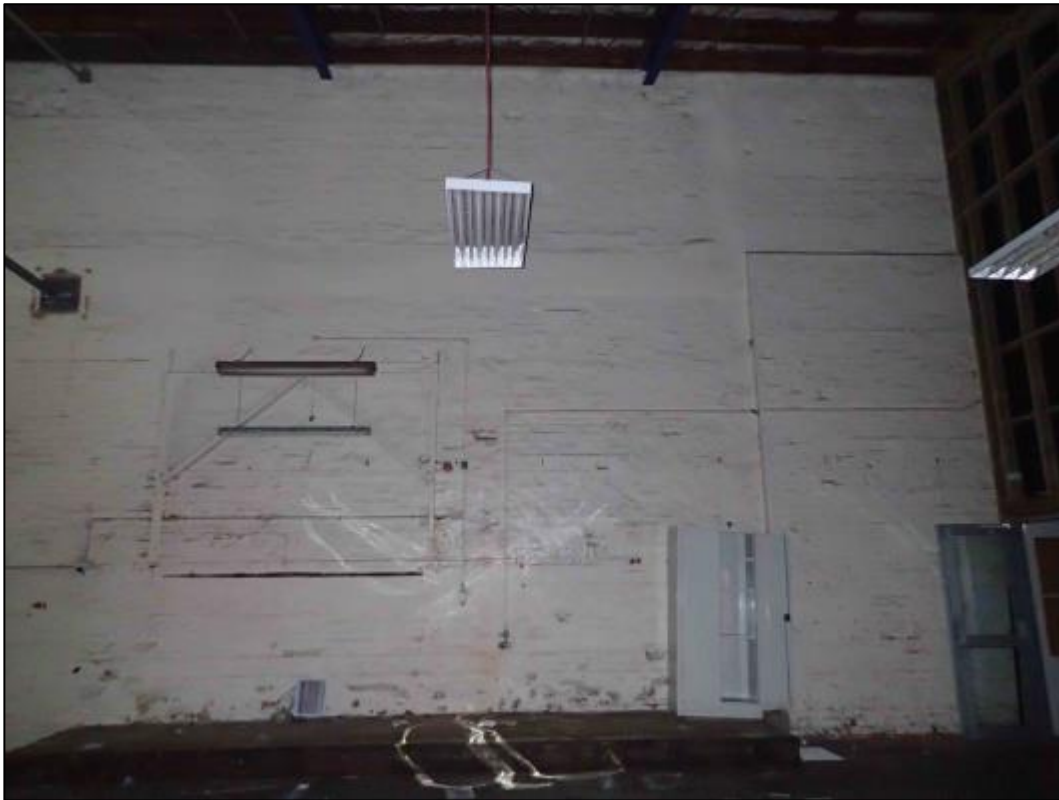
**Figure 7-18 Photograph looking north at wall between Dairy and Machine House Building and the Cadbury World and Office Building. Note that the eastern end of the building has been raised.**

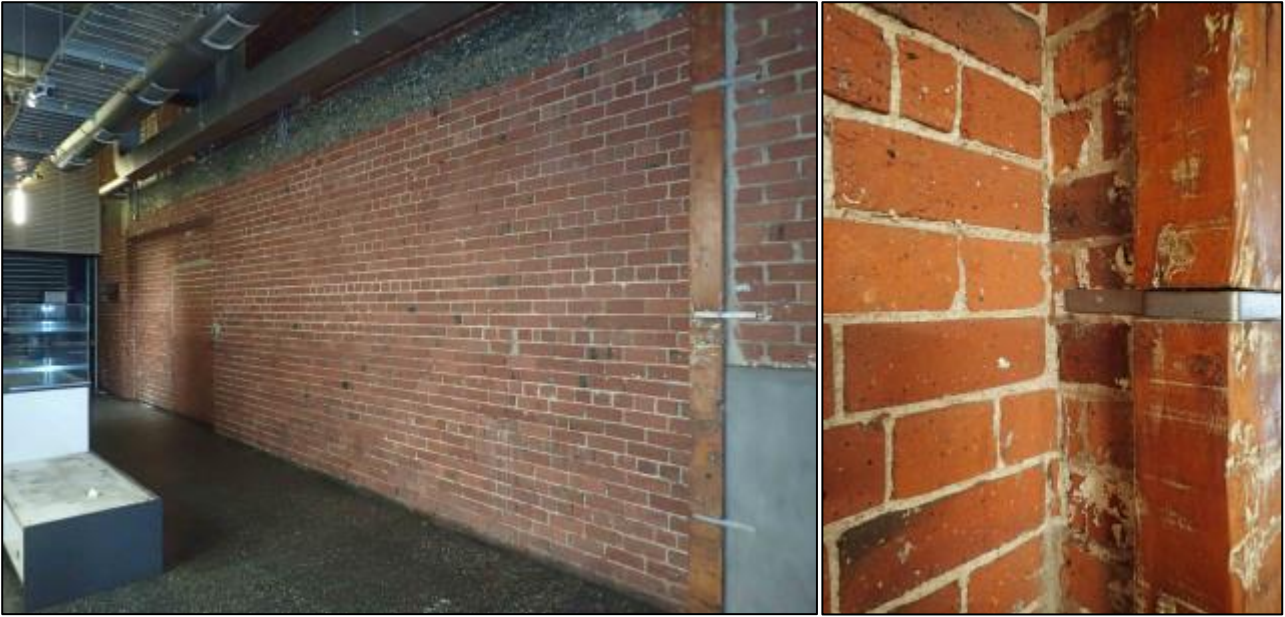
There were remnants of the pre-1900 granary/malt floor located throughout Cadbury World and café interior. In the café a brick wall running east-west, which was present by 1922 (the presently bricked in doorway is visible in plans from this time), abutted an earlier brick wall running north-south (Figure 5-23 and Figure 5-24). This wall demarcates the east extent of the pre-1900 granary and malt floor. It is unclear if when the east west wall was added, the north-south wall was opened to create an accessway through the building or if the opening was always present to provide access to the rear of the building. The remainder of the brick wall would have formed the granary/malt floor is covered with modern cladding and linings; however, it likely extends through Cadbury World to the south and into the office/reception building to the north.

Figure 7-19. Photographs looking northwest (left) at southern internal partition wall on the ground floor of the Cadbury World Building and northeast (right) at the abutment of the same wall to an earlier external wall to the west. The wall was likely present from 1922. Note the blocked-in doorway on the northern internal wall.

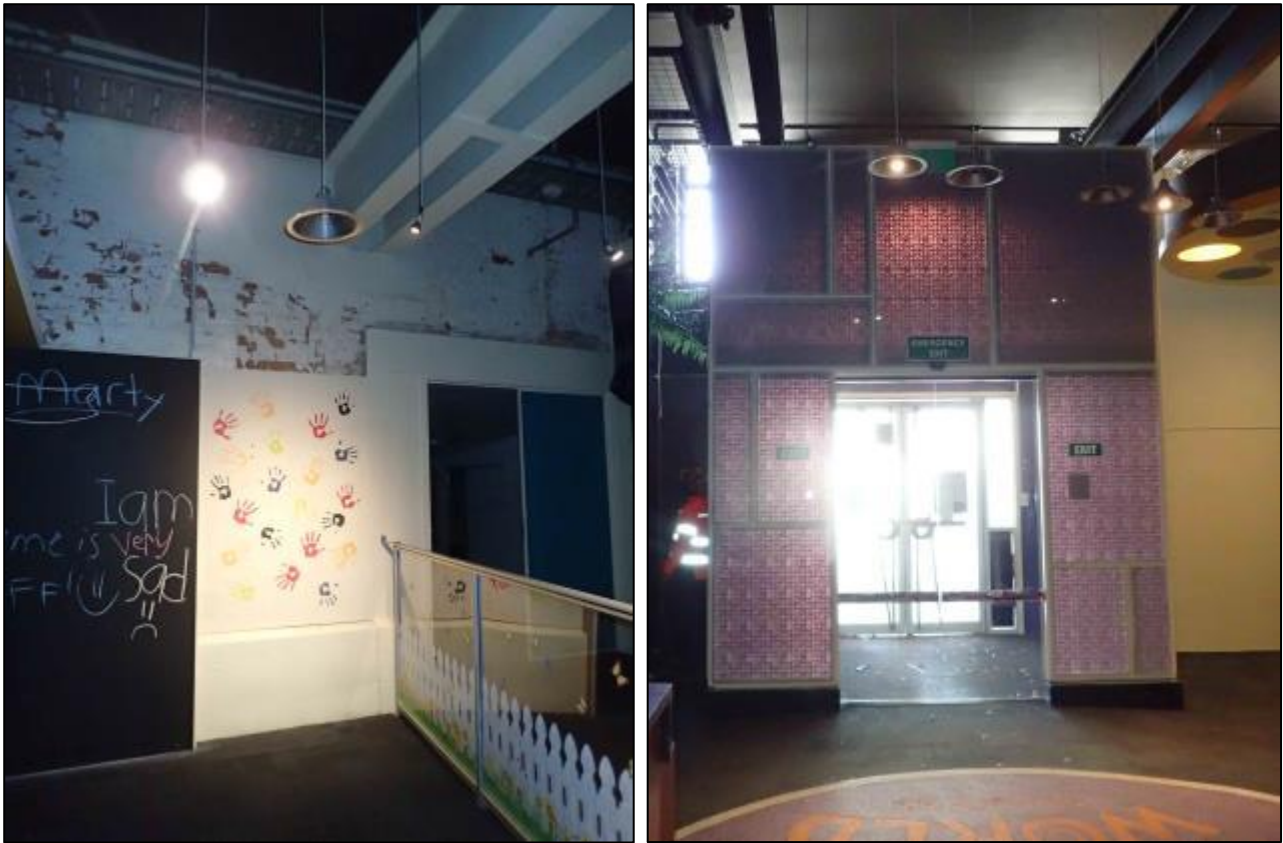
Figure 7-21. Photographs looking east (left) and west (right) on the ground floor of the Cadbury World building showing steel beams. Note the windows of the mezzanine floor above the door in the photograph on the left.

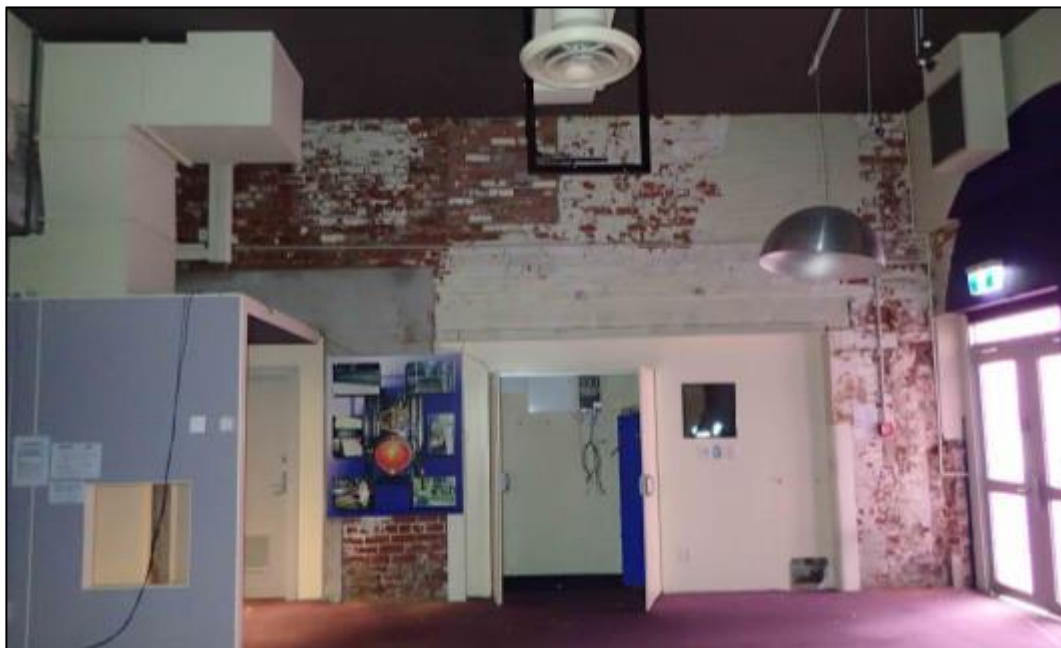
Figure 7-22. Photograph of interior wall of Cadbury World building that would have originally form the north exterior wall of the pre-1900 kiln. Note the bricked in windows of what was once the mezzanine level.

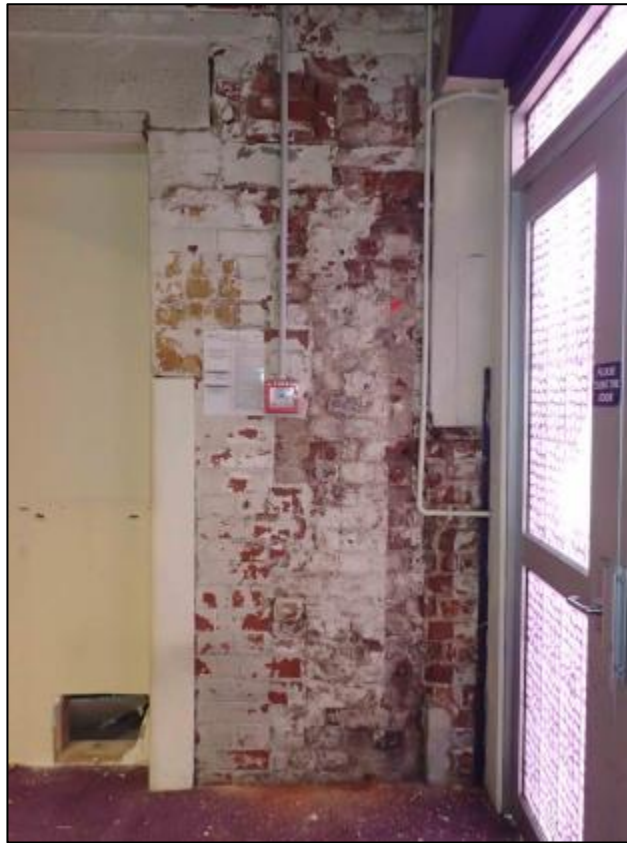
The mezzanine level of the granary/malt floor, and kiln building was removed in 1959 and the additional steel supports are visible throughout the ground floor of Cadbury World (Figure 7-21). The open mezzanine level windows are partially visible along the west wall of Cadbury World, while three former windows are visible along the form northern external wall of the kiln building (Figure 7-22). There is also evidence for a partition wall or perhaps an external wall, suggesting the building was extended slight south (Figure 7-23)

**Figure 7-23. Detail photograph of interior wall of Cadbury World building that would have originally form the north exterior wall of the pre-1900 kiln showing a possible ground floor partition wall and joist insertion point for the original mezzanine level.**

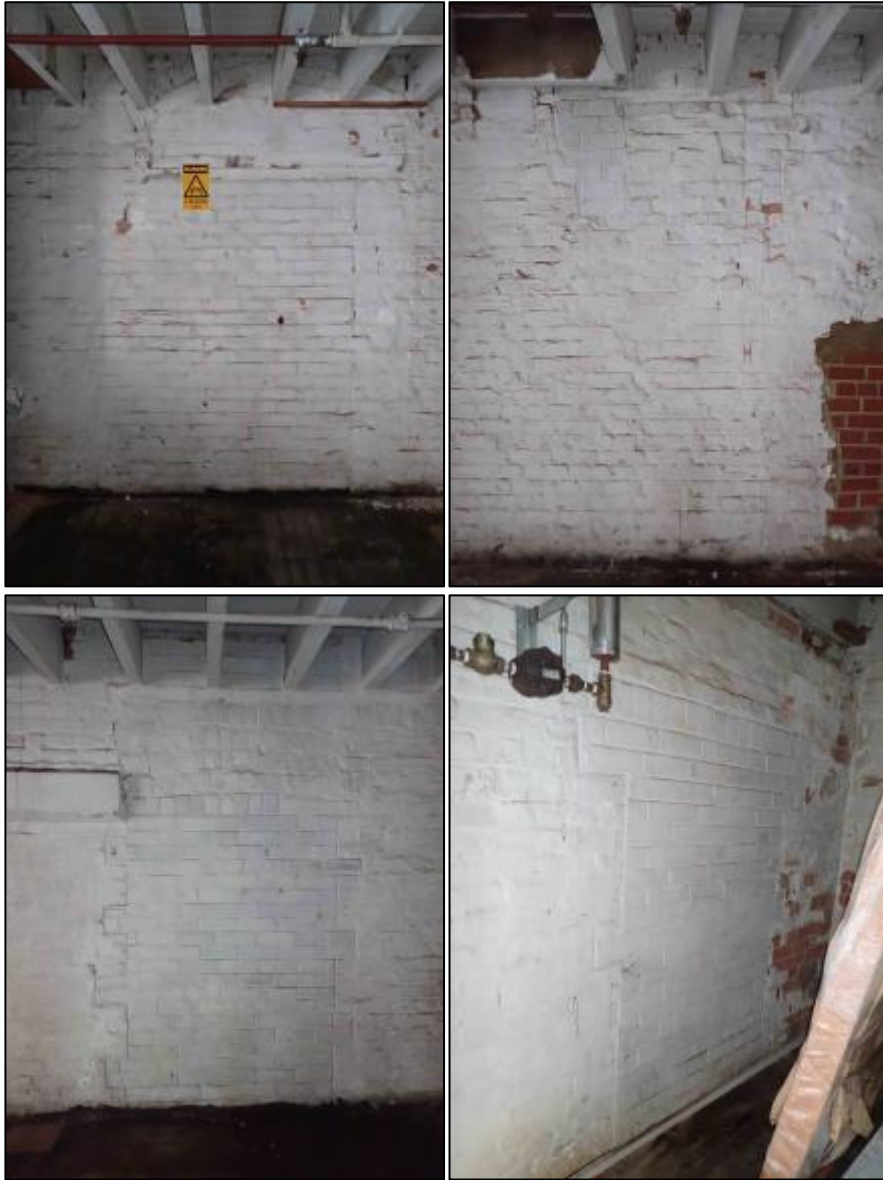
Figure 7-24 Blocked in doorways and windows in the former kiln building looking east (top right and left and bottom left) and northeast (bottom right).

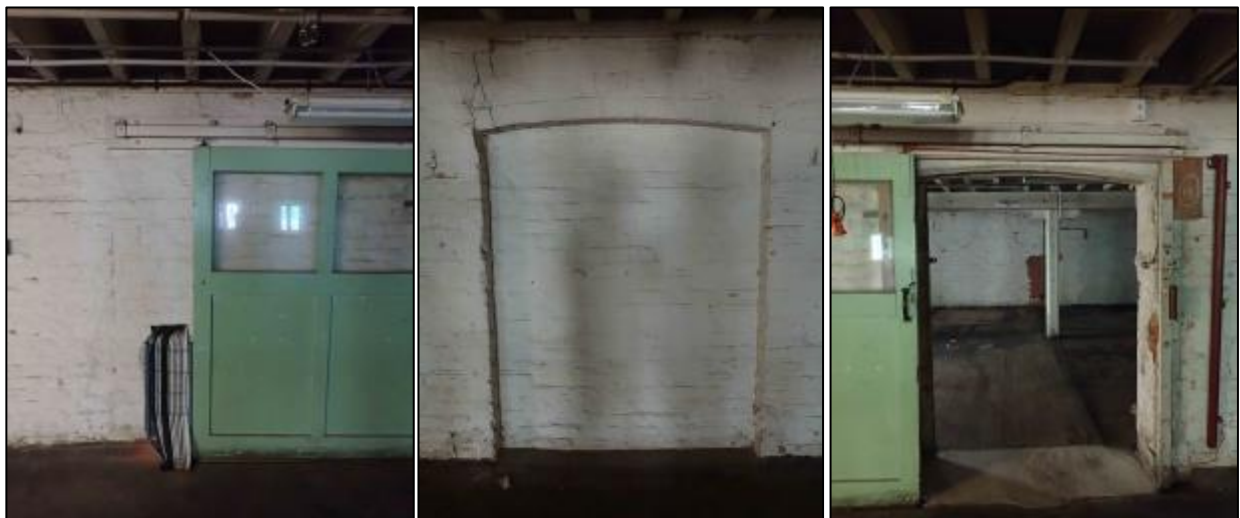
Figure 7-25 Photographs looking east at two blocked in doorways (top) either side of current doorway (bottom) to the eastern room of the former kiln and smutters room.

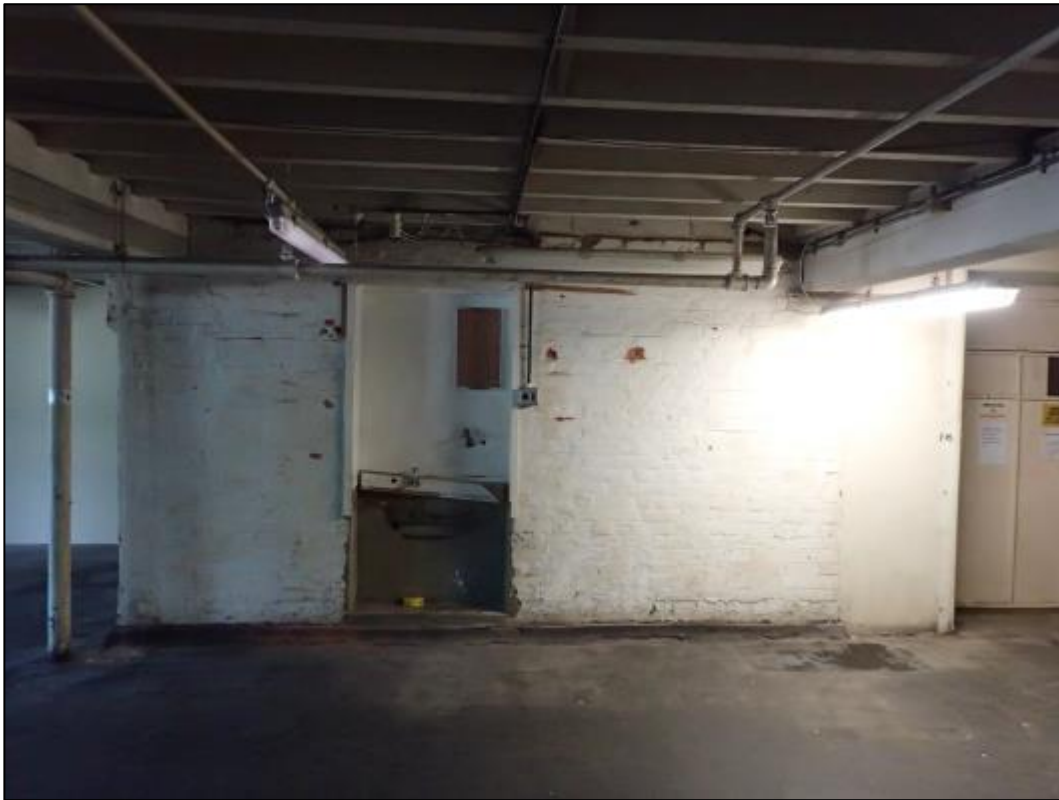
Towards the west of the north extent of the former kiln building, a possible former window frame or doorway is visible (Figure 7-26). The now blocked in feature was either a window constructed prior to the addition of the confectionery factory on the other side of the wall between 1922 and 1942, or a doorway established (possibly from a former window) through into the later addition.

Figure 7-26. Photograph looking north at original kiln wall. There is a stone arch visible above the tap area to the east is a diagonal line rising up.

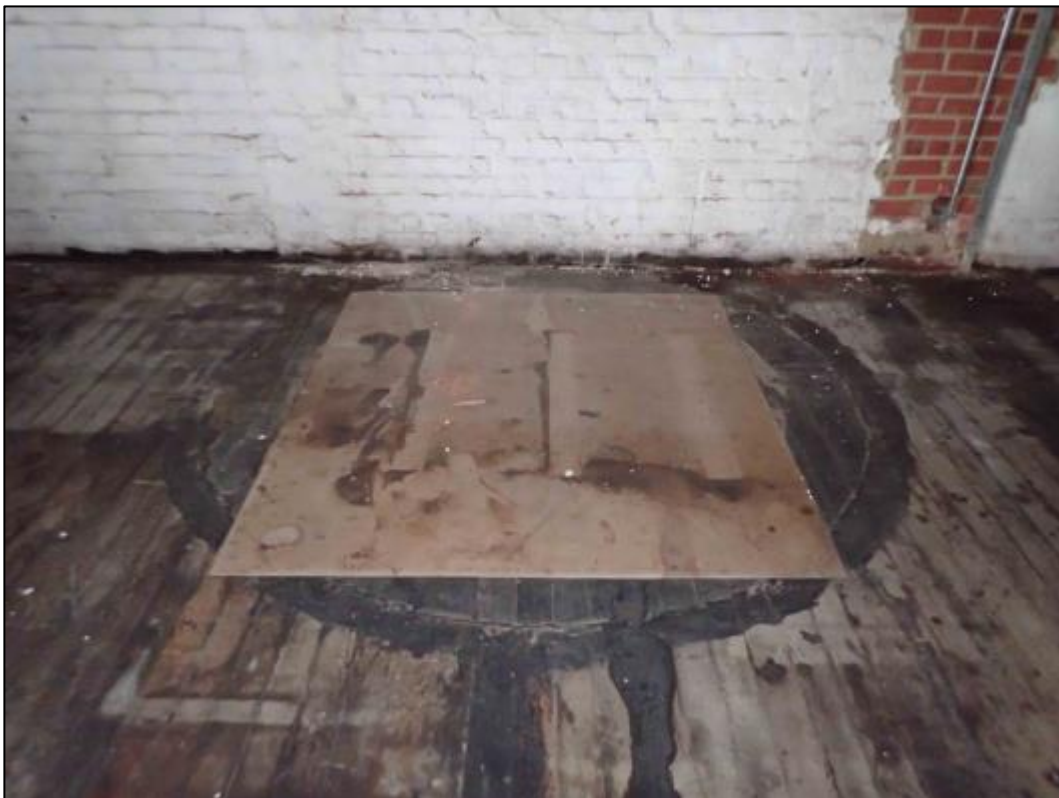
Figure 7-27 Photograph looking north at circular floor stain and covered floor in former kiln building.

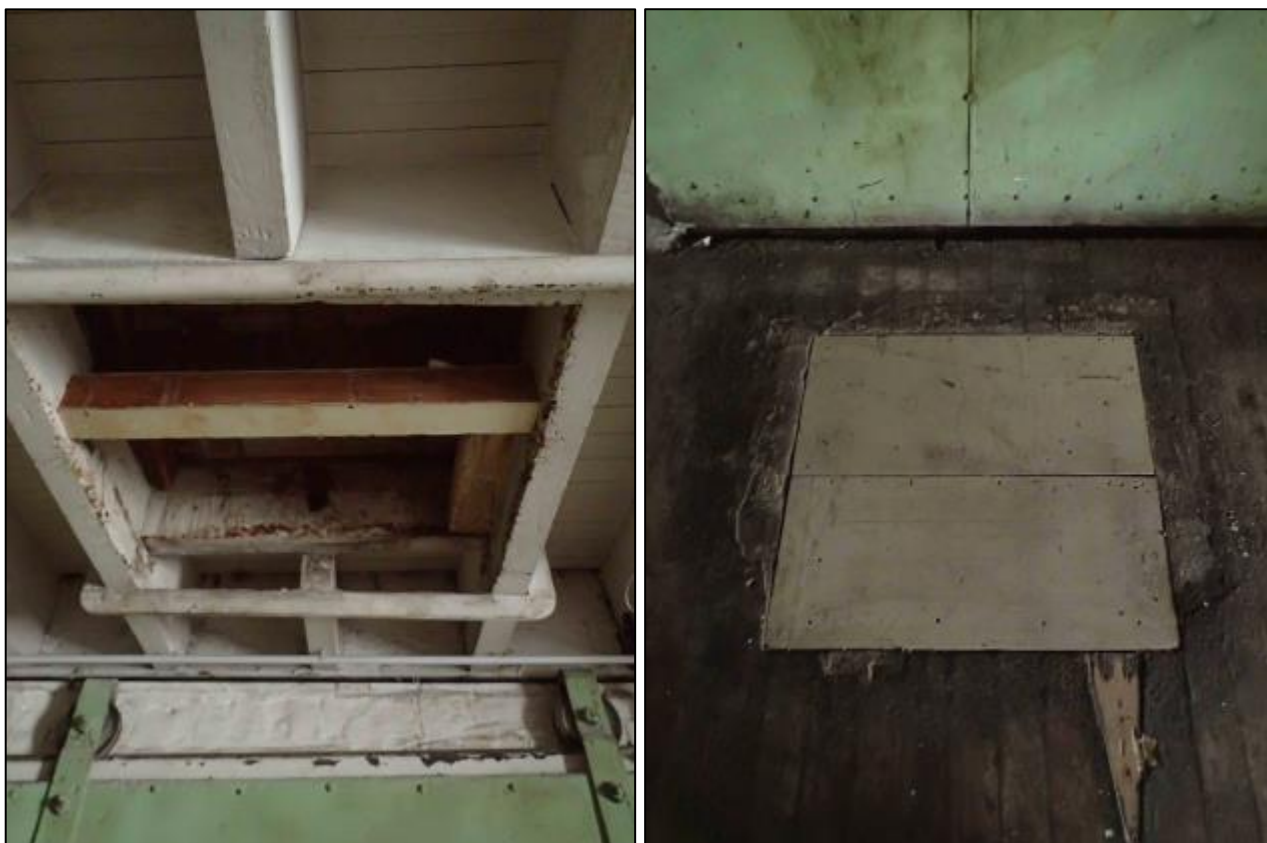
Figure 7-28 Photographs showing location of blocked in roof (left) and floor (right) of possible former chimney in former kiln building.

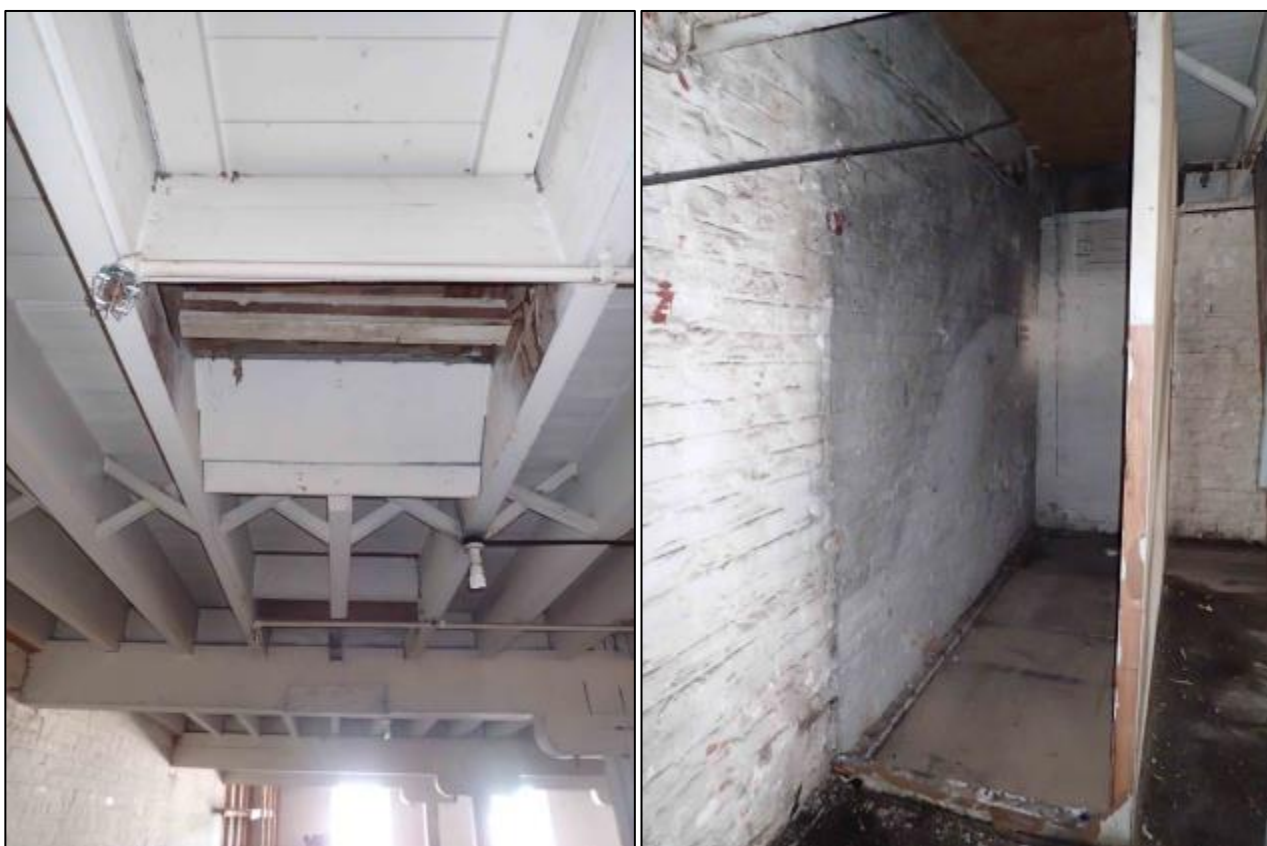
Figure 7-29. Photographs showing former stairwell in the 1901 southern extension looking west in the western area of the former kiln building (left) and southwest in the most easterly room of the same building (right)

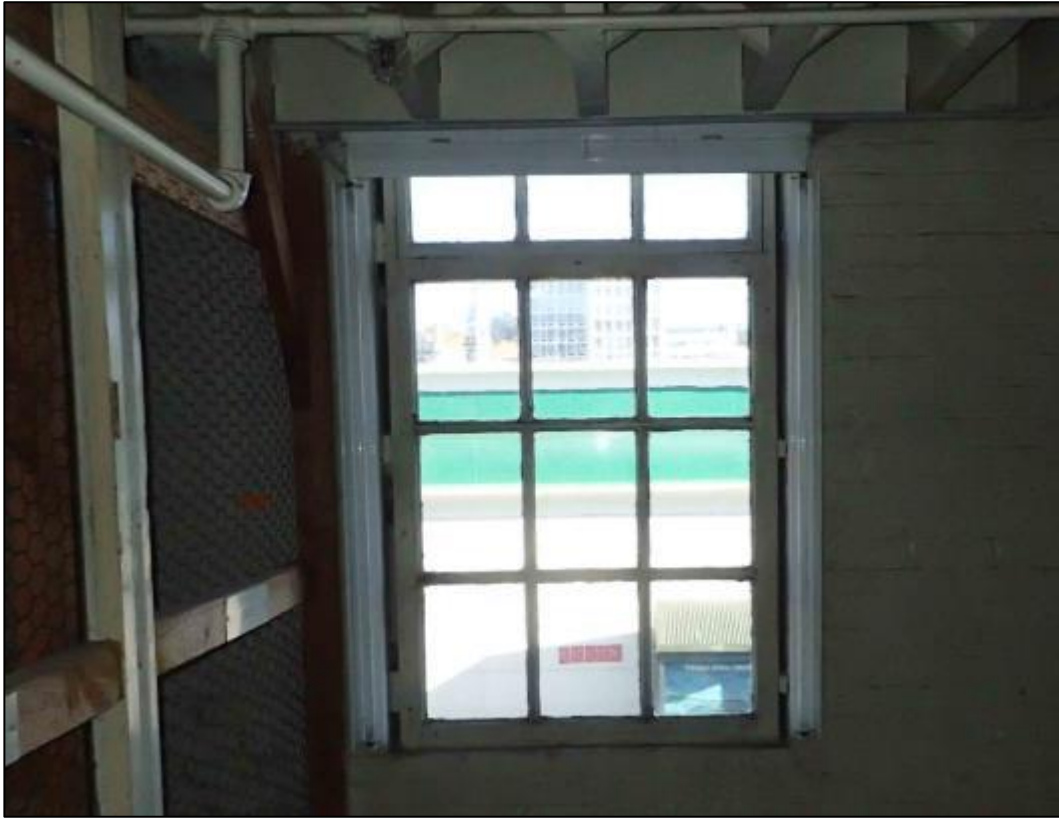
**Figure 7-30** Photograph looking west at multiple fixed pane window on the first floor of Cadbury World. All windows along the western wall are the same suggesting they were added and older windows replaced to match the 1902 and 1915 windows when the central portion of the granary and malt floor was added or that the new windows were added to match the earlier 1889 to 1901 style of windows.

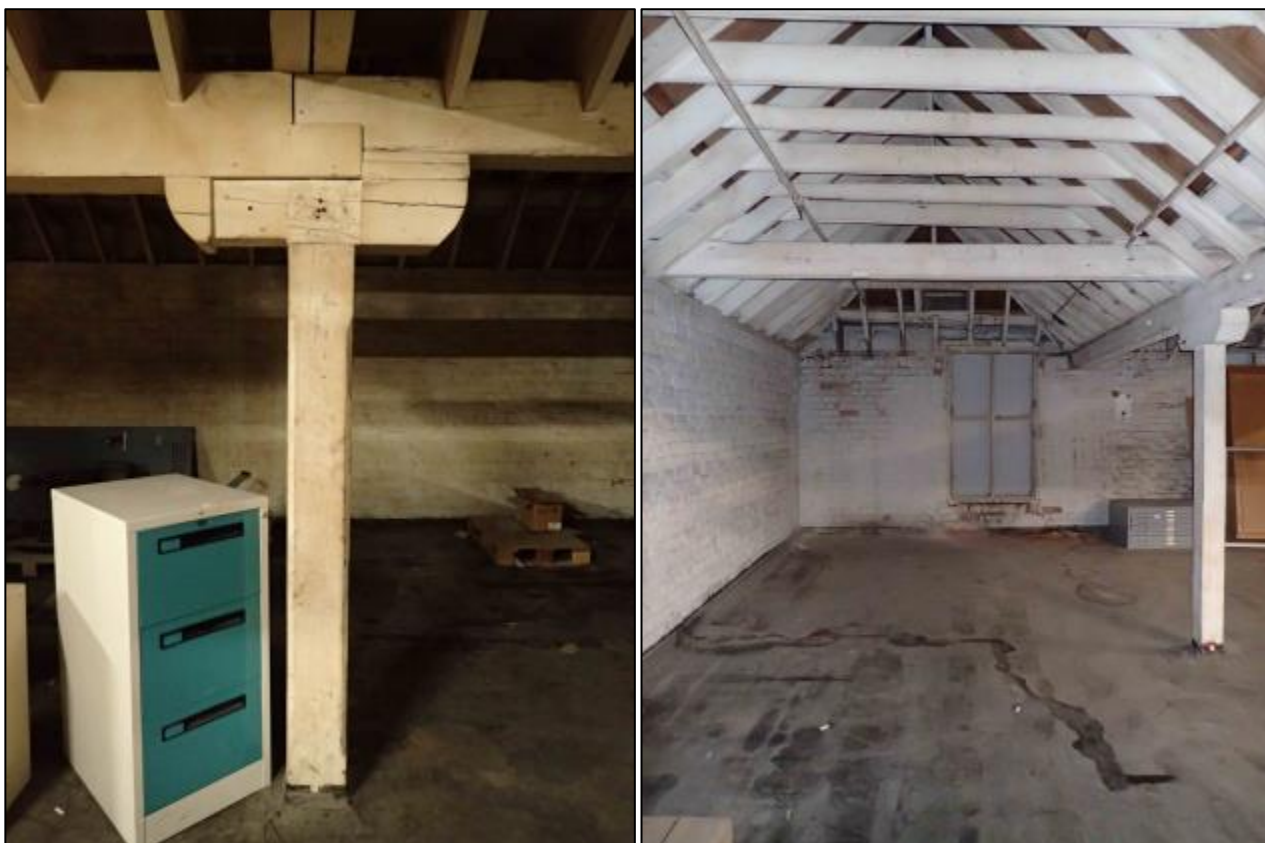
Figure 7-31 Photograph looking south (left) at column in the second floor of the Cadbury World building with the 1901 southern extension behind and photograph looking west (right) at roof structure of the southern extension.

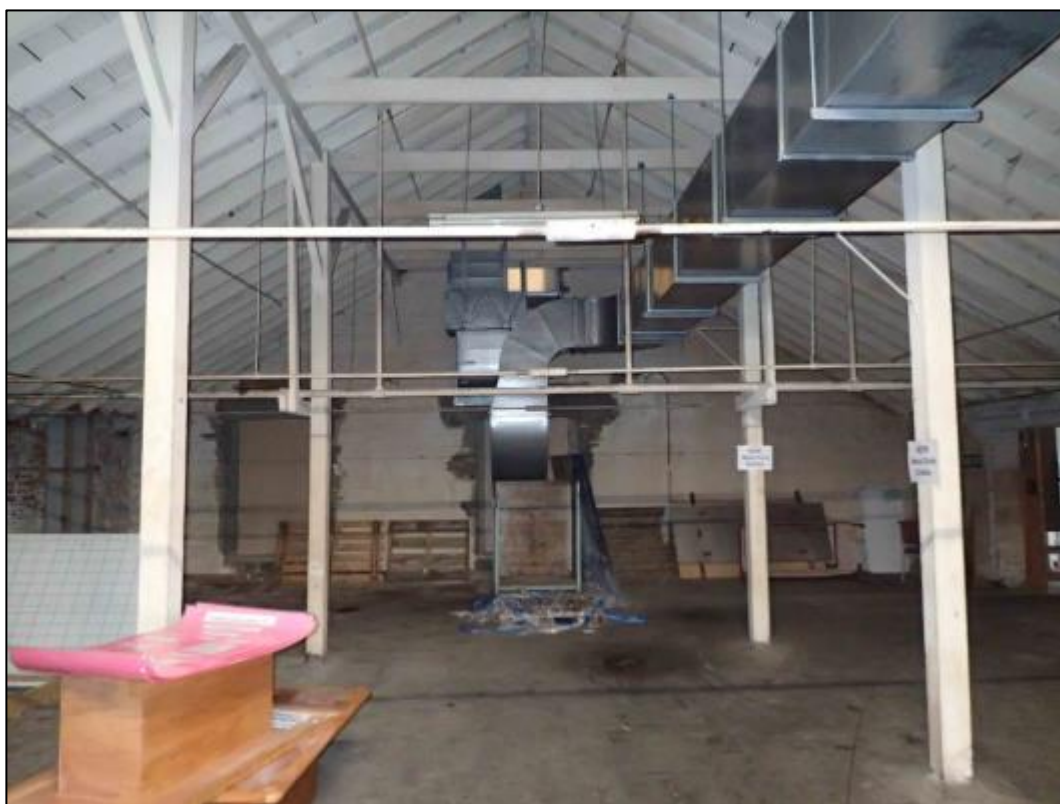
As with the first floor, there are a number of blocked in windows or doorways. Two blocked in windows were visible on the north wall of the former granary and malt floor building as well as one smaller window still present (Figure 7-32). These windows are associated with the 1902-1915 upper storey addition as this would have been an exterior wall, established prior to the 1915-1922 raising of the office/reception building immediately north.

Figure 7-32 Photograph looking north at the roof framing and the windows of the second floor north wall of the Cadbury World building associated with the 1901-1915 storey addition. Prior to the 1915-1922 raising of the offices and shop building this would have been an exterior wall.

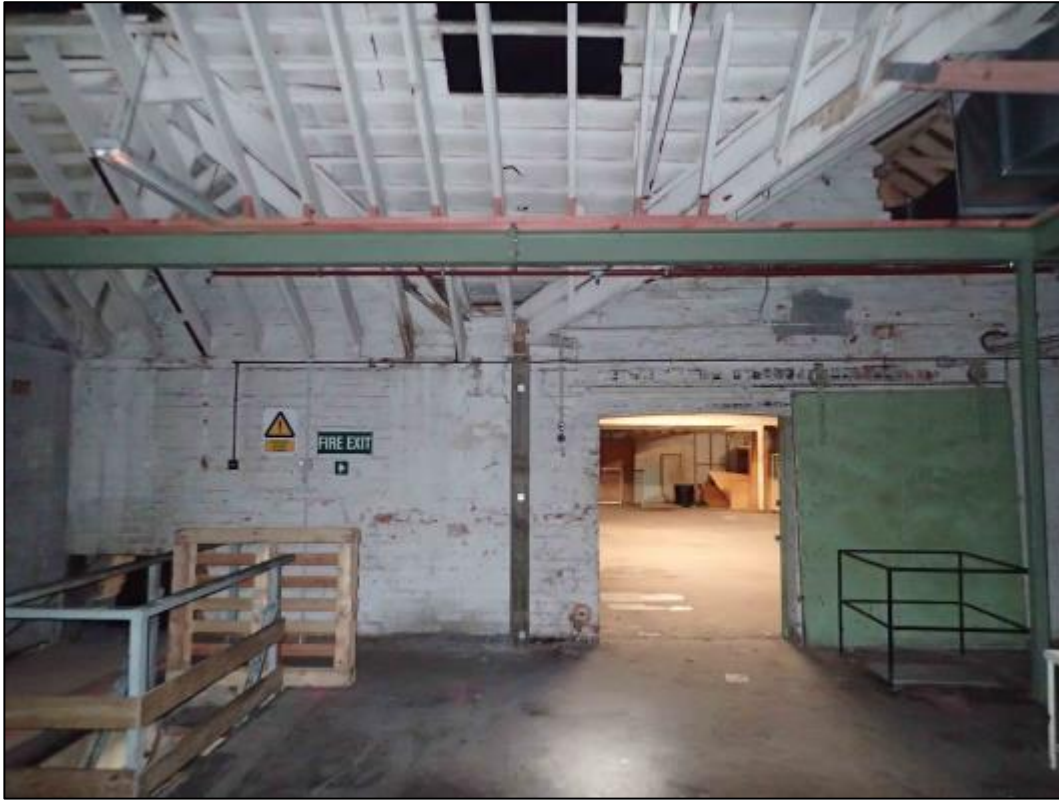
On the second floor it is possible to view the roof framing of the raised former granary/malt floor, and kiln building. The central gable running east-west and the adjacent southern extension gable from 1901, as well as the later northern raising extent between 1902 and 1915 feature common roof framing with collar ties (Figure 7-31 and Figure 7-32). Where the east-west gables met the cross gable in the west at the rear of the former kiln building, the building features common roof framing reinforced with steel (Figure 7-33).

Figure 7-33 Photograph looking north at interior of Cadbury World building showing steel framing added to roof structure and steel columns. Note earlier skylights have been covered.

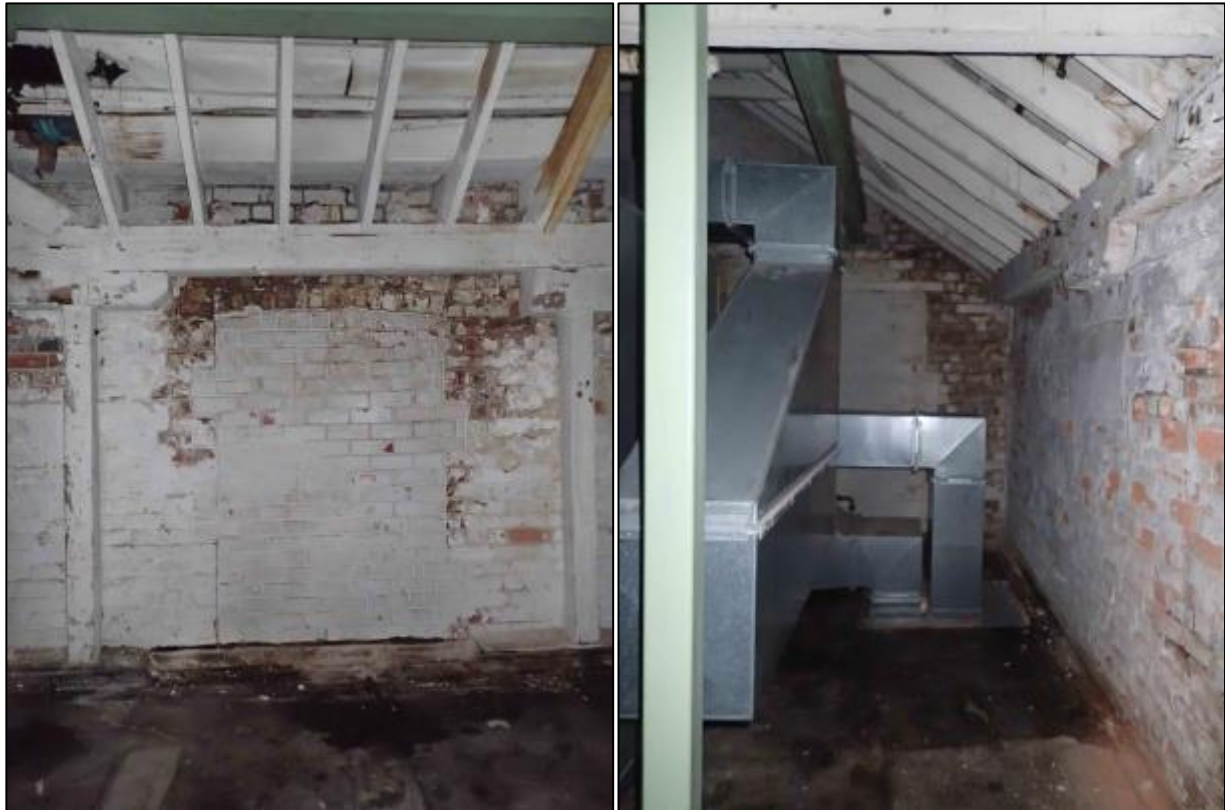
Figure 7-34 Photograph looking east (left) at a blocked in door way and north (right) at a blocked in window in the second floor of the Cadbury World building the most easterly room of the former kiln building.
