# Dunedin Hospital Development, Cadbury Confectionary Ltd Buildings

A Heritage Impact Assessment

Report Prepared for Ministry of Health  
Author: Megan Lawrence, Naomi Woods, Dawn Cropper  
and Hayden Cawte  
Reviewed by: Dawn Cropper  
Submitted: May 2020

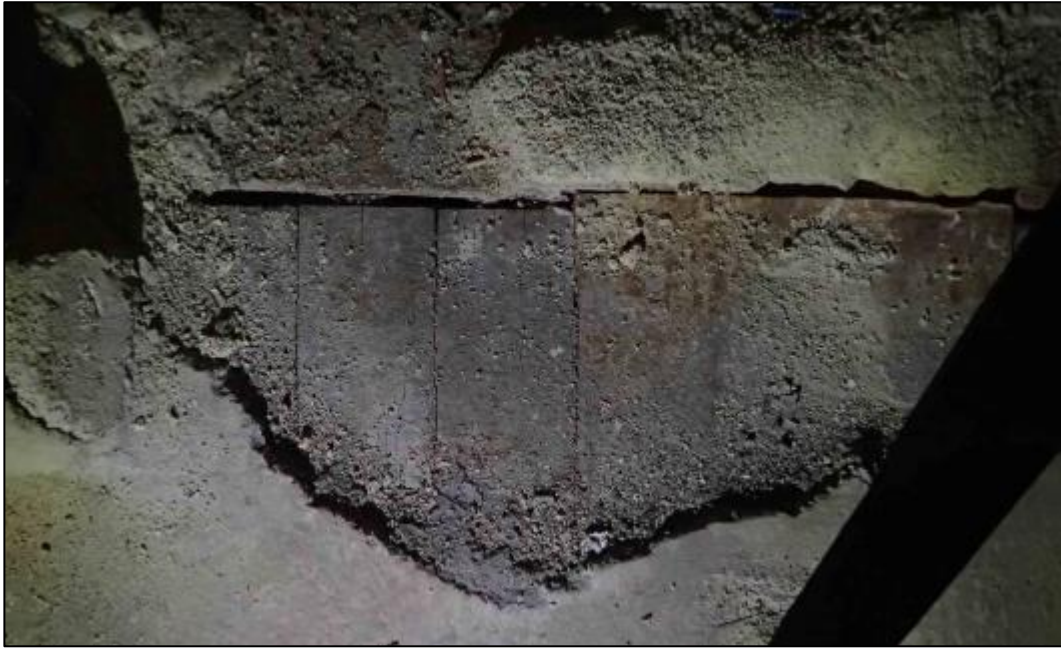
The floor of the former granary/malt floor, and kiln building was covered with concrete however a small patch of tongue and groove floorboards was exposed beneath in the most eastern room of the building (Figure 7-35). The walls were painted brick.

**Figure 7-35** Photograph of tongue and grove timber underneath concrete of the floor in the second floor of the Cadbury World building.

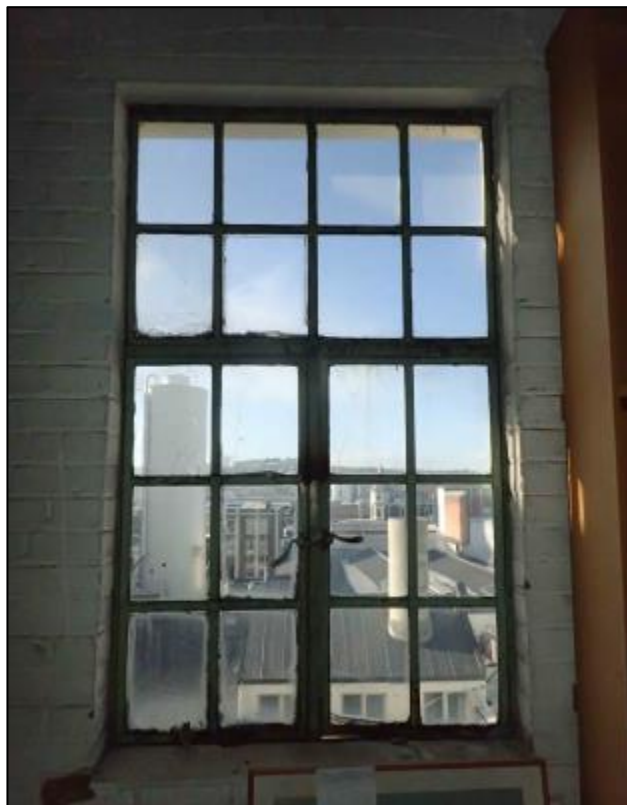
Only the later Confectionery factory to the rear of the building had building had four storeys and it is only accessible from the neighbouring Office Building. Painted brick walls are visible in this section of the building, while steel casement windows face out to the south. This window is associated with 1920s or later additions to the building.

**Figure 7-36** Photograph of windows on third floor looking east from the confectionery factory towards the rear of Cadbury World.

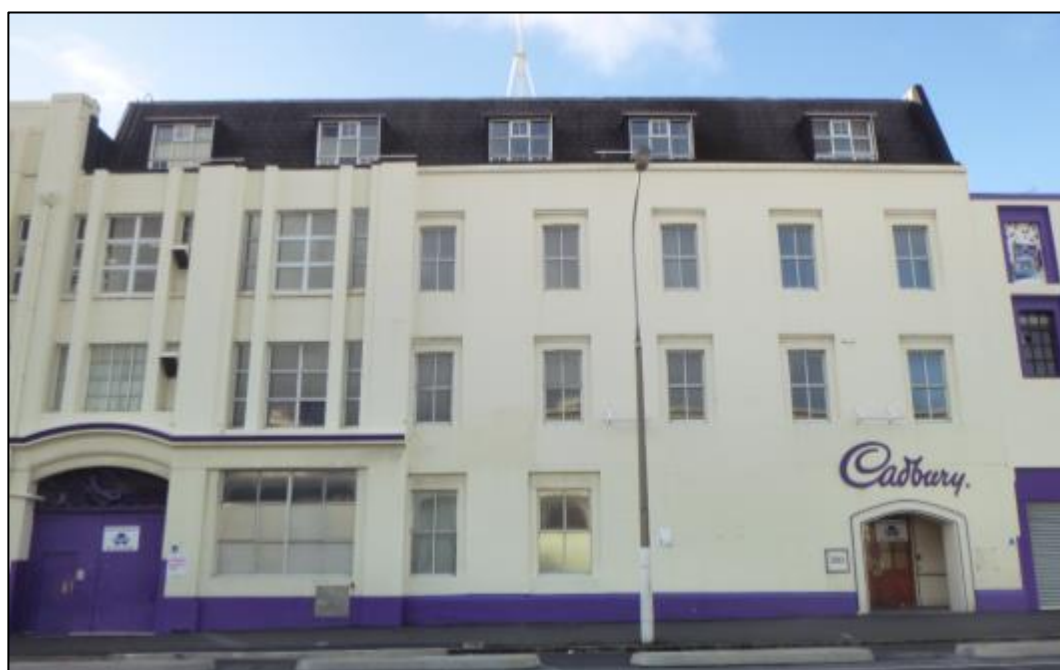
The façade of the Office Building is a blend of the multiple phases of construction throughout the building (Figure 7-38). The Office Building is four storeys and features a mansard roof. One doorway is present at the southern end of the building. It is interesting to note that the ground floor of the southern half of the building façade features very few windows in comparison to the rest of the frontage. This may be a result of the windows of the original granary/malt floor structure being filled in and rather than being realigned to match the extensions and additional storeys added later.

Figure 7-38. Photograph looking east at the Cumberland Street façade of the Office Building.

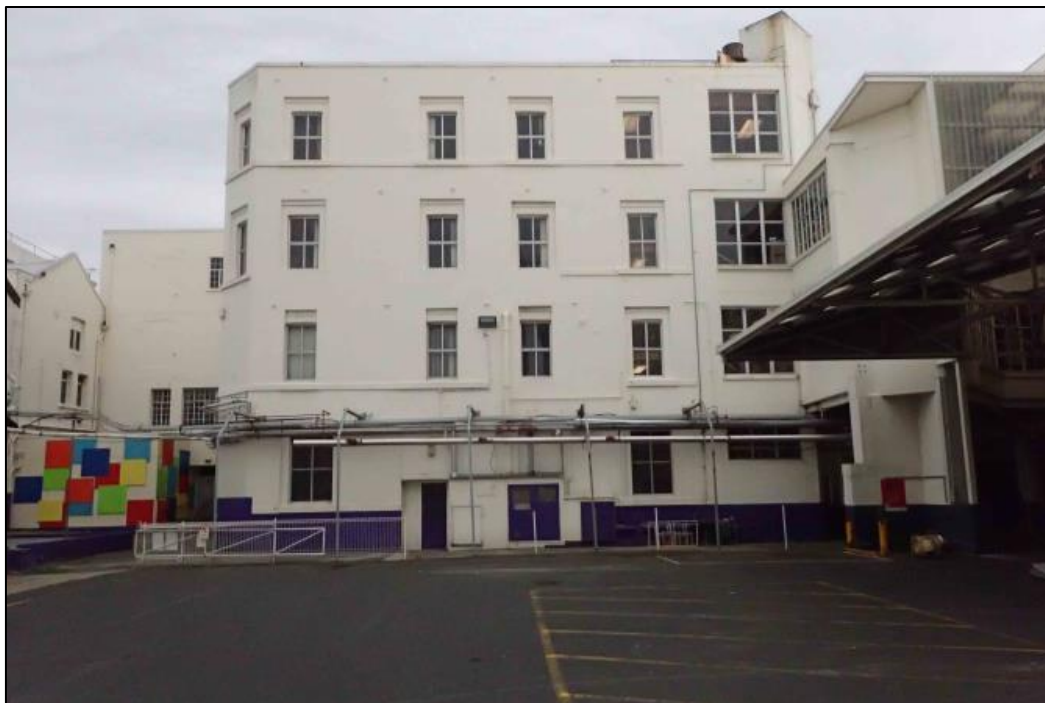
The rear of the Office Building has a painted plaster finish (Figure 7-39). There are three entrances to this building on the ground floor on its northern and southern elevations. The earliest form of this extent of the building (the 1909 brick structure) is not visible as it was likely replaced in 1922 by a concrete building; however, the 1924 northern extension is visible as the windows are much larger than the four paned fixed windows to the south. The Office Building extent features flat pitched roofs except for the mansard roof visible from Cumberland Street.

**Figure 7-39. Photograph looking west at the rear of the Office Building (Block 2A).**

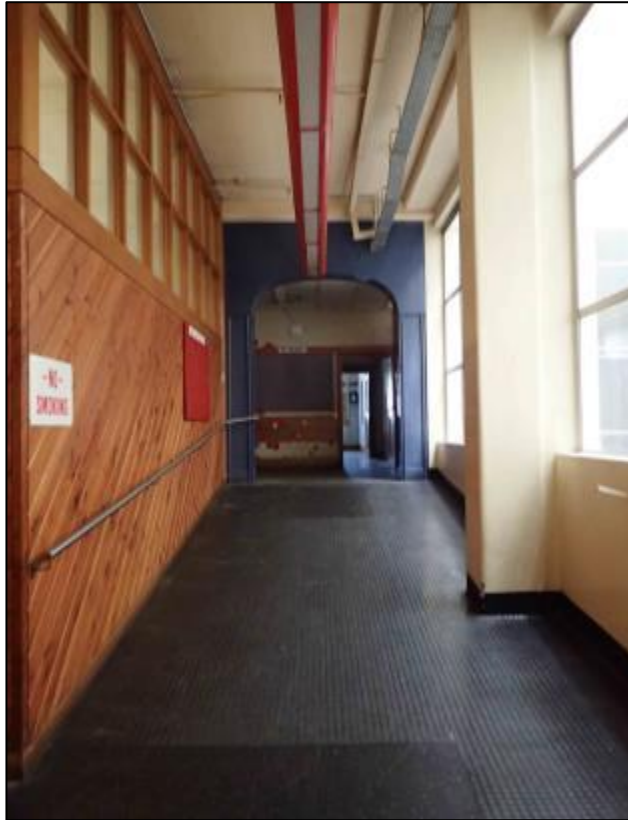
Figure 7-40. Photograph looking west the rise to the front portion of the Dairy and Machine House Building in the 1924 extension.

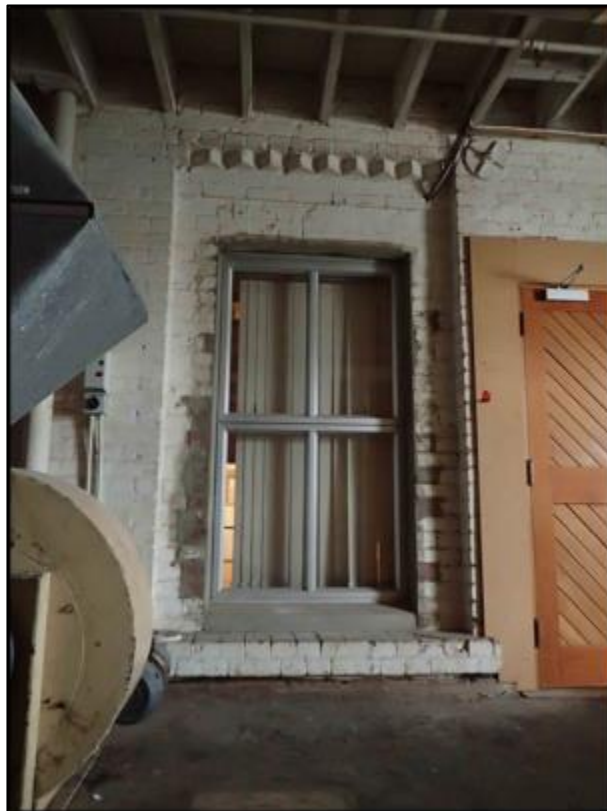
The former exterior windows of the Office Building are visible from the from the later 1922-1927 confectionery factory extension on the first and third floors (Figure 7-41 and Figure 5-44). The windows feature diagonal brick framing at the top of the window and suggest that later additions to the building kept a similar style of window to earlier parts of the building, with pointed brick framing at the top of the window. The first-floor window is associated with the 1915 western addition to the Office Building. Another similar former window was visible from the from the third floor of the latter confectionery factory building while the latter windows are associated with the fourth storey that had been added by 1926.

Figure 7-41. Photograph looking north at a former exterior window of the Office Building (Block 2A) associated with the 1915 western addition to the building. This photograph is taken from the later 1922-1927 addition at the rear of the Cadbury World building on the first floor.

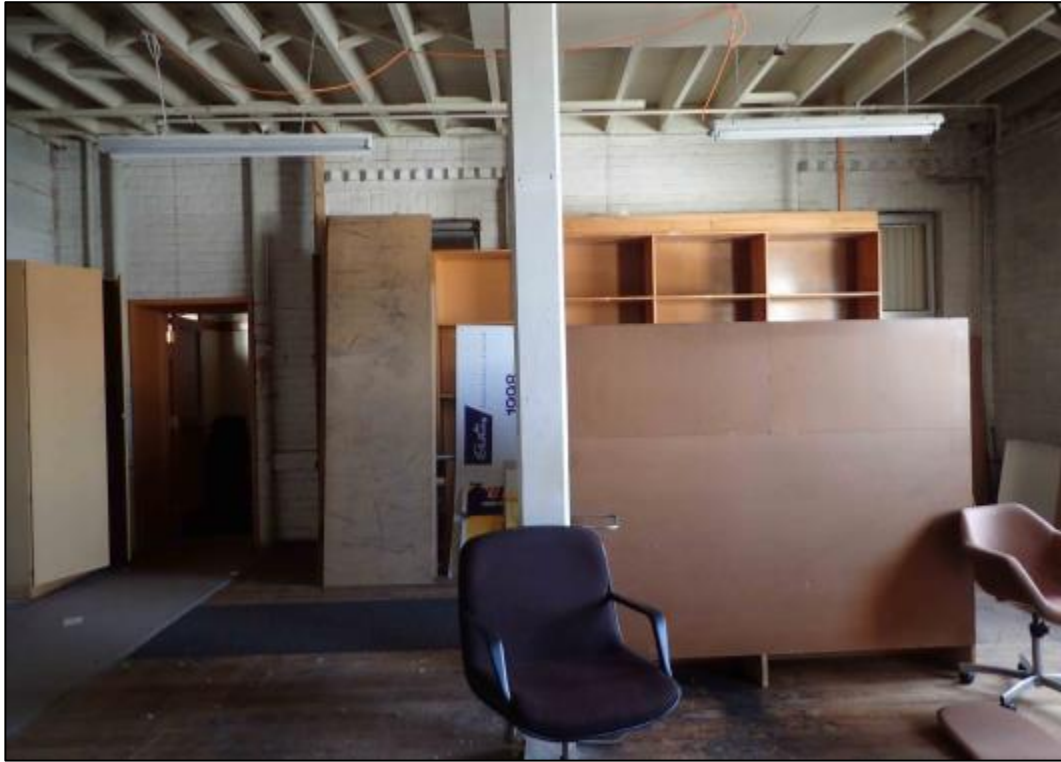
Figure 7-42. Photograph looking north at former exterior windows of the Office Building (Block 2A) associated with the 1915-1922 third storey addition to the building. This photograph is taken from the later 1922-1927 addition at the rear of the Cadbury World building on the third floor.

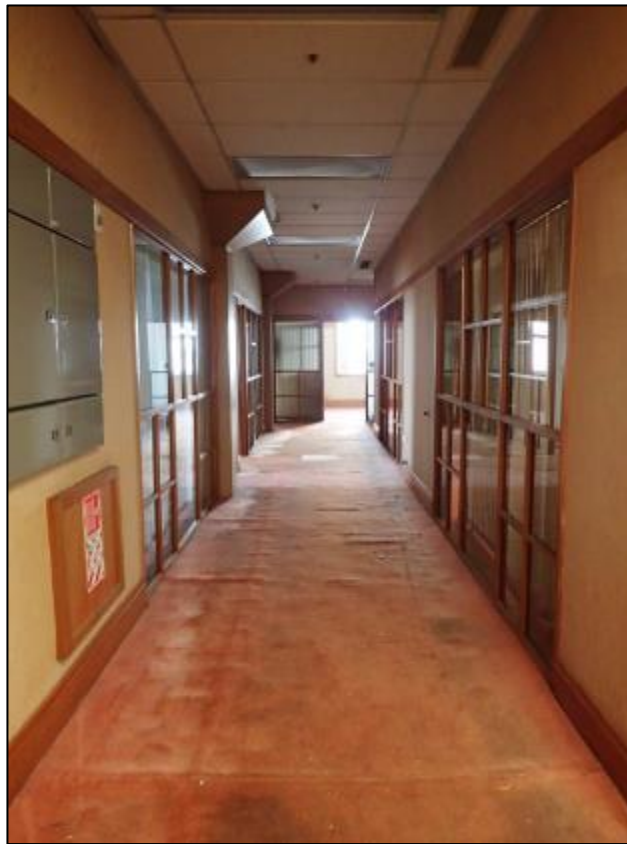
Figure 7-43 Photograph looking south at office portion of the Dairy and Machine House Building.

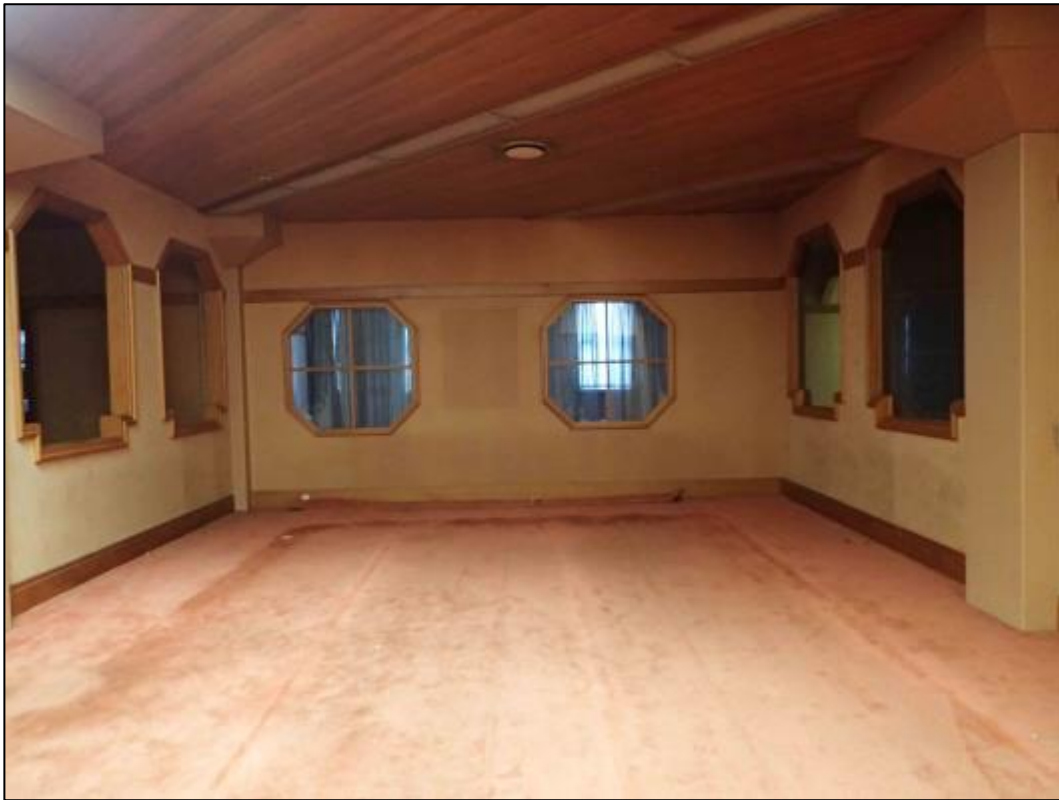
Figure 7-44 Photograph looking south at office portion of the Dairy and Machine House Building.

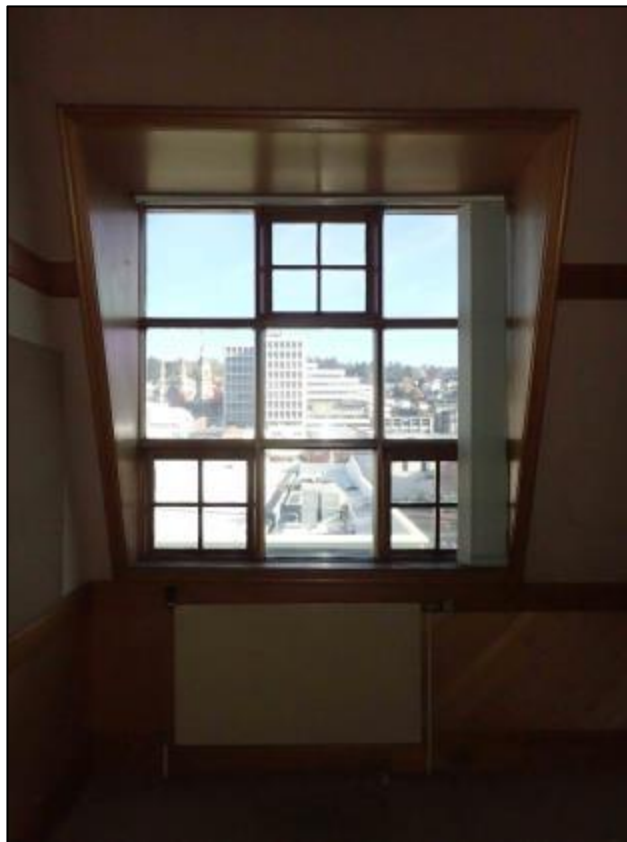
One key variation on the third floor was the presence of a central computer room, once home to Cadbury's Computer Department. This floor also featured different windows to the rest of the building (Figure 7-45). Facing out from the mansard roof are multi-pane windows, featuring top hung (awning) ventilators. These window types are associated with 1920s addition to the building.

Figure 7-45. Photograph of windows on third floor looking west facing out from the mansard roof.

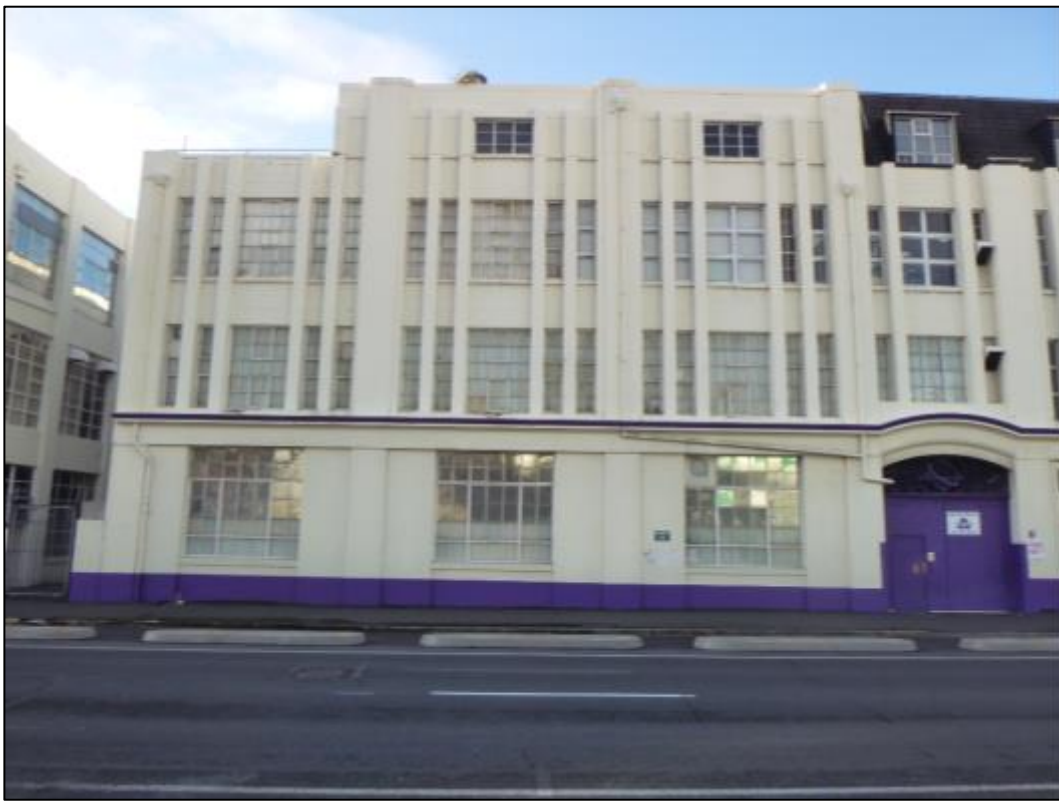
**Figure 7-47 Photograph looking east at the Cumberland Street façade of the chocolate factory building.**

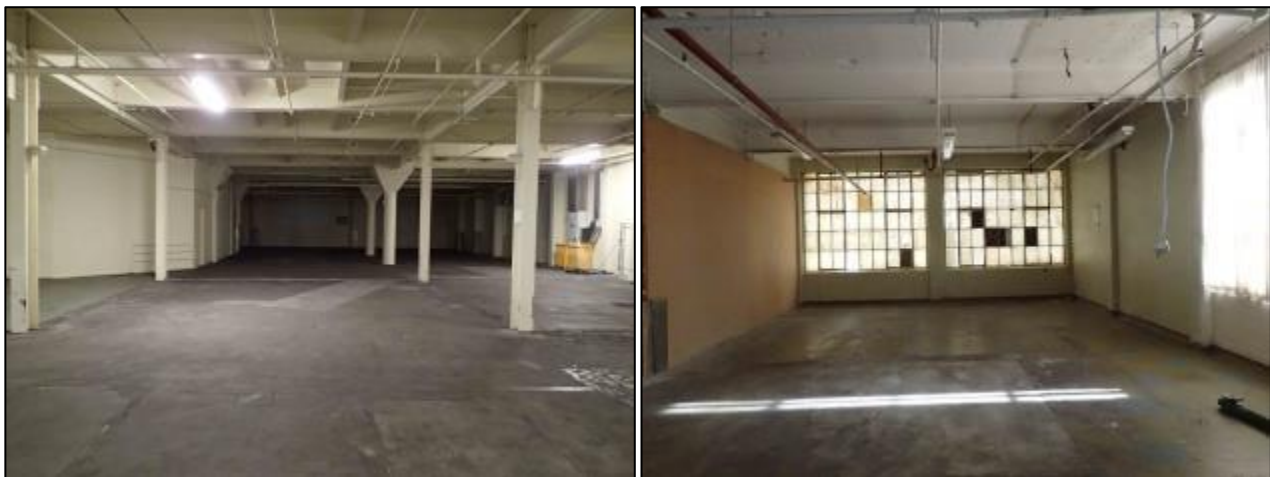
Figure 7-48 Photograph of the Chocolate Factory and Garage Building looking west at the former garage on the ground floor (left), and looking north at the former factory on the first floor (right).

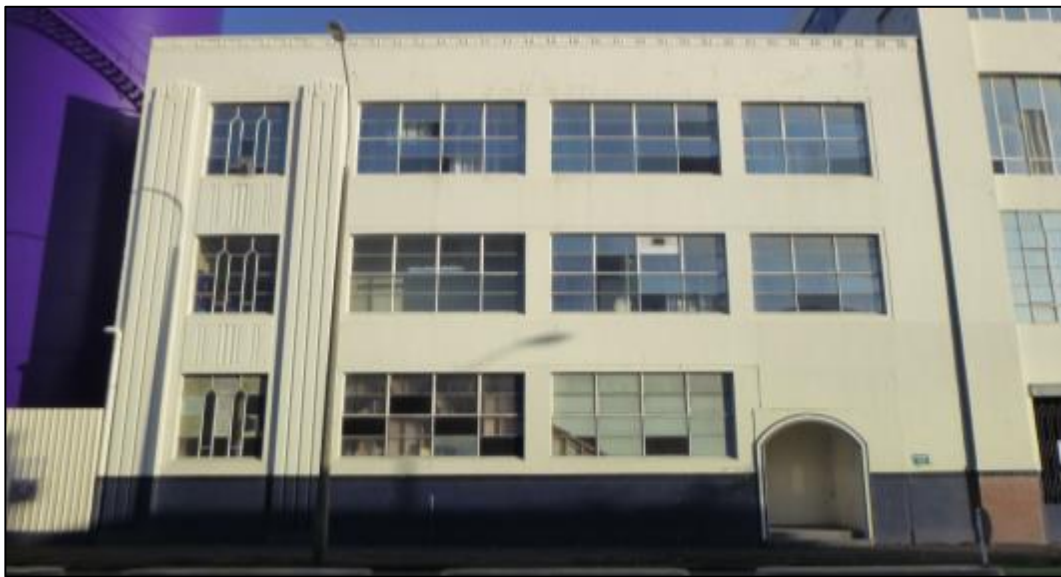
Figure 7-50 Photograph looking west at the Castle Street façade of the Chocolate and Biscuit Factory building.

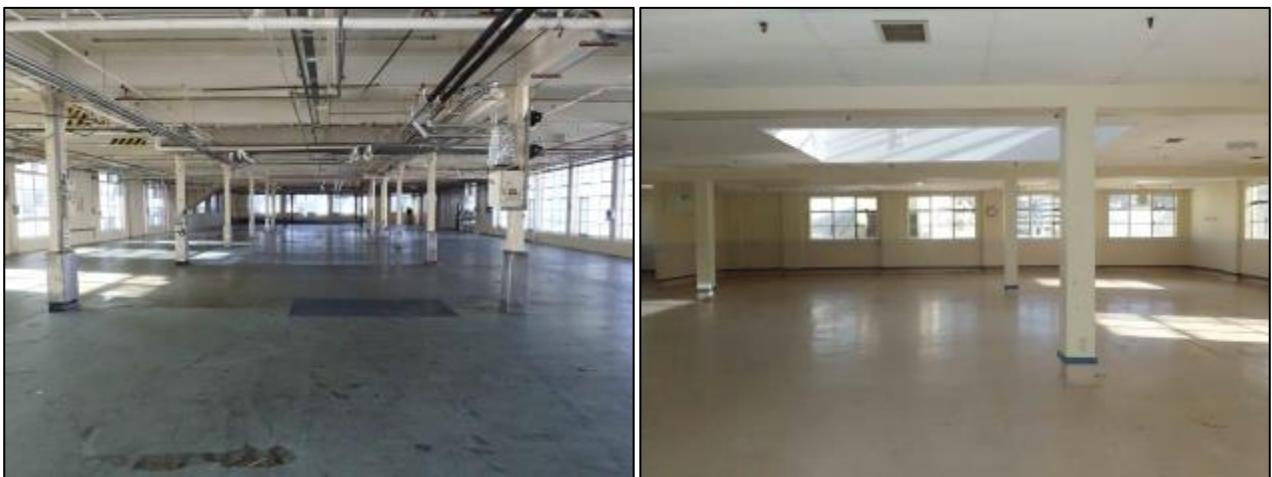
Figure 7-51 Photograph of the Chocolate and Biscuit Factory building looking east at the of the factory space (Block 3b-c) on the second floor (left); and, looking west at the cafeteria on the third floor (right).

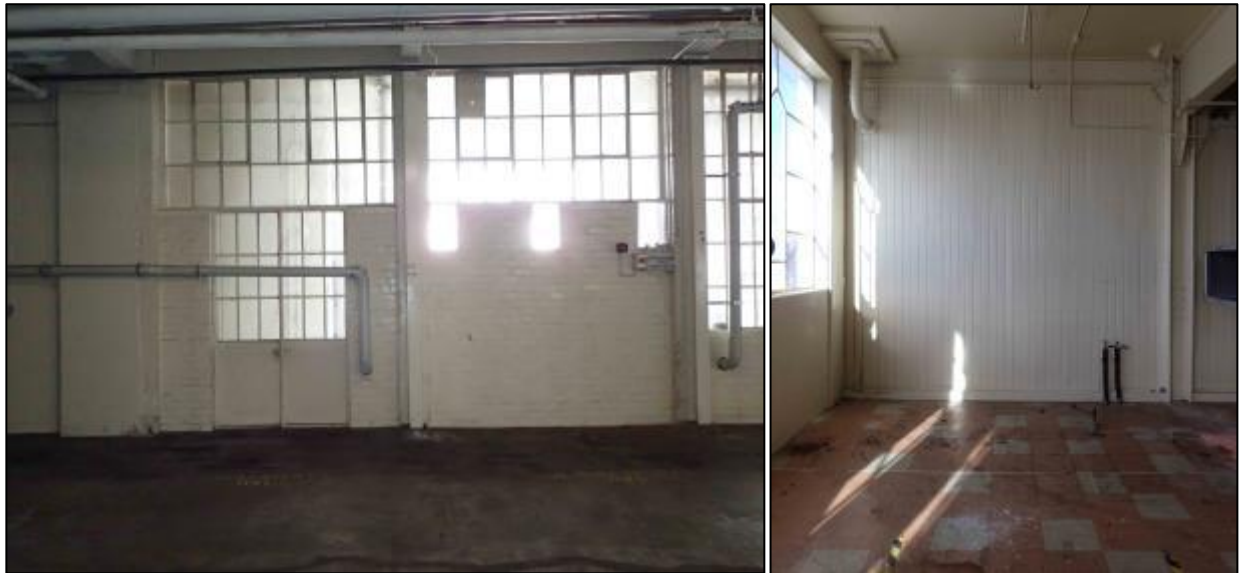
Figure 7-52 Photograph looking south at bricked in wall section in the Chocolate and Biscuit Factory (Block 3B-C) on the ground floor (left) and looking south at tongue and groove wall lining on the second floor.

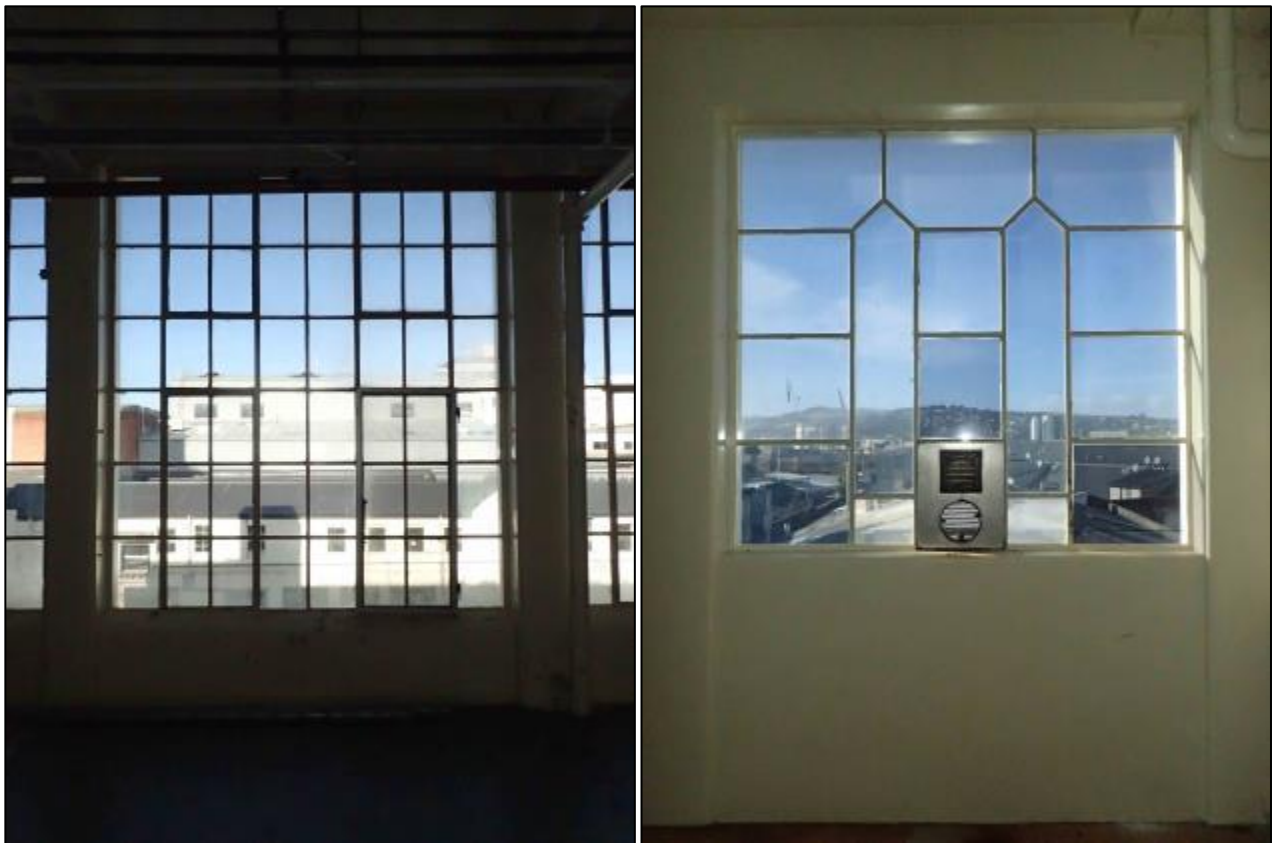
Figure 7-53 Photograph looking south (left) and east (right) at variant multi-pane window on the second floor of the Chocolate and Biscuit Factory building (Block 3B-C) second floor.

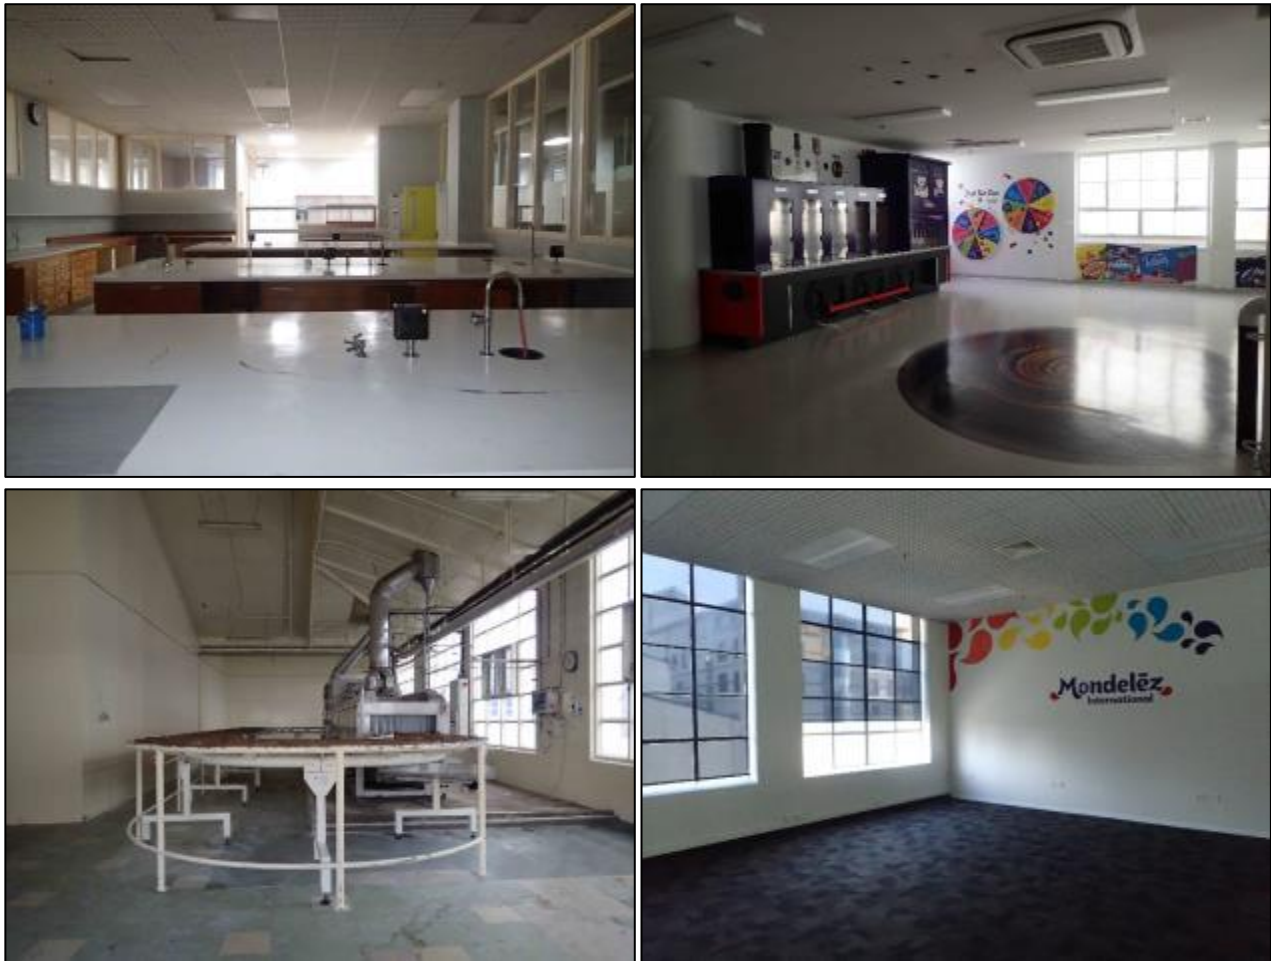
Figure 7-56 Photographs of Engineering Workshop, Labs, and Office Building looking west at food testing laboratory on the first floor (top left), northwest at Cadbury tour space on the first floor (top right), west at tin wash on the second floor (bottom left) and northwest at office room on the first floor (bottom right).

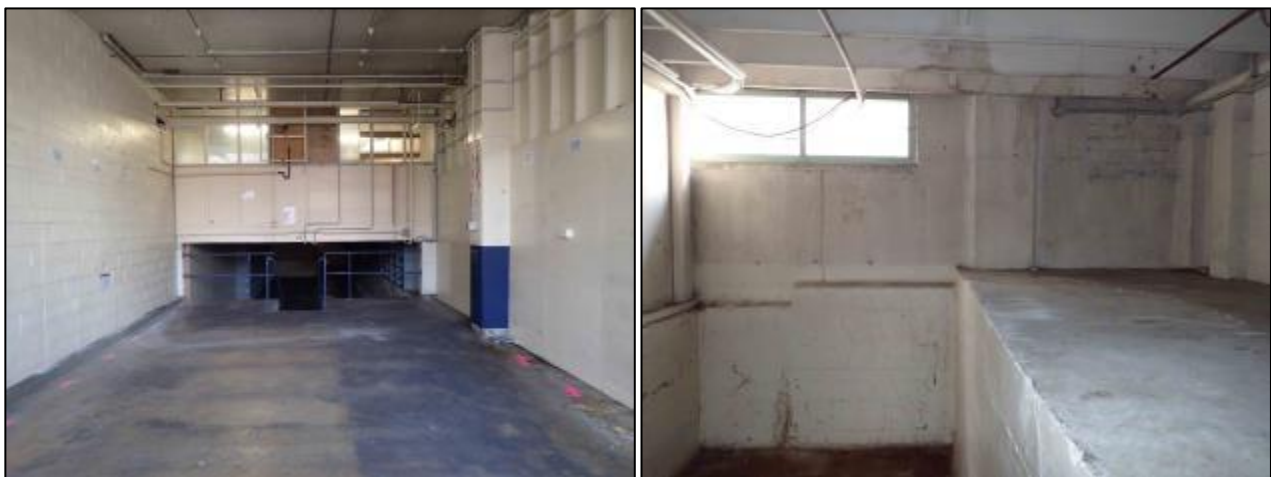
Figure 7-57 Photograph looking east into basement and Mezzanine from ground level (left) and at basement wall (right). Note the brick infill and the open window running up into the mezzanine level above.

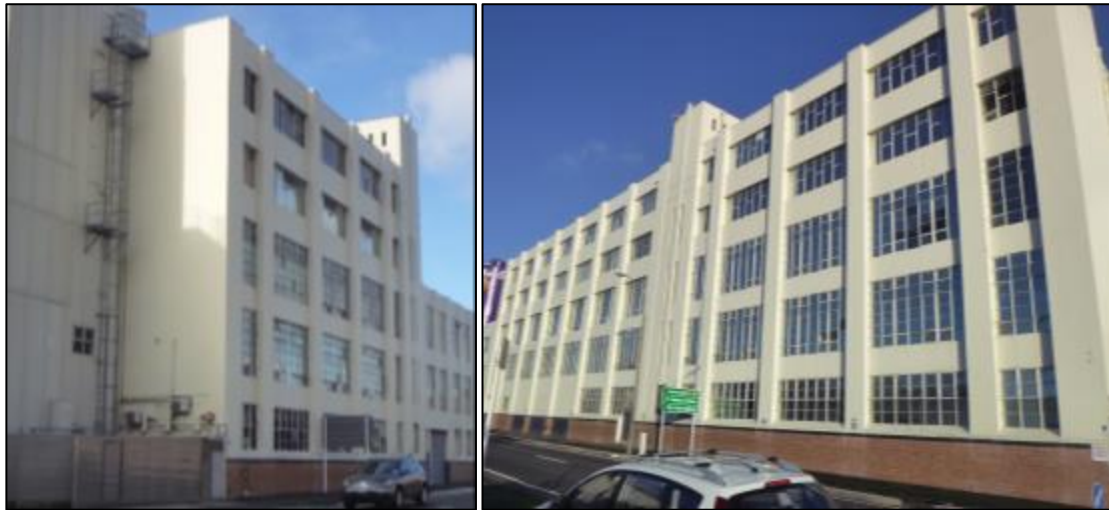
Figure 7-60 Cumberland Street (left) and Castle Street (right) façades of the biscuit and dispatch building.

The façade reflects the utilitarian nature of the building, with few decorative elements (Figure 7-60). There is a vehicle and a pedestrian access way present at the northern end of the building on Cumberland Street. Aside from minor changes, the façade of this building largely remains true to the initial designs and construction of the early 1960s. This building has been designed to match the earlier biscuit and dispatch building to the north with all of the windows on the Cumberland Street frontage are multi-pane steel sashes. Brown tiling featured around the bottom of the building is continuous from the biscuit and dispatch building. The building, although largely utilitarian, also complements the adjacent chocolate factory building façade with pilasters running vertically along the building.

As with the Engineering Workshop, Labs, and Office Building, the Biscuit Factory and Dispatch Building façades reflect the utilitarian nature of the building with few decorative elements (Figure 7-60). However, the building still complements the adjacent Chocolate Factory and Garage Building façade with pilasters running vertically along the building. A key feature of the east and west façades is the lift shaft which features a slightly more decorative pilaster running the height of the building adorned with long rectangular windows either side up to the fourth floor. There is a pedestrian doorway immediately south of the central lift shaft on the Castle Street frontage, another further south as well as a vehicle entrance at the south corner of the building. There are three covered blocks on the ground level of the Castle Street Frontage, south of the central lift shaft. These are the former vehicle entrances for the dispatch building. Aside from minor changes, the facades of this building largely remain true to the initial designs and construction between the late 1940s and early 1950s, however the upper two storeys of the building have lower ceiling heights, and this is reflected in the building's façades. All of the windows on the Cumberland and Castle Street frontages are multi-pane steel sashes. The brown tiling featured around the bottom of the building that continues around the side elevations and even inside where the later additions have been made to the building.

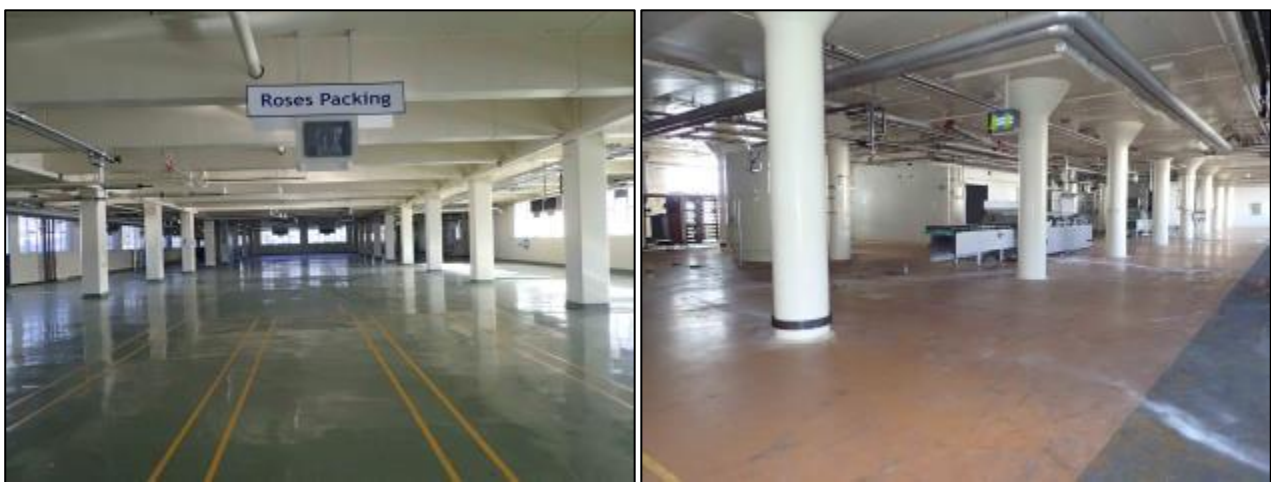
Figure 7-61 Photograph of the biscuit and dispatch building (Block 5C) on the third floor looking west (left) and on the first floor looking northwest (right).

The interior of the building predominantly factory space, with no attempts to disguise its concrete and steel construction. The rooms clearly feature the functions of various factory spaces (Figure 7-61 and Figure 7-62). The first and second floors of the factory feature columns with capitals reminiscent of the lotus style (also referred to as mushroom-shaped columns), which were utilised throughout modernist architecture in the 1930s (Figure 7-61 and Figure 7-63).

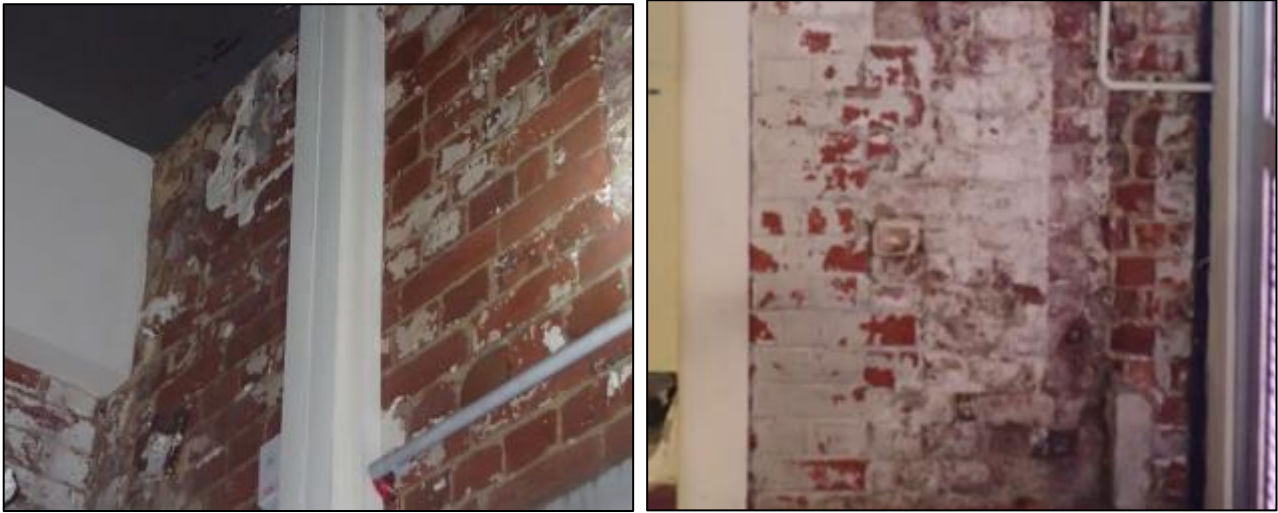
Figure 12-1 Examples of exposed and partially exposed brick from the Cadbury World building that might be salvaged and reused elsewhere in the hospital development.

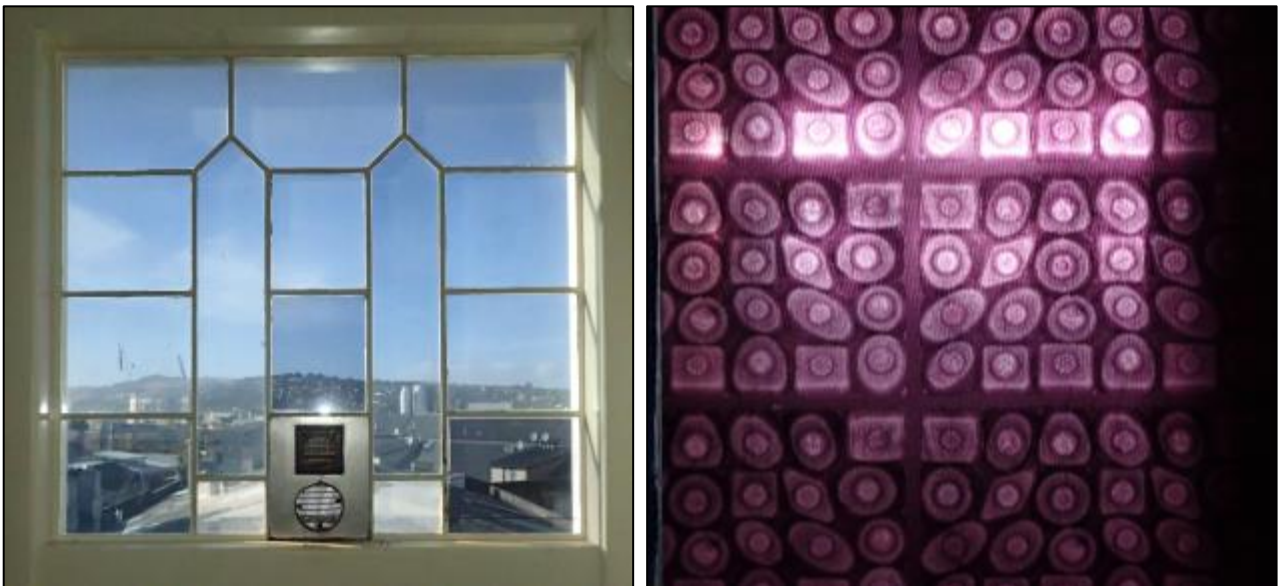
Figure 12-2. Detailing of windows in the Chocolate and Biscuit Factory building (left) and Biscuit Factory and Dispatch Building (right) that could be considered for recycling into the new hospital building.

When historic buildings cannot be adapted or moved, potential exists to reuse and recycle building materials. Historic buildings and structures contain a rich assemblage of building materials, and this is a valuable resource. Building materials that are good candidates for reuse, included stone, brick, timber, timber flooring, windows, doors, architraves and ceiling linings. Brick and timber are the easiest materials to reuse and incorporate into the new build because of their versatility, and even when materials are no longer structurally sound, they can be re-used (e.g., using bricks for paving, timber for linings and finishes, etc.). Historic bricks have a wonderful patina that simply cannot be replicated and are tangible pieces of the past that can be easily introduced into the new build (Figure 12-1). Similarly, historic timber is also a good candidate for reuse and recycling and bring a warmth that new timbers cannot replicate. The materials could also be considered for use in landscaping plans such as brick utilised in hard landscaping. There are possible distinct windows throughout the Cadbury Confectionary Ltd Buildings, as shown in Figure 12-2, that could be recycled, repurposed and feature in the new hospital building. While some distinct windows may be more recent additions, they all would help to display and retain the history of the site right up to 2019 in a physical and visible way.
