# Macraes Phase 4 Consenting

## Project Element 4.3.2: Open Pit Extensions

PSM71-287R Rev 2

# Executive Summary

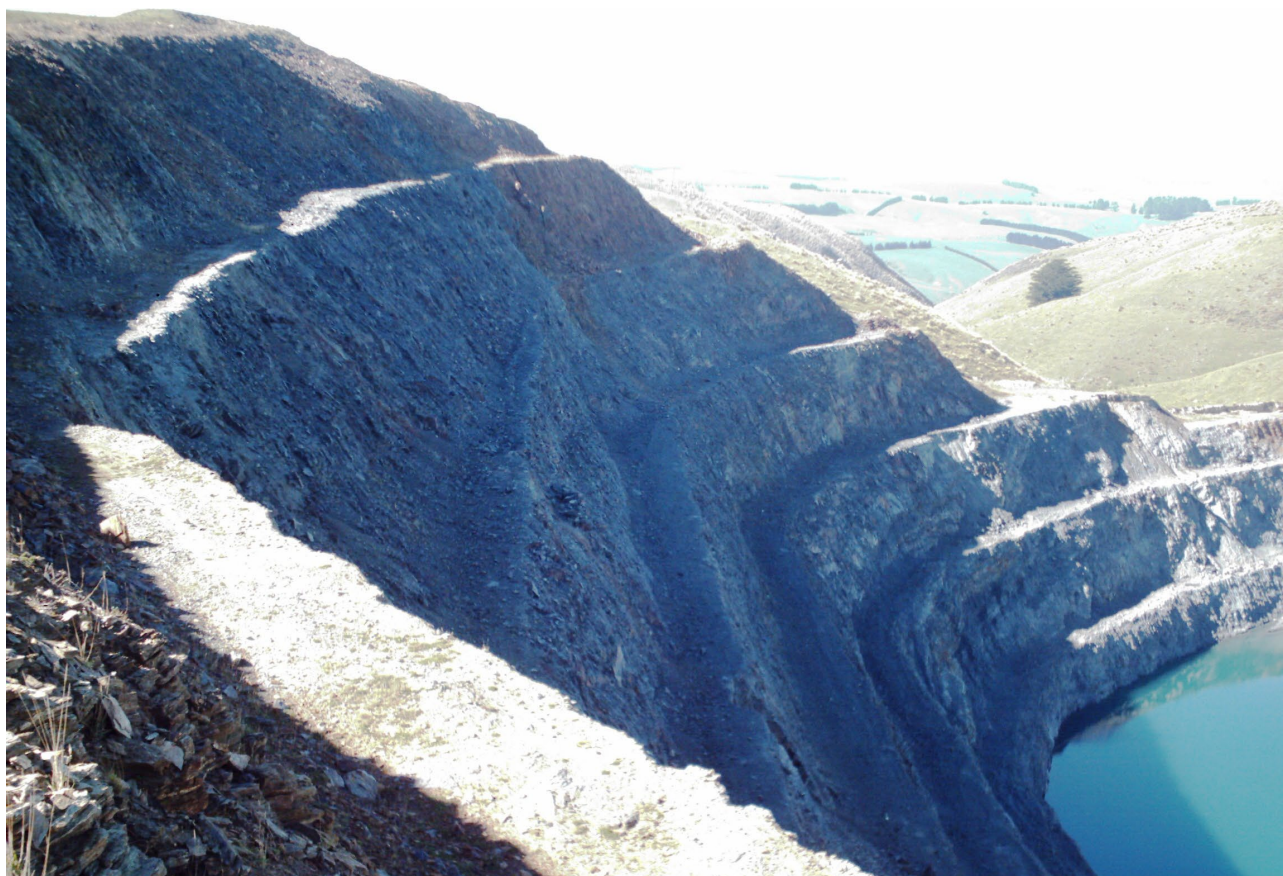
**Photo 9:** January 2009 - east wall taken from crest facing south. Berms are relatively clean.

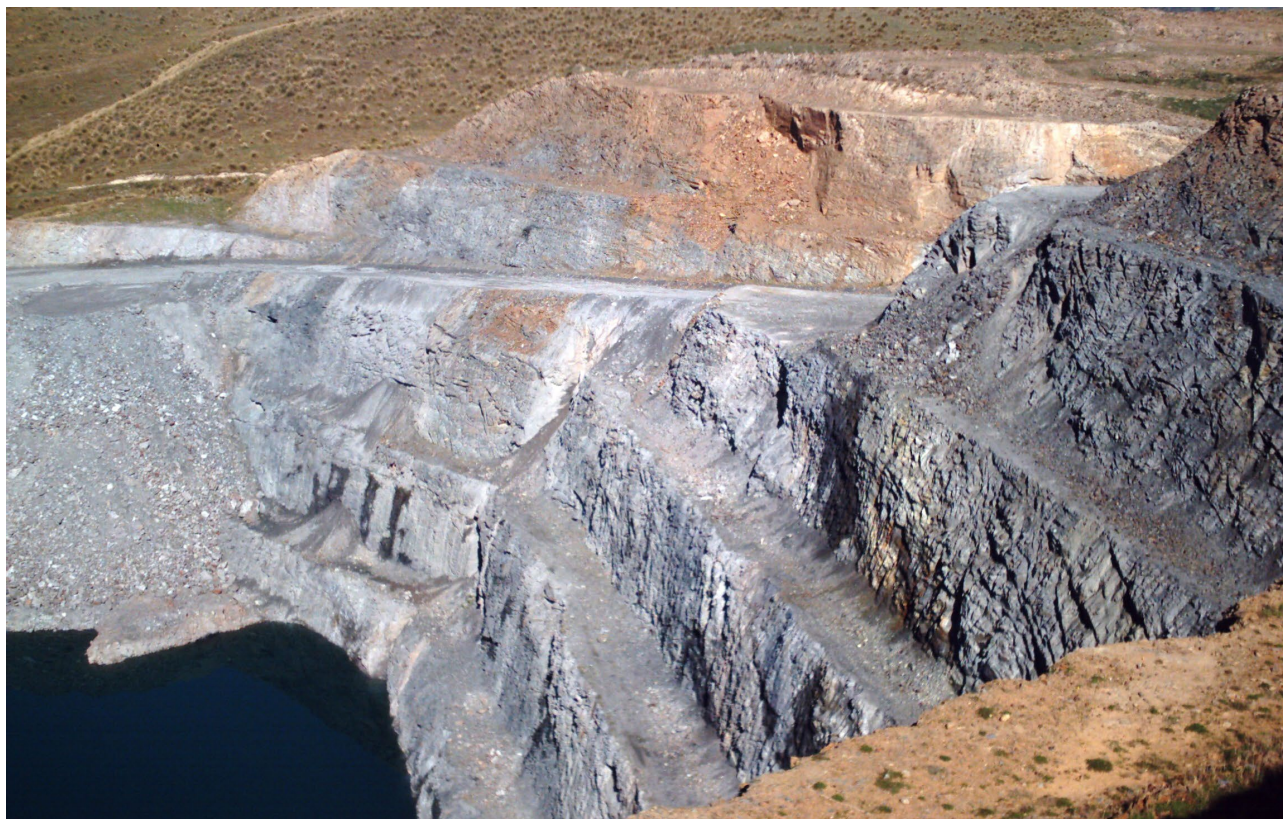
**Photo 10: January 2009 – north wall. Photo taken from crest looking west. Pre-split 75° batters. Note joint bound wedges.**
