# Application Form for a Resource Consent

Removal of tree T790, listed in the DCC District Plan Schedule 25.3 Significant Trees.

## **Assessment OF Environmental Effects of Removal of Silver Beech Tree (T790)**

# **Application for Removal of the tree T790 (Silver Beech) from the road reserve adjacent to 8 Michie St.**

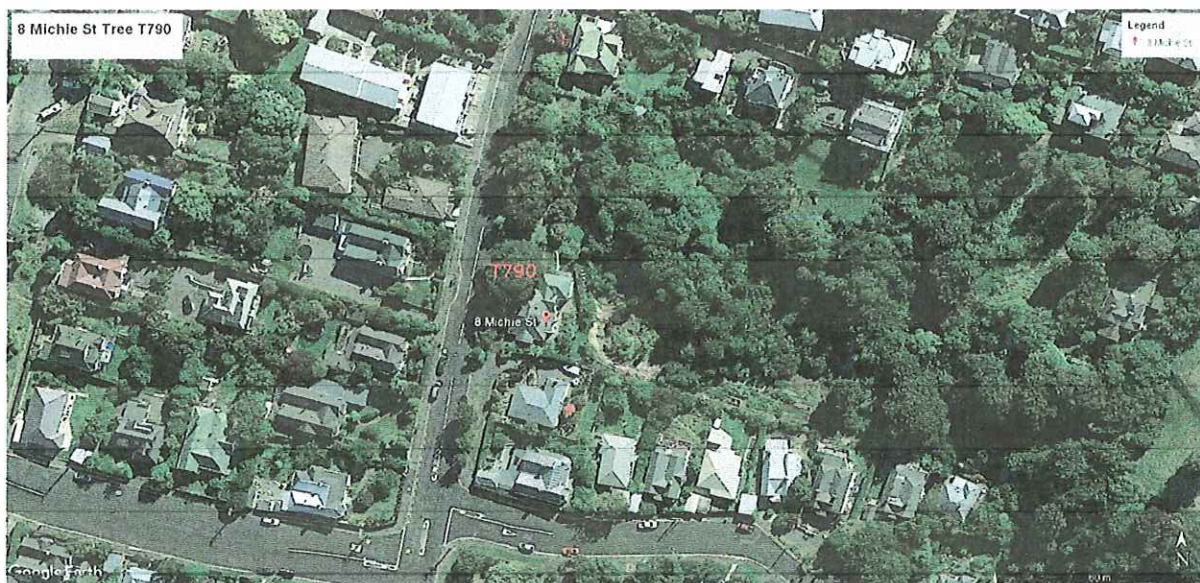
The tree's location is shown in the aerial photo in Figure 1. It shows the tree's position in the reserve and the extent to which it overhangs the boundary of 8 Michie St, and its proximity to the roadway.

Figure 1. Google Earth image (2015) of T790 location in the road reserve adjacent to 8 Michie St

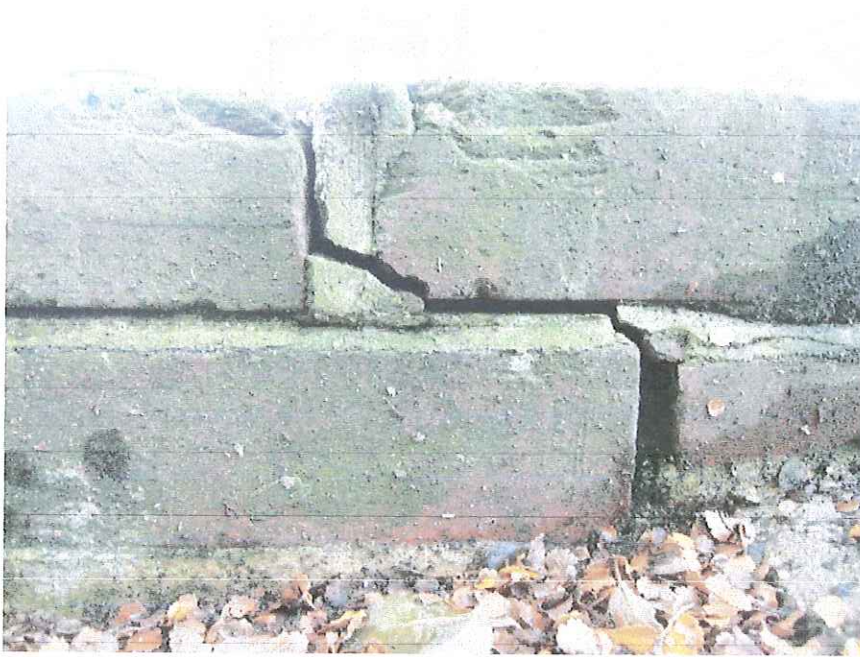
Photo 2. Crack at **1** in photo 1. Also evident is the 20mm elevation of the concrete slab to the right, which now impedes drainage from the drive.

**Patio foundation located under T790 dripline;** Cracking and uplift (Reference photo 1, tag 1, 2, 3 & 4 also photo 2, 3, 4 & 5)

**Cause of damage;** Incremental growth of underground tree roots encroaching from roadside tree T790

- 1; Demolish and rebuild patio incorporating bridging components to allow sufficient clearance and future growth of tree roots
- 2 Demolish and rebuild patio Remove T790 tree and roots to prevent future damage

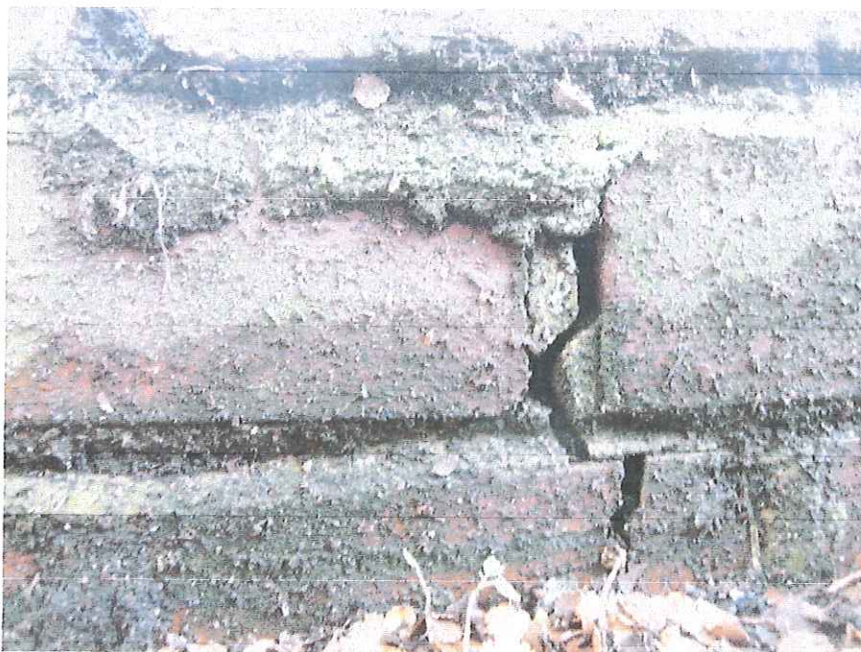
Photo 3. Crack at location **2** in photo 1.

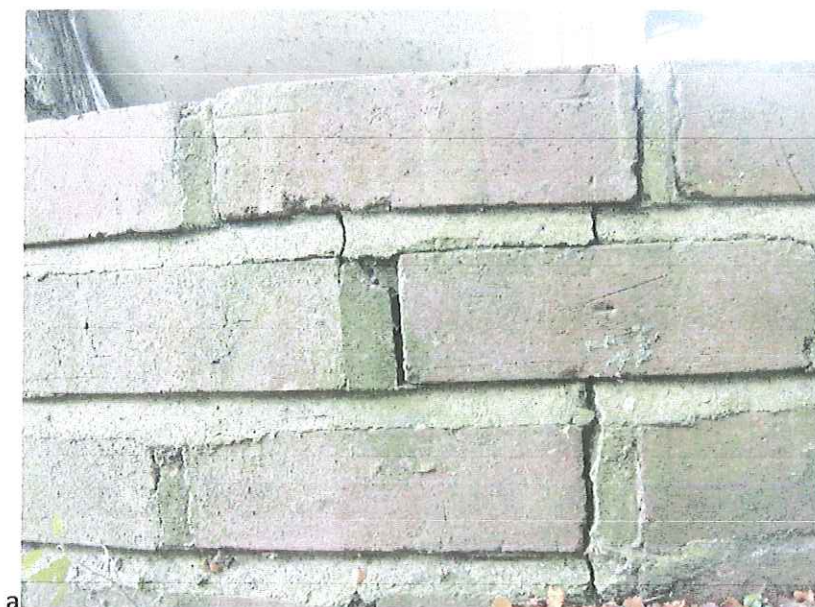
Photo 4. Crack at location **3** in photo 1.

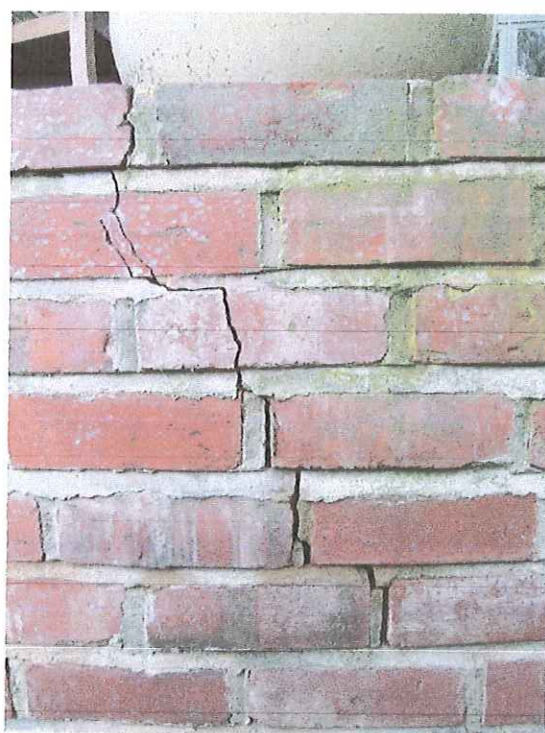
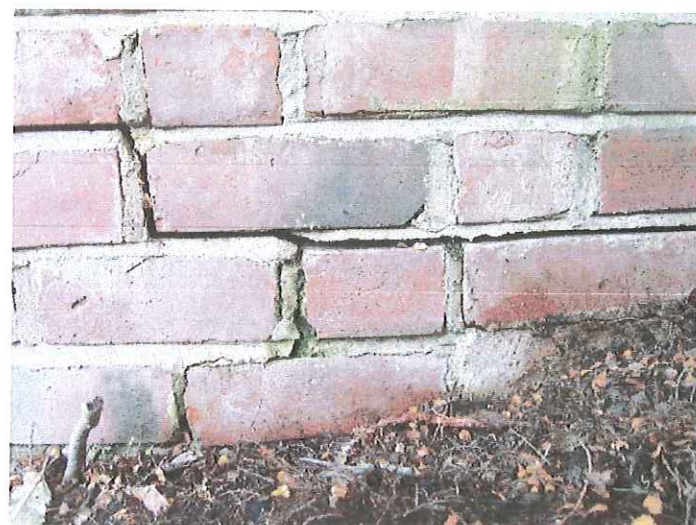
Photo 5A & 5B. Crack at location **4** in photo 1.

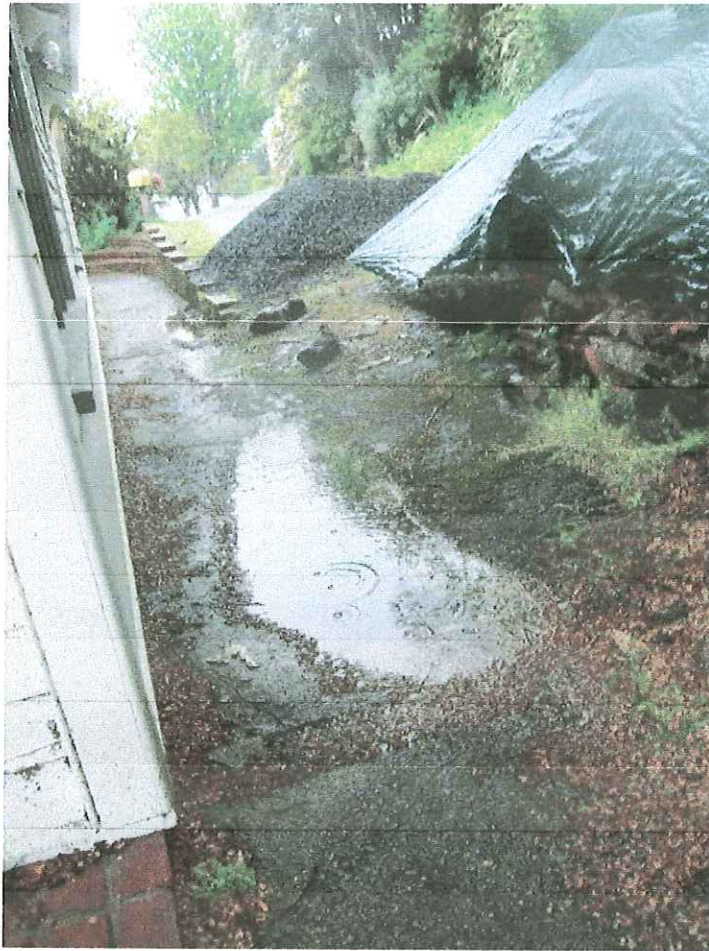
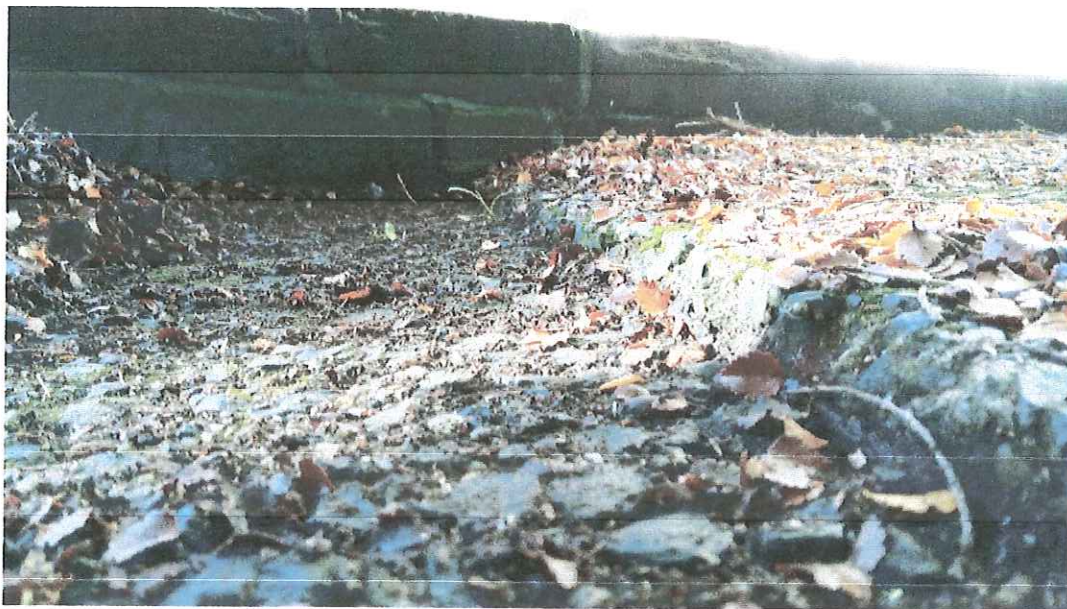
Photo 6A & B. Ponding of drainage from drive caused by 20mm elevation of concrete slab at bottom of picture (6B).

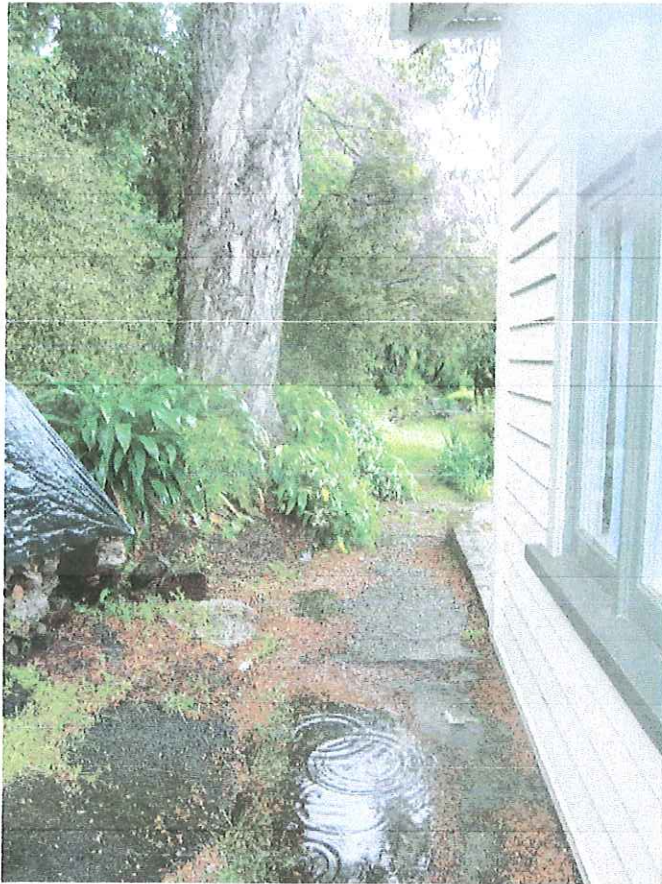
Photo 7. Ponding of water draining from drive, impeded by elevation of concrete slab beneath the tree.

**House foundations located under T790 dripline;** at risk of displacement / uplift (Reference photo 7)

**Risk of damage;** Incremental growth of underground tree roots encroaching from roadside tree T790

- 1 Remove T790 tree and roots to prevent future damage

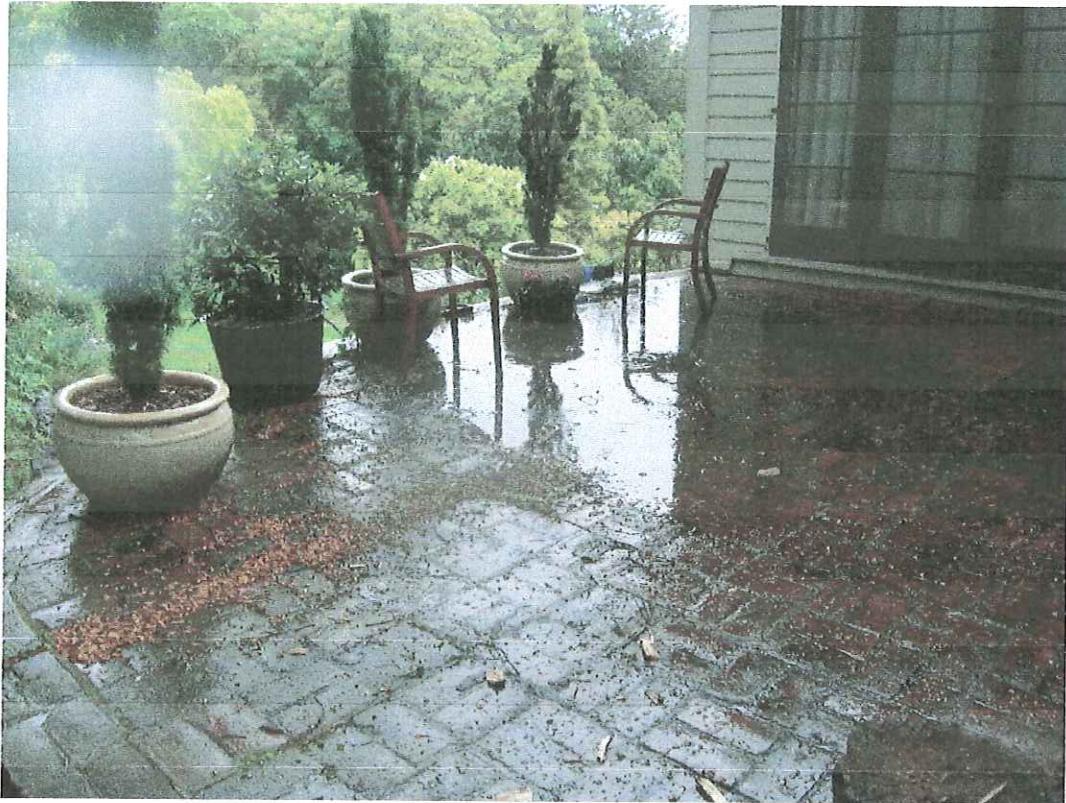
Photo 8. Ponding of water on patio, caused in part by elevation of left side of patio by tree roots.

**Patio paving located under T790 dripline;** Ponding with rainwater due to uplift at perimeter foundation (Reference photo 8)

**Cause of damage;** Incremental growth of underground tree roots encroaching from roadside tree T790

- 1; Demolish and rebuild patio incorporating bridging components to allow sufficient clearance and future growth of tree roots
- 2 Demolish and rebuild patio, remove T790 tree and roots to prevent future damage

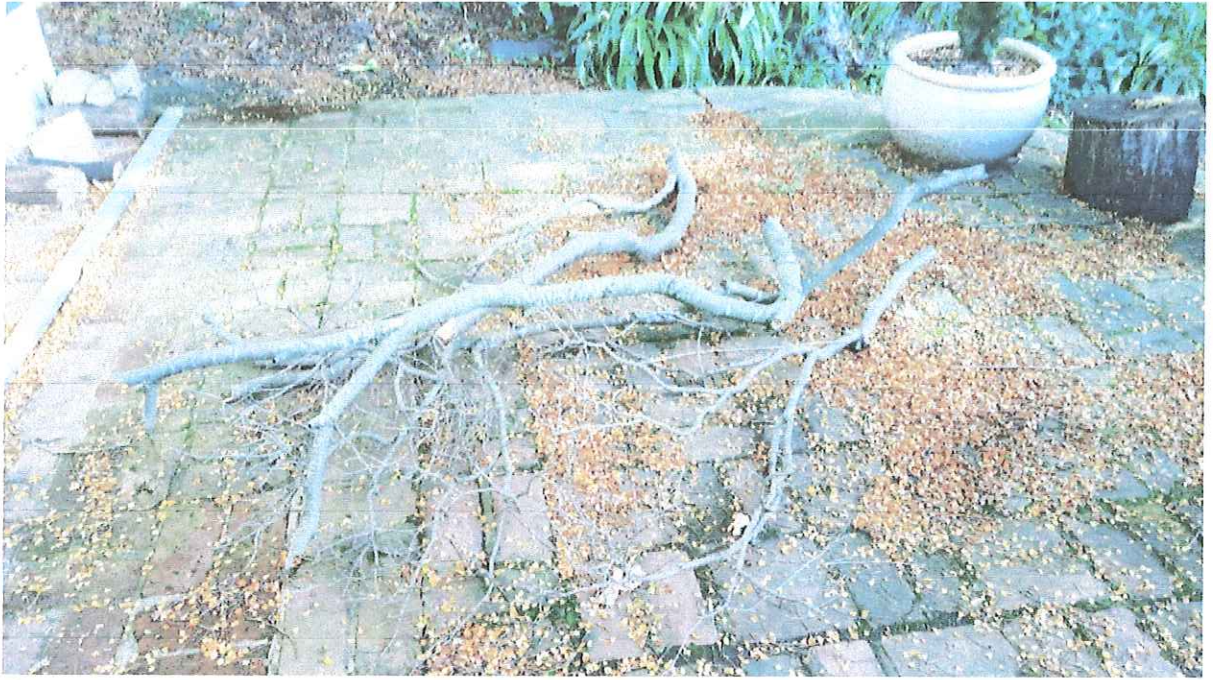
This danger is posed by falling branches. Several of these are recovered from the area each year, some of which can be several kilograms in weight. Falling from a height of several metres, these have the potential to cause serious injury (photos 9-10).

Photo 9. Recent branch fall from the tree.

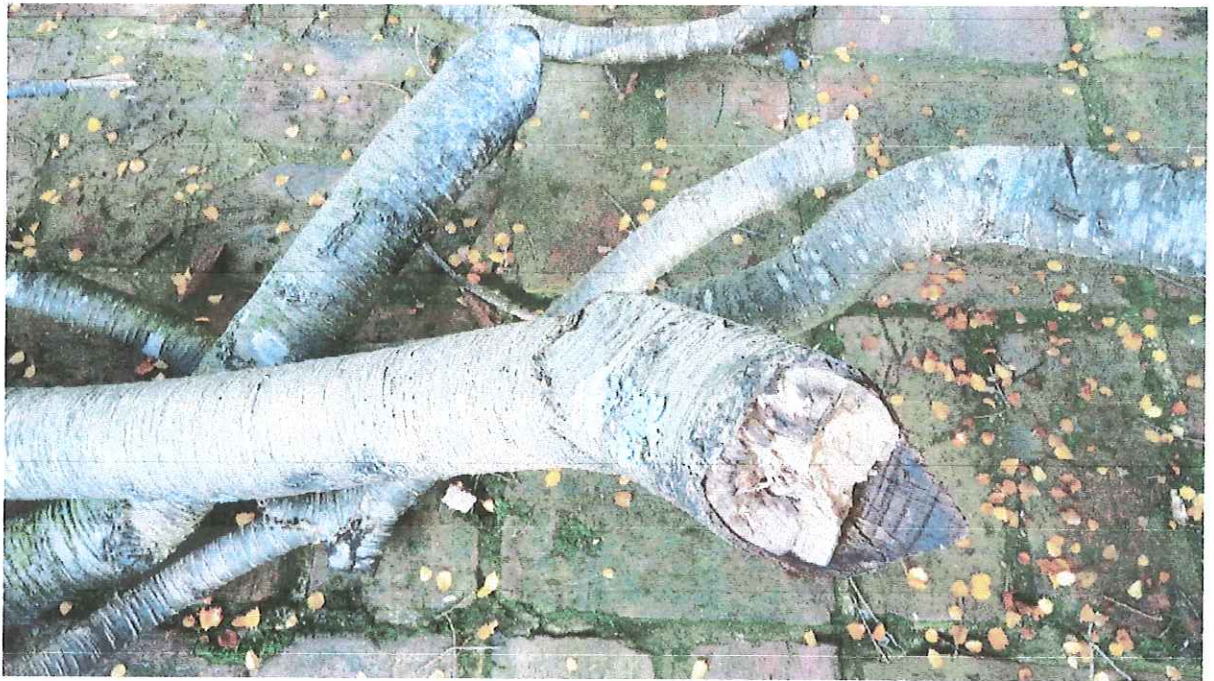
Photo 10. These examples are 2-3 kg in weight.

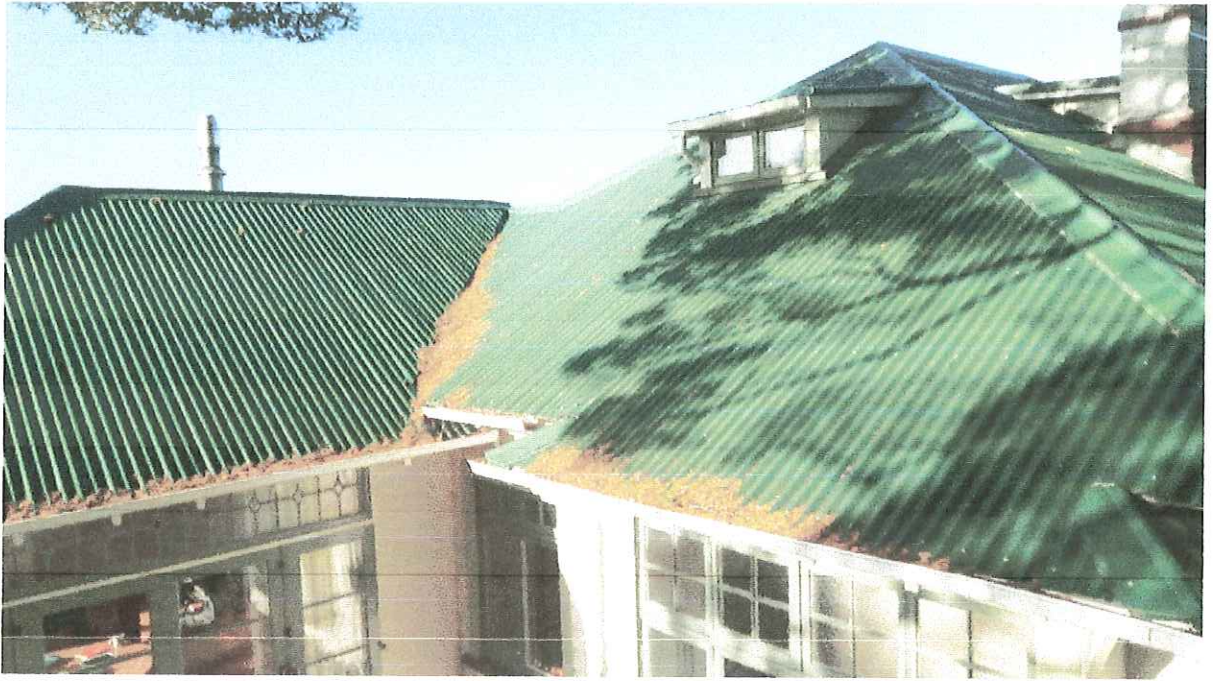
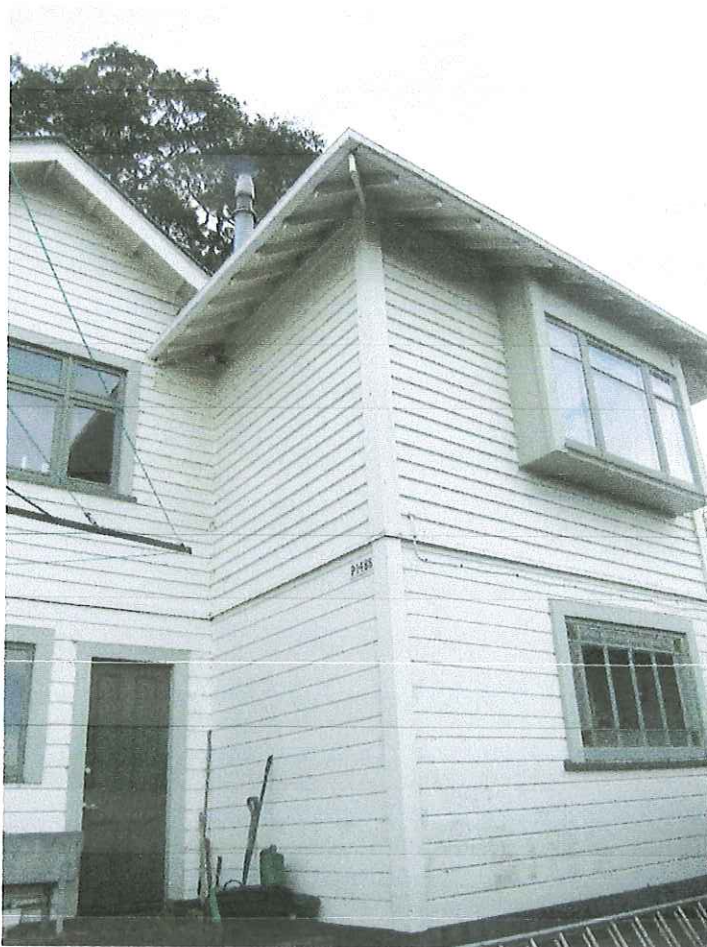
Photo 11 & 12. Leaf fall must be cleared twice a year from a gutter that, at the back of the house that is 5m above ground level.

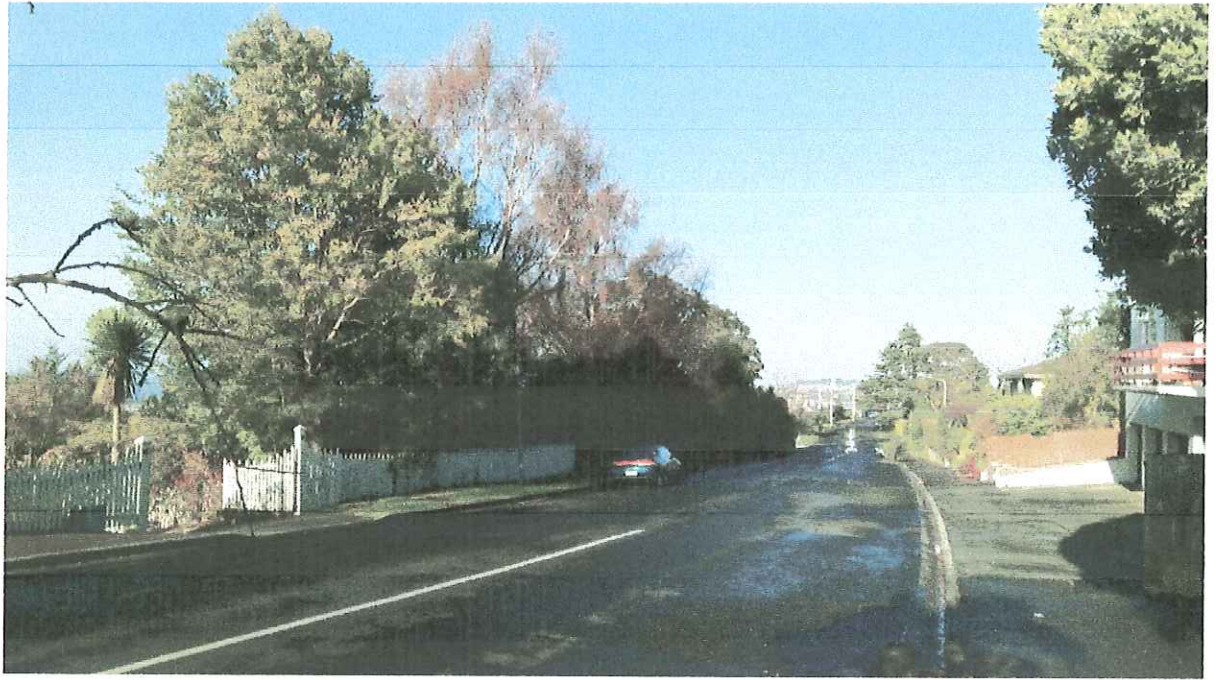
Photo 15. Heading south down Michie St, showing trees in the road reserve on the left of the road, including a red beech, two silver birches, a copper beech and at the far end the silver beech (T790), subject of this application.
