**OCEANA GOLD (NEW ZEALAND) LIMITED  
MACRAES OPERATION  
GOLDEN BAR WASTE ROCK STACK – STAGE 2  
DESIGN REPORT**

| <b>Title</b> | Oceana Gold (New Zealand) Limited, Macraes Operation, Golden Bar Waste Rock Stack – Stage 2, Design Report |

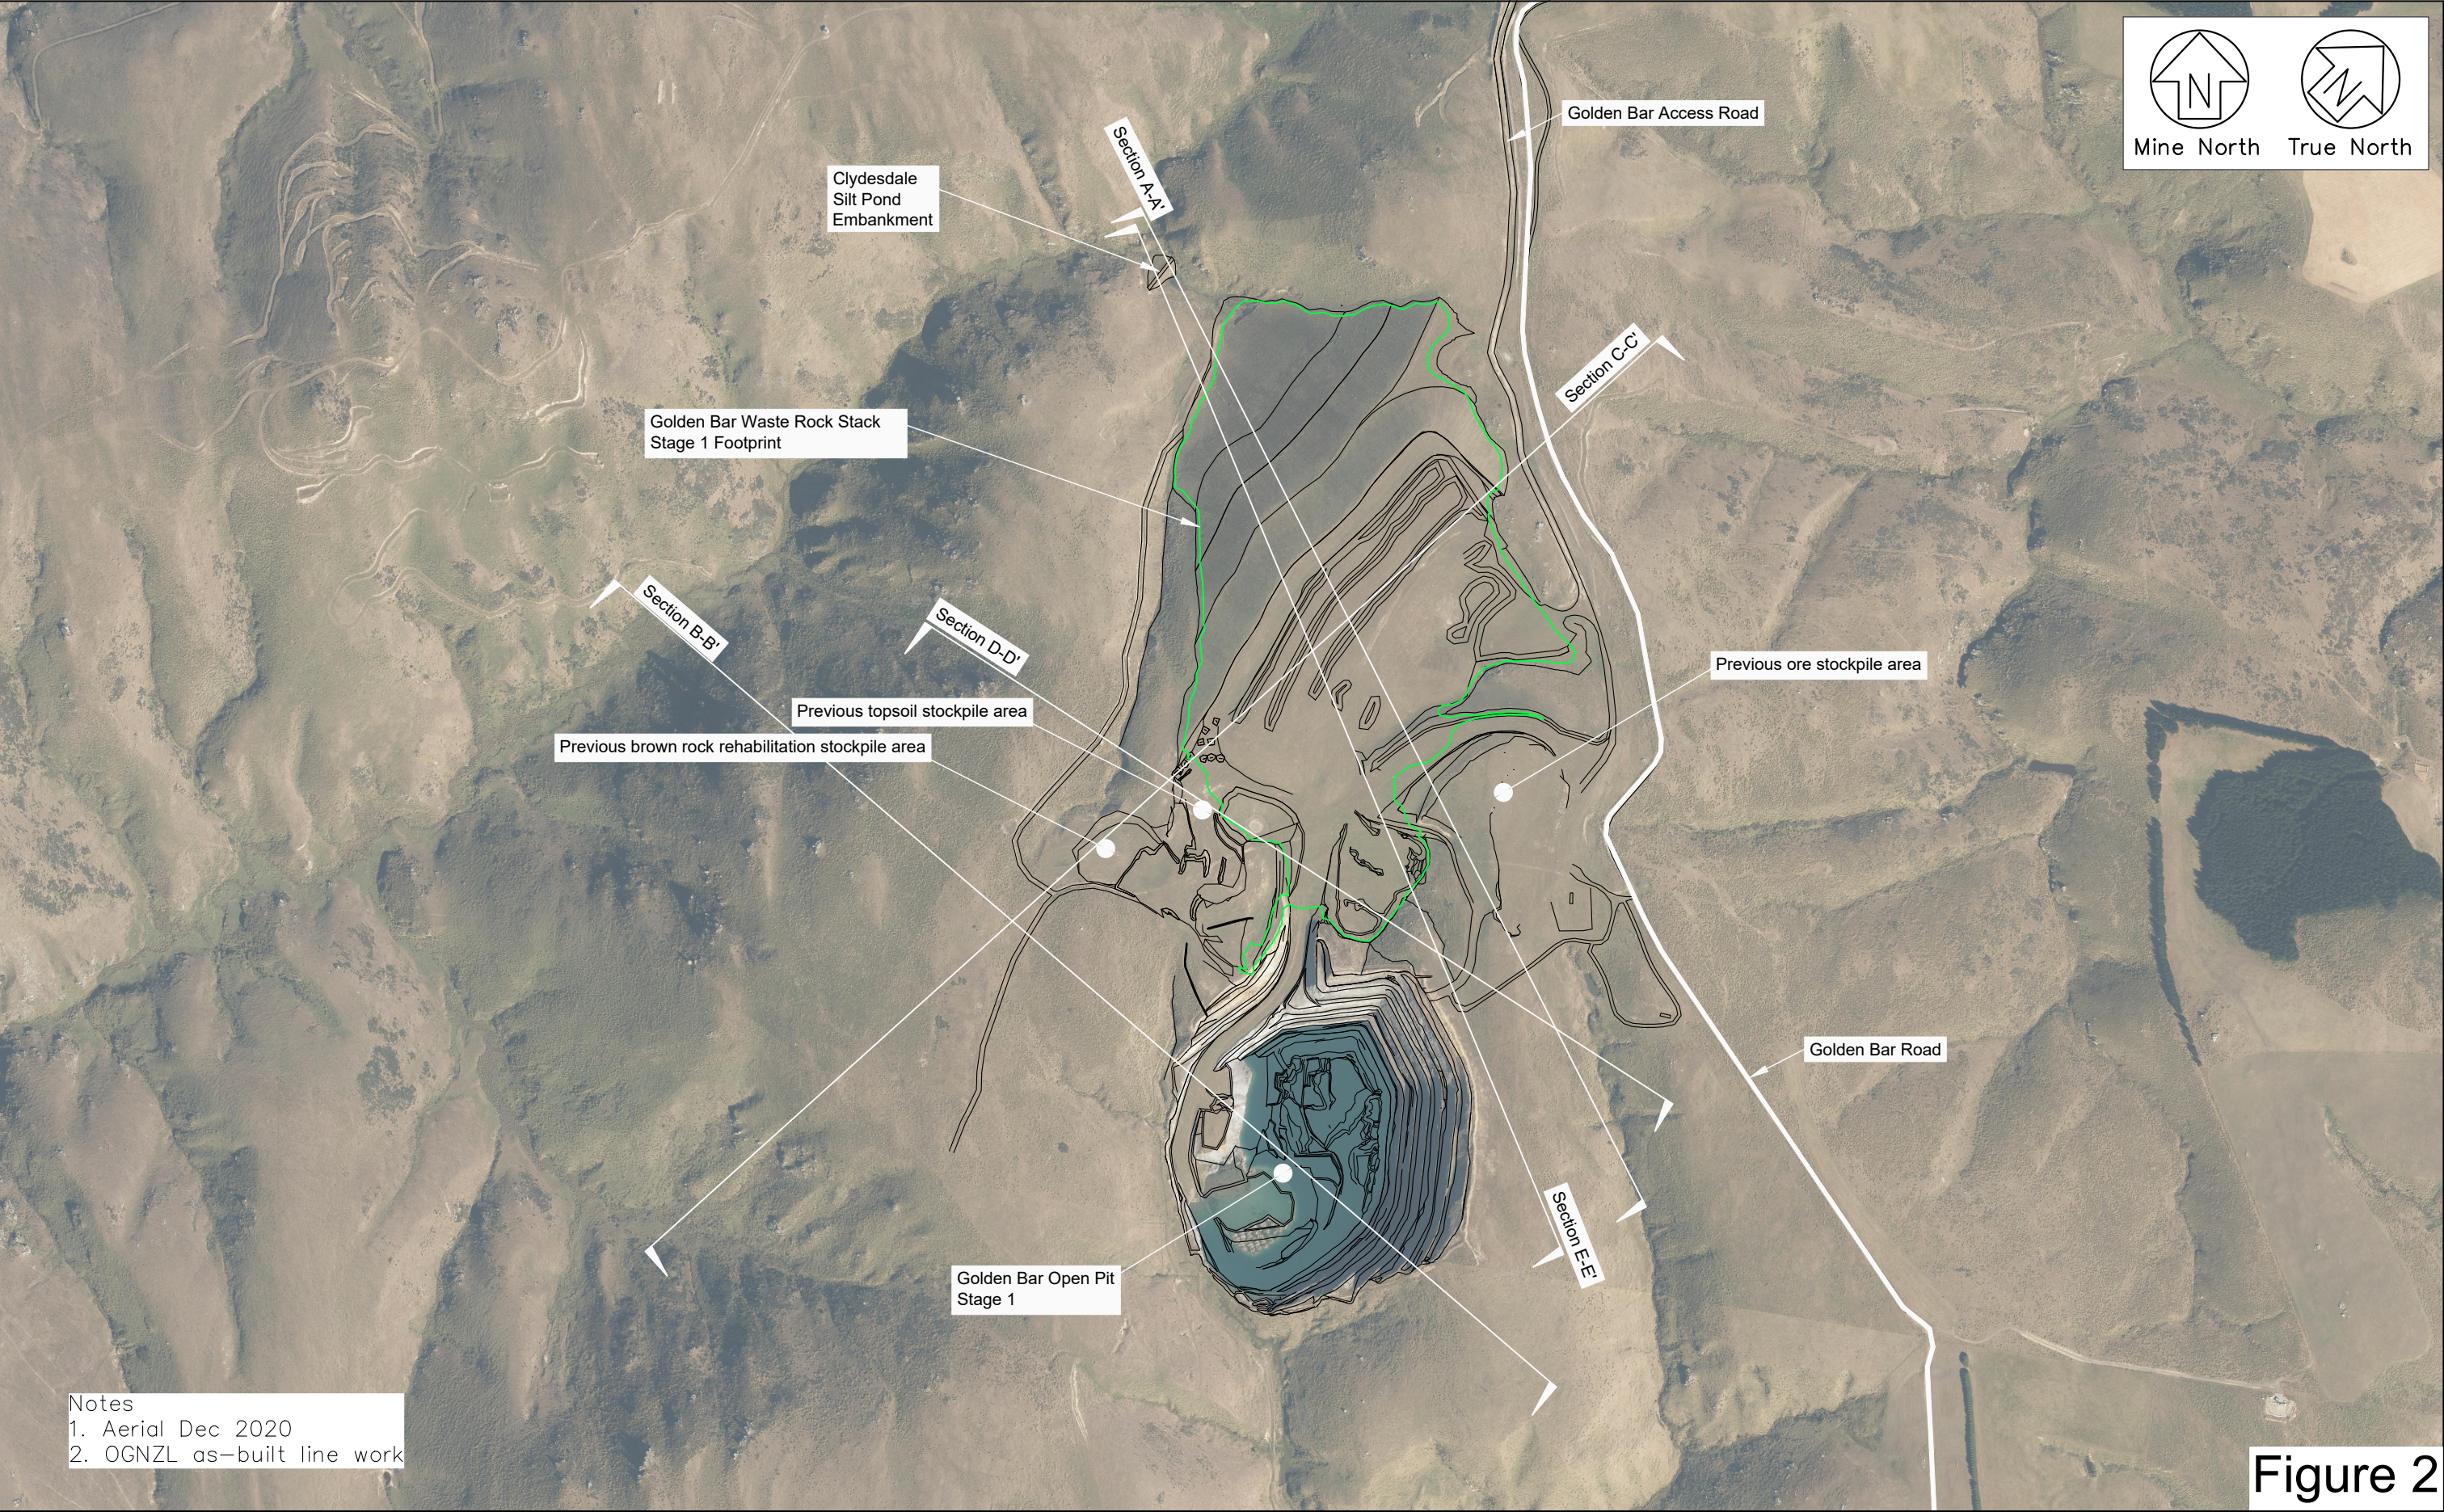
| Figure 2 | Golden Bar WRS and Pit Stage 1 – Site Plan |

The first stage of the mining at Golden Bar occurred from 2004 to 2006. The existing layout of the Golden Bar Stage 1 Open Pit and Golden Bar WRS are shown in Figure 2. An existing silt pond (Clydesdale Silt Pond) is located at the toe of the northern extent of the existing WRS. The existing WRS has been in place since 2006 and the performance has met design expectations. There is no evidence of instability, deformation, and little surface erosion.

Stability analyses have been undertaken for three cross sections (A-A', B-B' and C-C') through the WRS (locations shown on Figures 2-6). These are representative of the critical cross-sections in terms of loading, topography, and ground conditions. The cross sections are shown in Figure 7.
