## PLANNING APPLICATION DETAILS FORM

| <b>Property Address</b> | | 29 Queen Street Dunedin | |
| <b>Description of Application:</b> | | construct new commercial residential building | |

## **CONDITION REPORT – 29 QUEEN STREET, DUNEDIN**

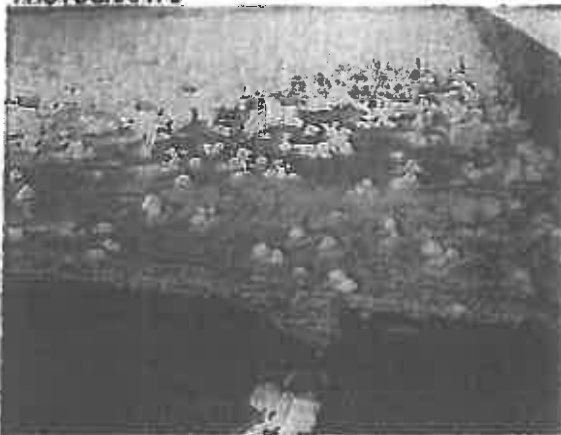
PHOTOGRAPH 5

The flat metal standing seam roof over the front entrance on the western elevation appeared in poor condition with extensive corrosion visible. This section of roofing is nearing the end of its economic life. Refer photograph 5. An apron flashing which fits under the plaster cladding and over the roof cladding appeared in average condition and weathertightness at this area could be considered 'at risk'. Refer photograph 6.

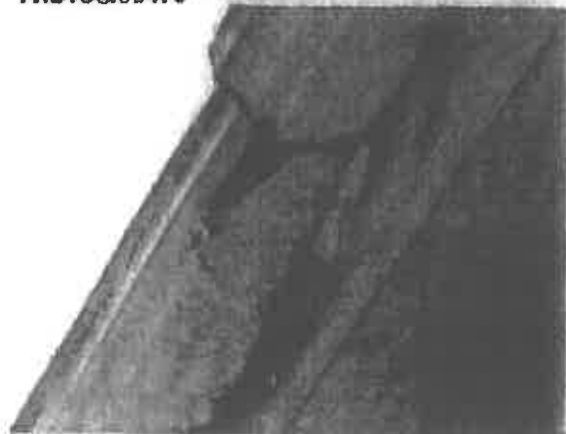
PHOTOGRAPH 8

Spoutings around the dwelling all appeared in poor condition. On the northern and eastern elevations broken and displaced spouting was noted, along with corroded areas. Spoutings on these elevations will require replacement. Refer photograph 8 and 18.

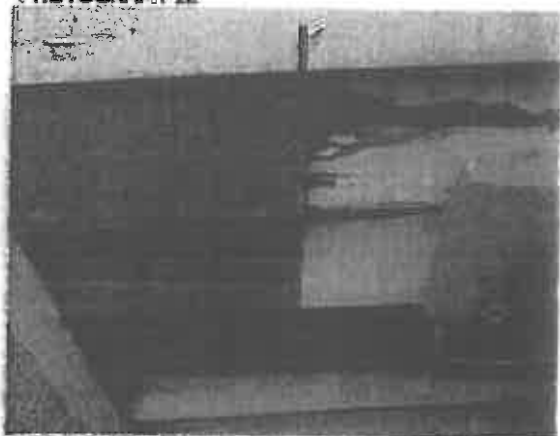
PHOTOGRAPH 14

Repairs have been carried out to many areas of the timber weatherboard sections of the dwelling. These repairs have been carried out in an untradesmanlike manner, with gaps noted around patching. Refer photograph 14. Extensive damage was noted to weatherboards right around the dwelling, with flaking and peeling paint noted in many instances, along with decay and cracking. These areas will require extensive remedial repair. Refer photograph 15 and 17.

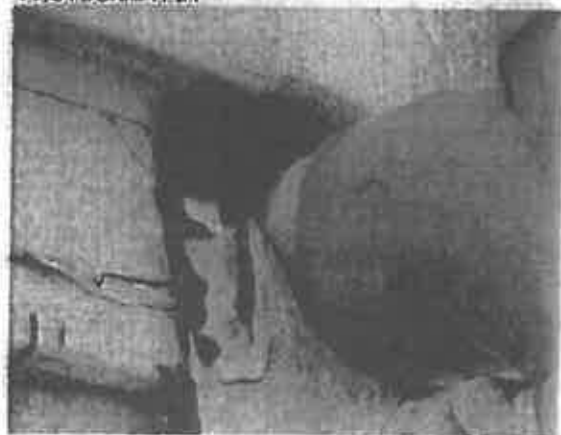
PHOTOGRAPH 16

Penetrations for services pipework around the dwelling are in poor condition and often poorly sealed, with many gaps apparent where moisture could ingress the dwelling. Refer photograph 16. Flashings will be required where gaps are apparent.

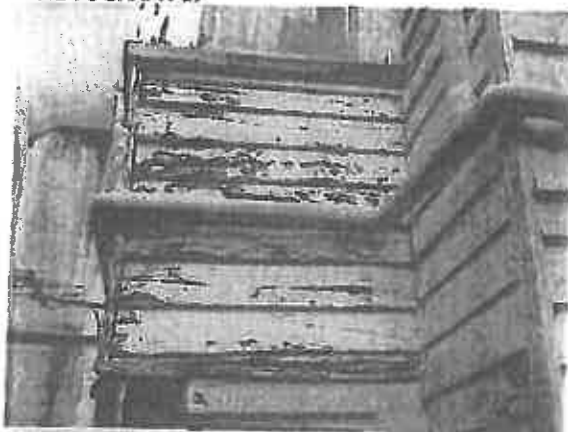
PHOTOGRAPH 19

Extensive weatherboard damage was noted around the bay window on the north eastern corner. Some slumping and distortion was noted to weatherboards in this area and this drops off towards the eastern elevation. Due to slumpage on the north eastern corner, consideration could be given to engaging a structural engineer to assess the integrity of the dwelling. Refer photograph 19 and 20.

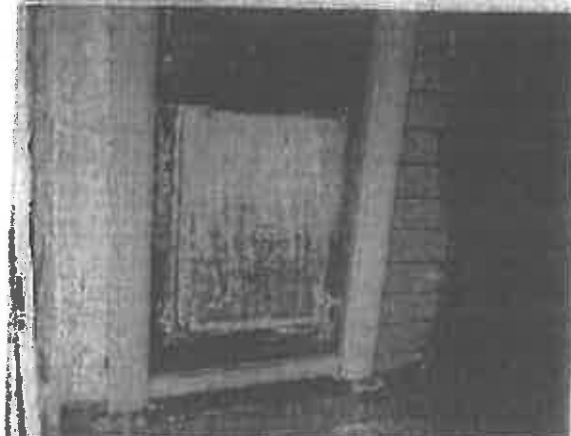
PHOTOGRAPH 23

The front entrance door appeared in average condition and would benefit from refurbishment. The rear entrance lower level door appeared in poor condition requiring replacement. Refer photograph 23.

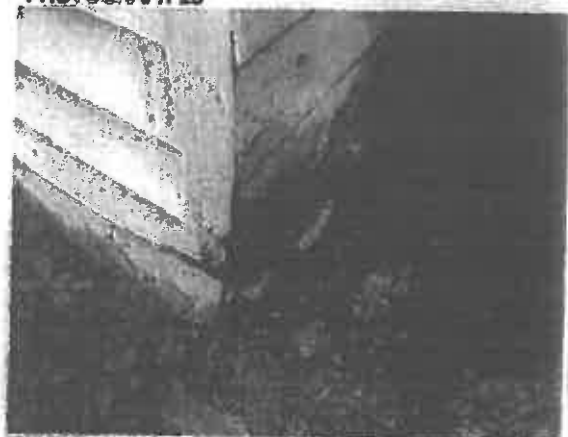
PHOTOGRAPH 30

Clearances were minimal between the plaster cladding and the ground. Standing water was apparent on paths due to stormwater discharge and this moisture may be able to access the internal timber framing, causing damage. Refer photograph 13. Along the northern elevation minimal ground clearance was noted, with weatherboards embedded into the earth ground lines which will cause accelerated decay to the weatherboards. An attempt has been made to provide some protection to boarding with corrugated iron being embedded into the ground, however the corrugated iron will also begin to decay. Refer photograph 30.

Minimal ground clearances were noted and timber weatherboards are beginning to decay. Refer photograph 30.

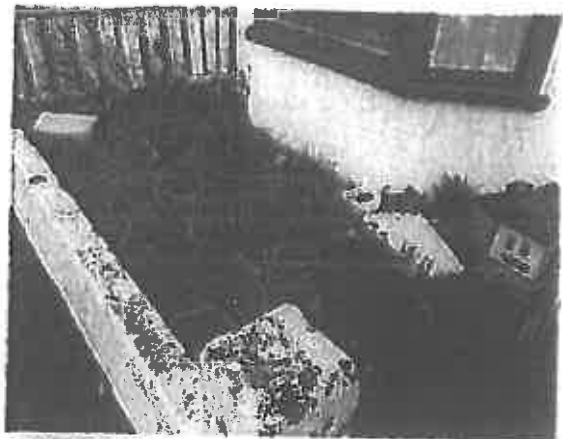
PHOTOGRAPH 34

The western property line has been formed by a low level plastered wall and this appeared in average/poor condition and will require painting. No gate has been installed and the letterbox appeared in average condition. The western elevation is overgrown and unsightly. Refer photograph 34.
