# Geotechnical Assessment of Lot-3, part 82 Riccarton Road East, Dunedin

Report prepared for

11 April, 2016  
(Amended 18 May, 2016)

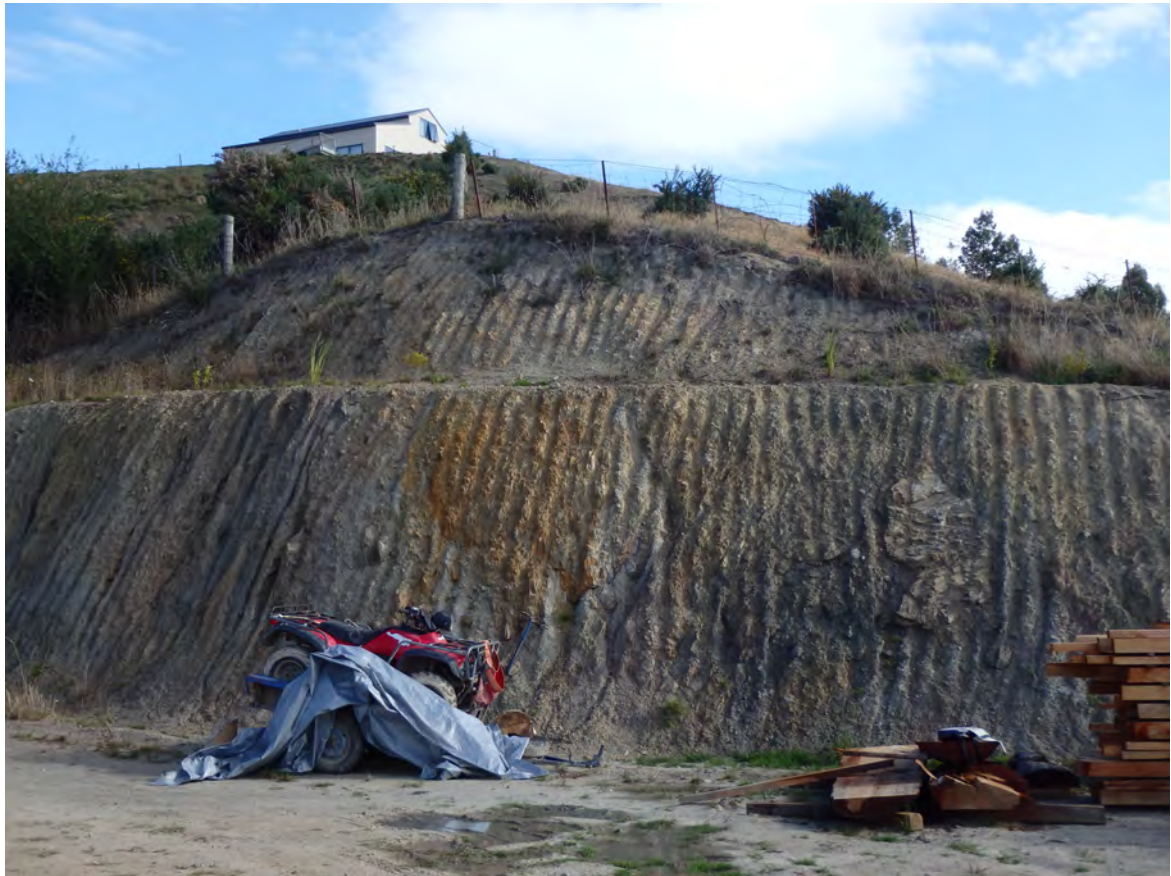
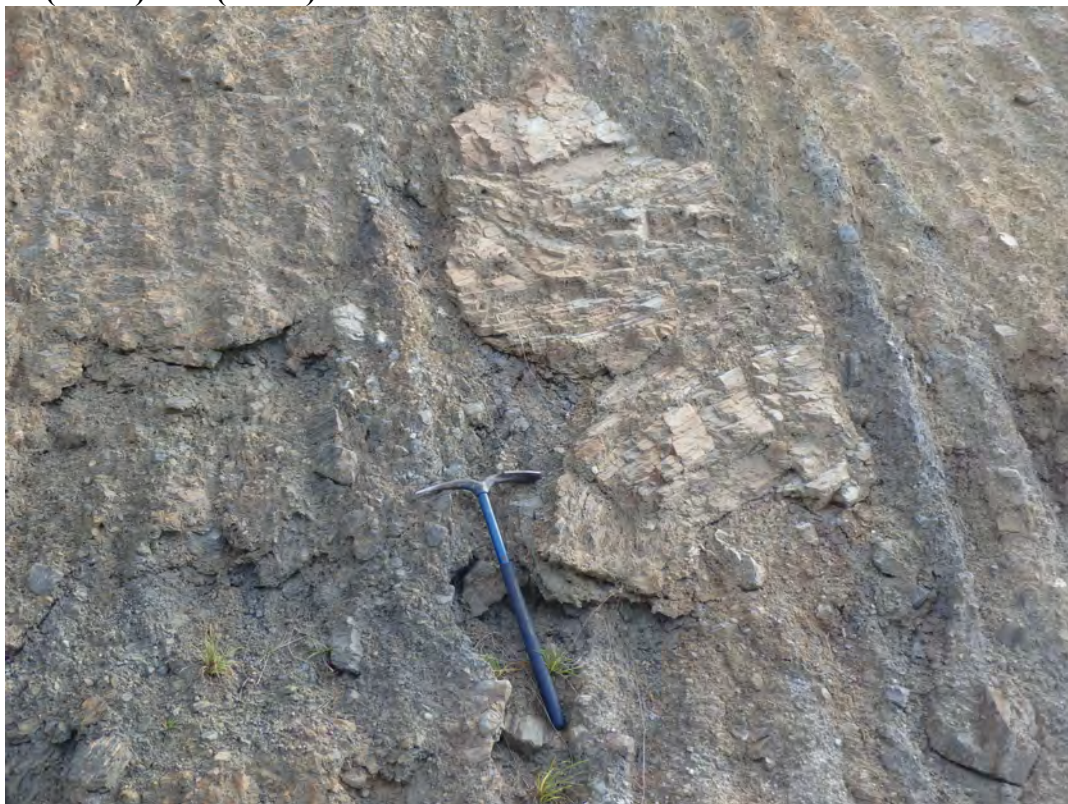
**A (above). B (below).**

**Figure 3** Schist breccia exposed near the eastern boundary of proposed Lot-3. **(A)** General view. Note the large block in the center of photo, and relatively thin (<50 cm) loessic soil beneath the fence line. **(B)** Close-up view of schist breccia.

I made an initial inspection of the property accompanied by the owner on 13 August 2015, and a further examination on 30 March 2016. Proposed Lot-3 occupies the lower northern flank of a ridge that extends west of Riccarton Road East (Figure 1). According to the 1:50,000 scale geological map of McKellar (1990), Lot 3 is underlain by schist rock (Figure 2). The property lies within a structural block bounded by strands of the Titri Fault which extends along the east side of Taieri Plain. Schist is exposed in recently cut slope batters within the adjoining property to the east, between Lot 3 and Riccarton Road East (Figure 3), and in a farm track cutting above Lot-3 (Figure 4). In both areas the schist has a blocky brecciated appearance. This is considered to be a result of tectonic deformation during past movements on Titri Fault. An alternative interpretation is that it is a very coarse grained part of the Henley Formation, an alluvial fan deposit of Cretaceous age locally found elsewhere on the southeast side of Titri Fault. Henley Formation is mapped by McKellar (1990) further to the southeast of the property (Figure 2). The brecciated schist consists of large in-tact schist blocks up to 2x2 m set at various orientations in dense rubbly broken schist matrix. The matrix is relatively unaltered, contains some calcite cement, and includes an estimated <5% of chlorite-derived clay sized material. The 50°-60° (measured from horizontal) batter slope appears stable (Figure 3A).

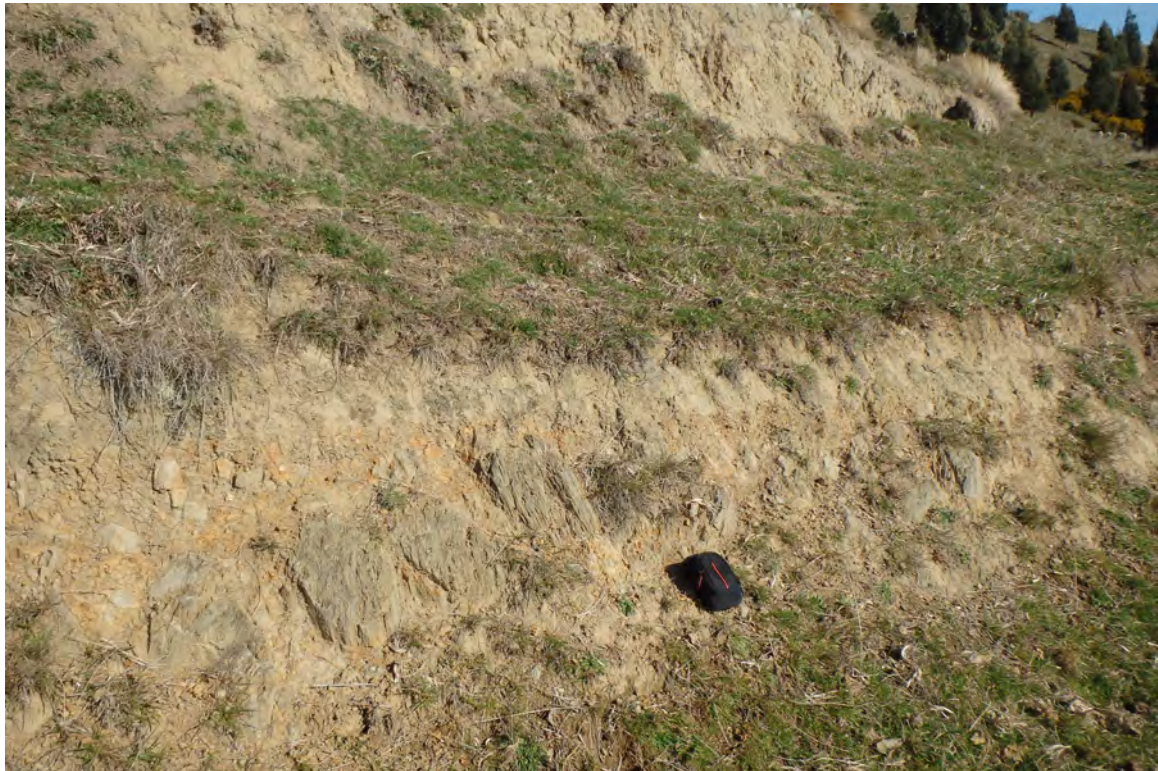
**Figure 4** Blocky schist (beneath 13cm long camera case) and overlying loess subsoil exposed upslope of proposed Lot-3, directly north of the existing barn building.

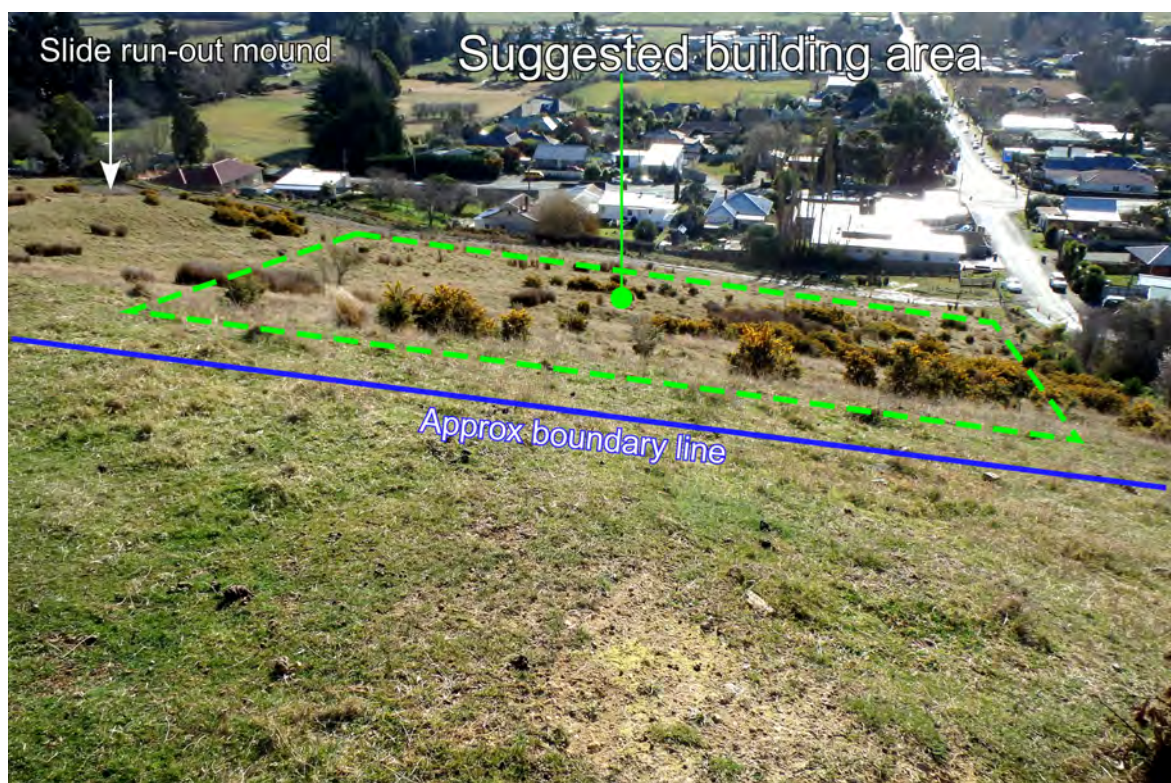
**Figure 5** Northwards view of the suggested building area.

- A** The easternmost approximately 1/3 of the area of proposed Lot-3, indicated in Figures 1 & 5 of this report, is considered suitable for a house platform.
- B** It is recommended that: (1) piles or concrete footings, and retaining walls are placed directly on schist after removal of soil cover, or on a correctly designed hard fill pad on schist; and (2) drainage systems are installed to intersect and remove any surface water or spring water flow that may affect the stability of ground in the vicinity of the building.

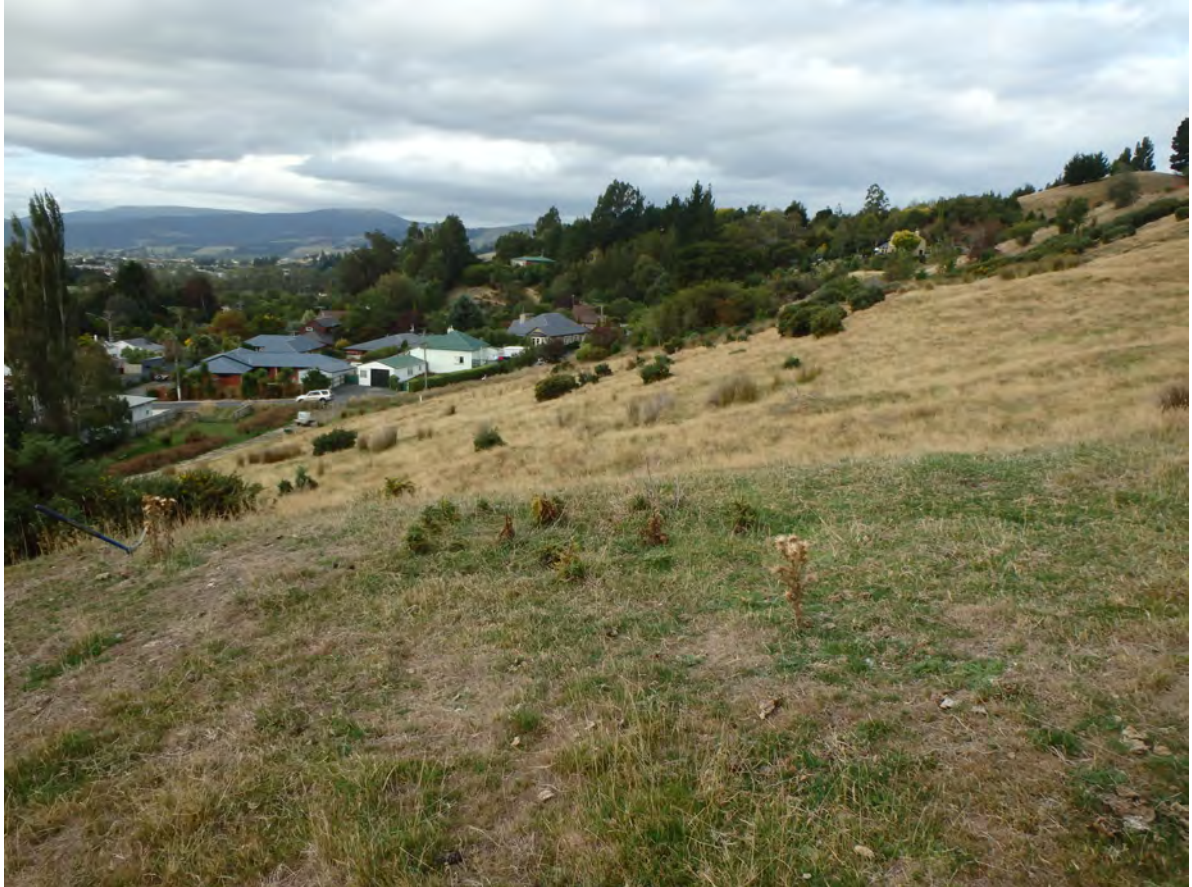
**Figure 6** View of the eastern 1/3 of proposed Lot-3 from the slide mound outlined in Figure 1.
