NZMCA - 20 BAY ROAD WARRINGTON

LANDSCAPE PLAN SHEET 1 OF 2

20 Bay Road, Warrington

Archaeological Assessment for Site No. I44-177 and I44-178

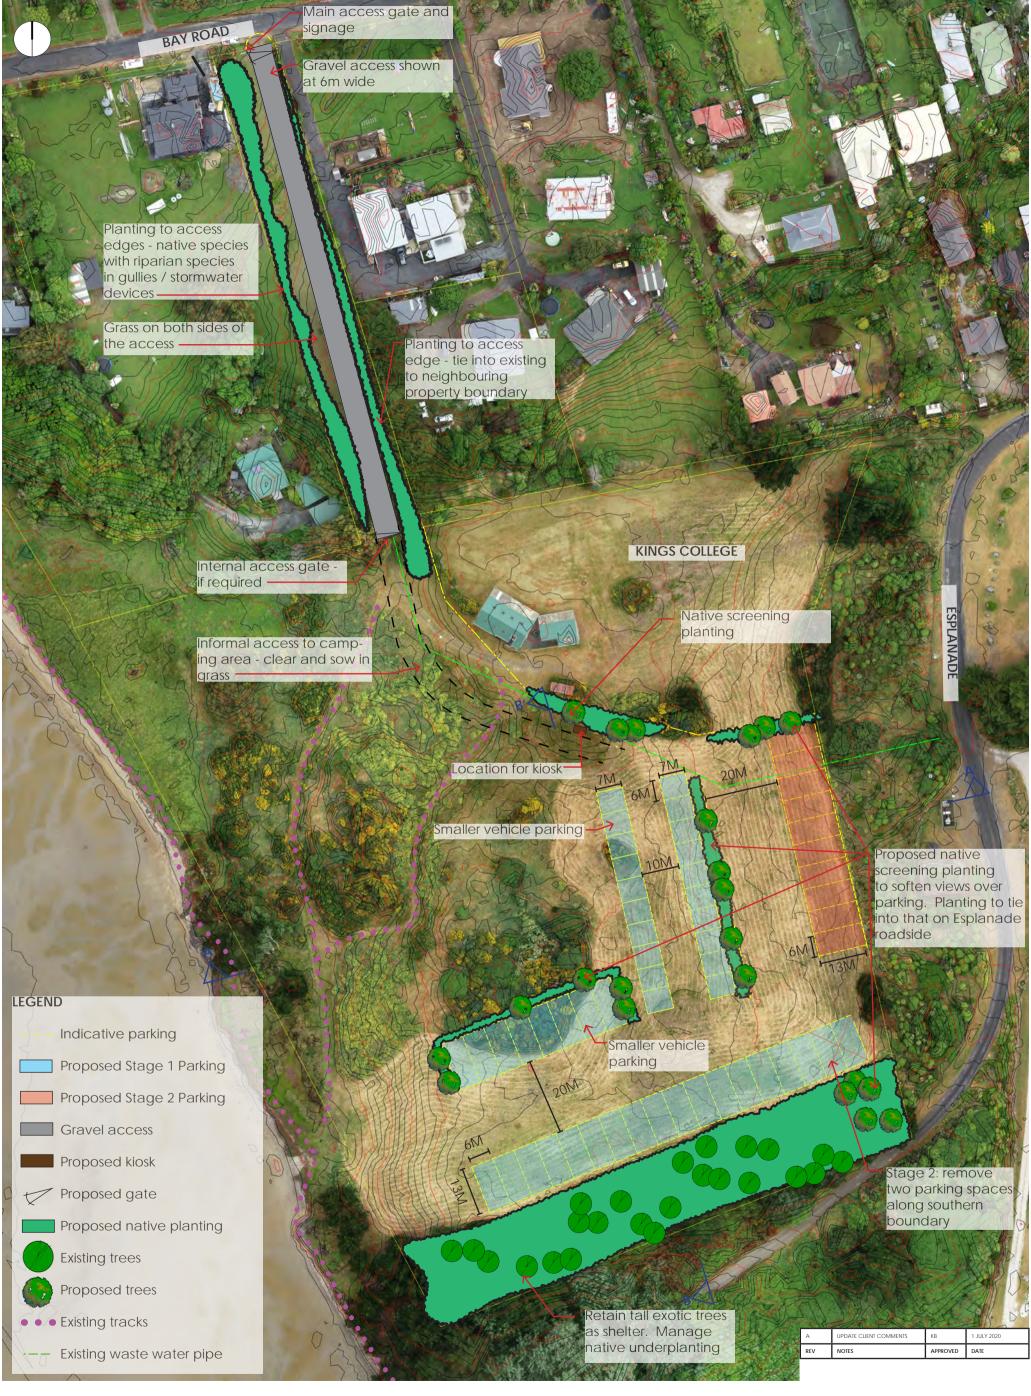
Access to the site is from Bay Road, down a gravel driveway, shared with the Kings High School property. The accessway is proposed to be widened to 6m. The gravel formation will end at the shared way between the camping area and the Kings College site. From there NZMCA members, as per membership rules, will travel along an unformed track, of which scrub will need to be cleared to enable, and sign in on arrival at a small

kiosk on the northern boundary. The site will be visually screened from the Kings High School buildings and surrounding residential properties with native planting to the northern boundary. This multi layered planting is to be of a depth and height to enable visual screening of camper vans and vehicles to adjacent properties. All planting on site is to be native, and eco-sourced, based on the list provided.

Parking as part of the Stage 1 proposal is focussed in the western part of the site. Small vehicles will be able to park in 20 No. bays, two rows that run north - south at the edge of the existing scrub. A strip of native planting will be included to the eastern edge of this to further provide screening to adjacent properties. Larger vehicles can park on the southern boundary (18 No.) and opposite, with a 20 m isle between. The eight parks opposite will also have a strip of native planting surrounding. The stand of pine trees on the southern boundary is to be retained and managed by the NZMCA.

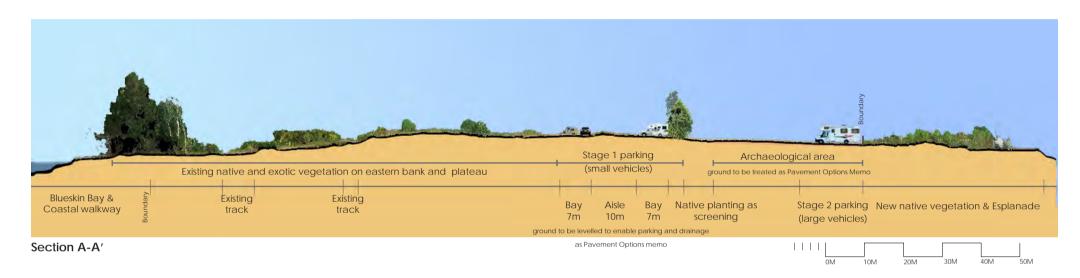
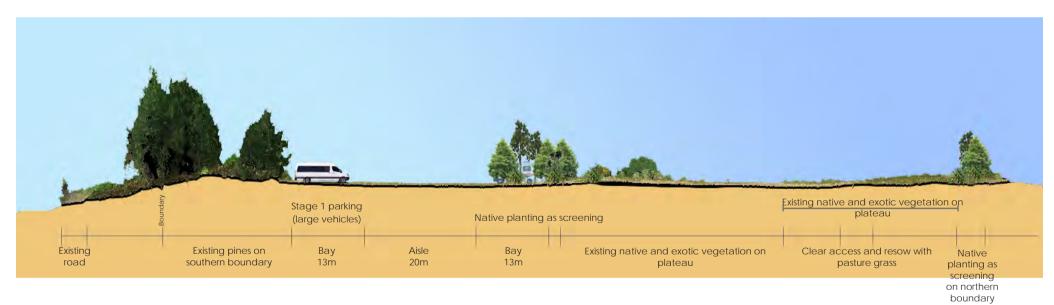
Section B-B'

Cross Sections

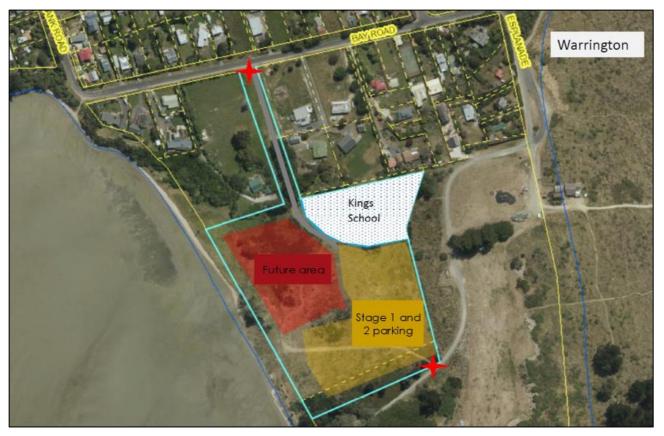
Figure 1-2. Planned stages of development, as provided by Stantec. Red stars mark current accessways, with the blue line showing the property boundary.

A small kiosk is to be installed at the south end of the driveway. This is to be within the gravelled area at the boundary between the Stage 1 and Stage 2 areas. The kiosk will require minor excavations. Slightly east of the kiosk, a small dump station is proposed. This will also require minor excavations.

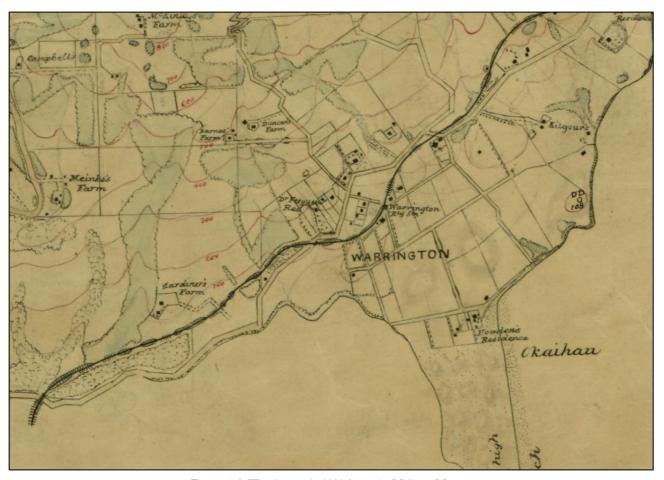
Figure 5-3. Warrington in 1901 from the Military Maps.

It was in the twentieth century that Warrington began to fully develop as a village. The population had increased to 108 by 1901 (Statistics New Zealand, 1901). A plan of the settlement from the 1901 military maps shows a number of buildings located around the railway line (Figure 5-3). Numerous farms can be seen around the settlement.

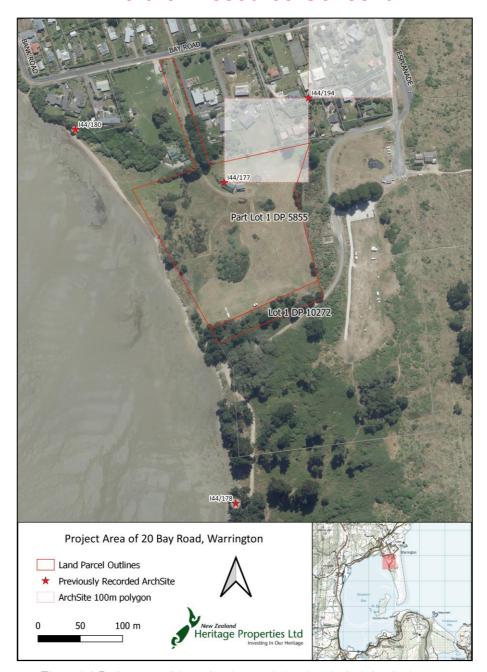
Figure 5-6. Project area with previously recorded archaeological sites in the area.

The project area at 20 Bay Road, Warrington, has a history that echoes the surrounding area. Historic research and the archaeological record have shown that the property was occupied by Māori through many phases. After the arrival of European settlers, the property was apparently used as both a nature reserve and a rubbish dump, resulting in the modification of the land to accommodate new tracks and accessways to the shoreline. While ArchSite places only one archaeological site within the property, this assessment indicates a second site likely extends into this area as well (Figure 5-6).

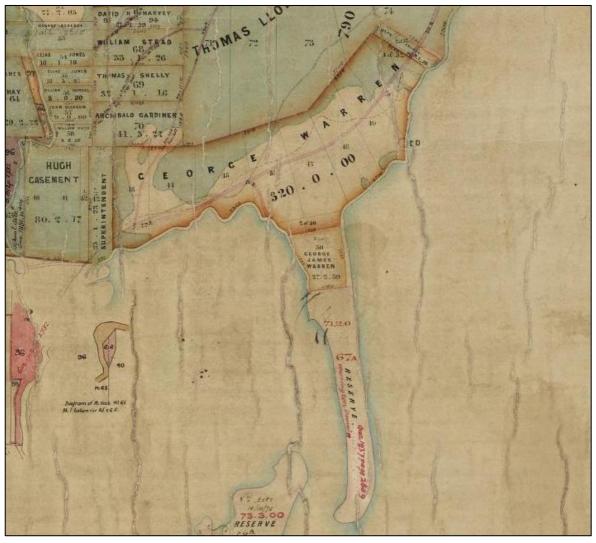
Figure 5-8. Close up of the 1862 Waikouaiti Survey District Crown Grants Index Map (Otago Crown Grant Index Records Maps, 1863).

20 Bay Road, Warrington, was originally surveyed as Part Sections 1 and 2 of 50, Waikouaiti Survey District (Otago Crown Grant Index Records Maps, 1863). This was owned by George James Warren, along with the large sections of land covering much of the Warrington area going north (Figure 5-8). The 1901 Military Map (Figure 5-3) shows the eastern half of Past 2 now occupied by Howden's Manor house, with a few other smaller houses marked. At this point, the area included as 20 Bay Road was not occupied. While Allingham mentioned a rubbish dump on the property within the SRF, no further documentation could be found associated with this.

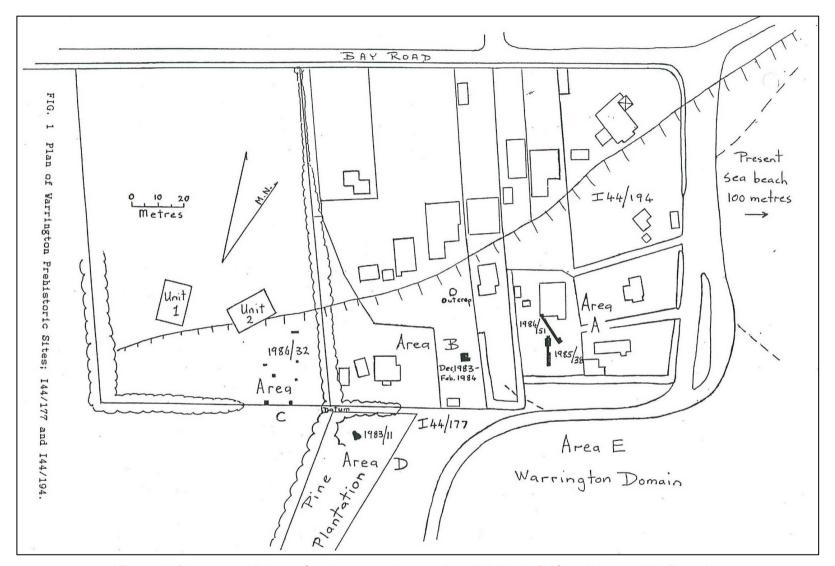
Figure 6-2. Sketch map of Allingham's various excavation areas from 1983-1987 for I44/177 (Allingham, 1987 Figure 1).

The 1985 to 1986 excavations involved trenches for a 2.5m x 1.2m septic tank, 3m x 0.5m overflow drain, and 6m x 0.8m sump in Allingham's Area A (Figure 6-2). These trenches found multiple cultural layers, dating to the "Classic period", intermediate period and early Māori, based on artefact type (Allingham, 1986). Fire scoops, FCR, lithic material, worked bone and kokowai were all found in this visit. The areas of excavation monitored in this phase were to the northeast of the current project area.

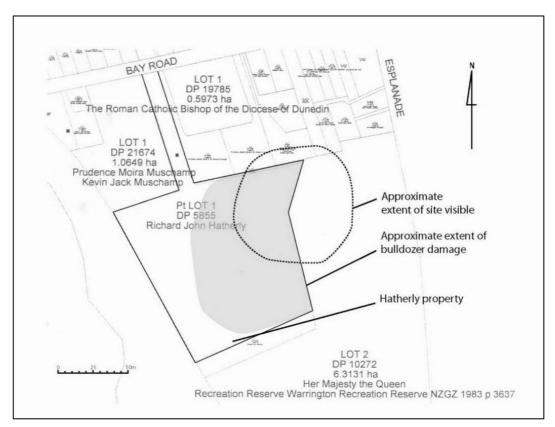
Figure 6-4. Depiction of site damage and visible site extent at 20 Bay Road (as seen in Walter & Jacomb, 2008 Figure 4).

Walter notes that the damage to the site that took place first in 2001, following the subdivision of the land, and then again in 2005 included the removal of trees, slashing of scrub, contouring of the land removing the humps of the some of the higher dunes, and harrowing. As expected, the contouring proved to be the most destructive activity (Walter & Jacomb, 2008). The activity took place across much of the land parcel, although the northeast corner where site I44/177 is located appeared to have suffered the worst damage. Walter and Jacomb completed a site visit including test pitting and augering for the 2008 report, noting that the visible extent of the site covered much of the northeast corner, a larger area than recorded previously (Figure 6-4).

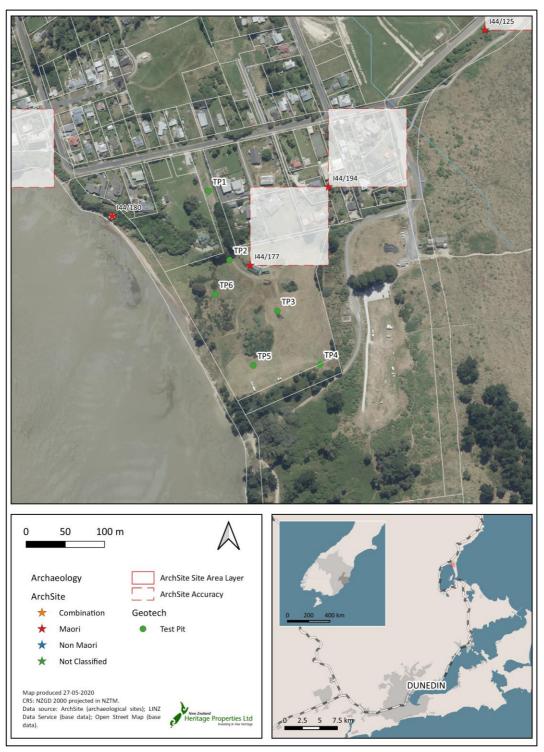
Figure 6-5. Location of geotechnical test pits completed by Stantec under authority 2020/540.

As part of the proposed redevelopment of the site, an exploratory authority (2020/540) was obtained to undertake geotechnical investigations. This test pitting was completed by Stantec on 13 May 2020, monitored by NZHP archaeologist Jessie Hurford. This test pitting took place in six locations across the project area, including two in the north and one in the south accessways, two in opposite areas of the proposed parking area and one in the low ground in the western side of the project area (Figure 6-5). These test pits were approximately 300mm x 300mm and were excavated to a depth of approximately 500mm. Little cultural material was encountered during these tests, with the stratigraphy consisting of various coloured sand, clay and sandy loam. One bluestone cobble was encountered in TP6 which was tested to continue in some form for approximately 1m. This cobble is an unexpected find on the site, and likely represents a manuport; however, it is unclear which phase of site use this may be associated with (i.e., occupation by mana whenua or pākehā).

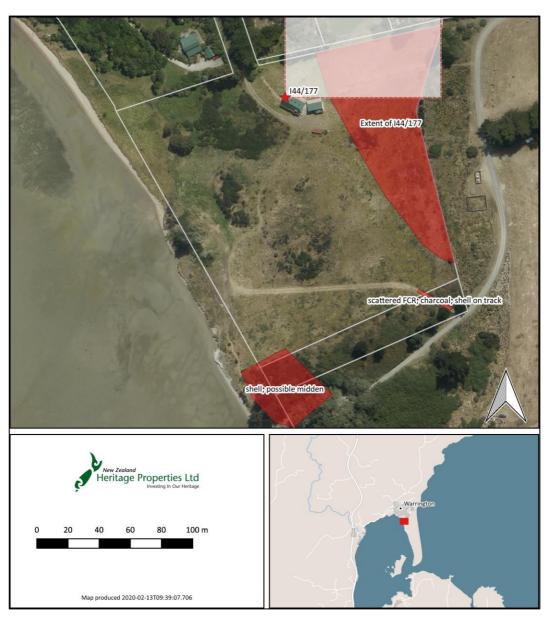
Figure 7-1. Areas of interest identified during the site survey, February 2020.

A pedestrian survey was completed on 5 February 2020 by Dawn Cropper and Victoria Ross, which identified clear areas of archaeological interest as well as modern site disturbance (Figure 7-1). The survey was conducted in 10m transects generally running in line with the property boundaries. Conditions on the day were clear and sunny; however, rain had inundated the site in the past week. At the time of the survey, the vegetation largely consisted of grass, with small bush areas in depressions and on rises. Sand dunes on the west were evident in multiple waves. The southern portion of the project area, located within Lot 1 DP 10272, was forested with an access track leading to a road. Overall, visibility was low, with grass and bush impeding identification of site extent and above ground features. However, it is thought that I44/177 extends further south than previously recorded, while I44/178 may exist only in the very southwest of the project area.

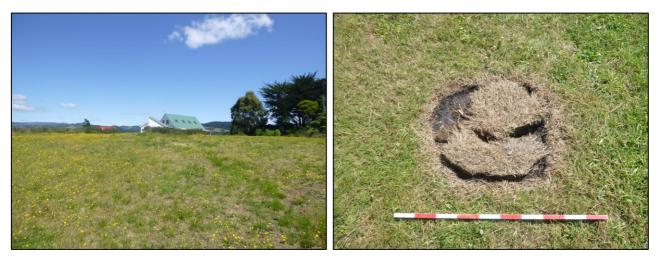
It was evident across the site that activity had taken place which involved minor earth disturbance. At least one recent small dig out for a fire was seen, with the turfed square placed to the side (Figure 7-2). Areas of vehicle movement were also visible in the crushed grass and sand. Levelling and landscaping of the northern half of the project area was also evident, as was reported on by Allingham and Walter. These works have created levelled areas with what appears to be at least one artificial hill on the west side of the property potentially for drainage.

Figure 7-2. Left: looking north across site showing the grassed and undulating nature of the area. Right: recent earth disturbance visible in the site, showing evidence of a small fire. Turf replaced by archaeologist. Looking north.

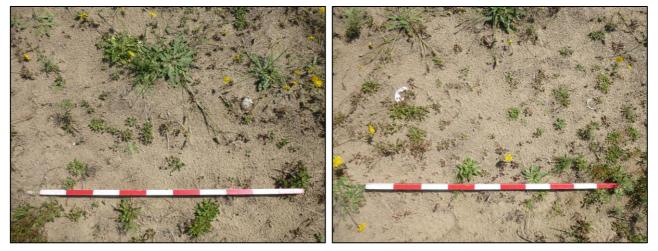
The eastern side of site had numerous sandy exposures. Where the grass cover was thinner, sand was visible with patches of cultural material. In the northeast of the site, bone (burnt and unburnt), shell, charcoal and FCR were visible on the surface (Figure 7-3). It is thought that this material belongs to archaeological site I44/177, and evidence seen on site indicates that this extends further than was previously recorded on the SRF, covering nearly the full length of the eastern side of property.

Figure 7-3. Shell and bone exposed in the sand in the northeast area of site. Looking north.

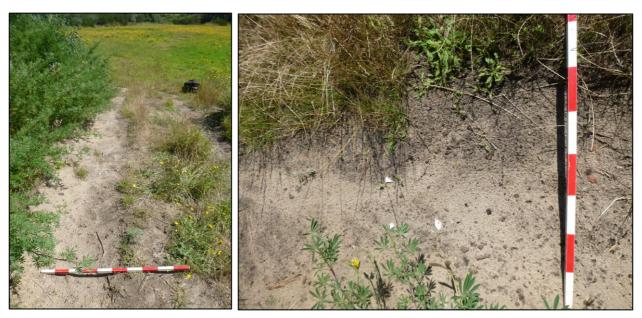
Most of the centre of the site was covered in grass, and in this area of reduced visibility no features were identified. In small areas charcoal was visible within the sand, but whether this is of archaeological origin could not be determined. In the southeast corner, where the secondary access comes into the site through Lot 1, further erosion was visible in the access track. In this area shell, bone, charcoal and charcoal staining, as well as small pieces of FCR were identified (Figure 7-4).

Figure 7-4. Eroding cultural material in the access track on the south side of site. Looking northwest and east.

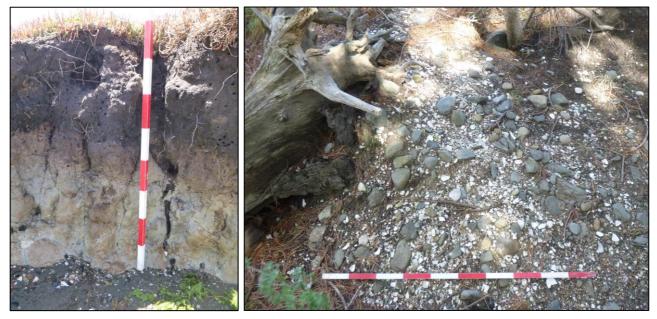
of waterworn boulders. NZHP's visual inspection of these deposits was unable to confirm if this is archaeological or is the remains of a naturally occurring layer of shell, washed up and disturbed in one of the many tidal surges recorded for the area. In this area there was also a single piece of under glaze transfer printed ceramics. As this was in the general area of the shell deposits, it is again unclear if this is related to the artefacts recorded in the archaeological site or is a post-1900 introduction.

Figure 7-5. Left: the natural bank face at the western boundary of the project area, looking east. Right: shell deposit found in the forested area at the south corner of the project area, looking west.

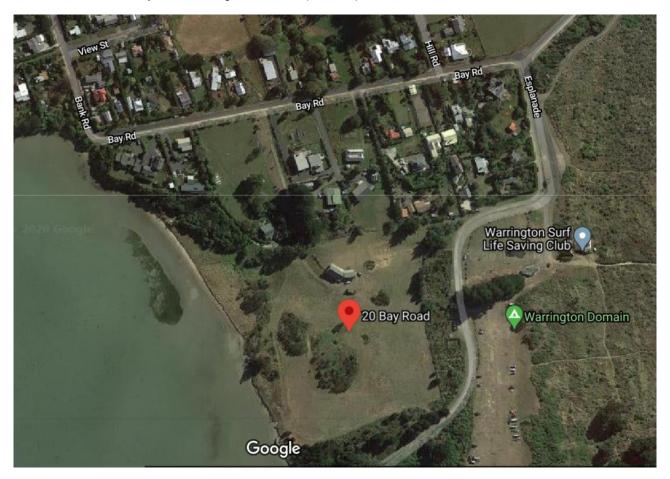
Figure 1.1 Bay Road Site Map

The site location is 20 Bay Road Warrington, 5065177 (Situation) LOT 1 DP 10272.

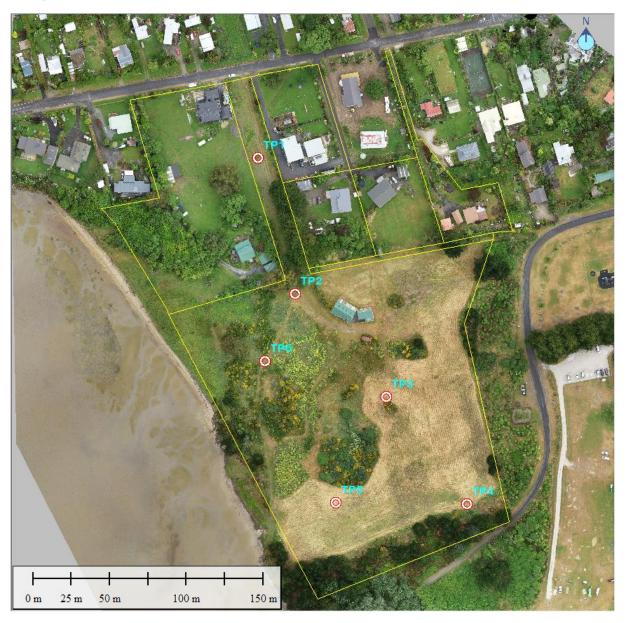
Figure 2.1: Test Pit Locations

The figure below shows the location of the six test pits.

Pit 1	Pit 2	Pit 3	Pit 4	Pit 5	Pit 6
Easting	397316	397340	397399	397452	397367	397321
Northing	811391	811302	811235	811165	811167	811259
Height R/L (m)	10.1	3.92	5.78	4.58	5.76	2.32

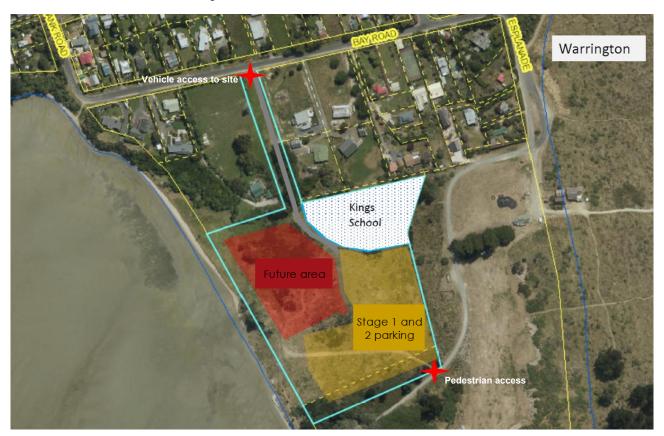
Figure 1: Indicative Site Plan.

It is proposed to upgrade the entry driveway to a higher standard un-sealed gravel surface than currently exists, while the remainder of the site will remain as a grass covered area.

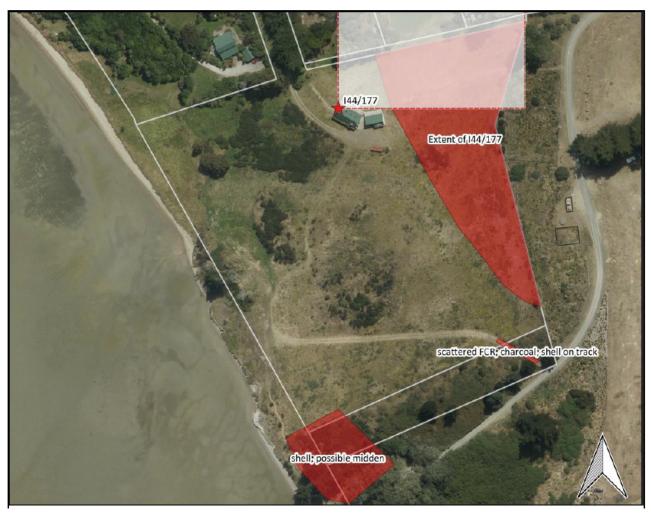
Figure 2: Areas of Archeological Interest identified during Site Survey, Feb 2020.

The areas identified as containing near or at surface artefacts, requires some form of protection from direct traffic loading to ensure any artefacts remain protected and un-damaged. **Figure 2** below shows the indicative extent of the archaeological area with minimal cover to the layer of interest.
