**AND** Application for subdivision  
and earthworks consents for  
15 lot residential development  
at 94 Holyhead St, Outram.

**STATEMENT OF EVIDENCE OF JEAN-LUC PAYAN FOR OTAGO  
REGIONAL COUNCIL**

**Dated 10 NOVEMBER 2017**

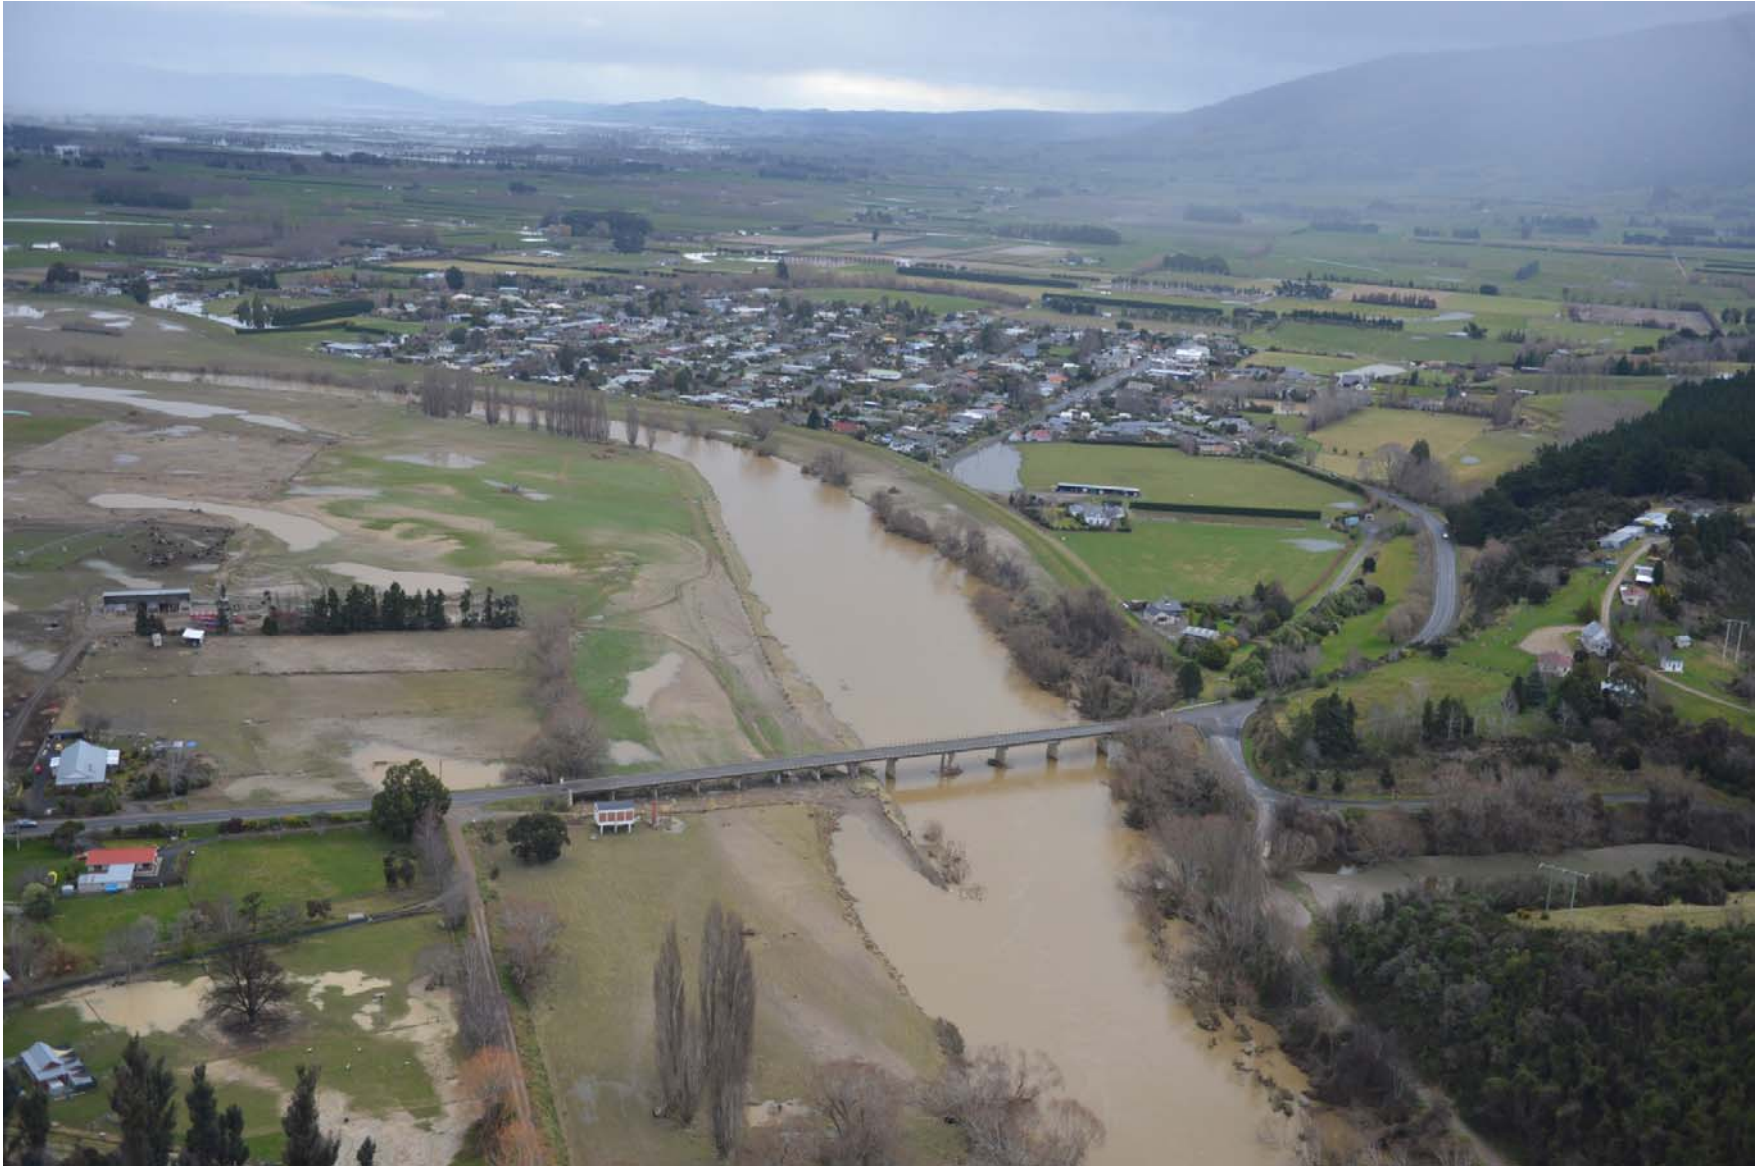
Figure 2. Vicinity of 94 Holyhead Street, Outram – 22/07/2017 morning. The Taieri River is on the bottom left corner with the Outram Township in the distance. The flow in the Taieri River is approximately  $1600\text{m}^3/\text{s}$  and the river has just peaked and has started to recede - Photo extracted from an ORC video.

13. Figure 2 shows ponding on the site of interest during the July 2017 heavy rainfall event. This ponding is very likely to be the result of internal runoff and coincide with the lower sections of the site. Anecdotal observations made after the July 2017 heavy rainfall event indicates that some areas of the site of interest took few days to drain (Figure 3).

14. It is important to appreciate that this area is heavily reliant on the Scheme floodbanks to mitigate the Taieri River flood hazard (Figure 2 to Figure 6). The area also relies on a network of drains and swales to remove runoff resulting from heavy rainfall events.
15. The whole West Taieri area (including Outram) is protected from flooding from the Taieri River up to a flow of 2,500m<sup>3</sup>/s (measured at Outram).
16. The floodbanks in the vicinity of Outram are earth banks, typically 2.5m to 3m high and about 3.5m wide (Figure 5 and Figure 6) and could potentially have high water level on the riverside for extended periods of time (several hours).
