# Macraes Phase 4 Consenting

## Project Element 4.3.2: Open Pit Extensions

PSM71-287R Rev 2

# Executive Summary

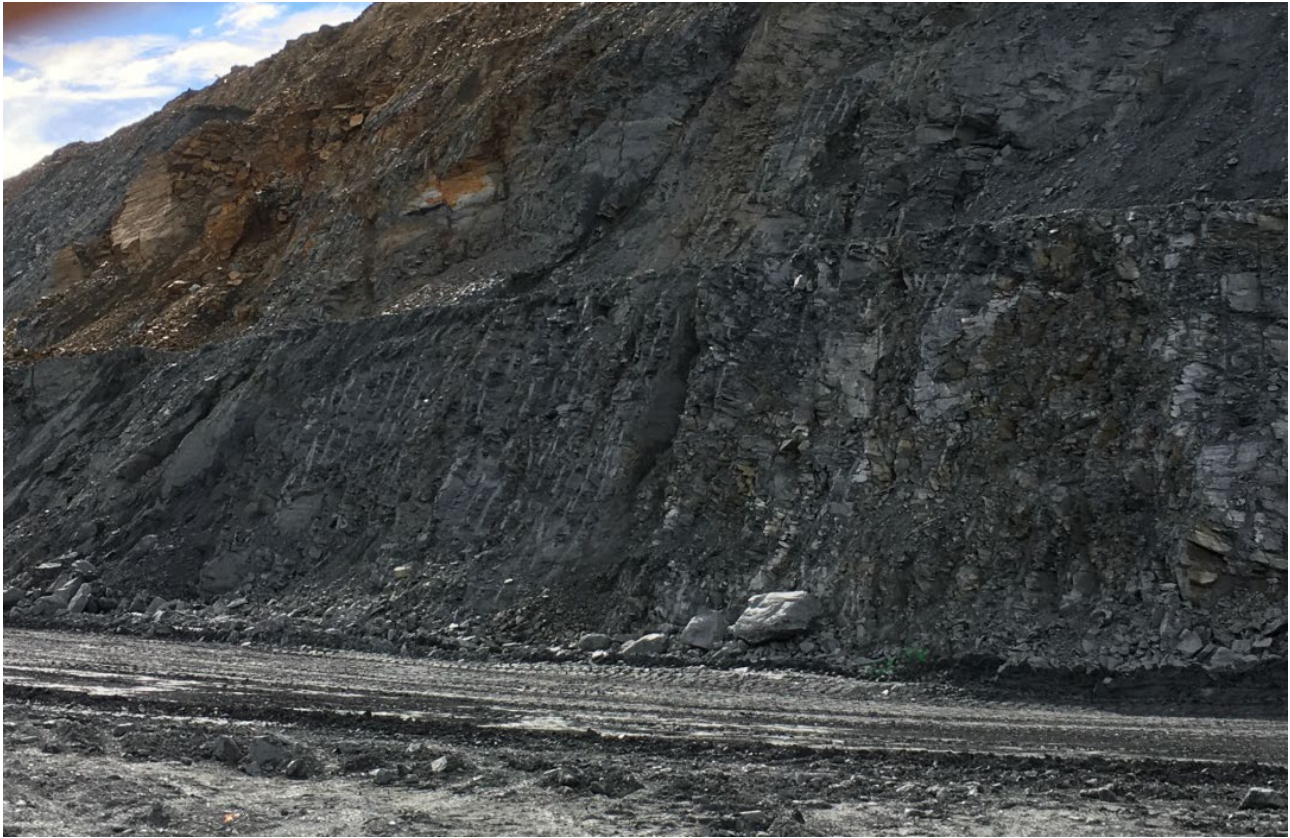
**Photo 4:** Coronation Pit Stage 2– eastern wall immediately south of the ‘fish bowl’. Westerly dipping faults can be seen outcropping at 270°.

The performance of Stage 2 eastern wall was reviewed in July 2017<sup>26</sup>. A 'nose' oriented towards 270° at approximately 19700 mN south of the 'fish bowl' performed poorly with 22.5 m batters due to outcropping north-south trending, westerly dipping faults, Photo 4. The southern limb of the slope south of the 'nose' also performed poorly in this rock mass, Photo 5. It was recommended that for future slopes cutback in this area, the batter height should return to 15 m<sup>26</sup>. This section of wall in relation to CO6 design is presented in Figure 1.
