**OCEANA GOLD (NEW ZEALAND) LIMITED  
MACRAES OPERATION  
TRIMBELLS WASTE ROCK STACK  
CLOSURE STABILITY REPORT**

| <b>Title</b> | OCEANA GOLD (NEW ZEALAND) LIMITED MACRAES OPERATION TRIMBELLS WASTE ROCK STACK – CLOSURE STABILITY REPORT |

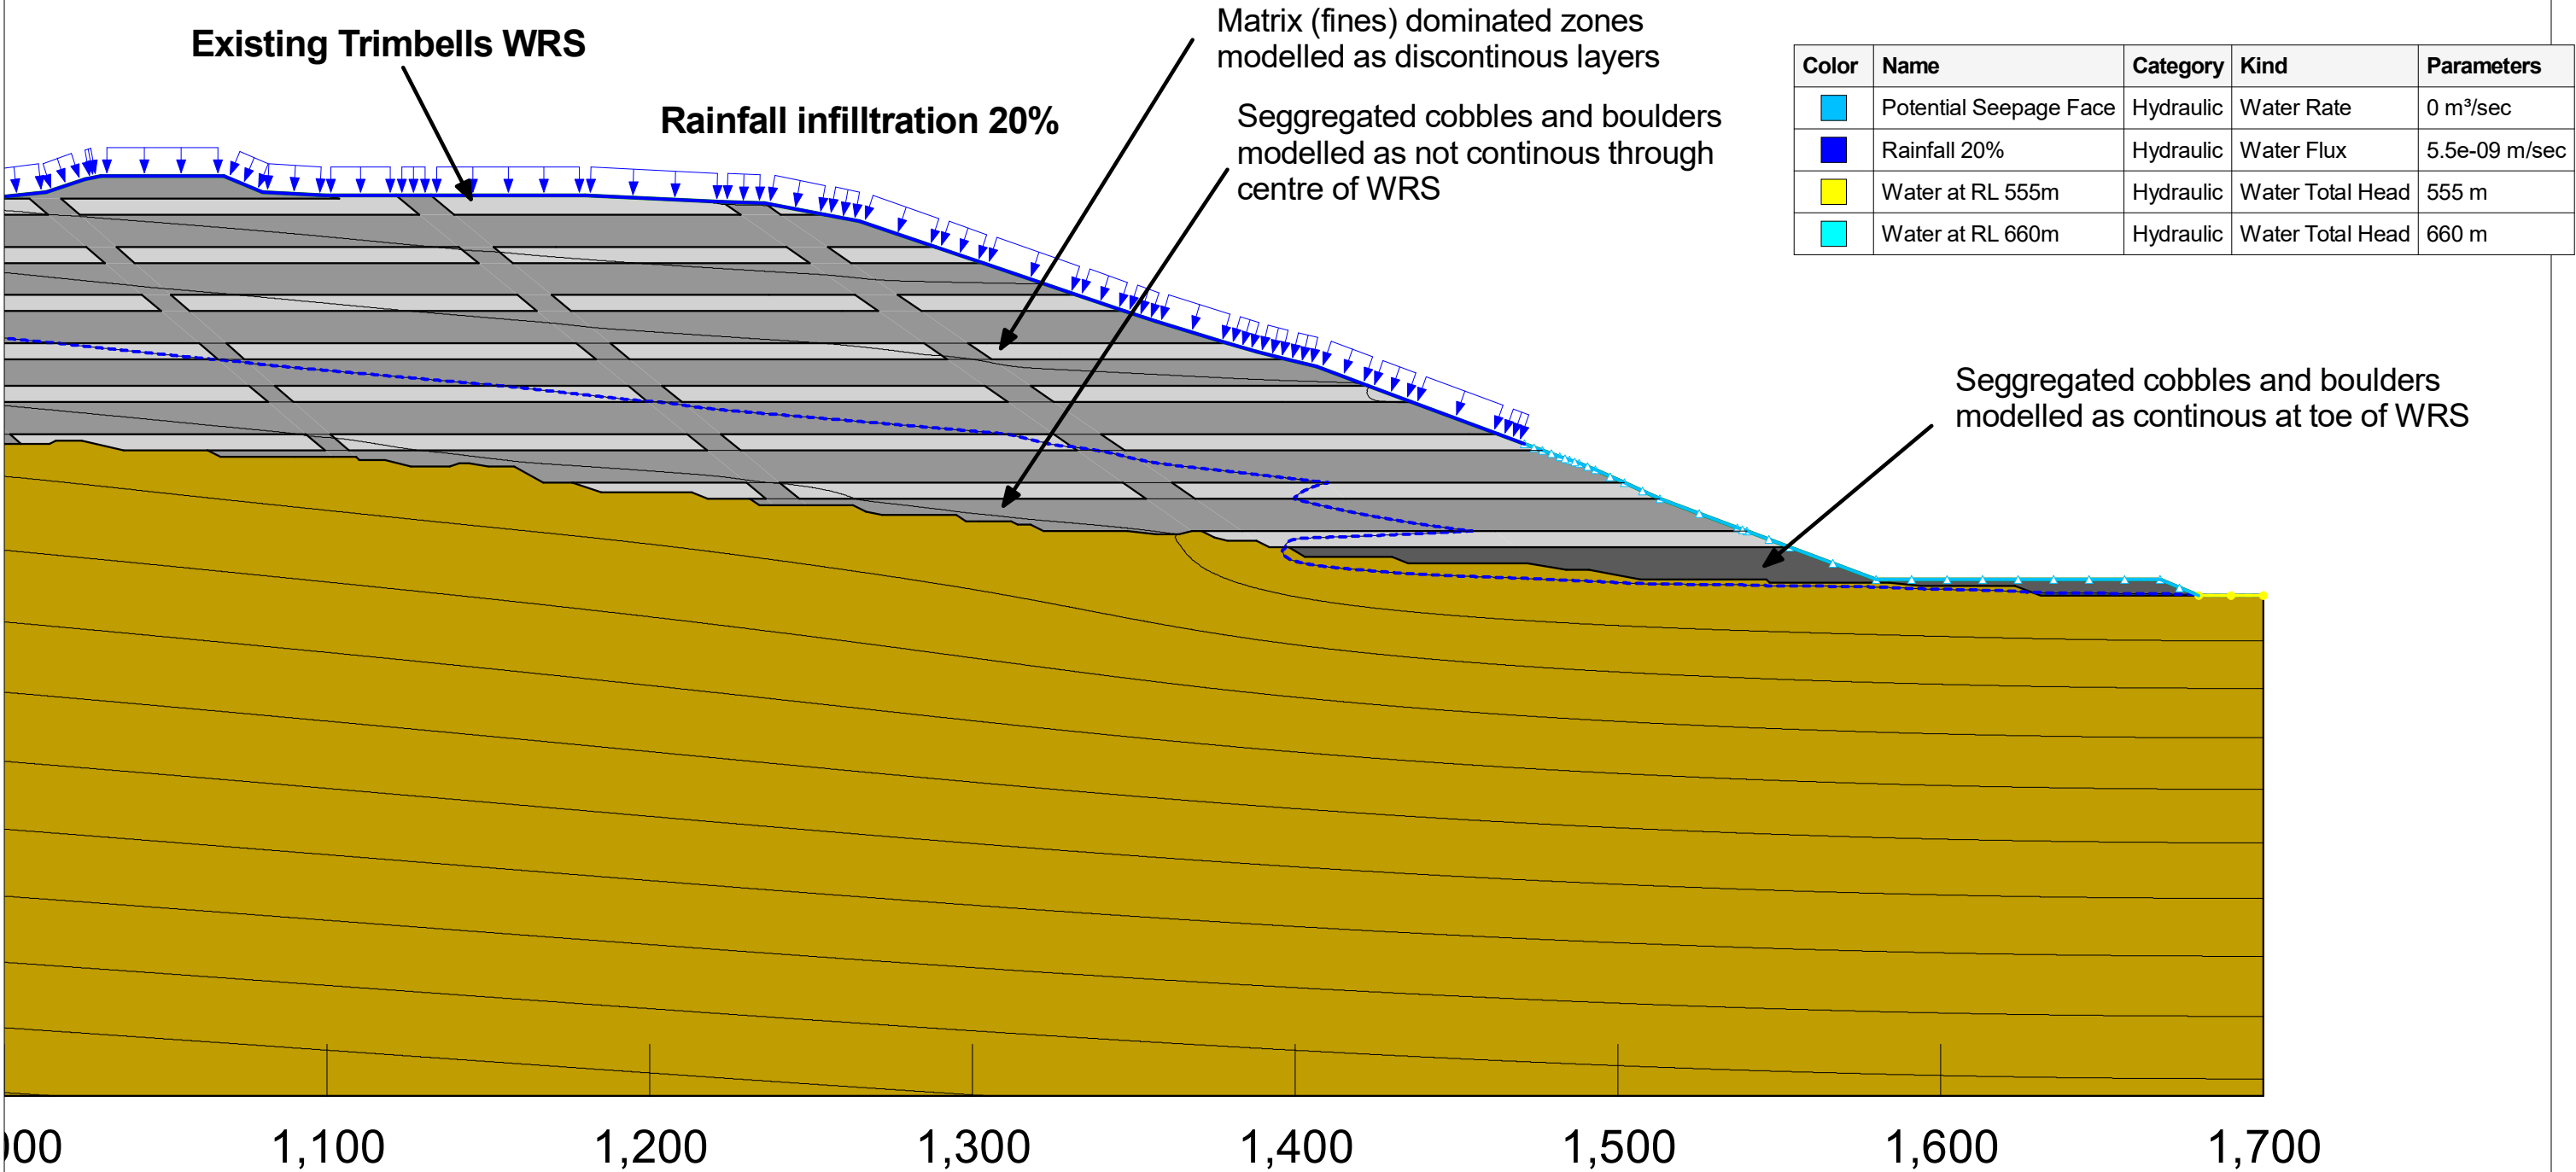
Figure A01

Seepage analysis for pore pressure profile

A seepage analysis has been undertaken assuming a Coronation Pit Lake long-term level of 660m RL. This level is controlled by the proposed spillway to the south and results in a head of approximately 23m above the low point in the Coronation pit wall. A rainfall infiltration rate of 20% is assumed for the WRS. The analysis is undertaken for the Model Section. Permeability contrasts expected in the WRS have been considered. The purpose of the seepage modelling is only to determine the likely pore pressure regime for stability analysis. The permeability values applied are summarised in Table 3 and the figures in Appendix A.

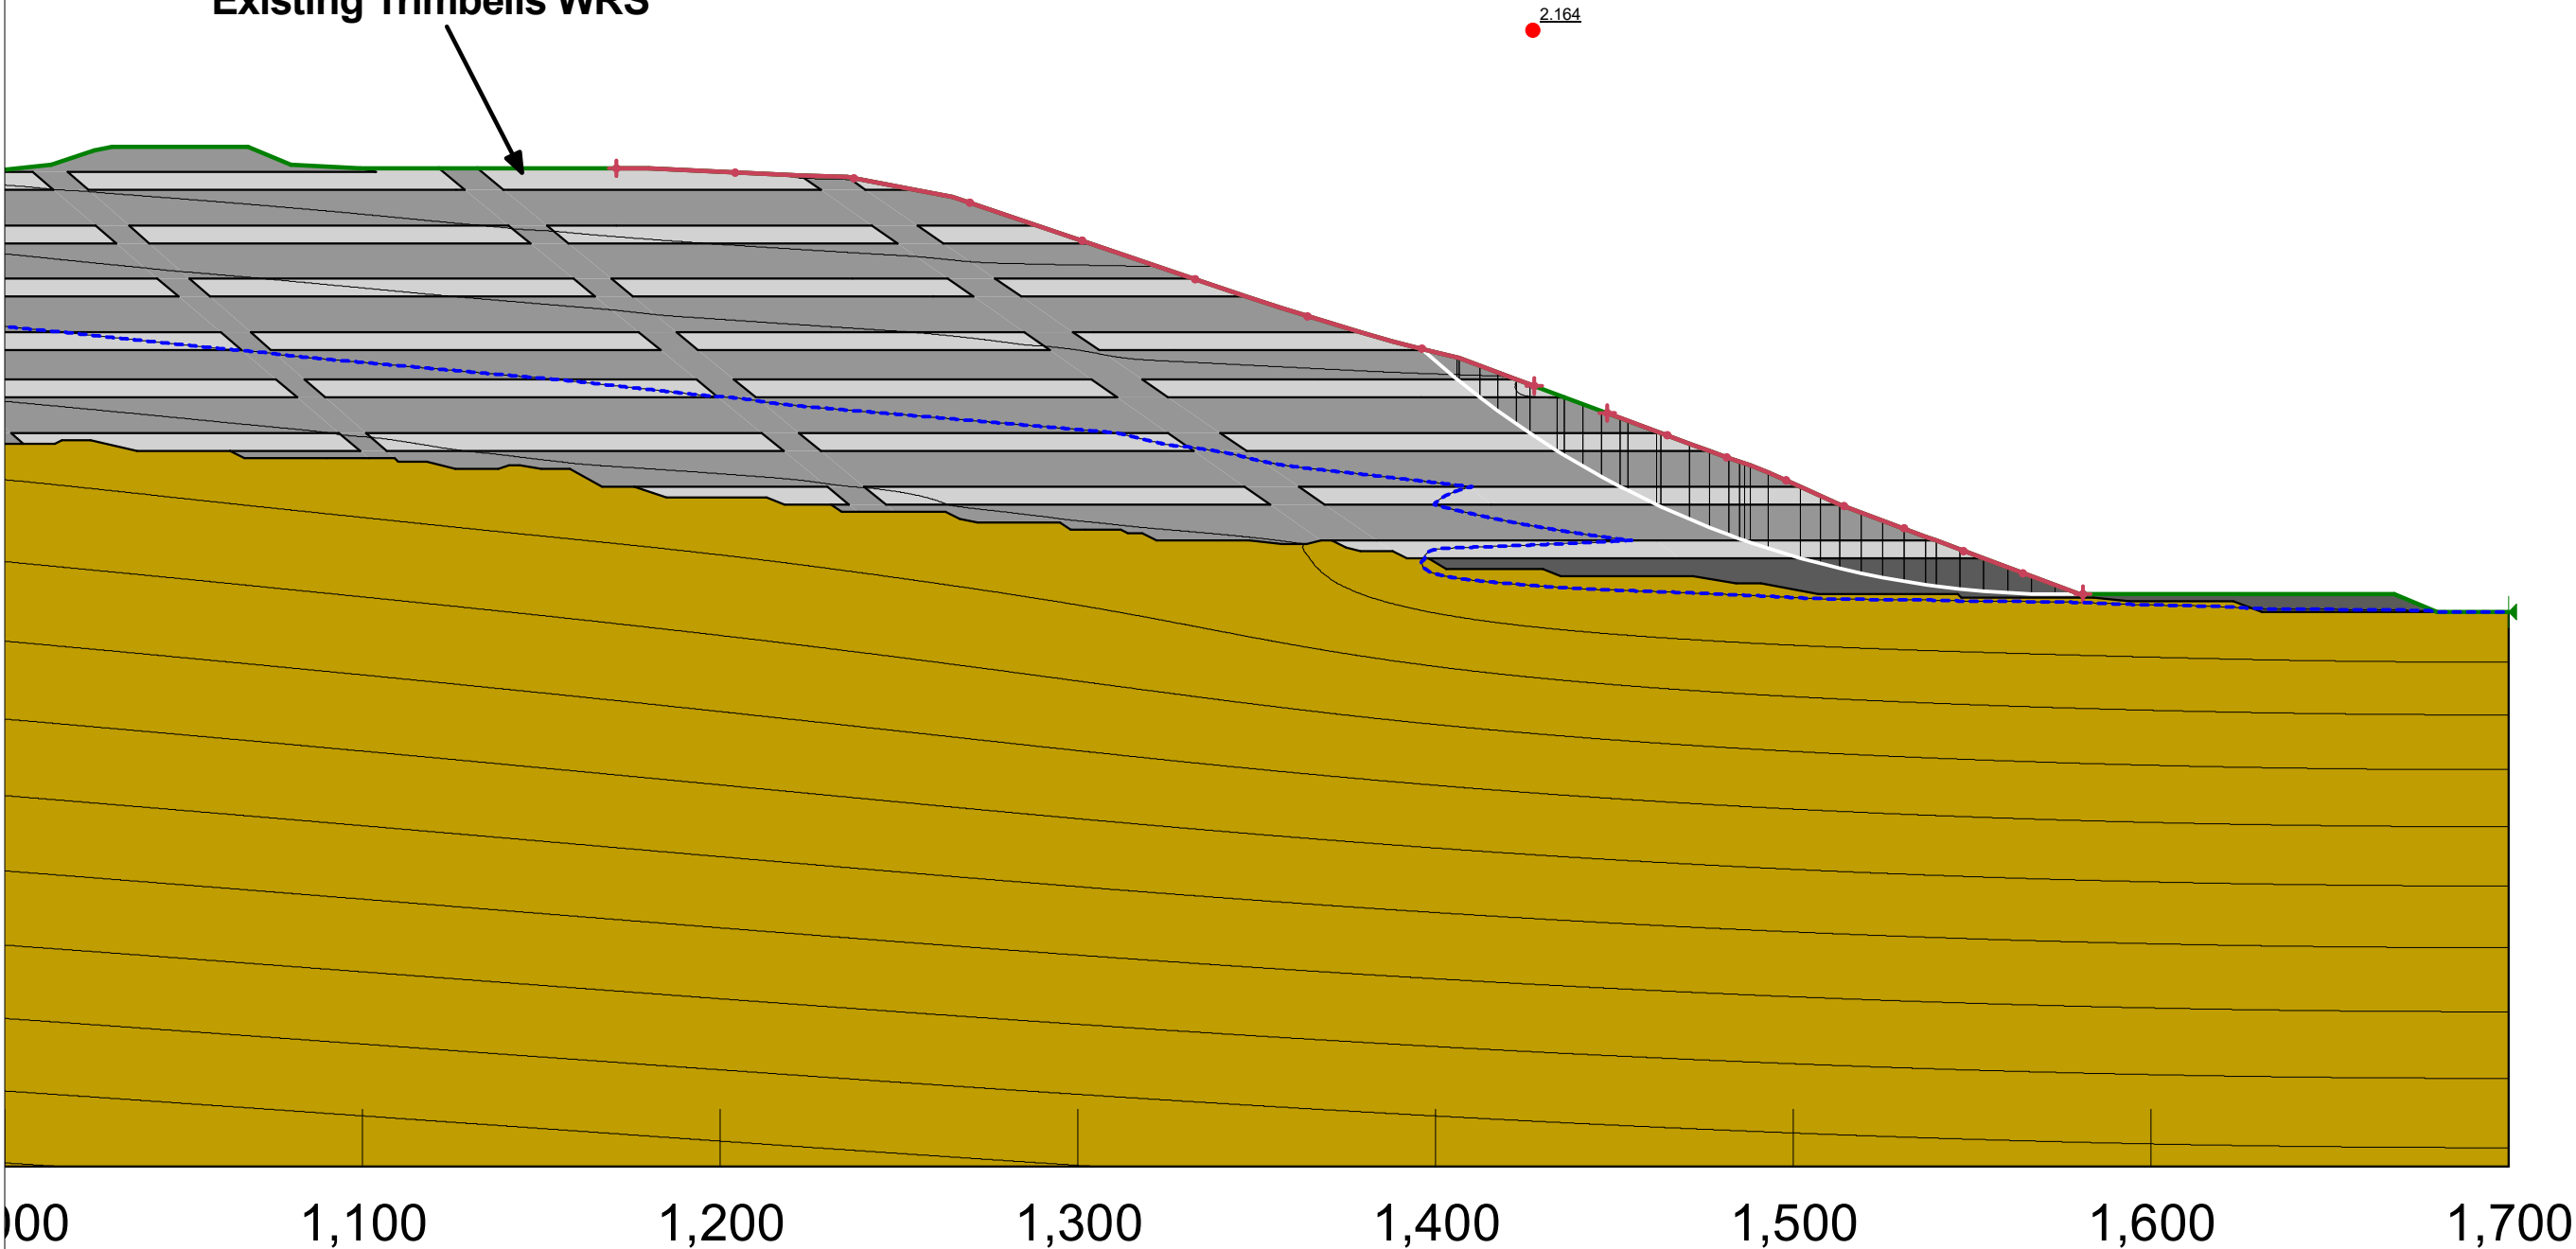
Figure A02

Stability - Static - Peak - Circular

The results from the static and seismic analyses are summarised in Table 4 with detailed results provided in Appendix A. The results of the stability assessments indicate:

1. Static limit equilibrium Factor of Safety (FoS) for the peak drained condition are all greater than the required 1.5.
2. Static limit equilibrium FoS for the post-earthquake softened condition are all greater than the required 1.2 for the downstream slope.

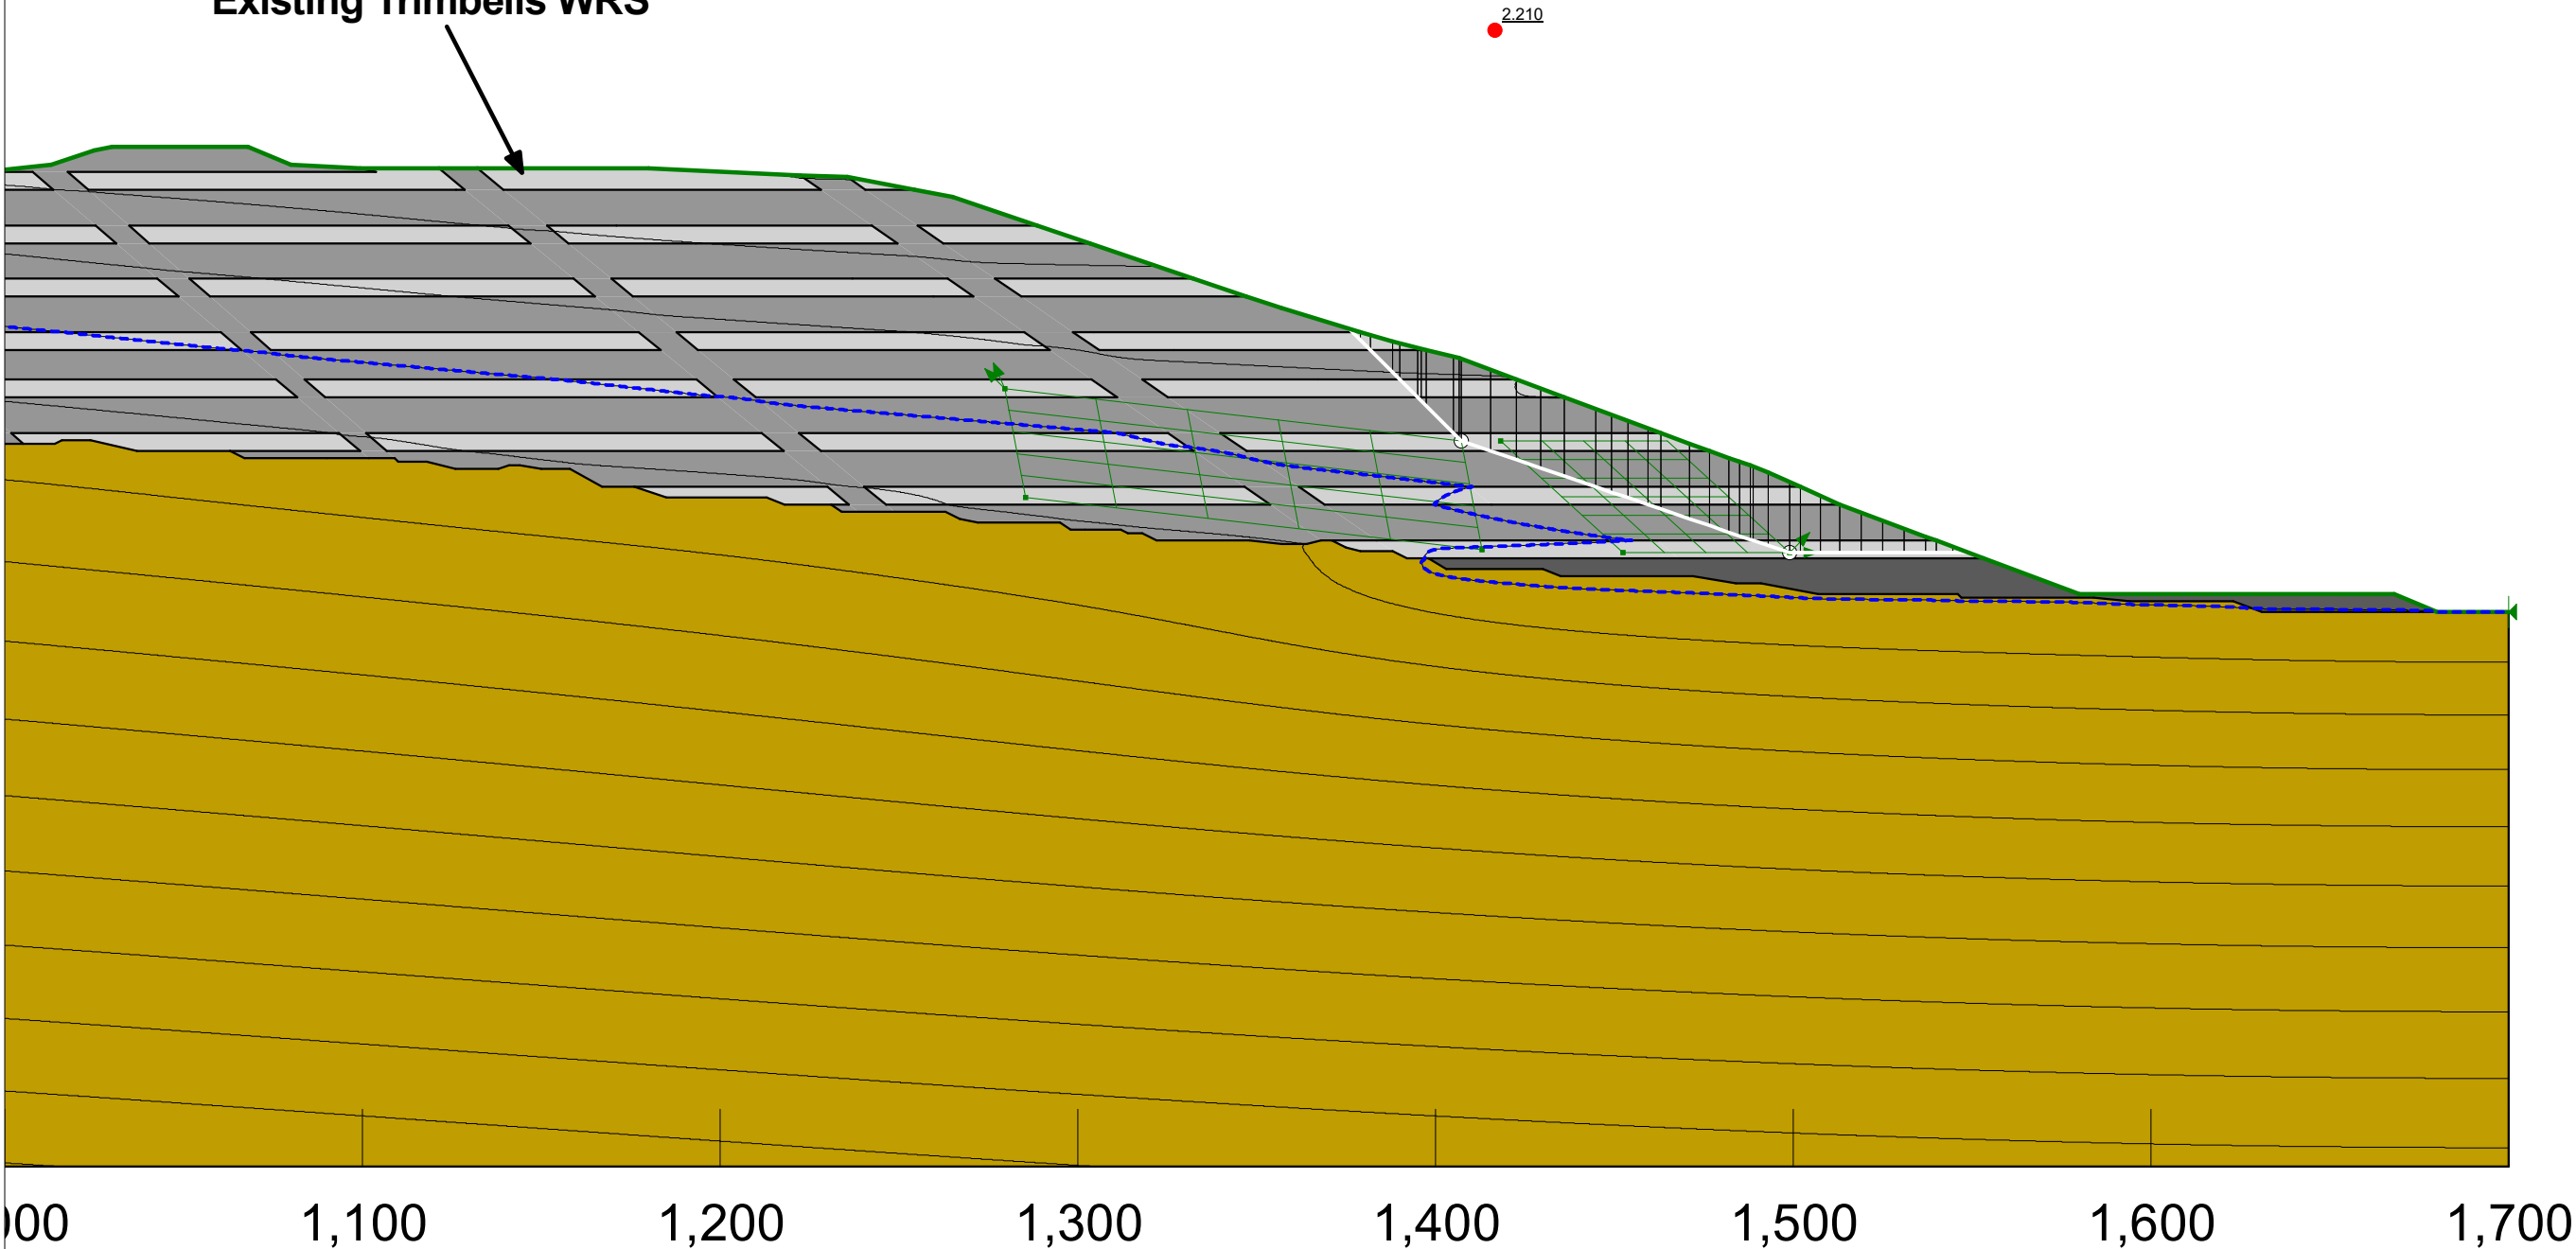
Figure A03

Stability - Static - Peak - Planar

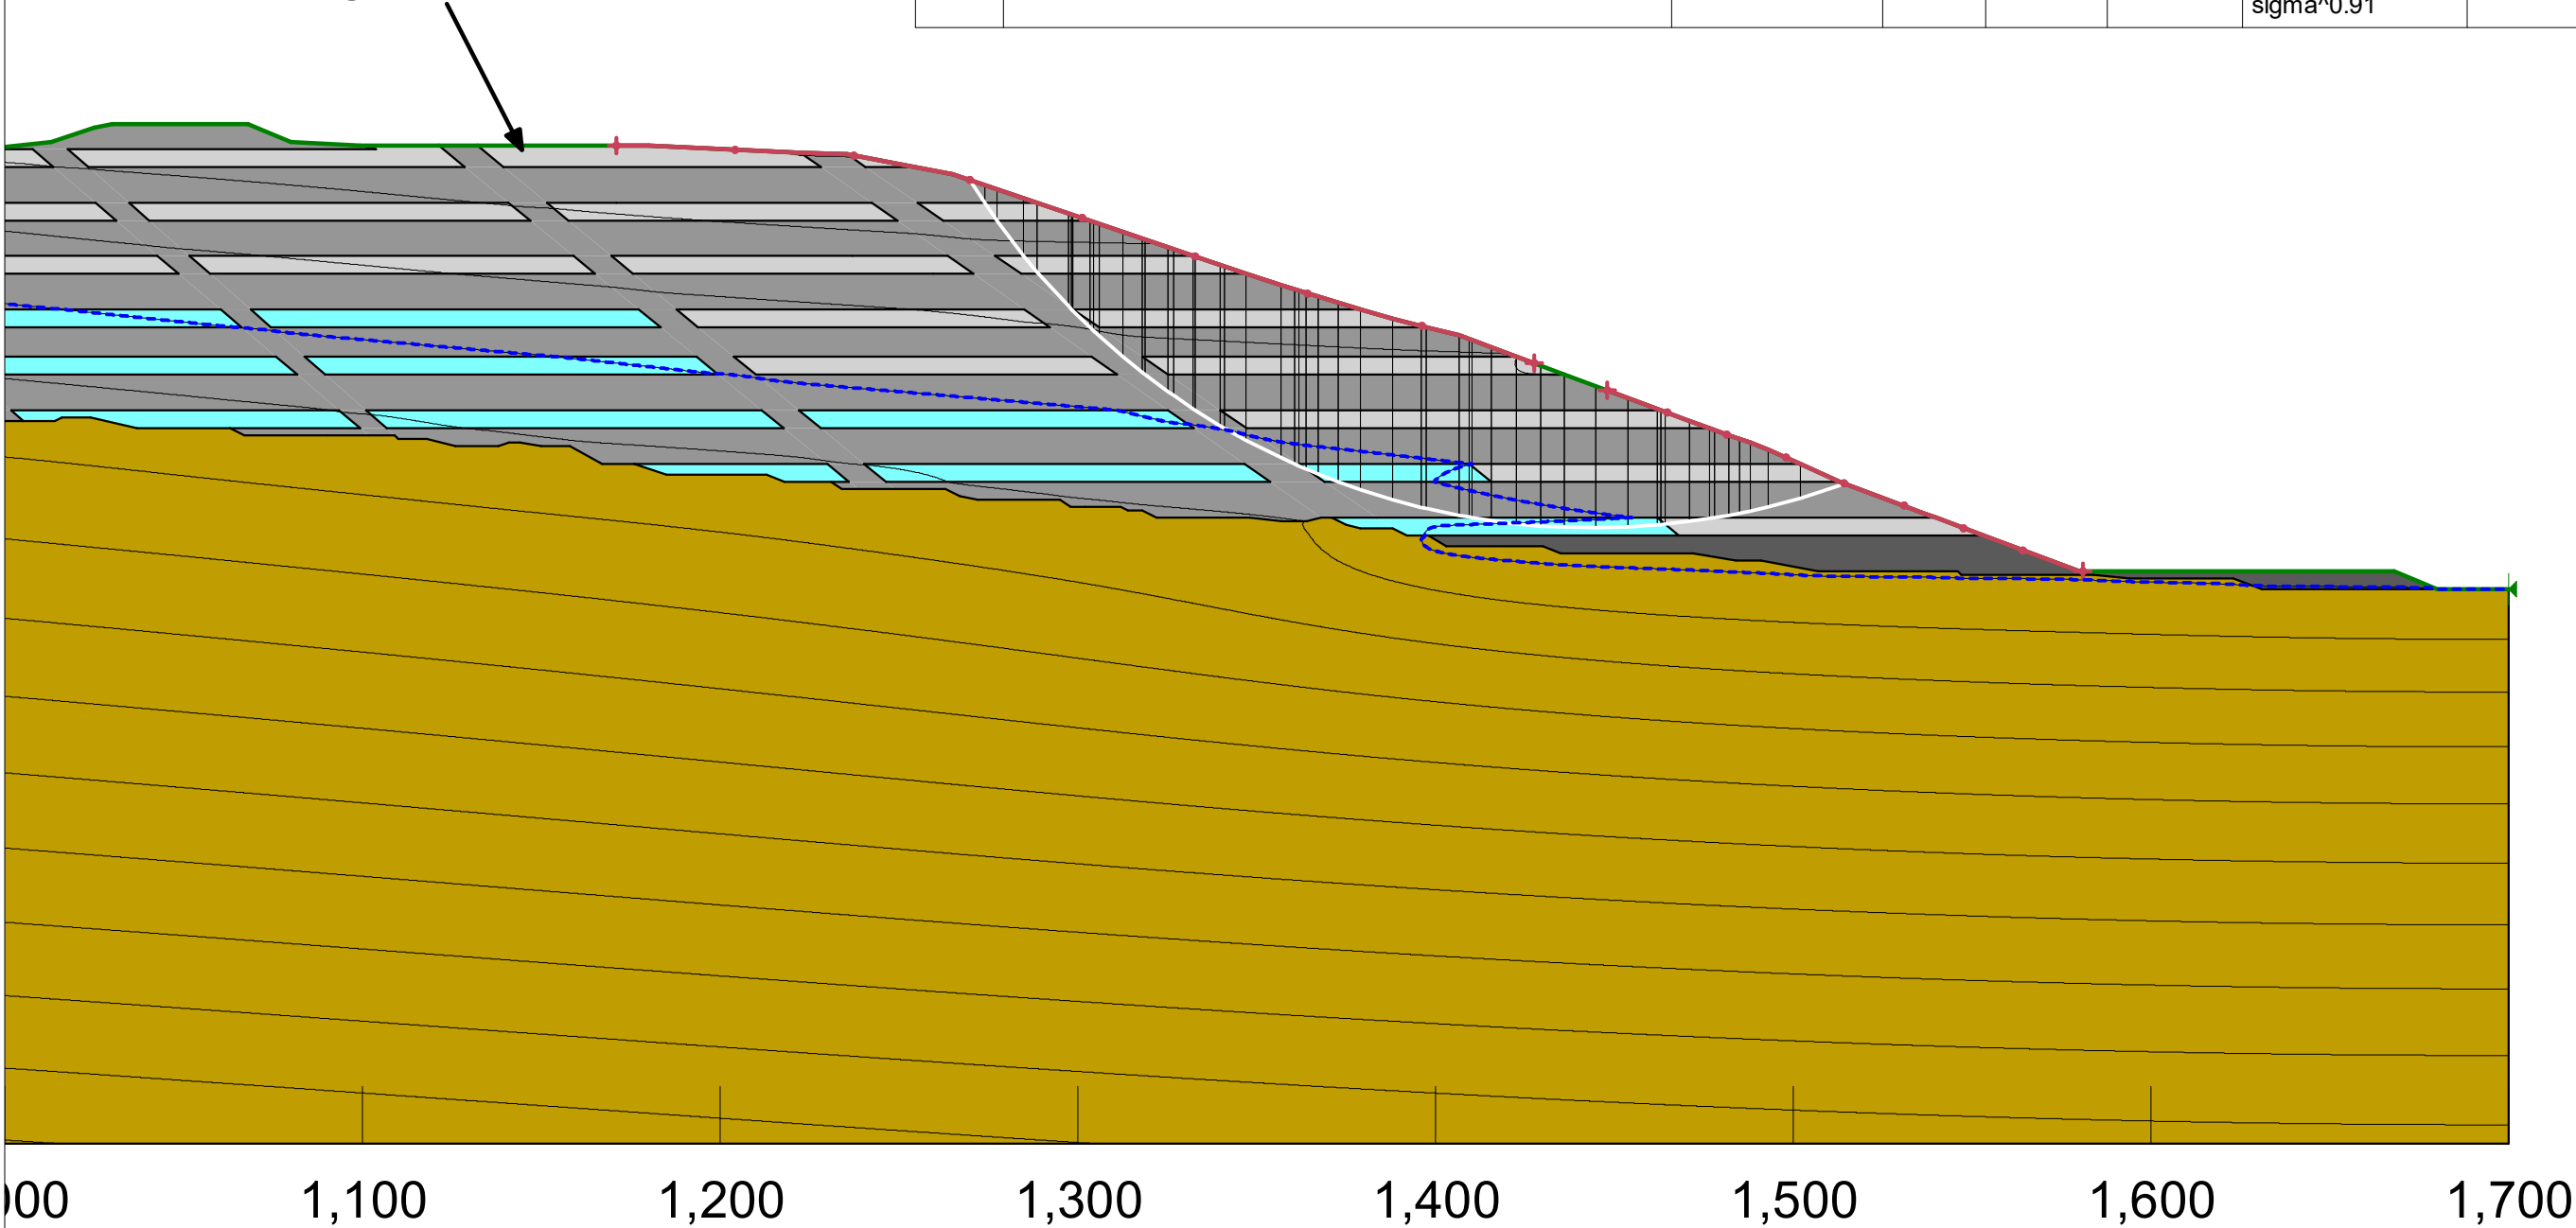
Figure A04

Stability - Post EQ - Softened - Circular

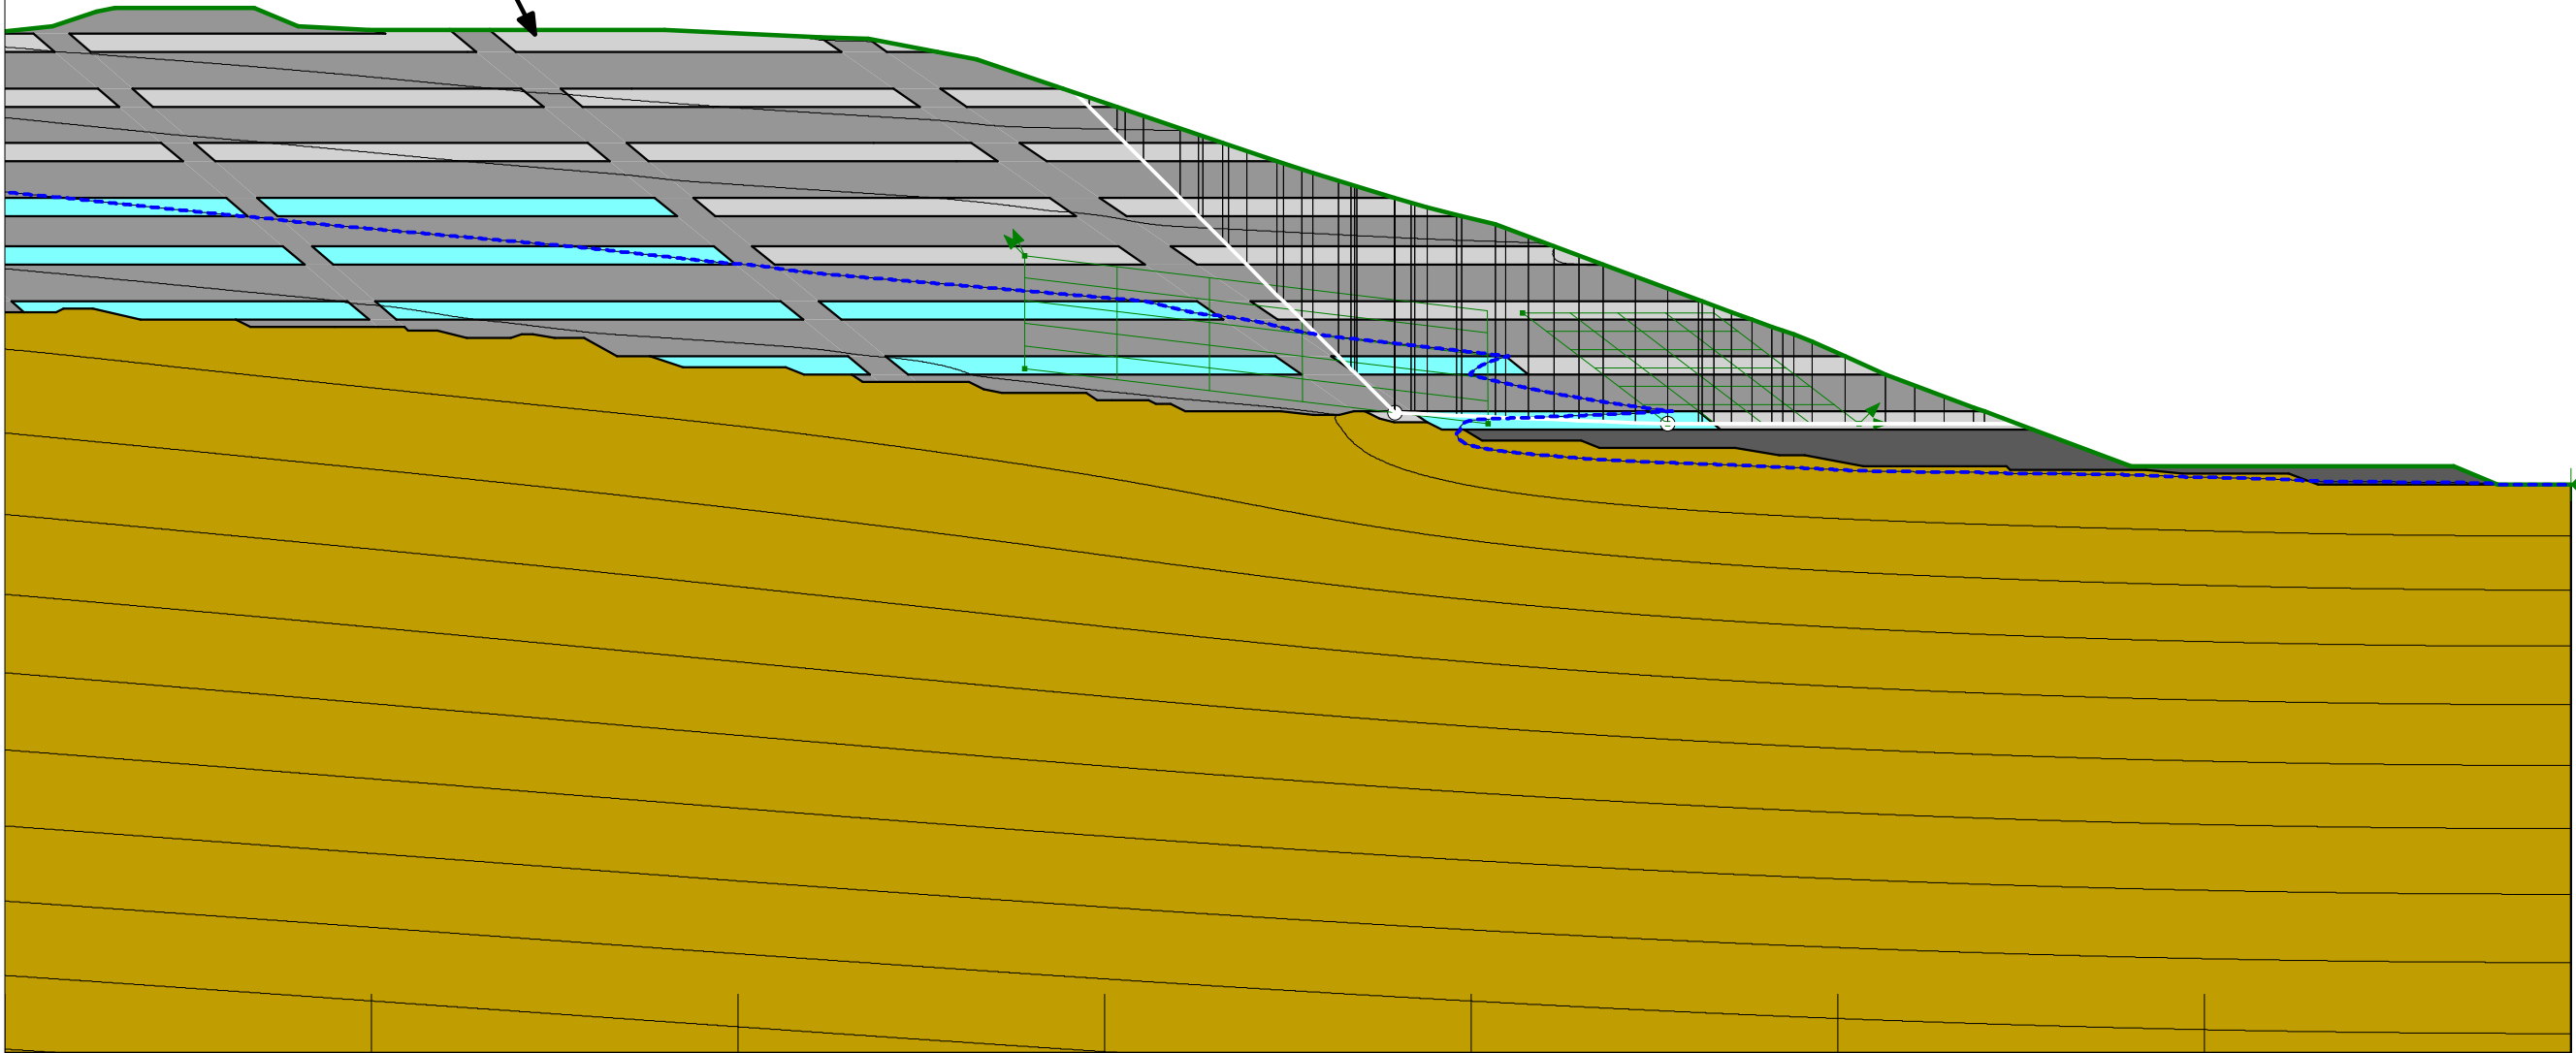
Stability - Post EQ - Softened - Planar

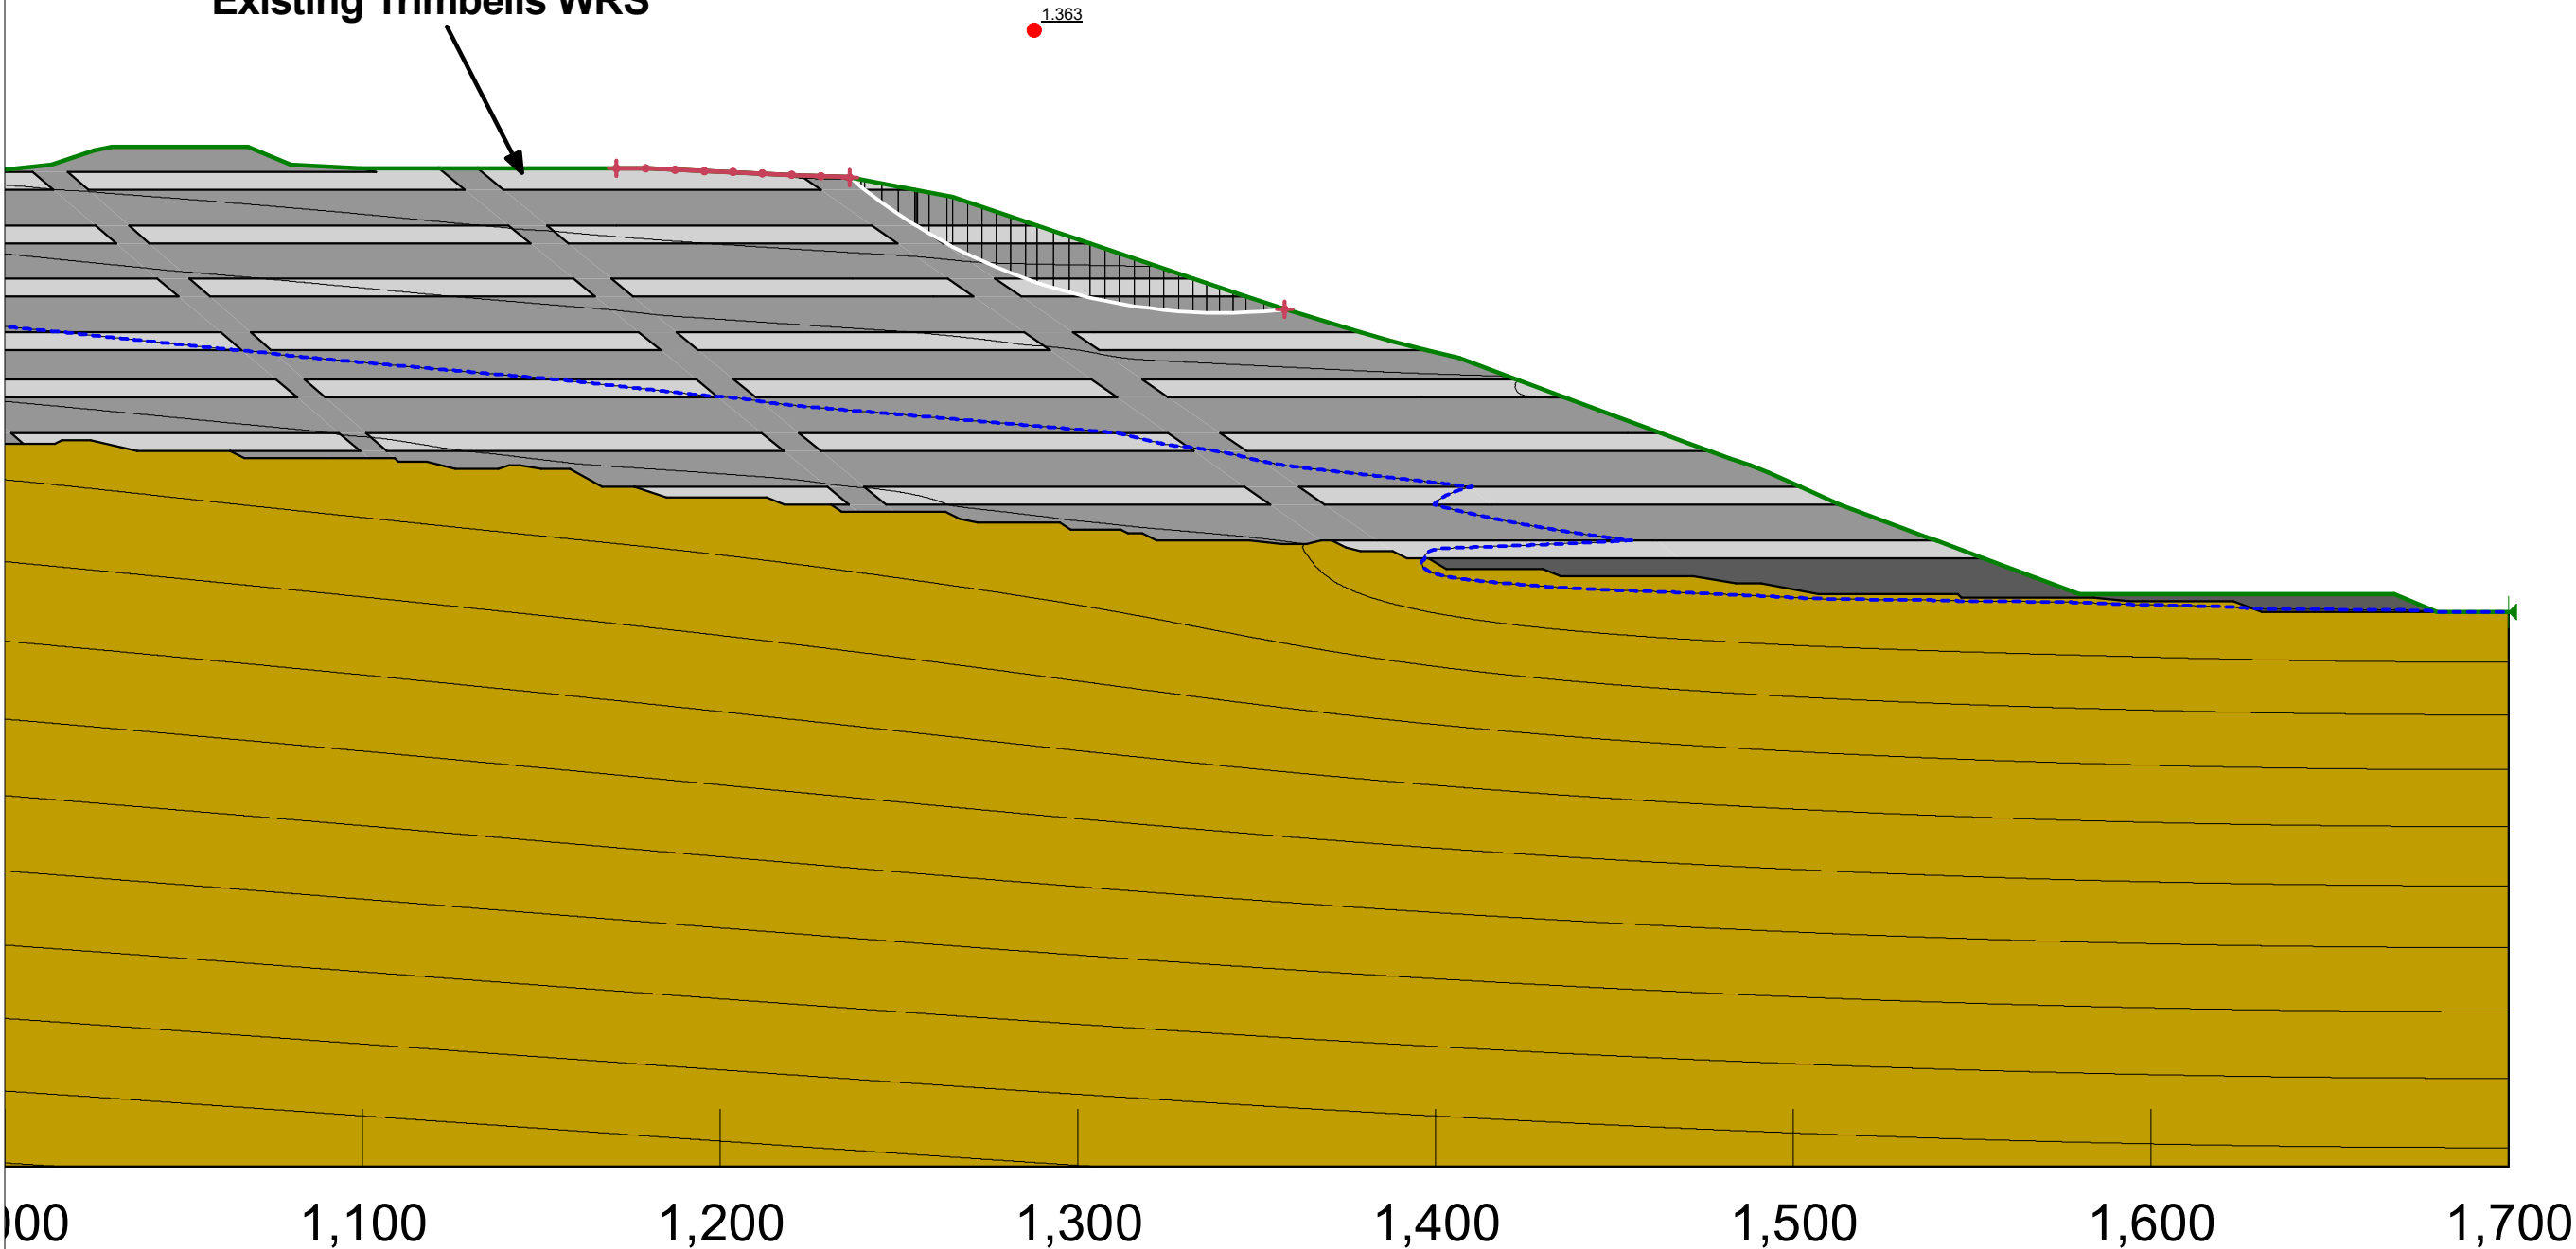
Figure A06

Stability - EQ150yr - Peak - Circular - 1/3rd H

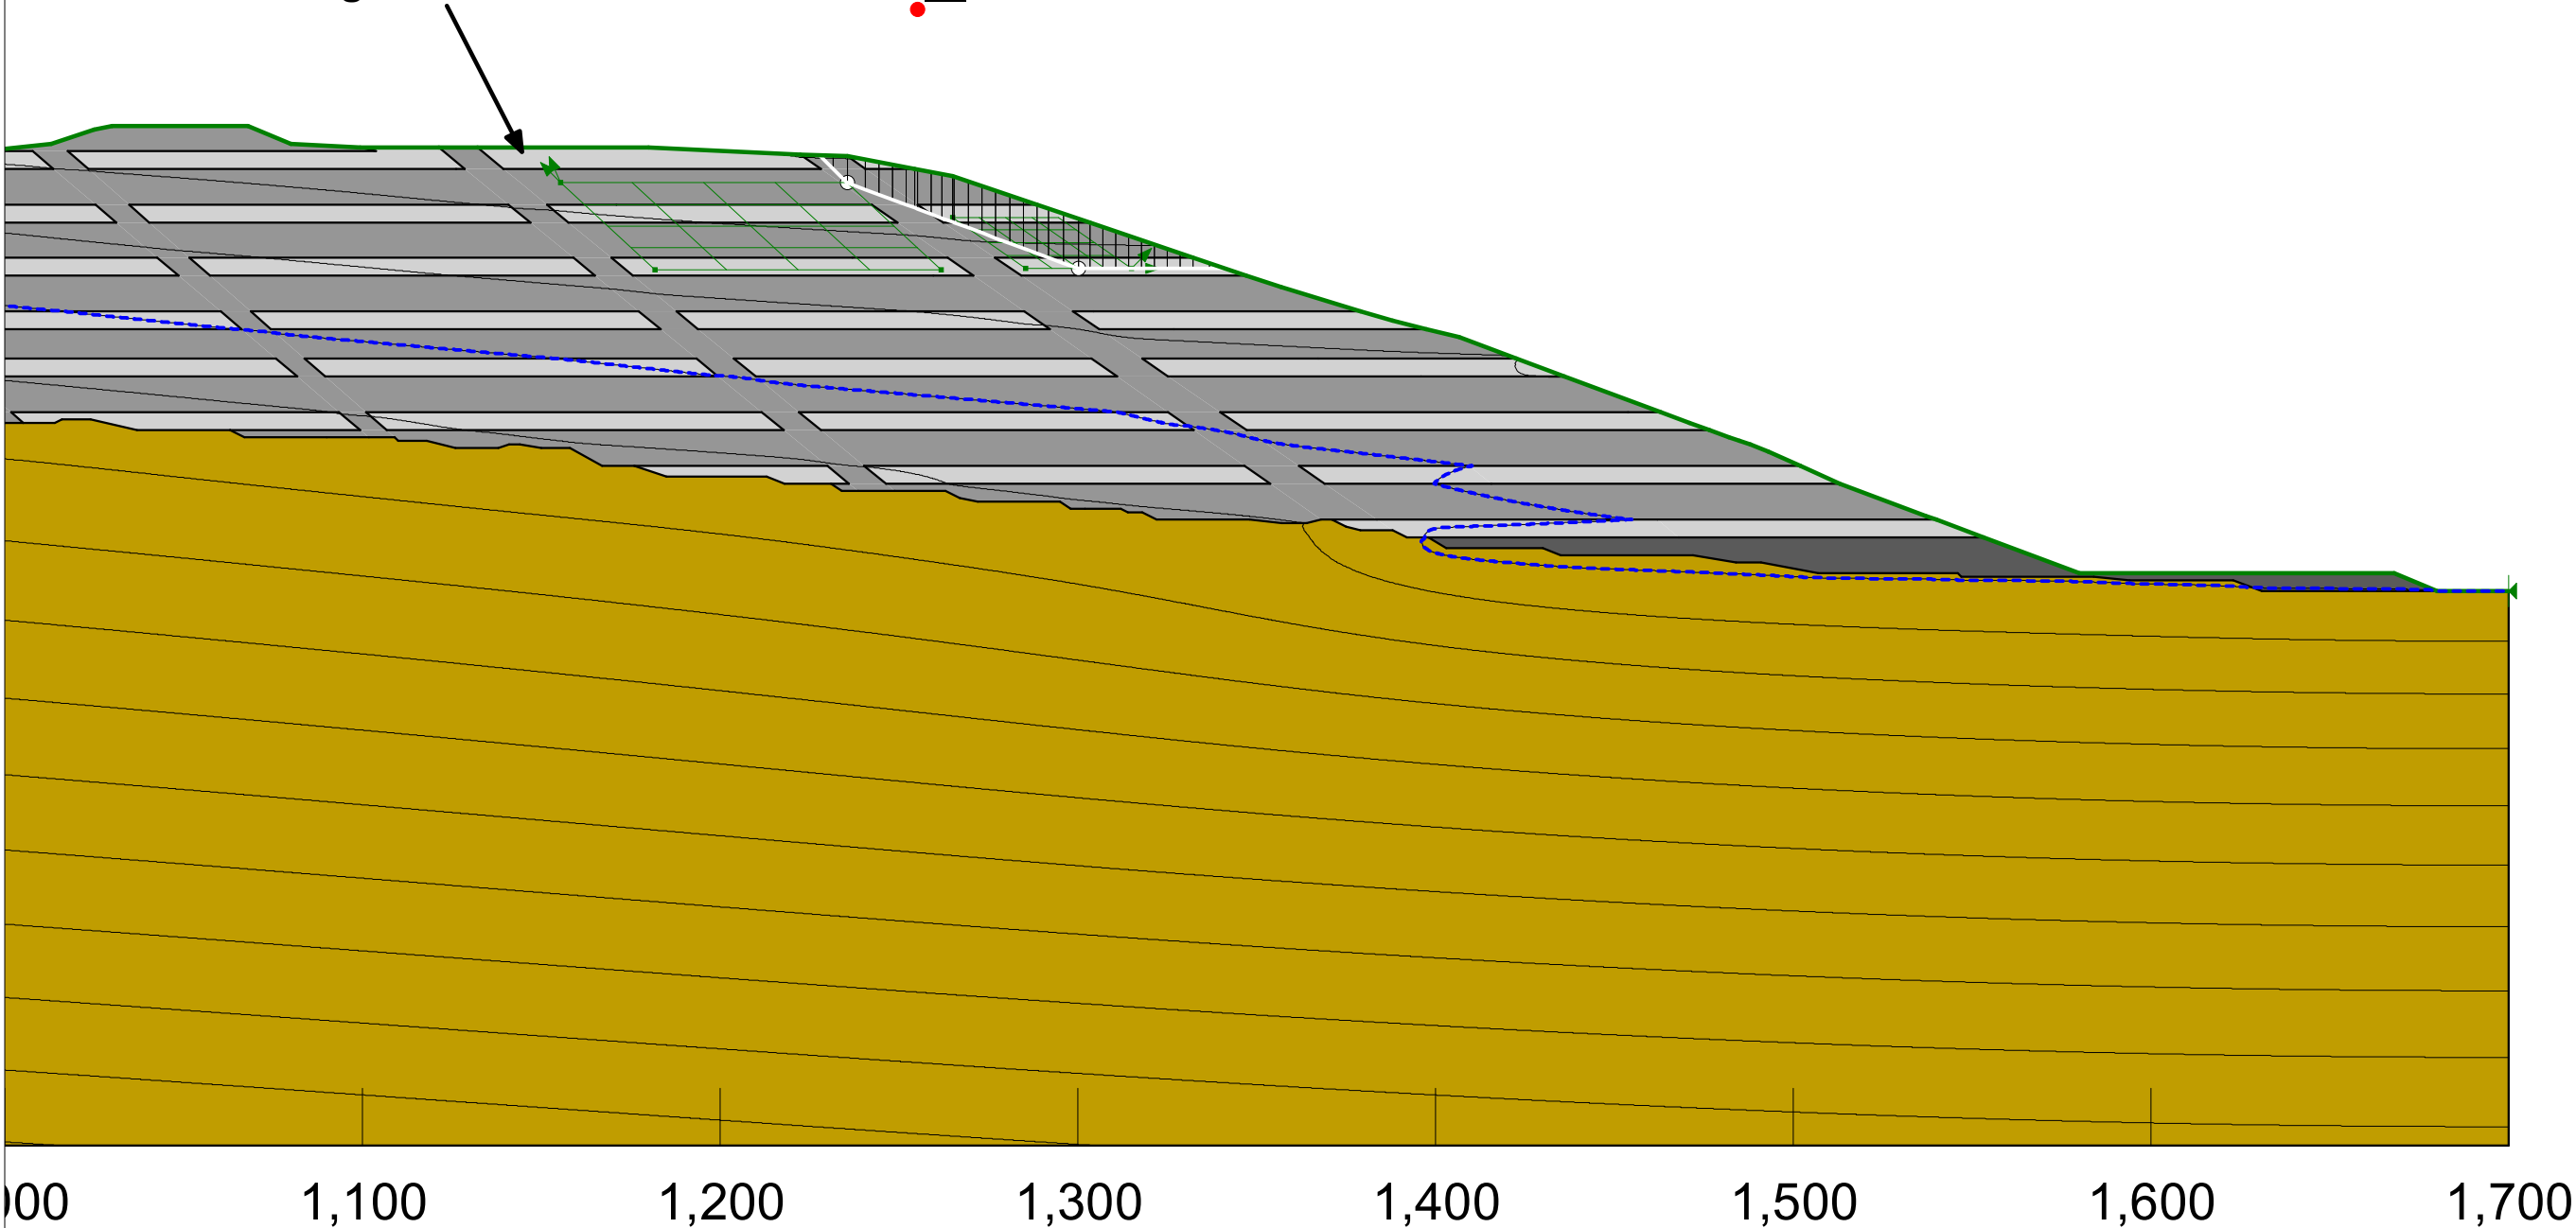
Figure A07

Stability - EQ150yr - Peak - Planar - 1/3rd H
