**OCEANA GOLD (NEW ZEALAND) LIMITED  
MACRAES OPERATION  
TRIMBELLS WASTE ROCK STACK  
CLOSURE STABILITY REPORT**

| <b>Title</b> | OCEANA GOLD (NEW ZEALAND) LIMITED MACRAES OPERATION TRIMBELLS WASTE ROCK STACK – CLOSURE STABILITY REPORT |

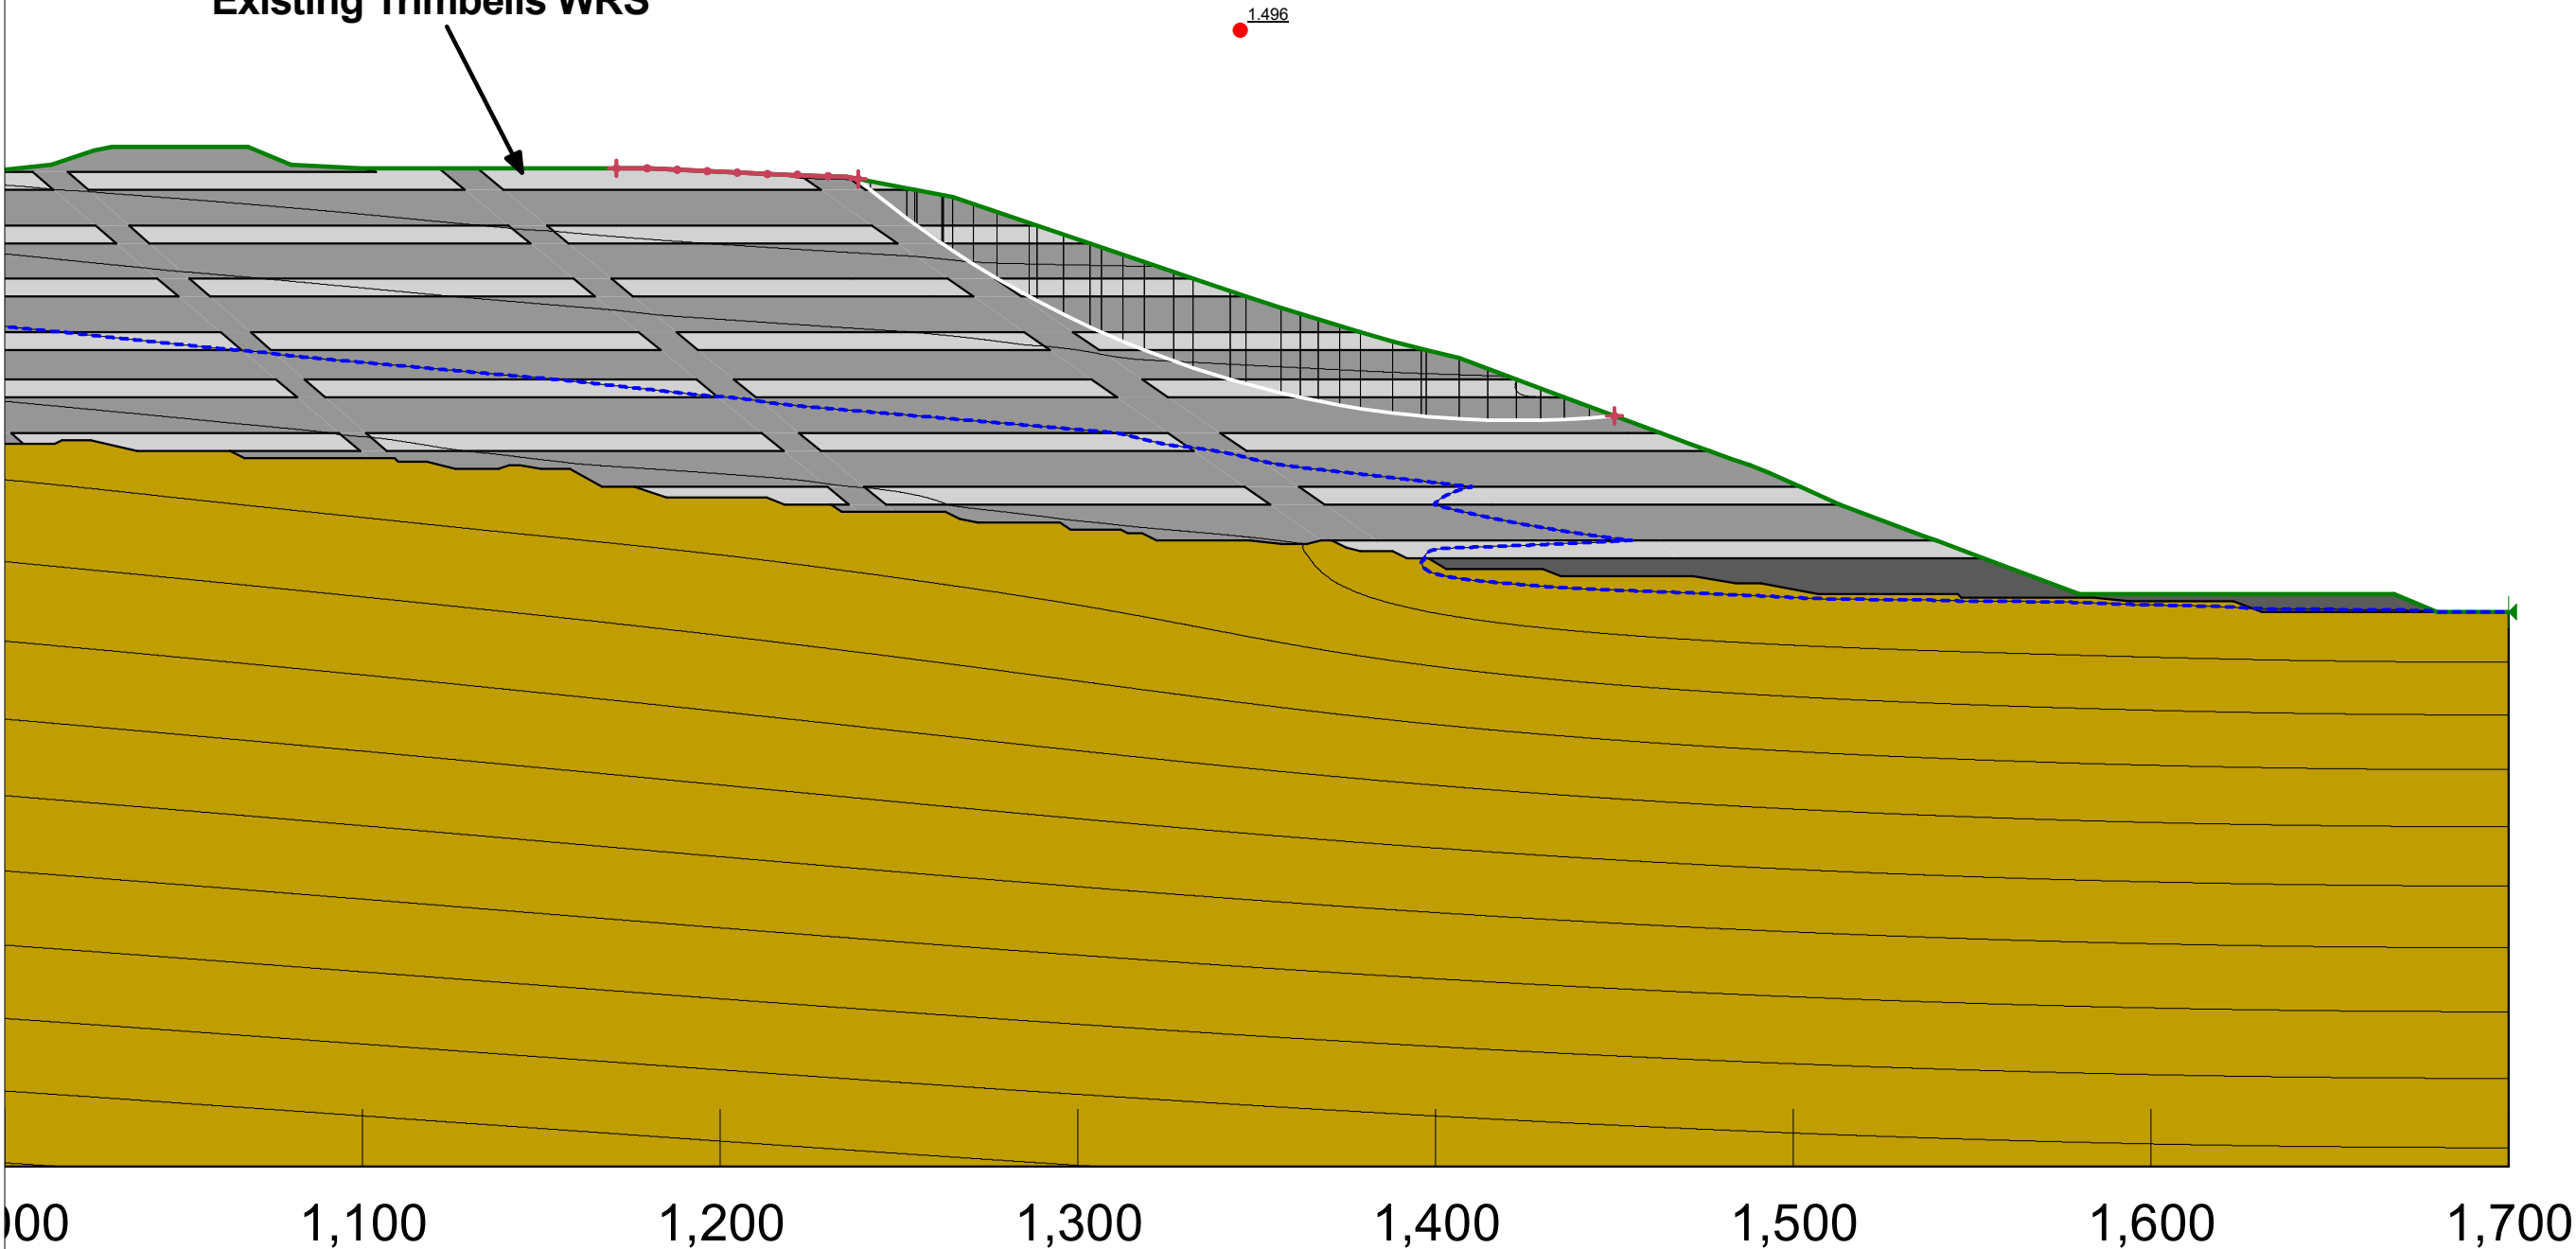
Figure A08

Stability - EQ150yr - Peak - Circular 2/3rd H

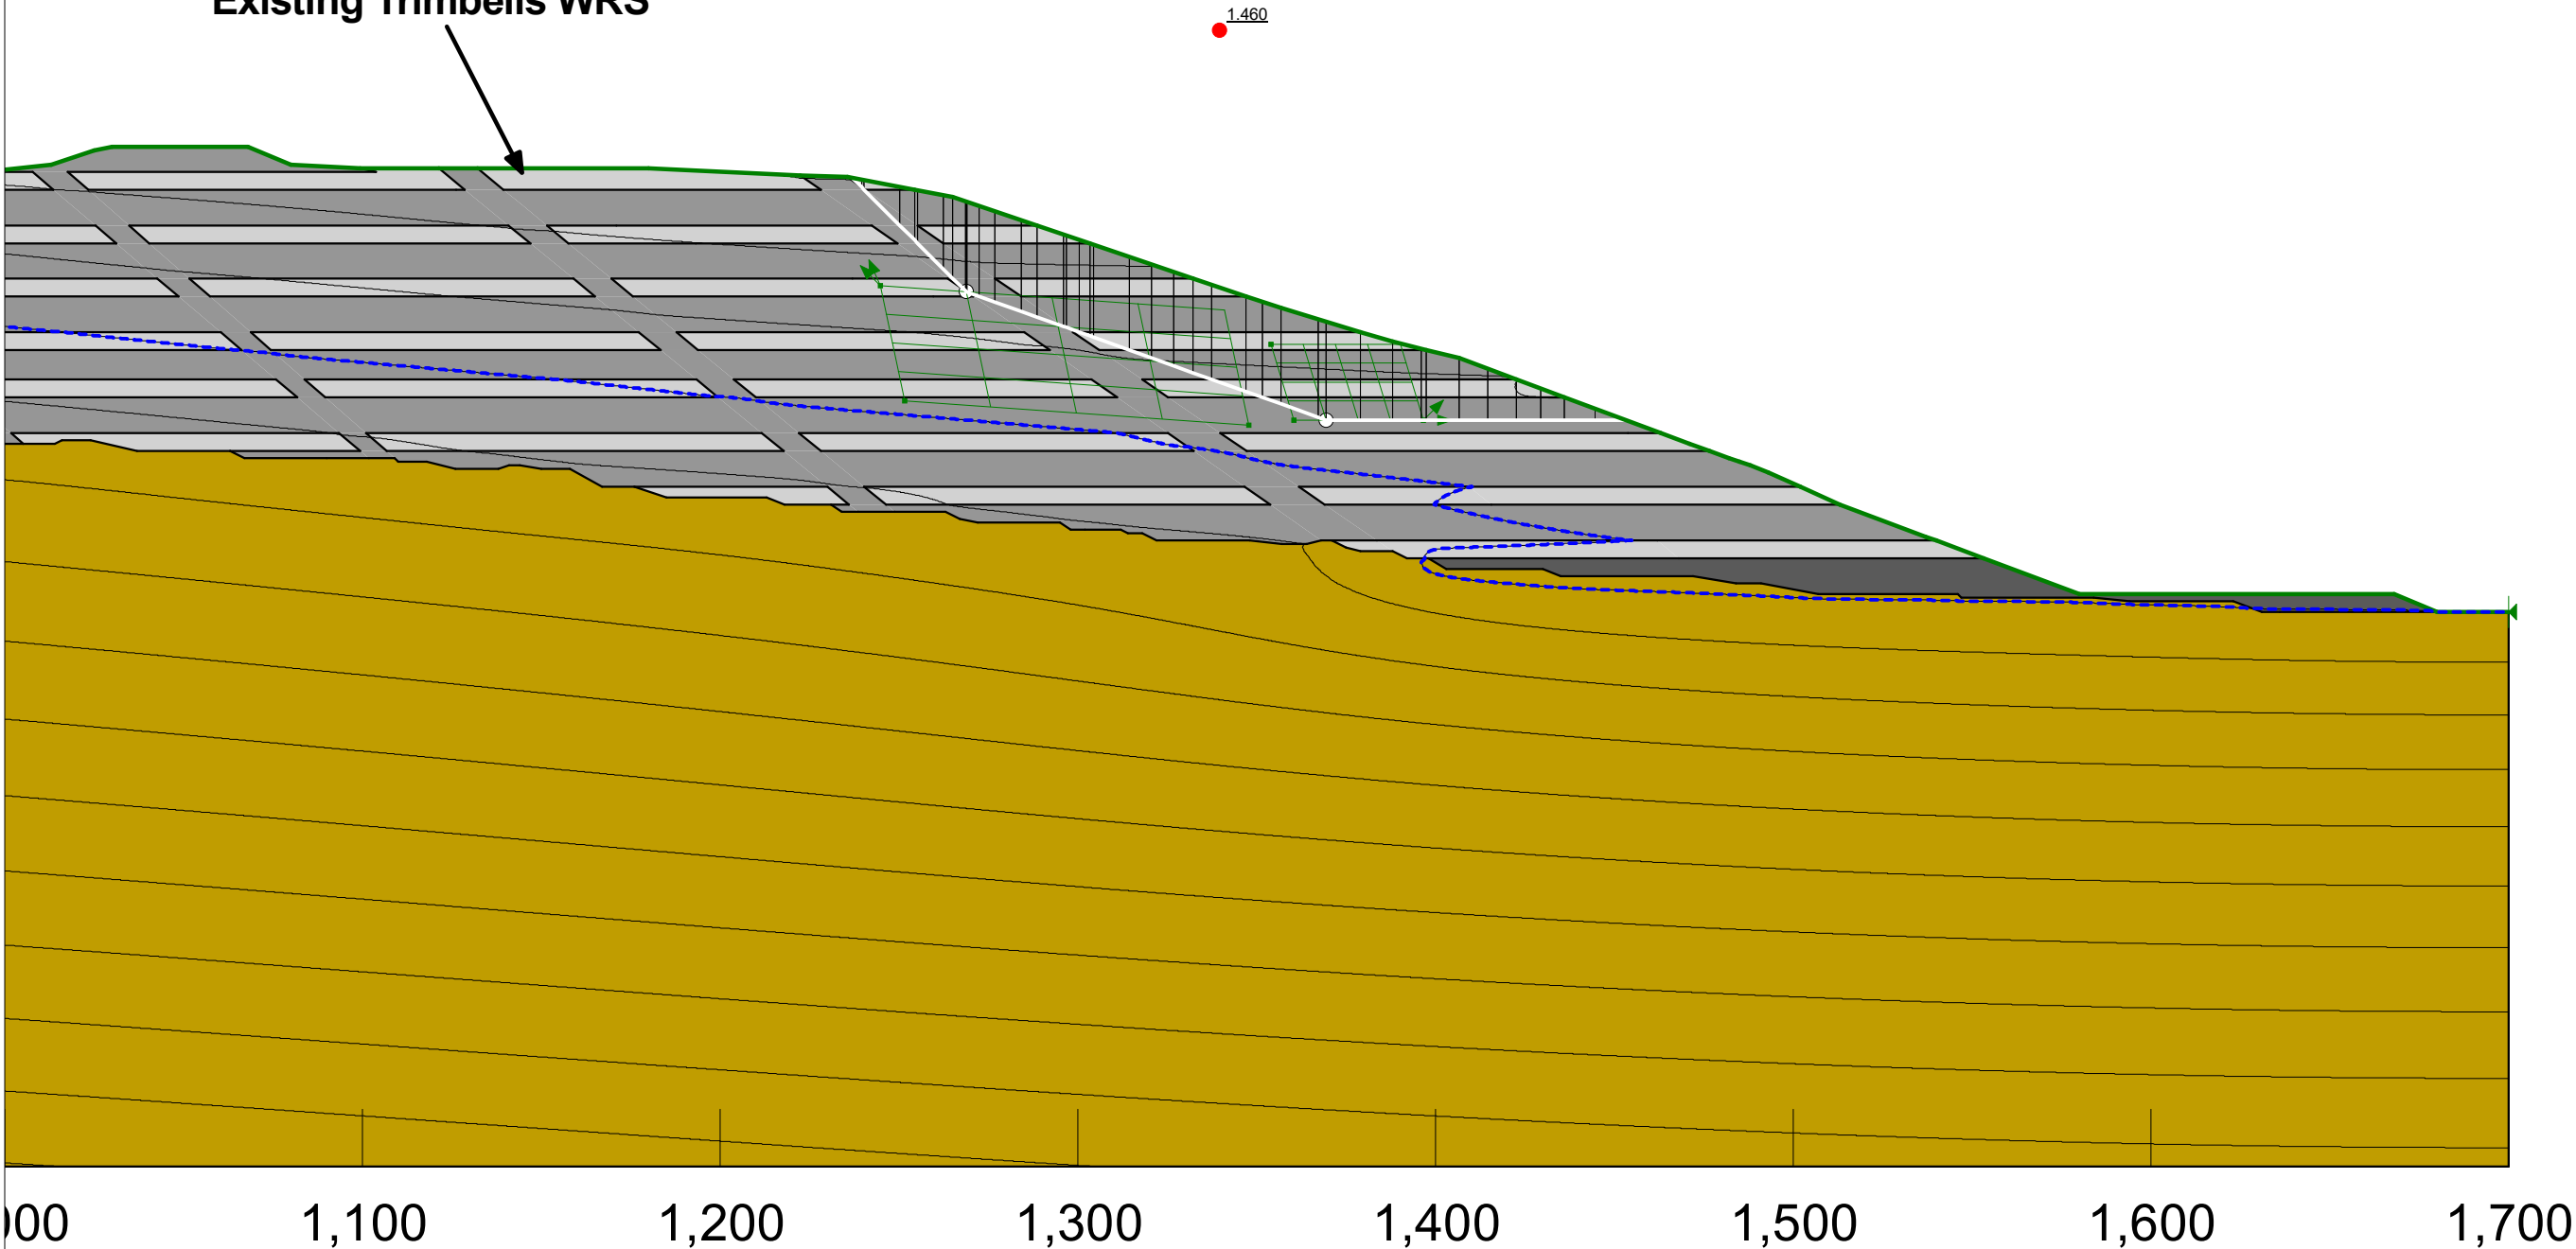
Figure A09

Stability - EQ150yr - Peak - Planar - 2/3rd H

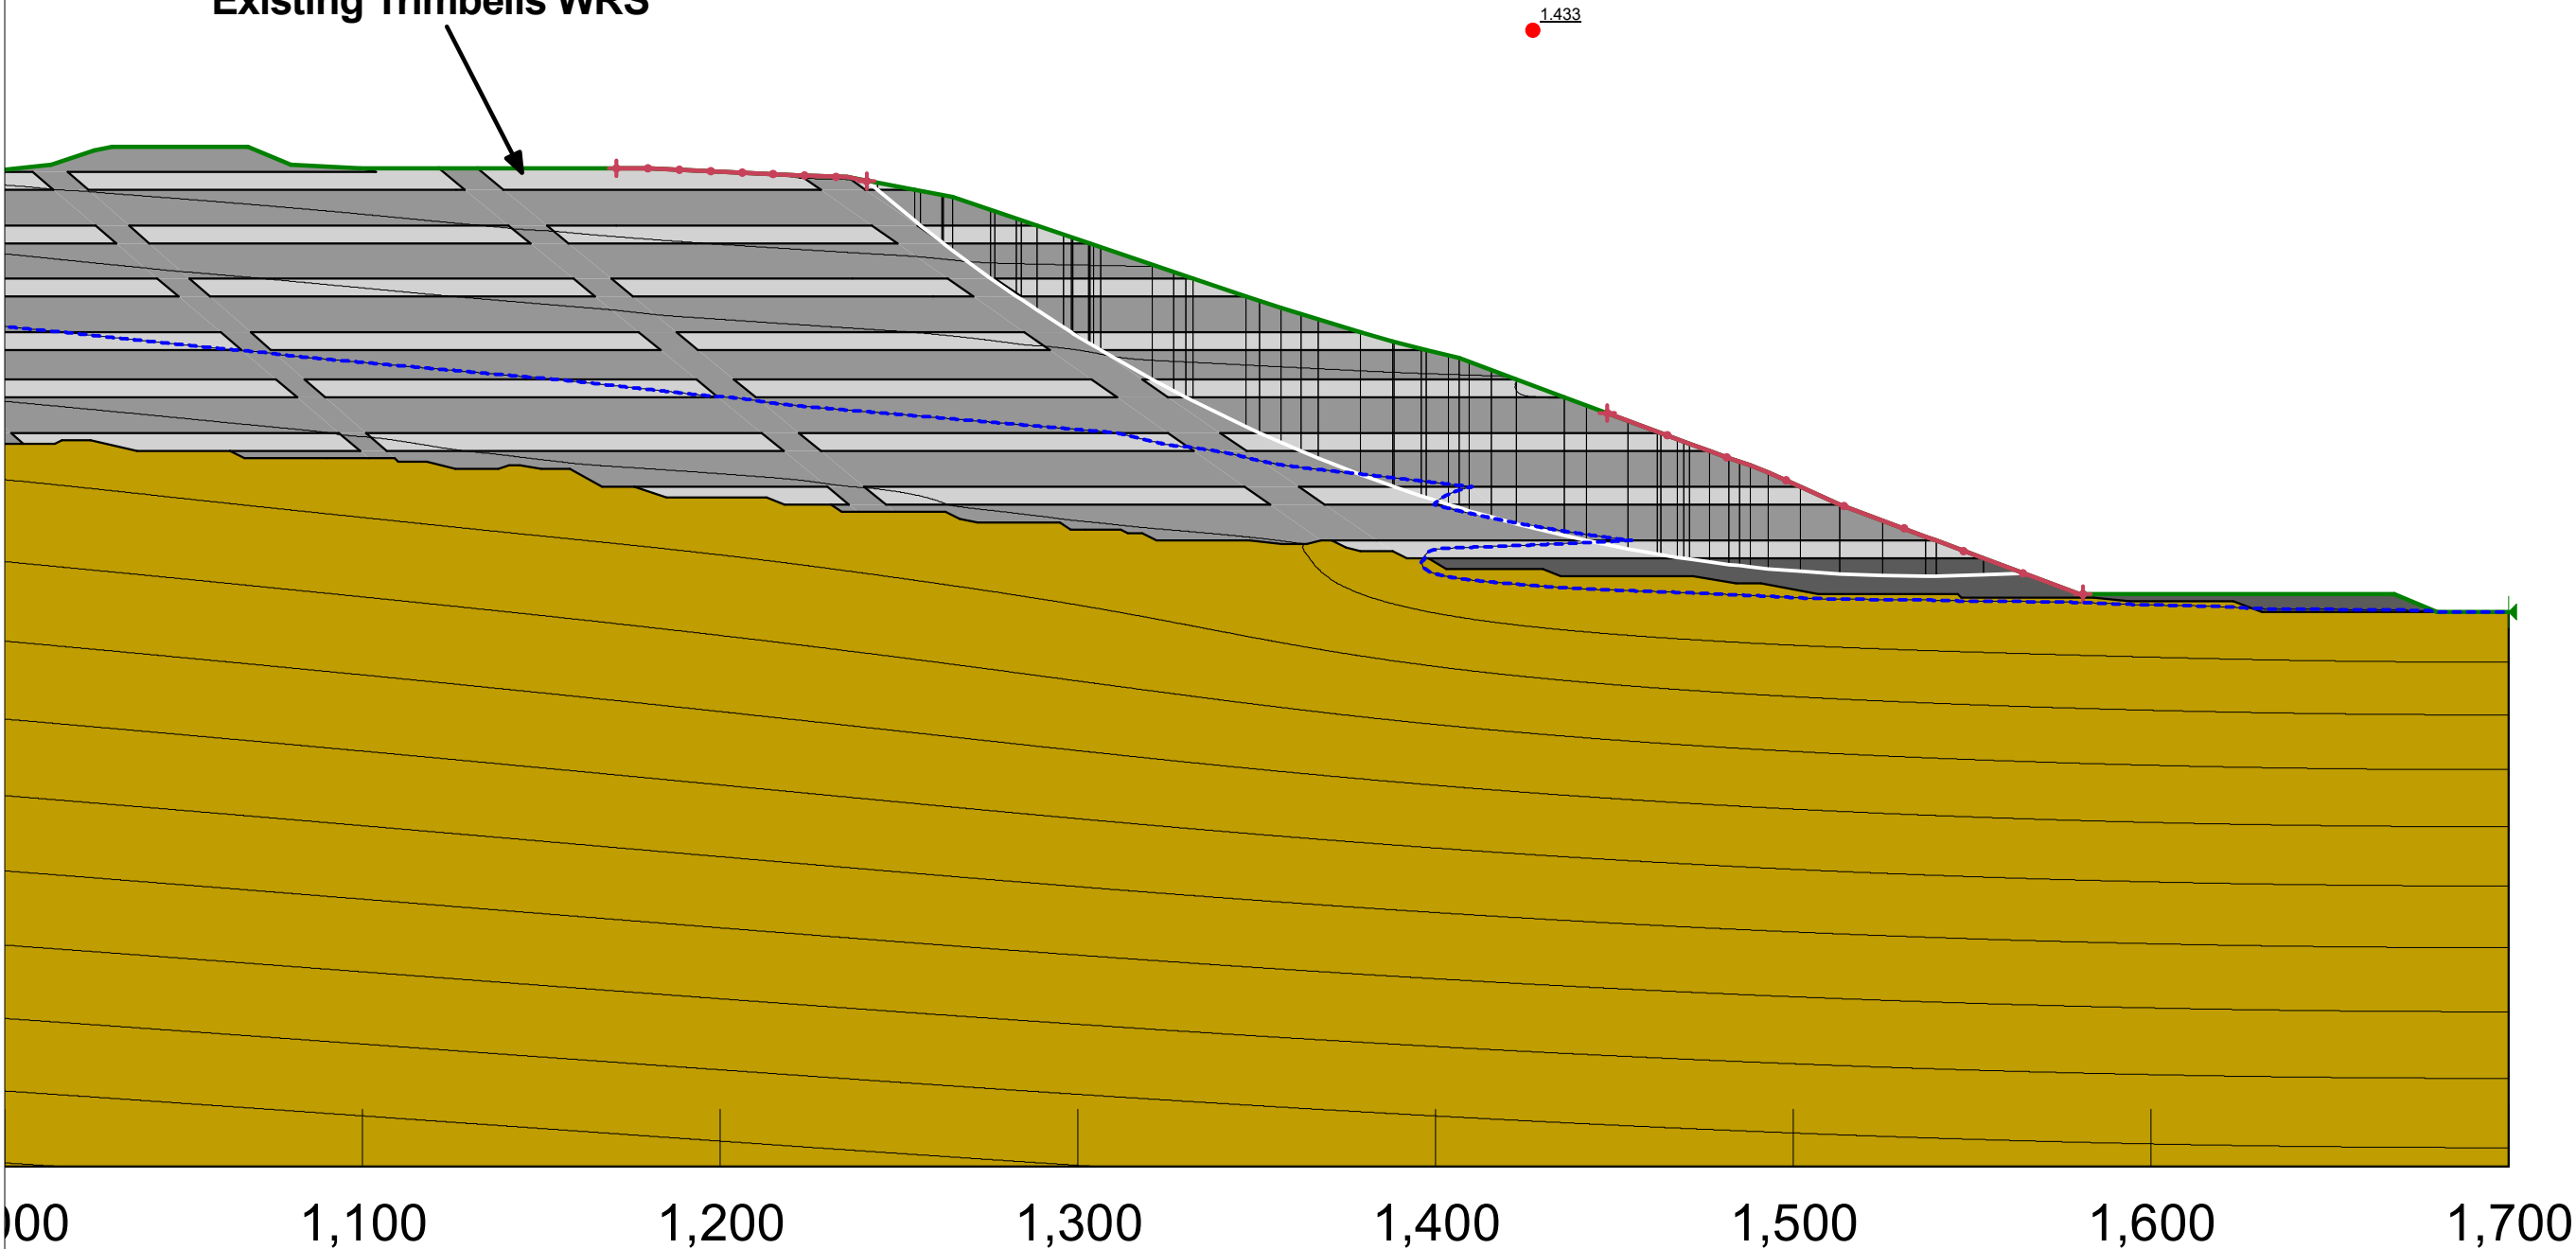
Figure A10

Stability - EQ150yr - Peak - Circular 2/3rd H

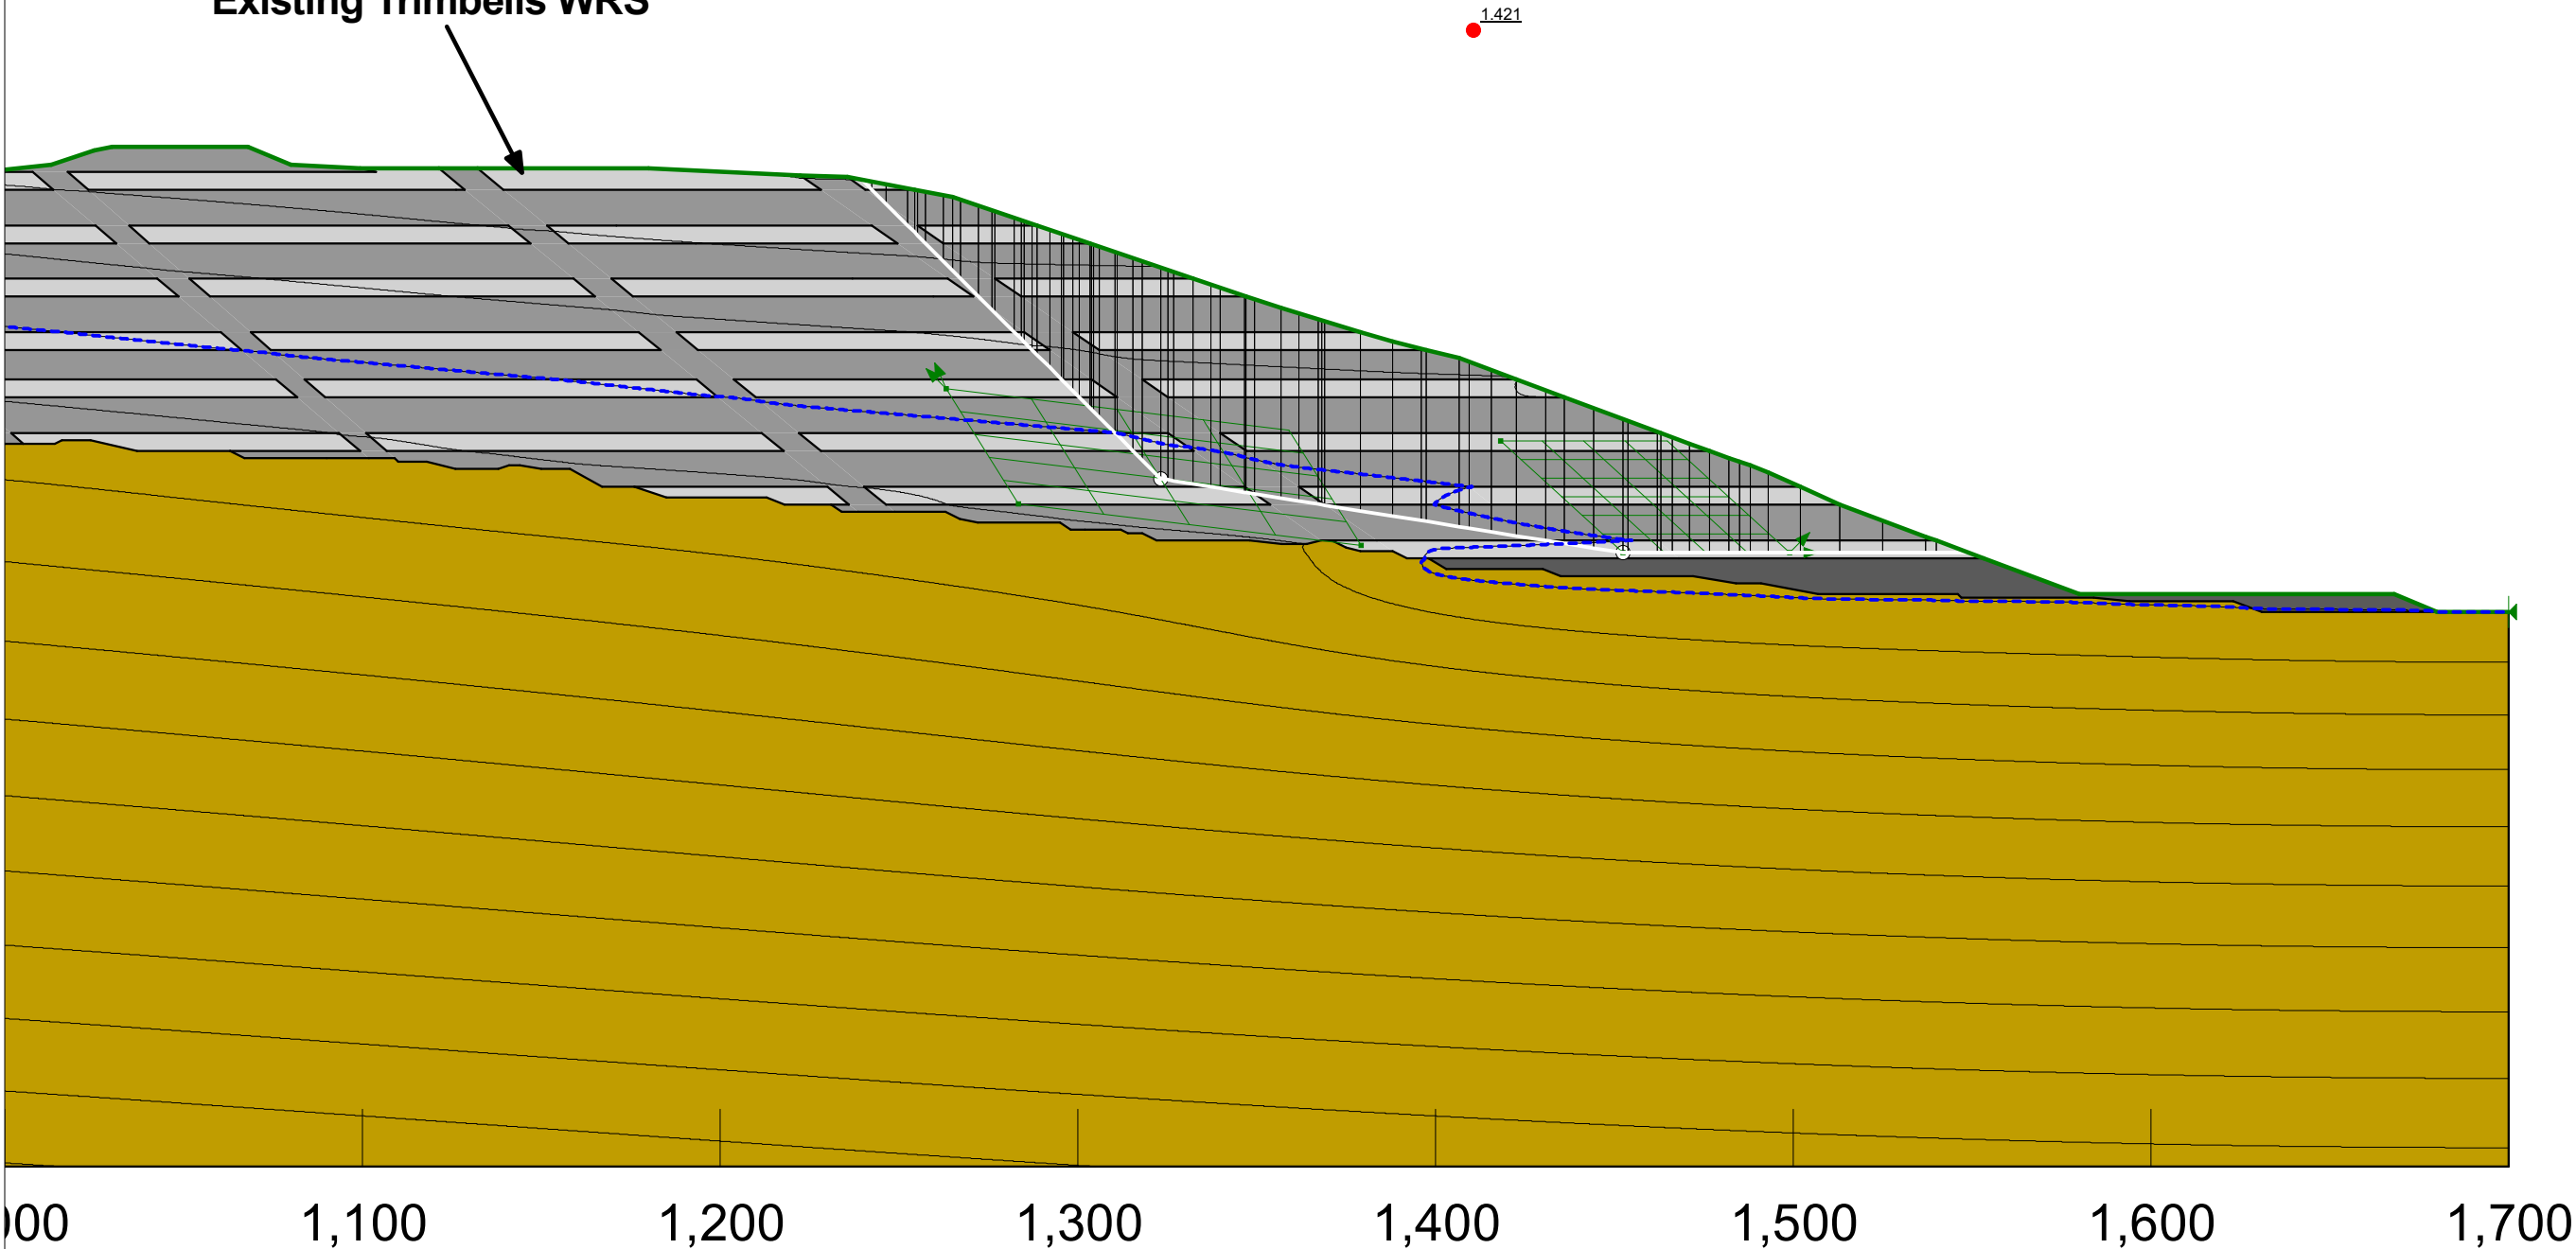
Figure A11

Stability - EQ150yr - Peak - Planar - 2/3rd H

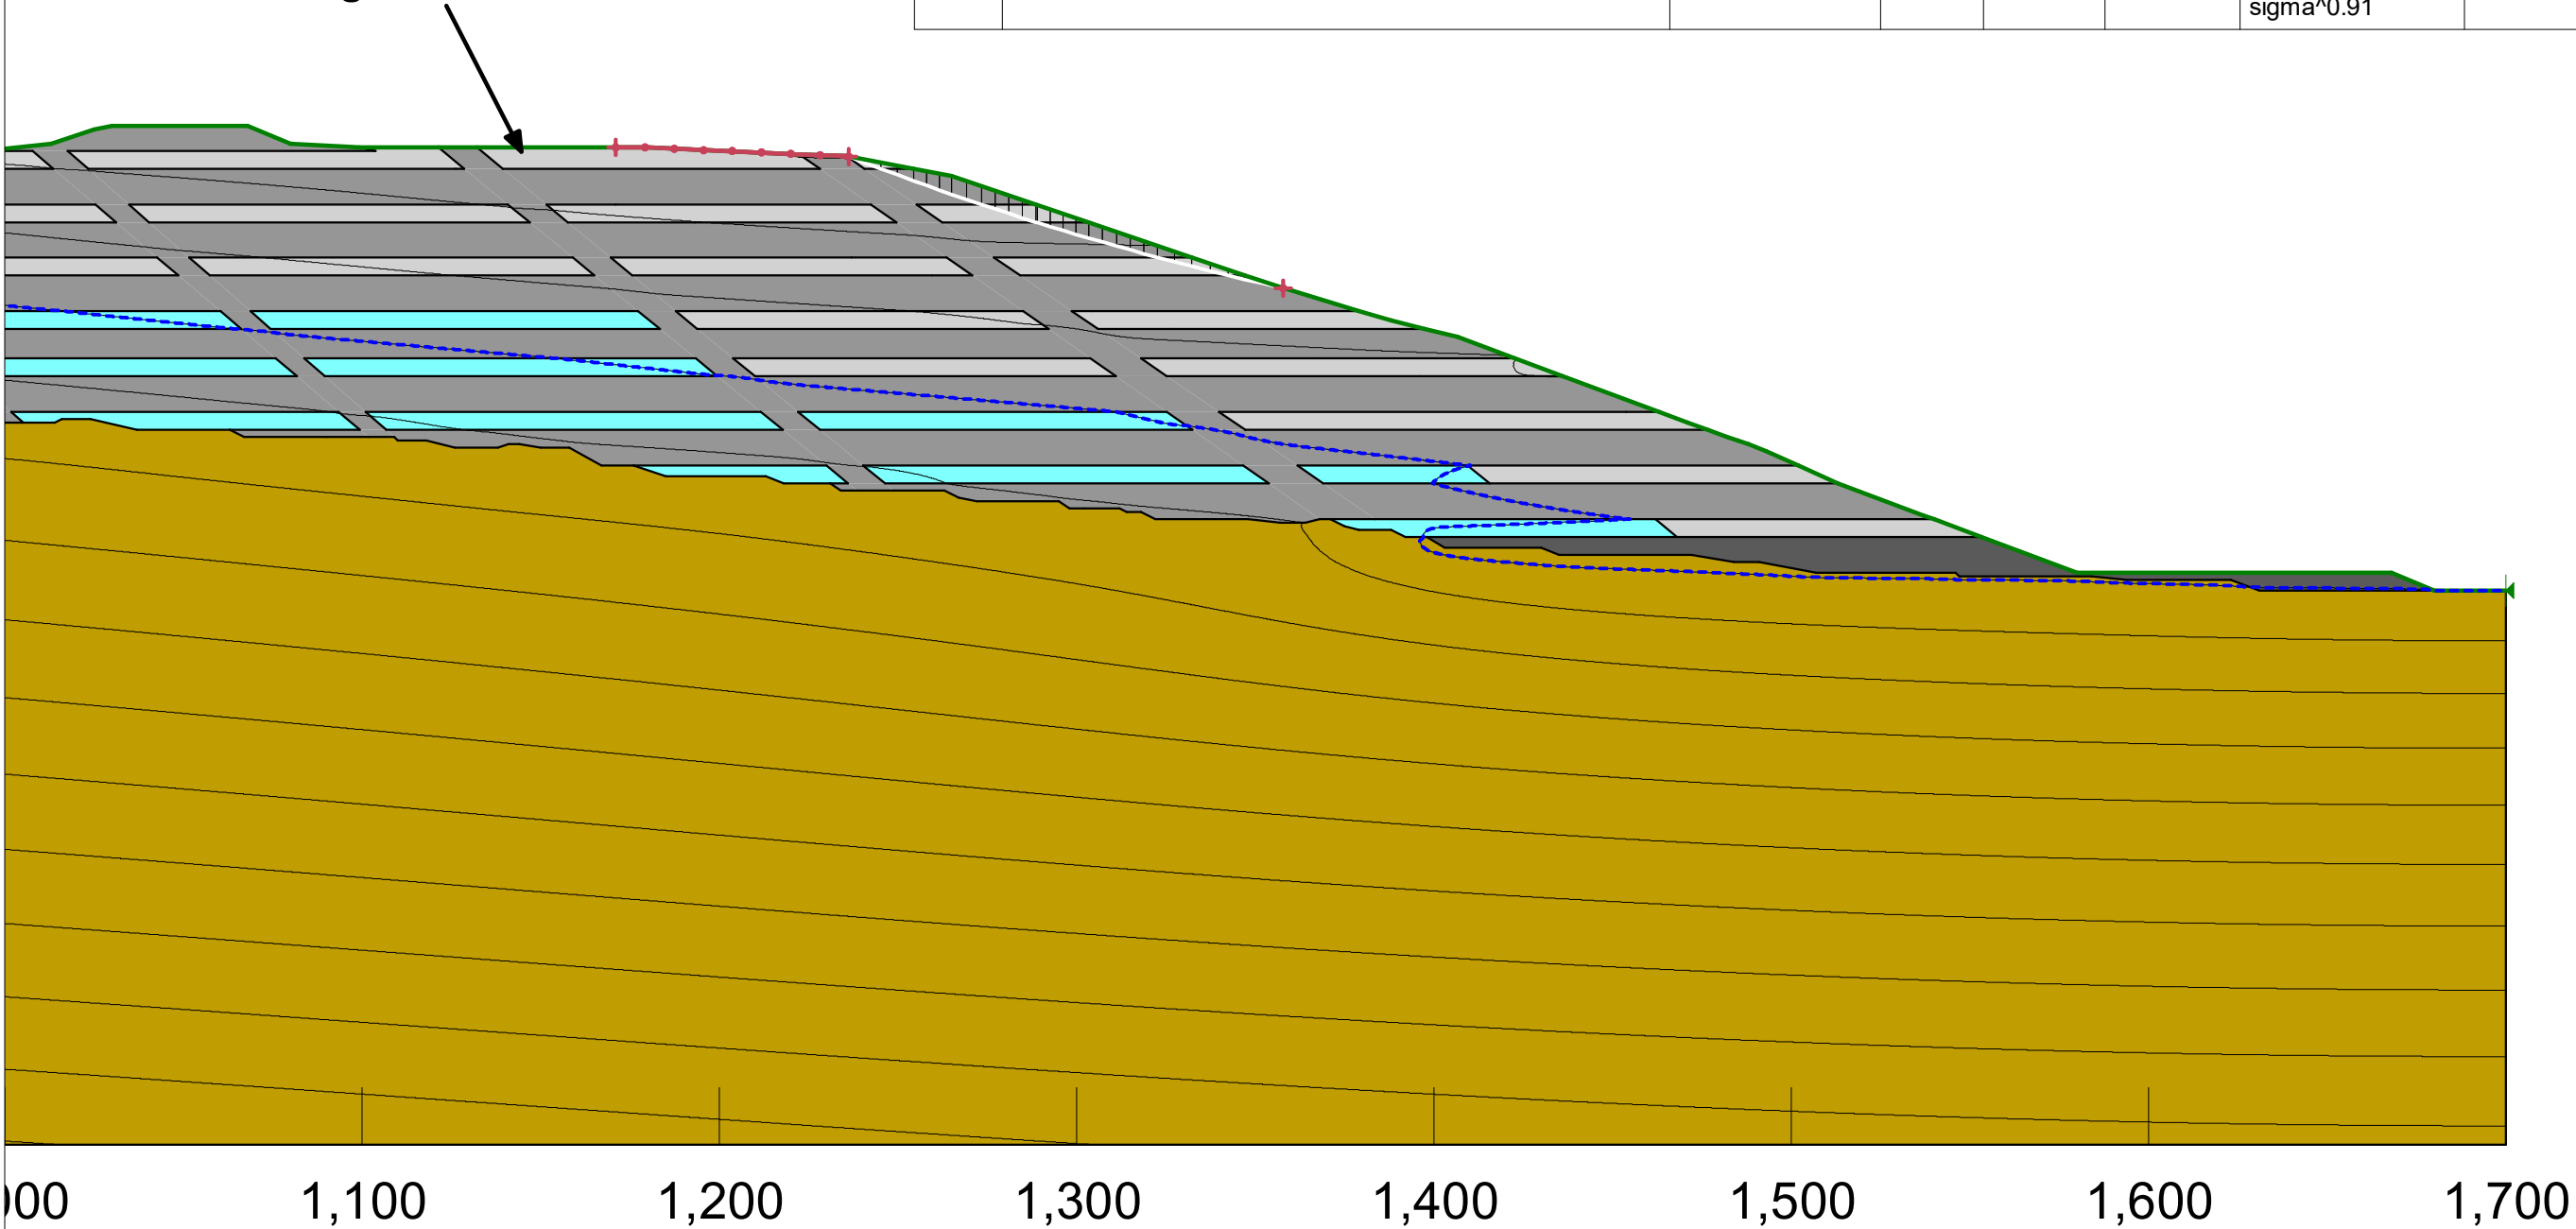
Figure A12

Stability - ky - Residual - Circular - 1/3rd H

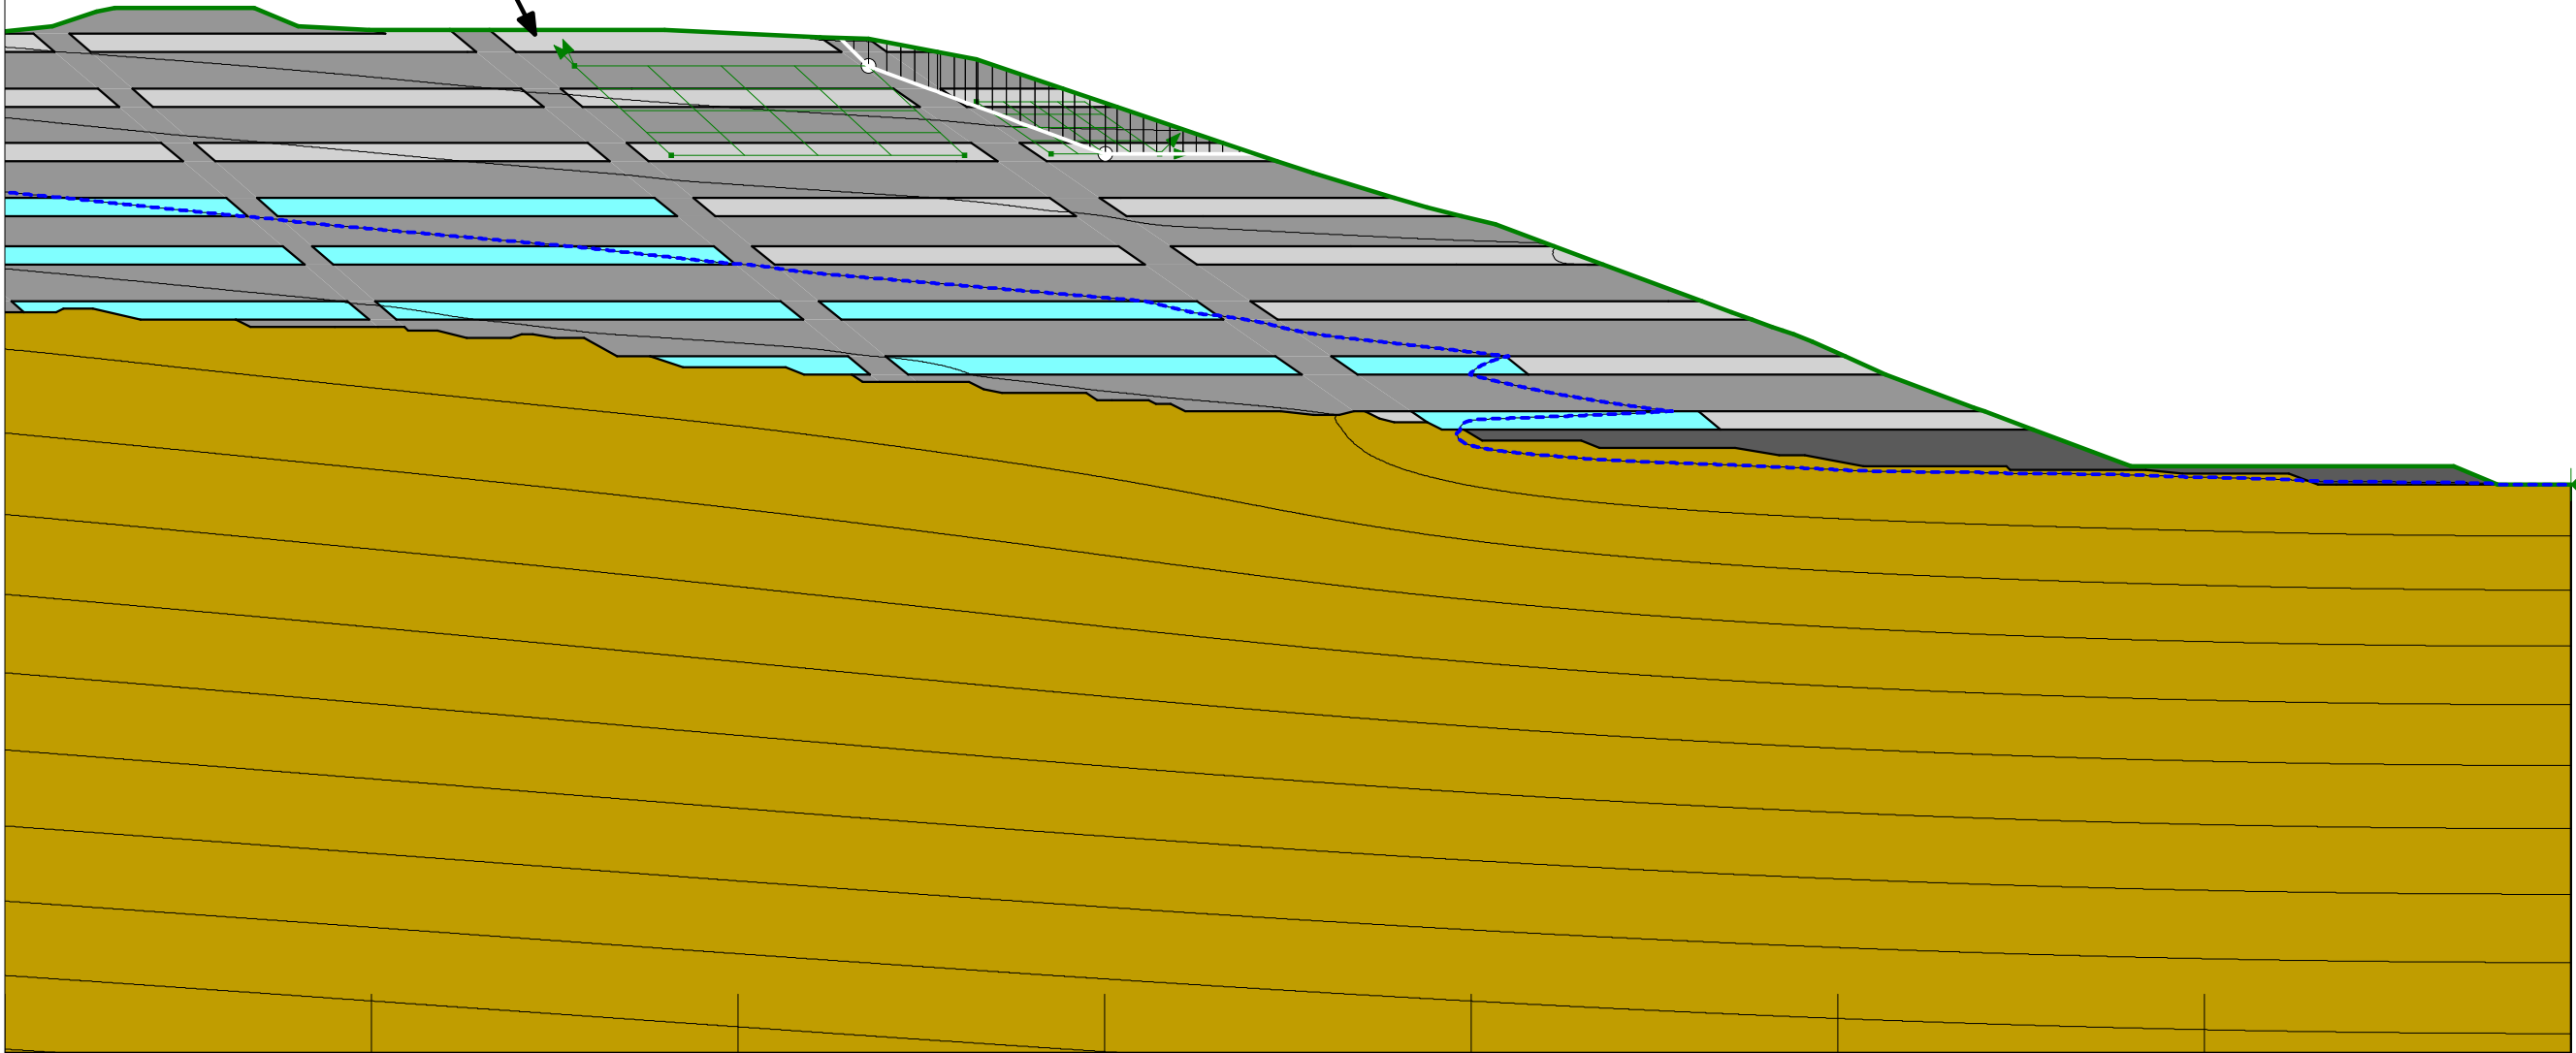
Figure A13

Stability - ky - Peak - Planar - 1/3rd H

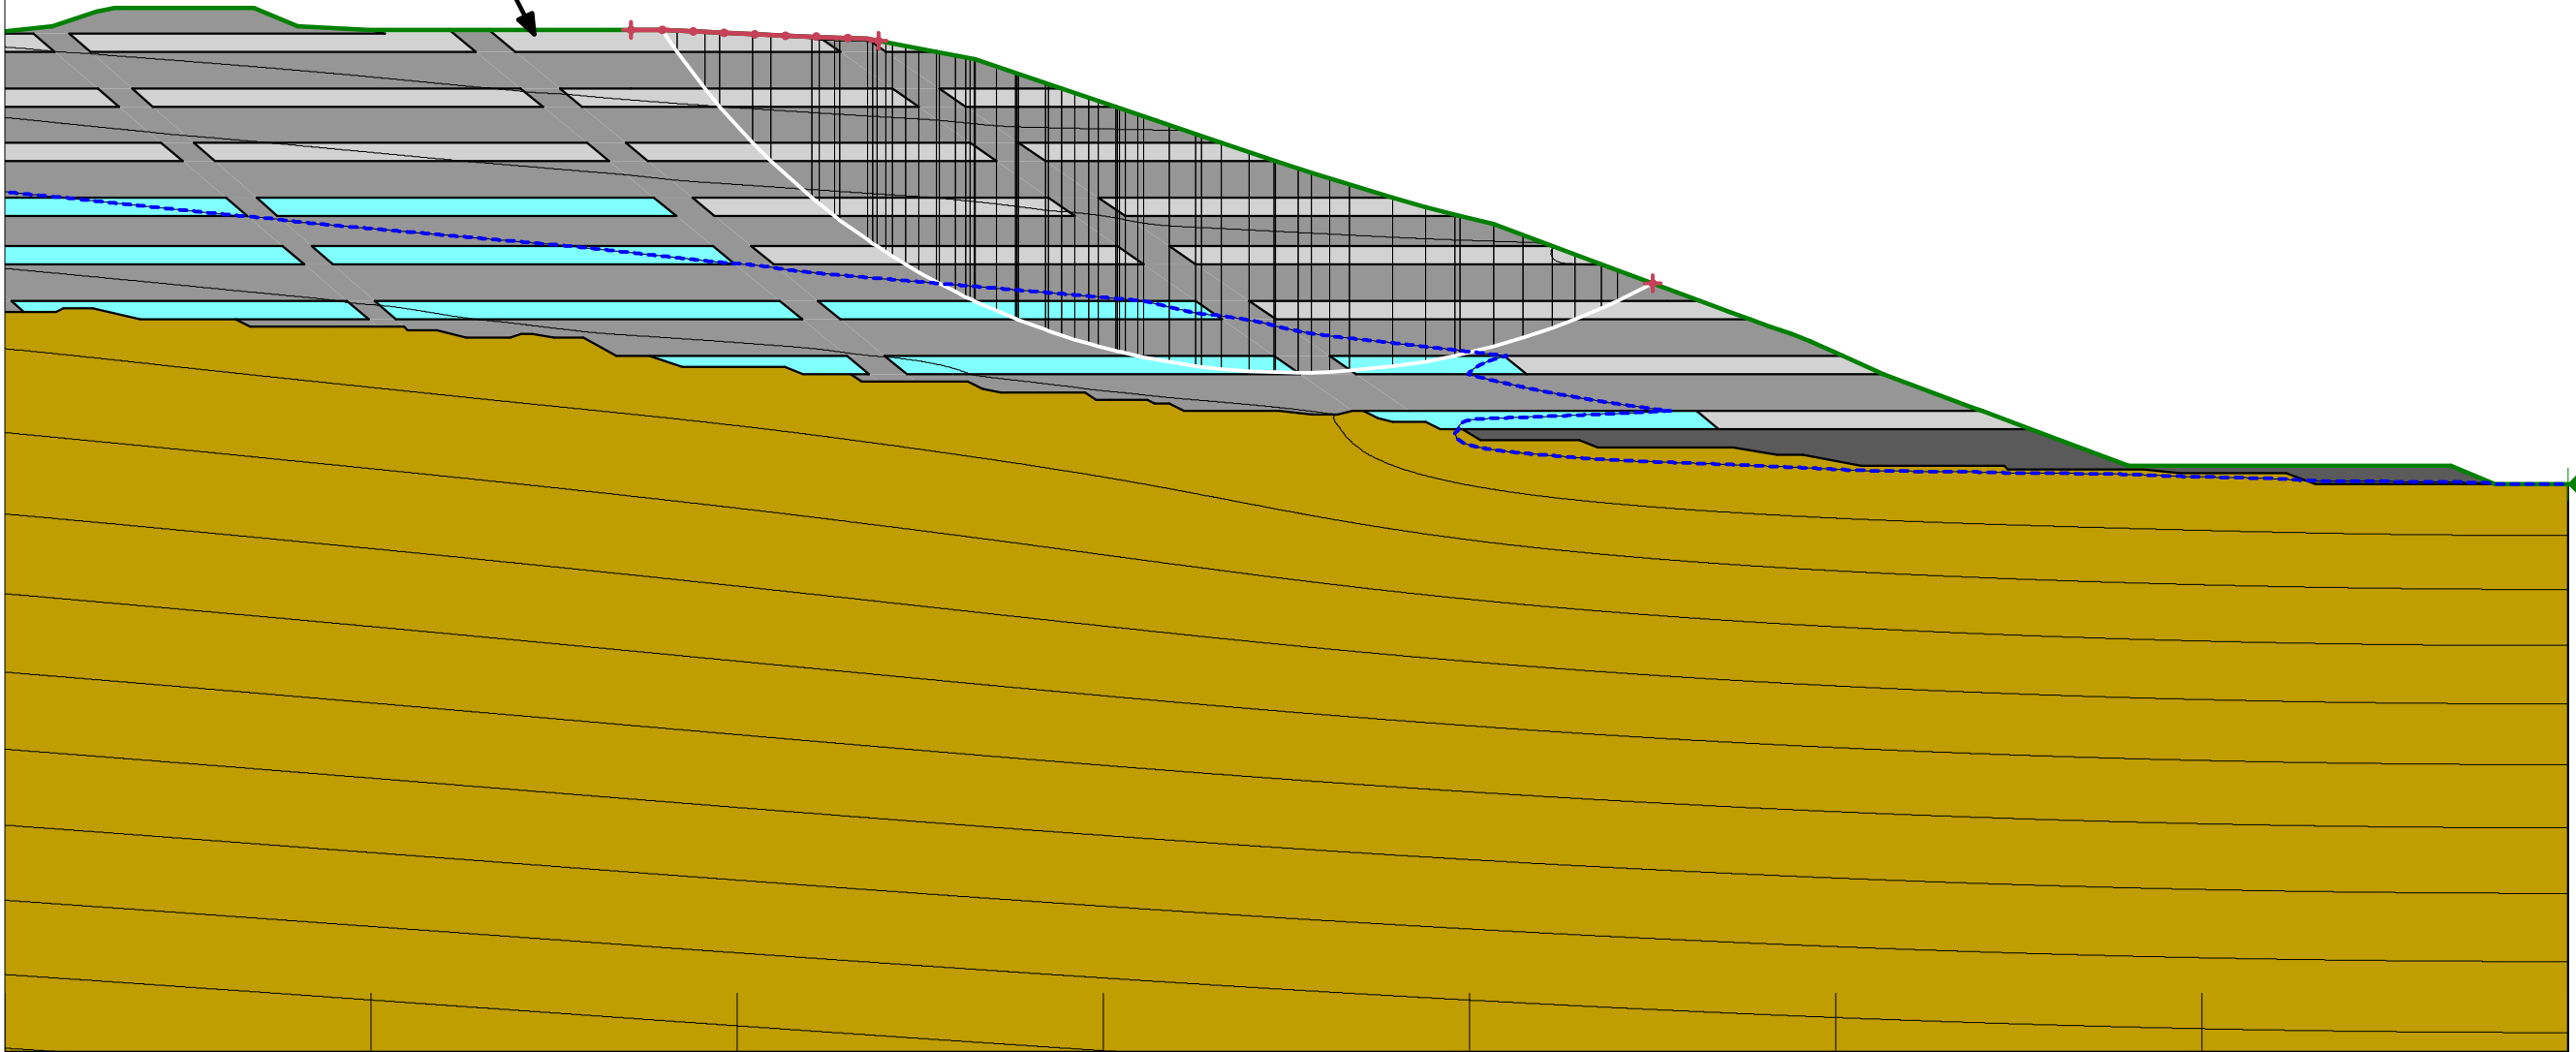
Figure A14

Stability - ky - Peak - Circular 2/3rd H
