**OCEANA GOLD (NEW ZEALAND) LIMITED  
MACRAES OPERATION  
TRIMBELLS WASTE ROCK STACK  
CLOSURE STABILITY REPORT**

| <b>Title</b> | OCEANA GOLD (NEW ZEALAND) LIMITED MACRAES OPERATION TRIMBELLS WASTE ROCK STACK – CLOSURE STABILITY REPORT |

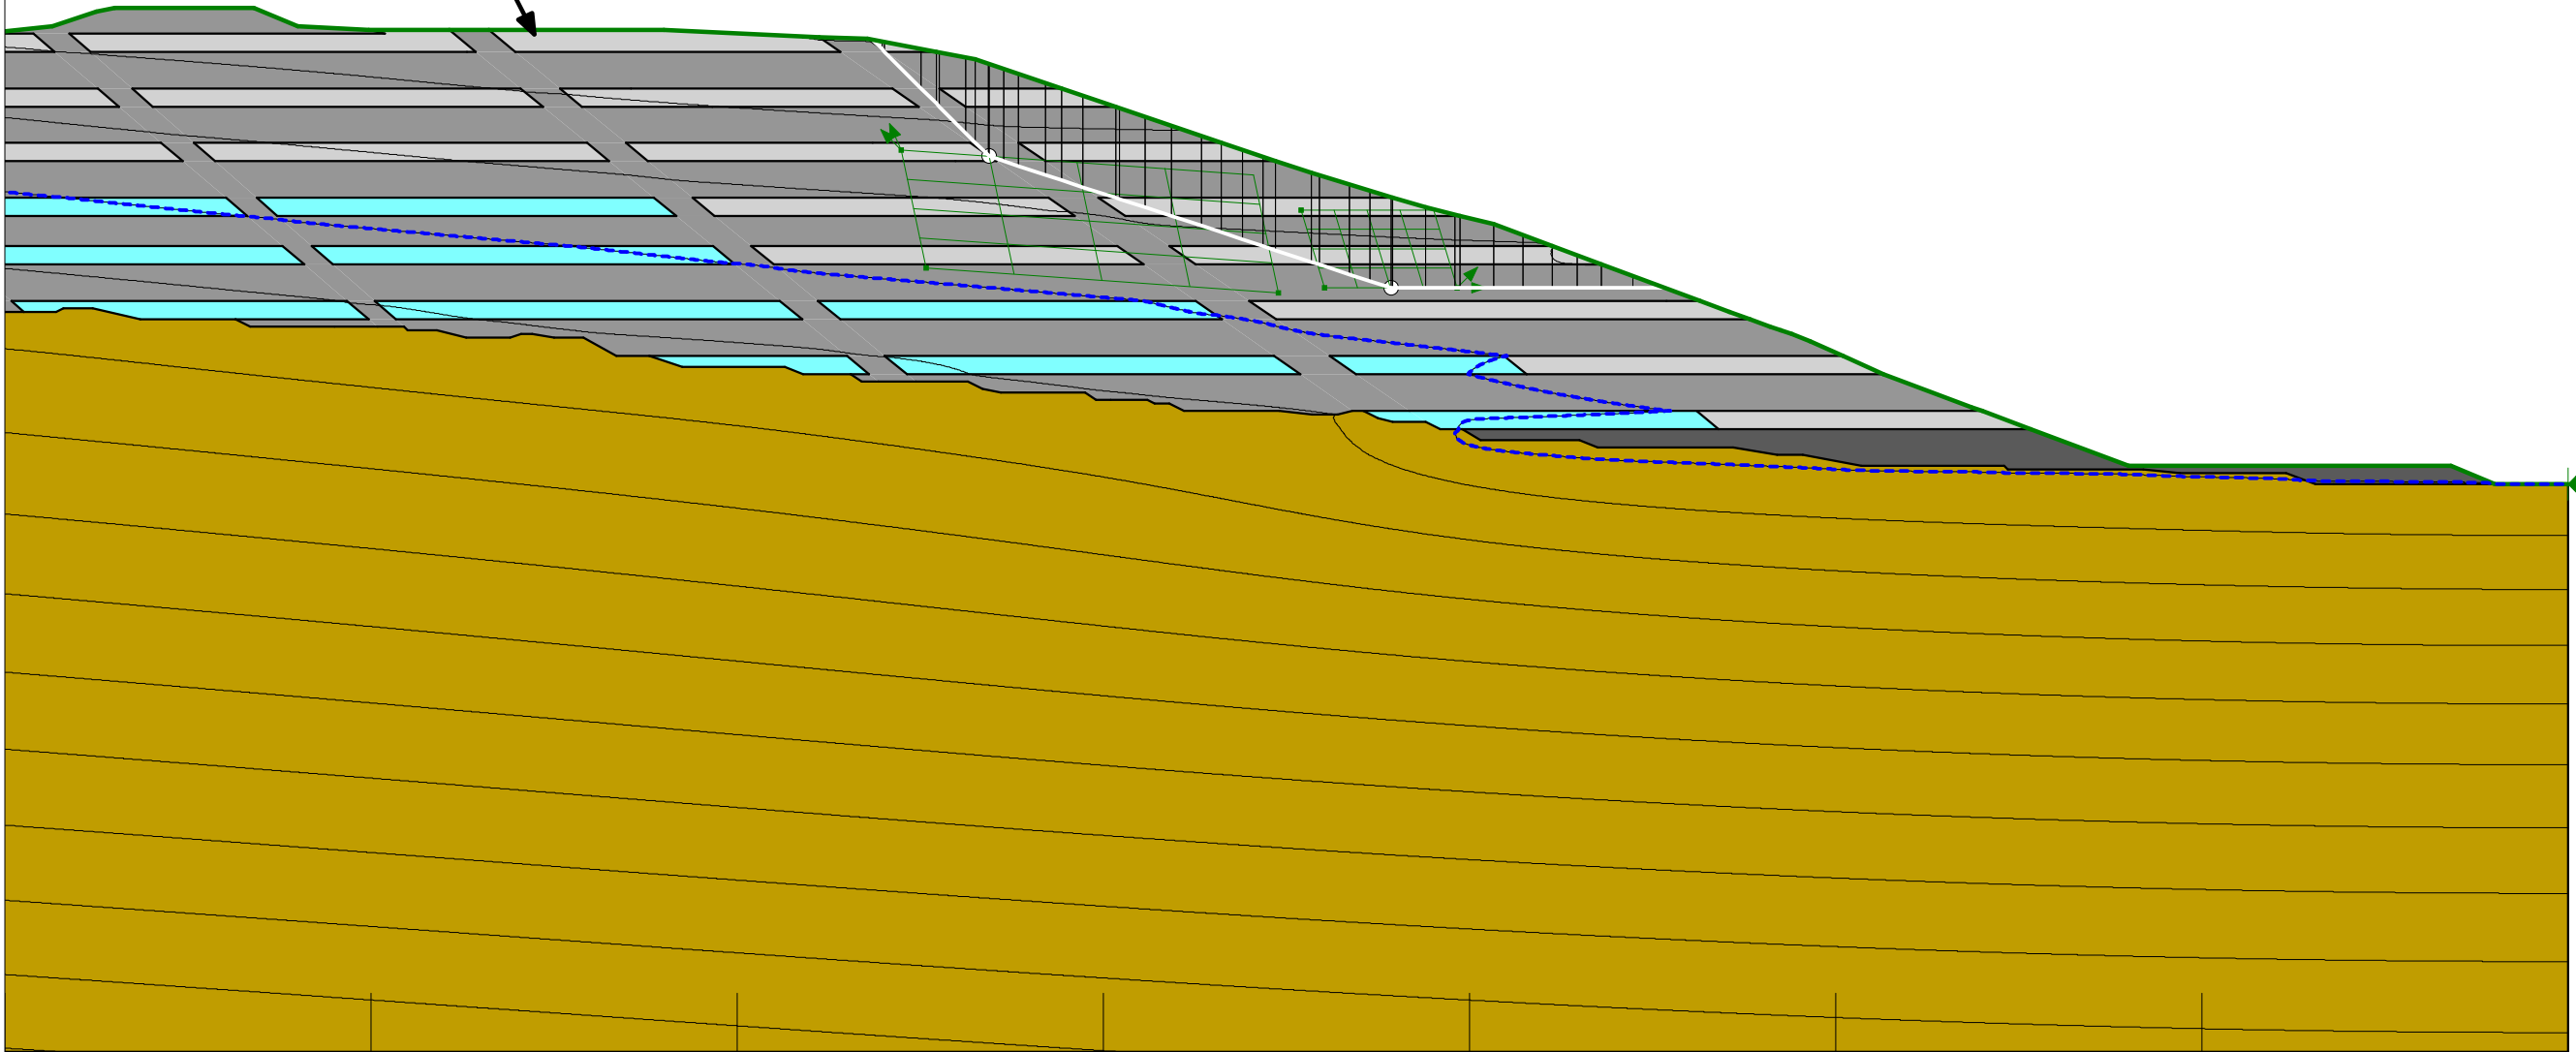
Figure A15

Stability - ky - Peak - Planar - 2/3rd H

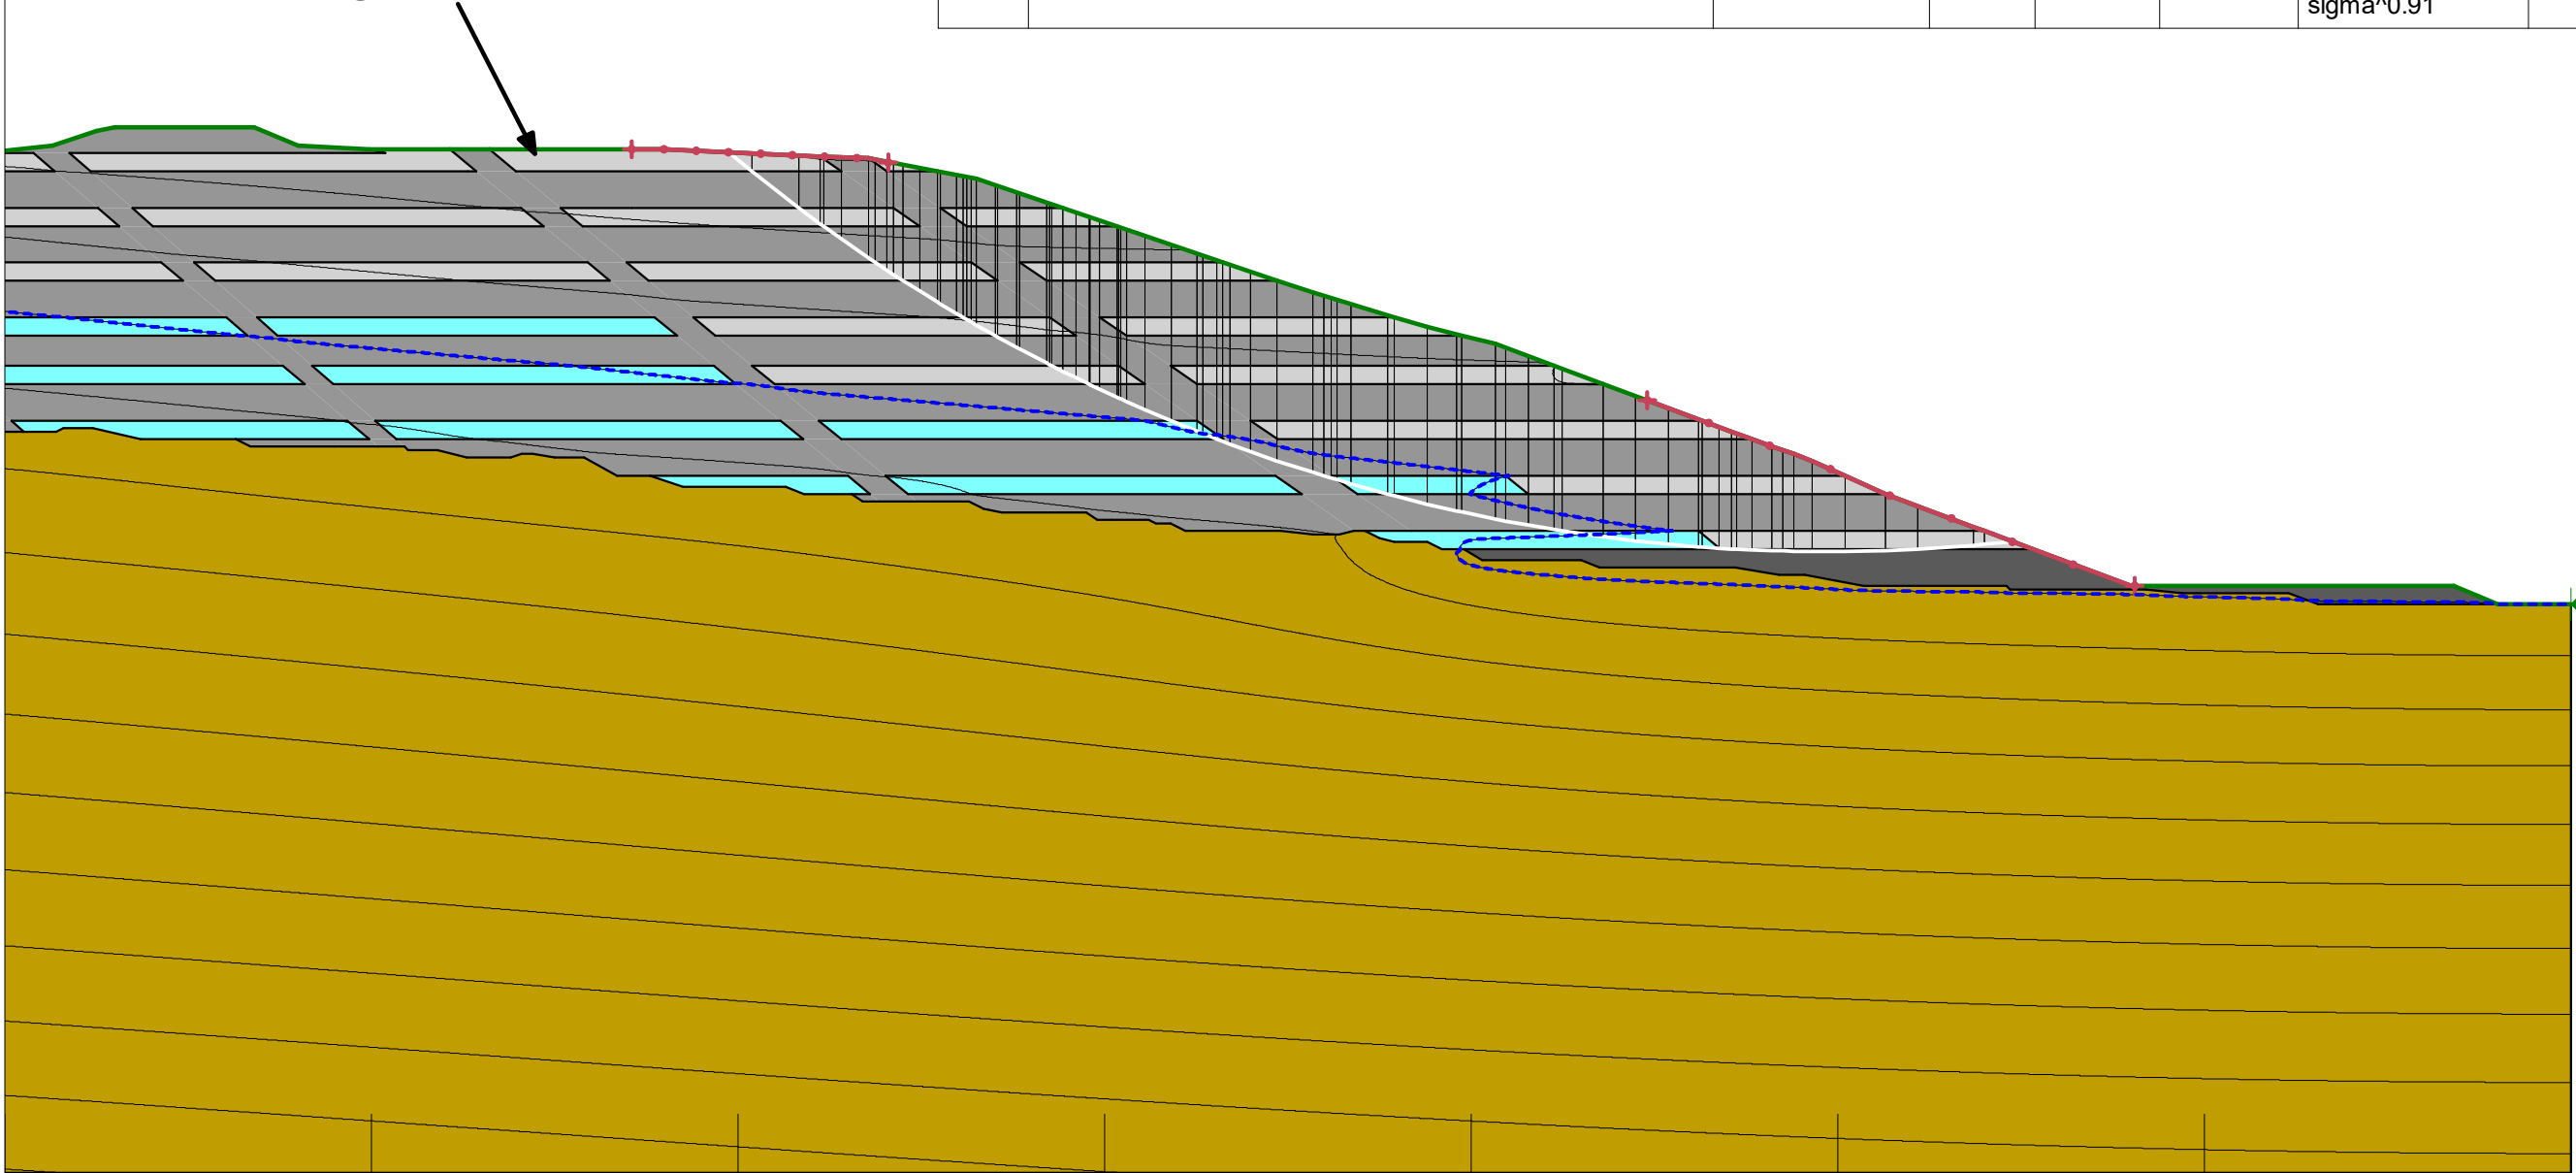
Stability - ky - Residual - Circular H

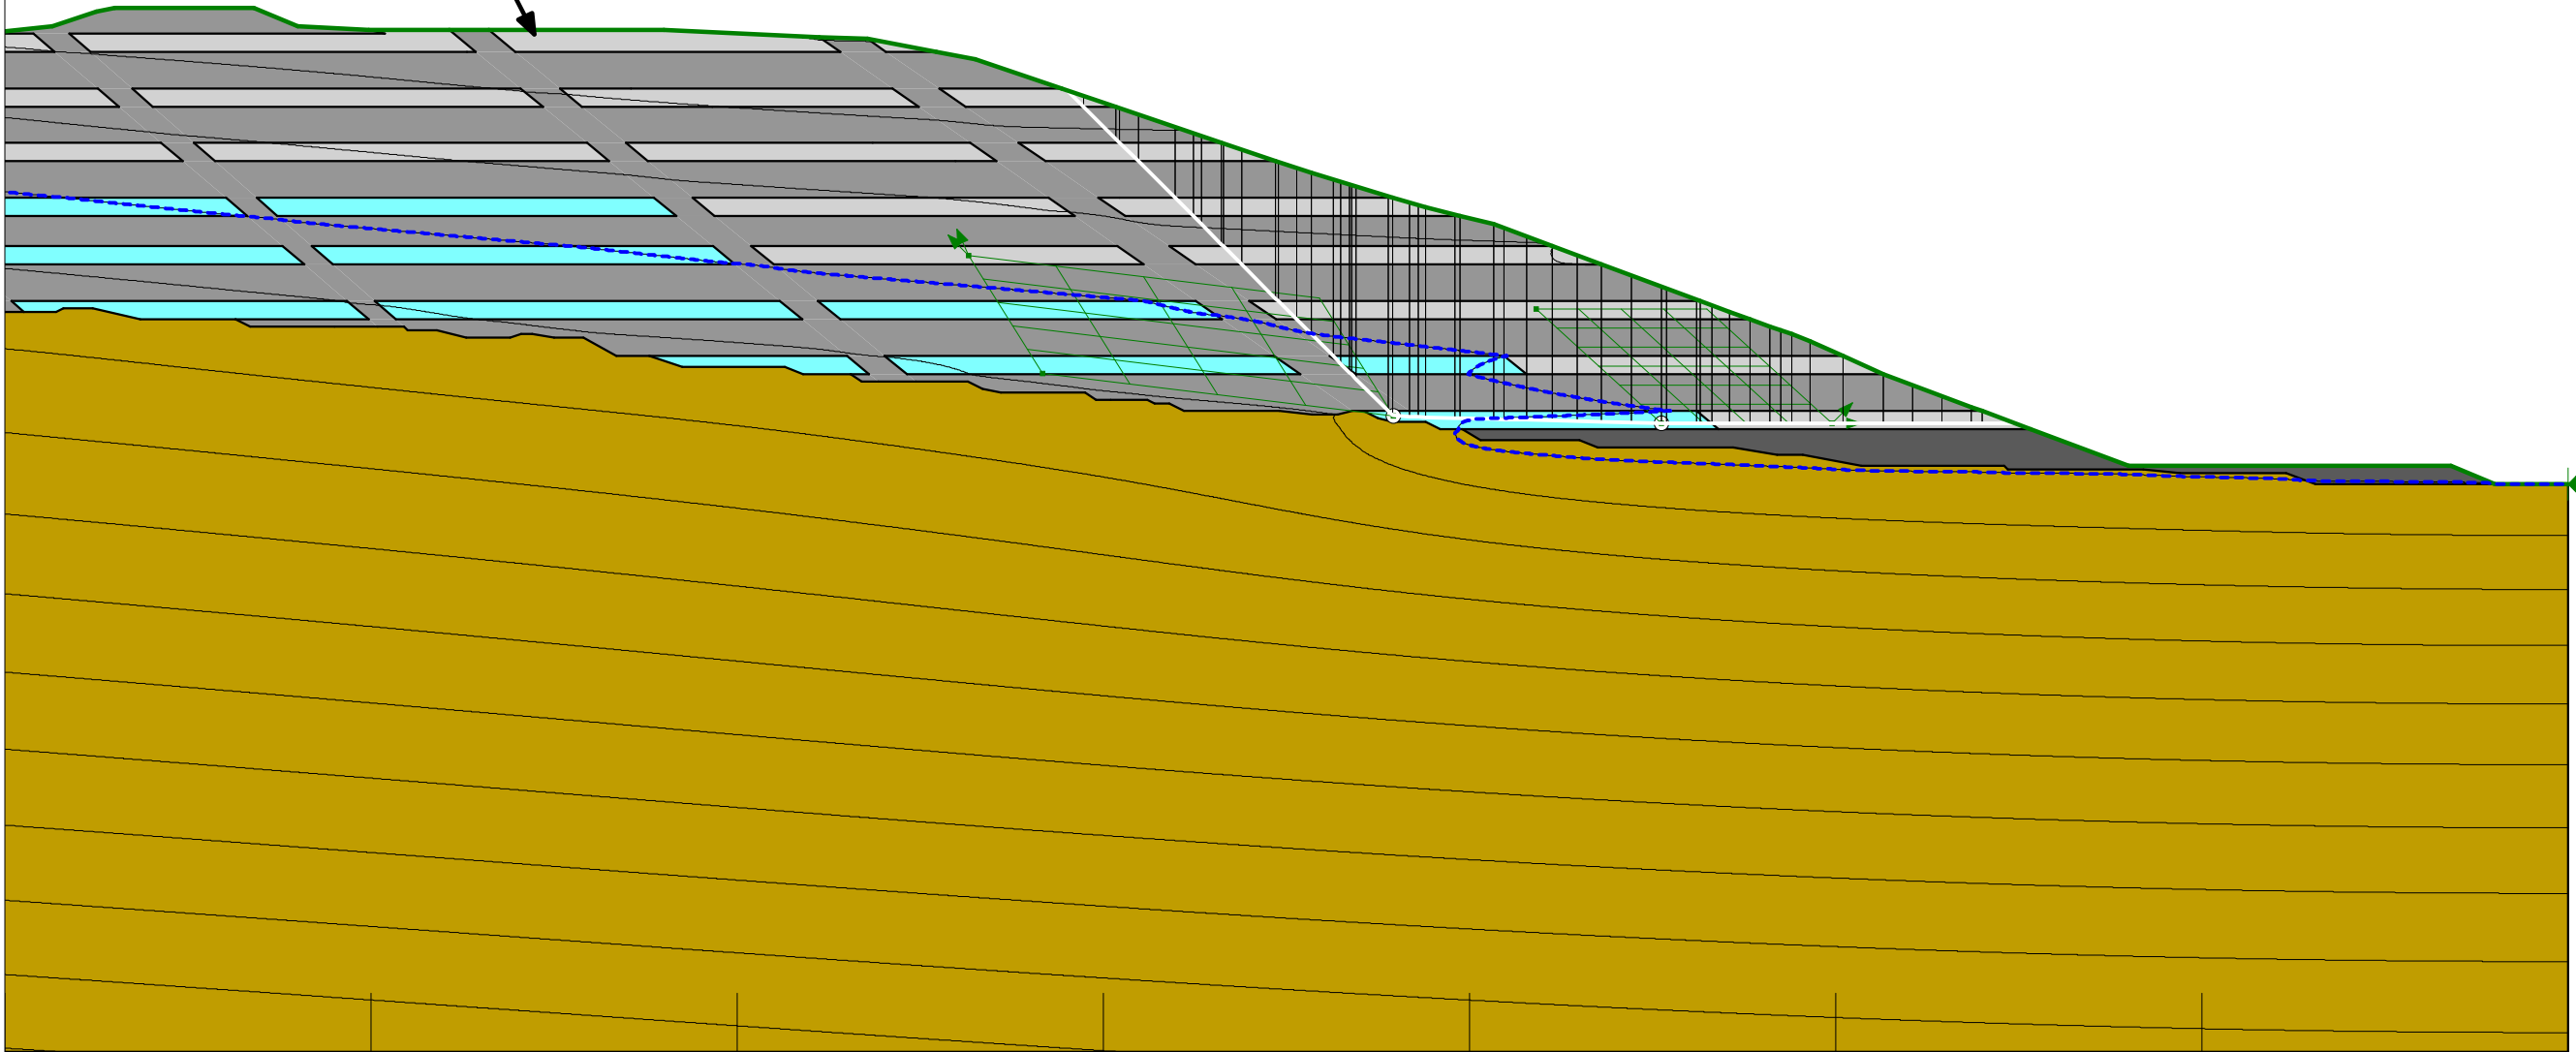
Stability - ky - Residual - Planar - H
