# Dunedin City Council Civil Defence and Rural Fires

## Waitati Flood Reporting

August 2006

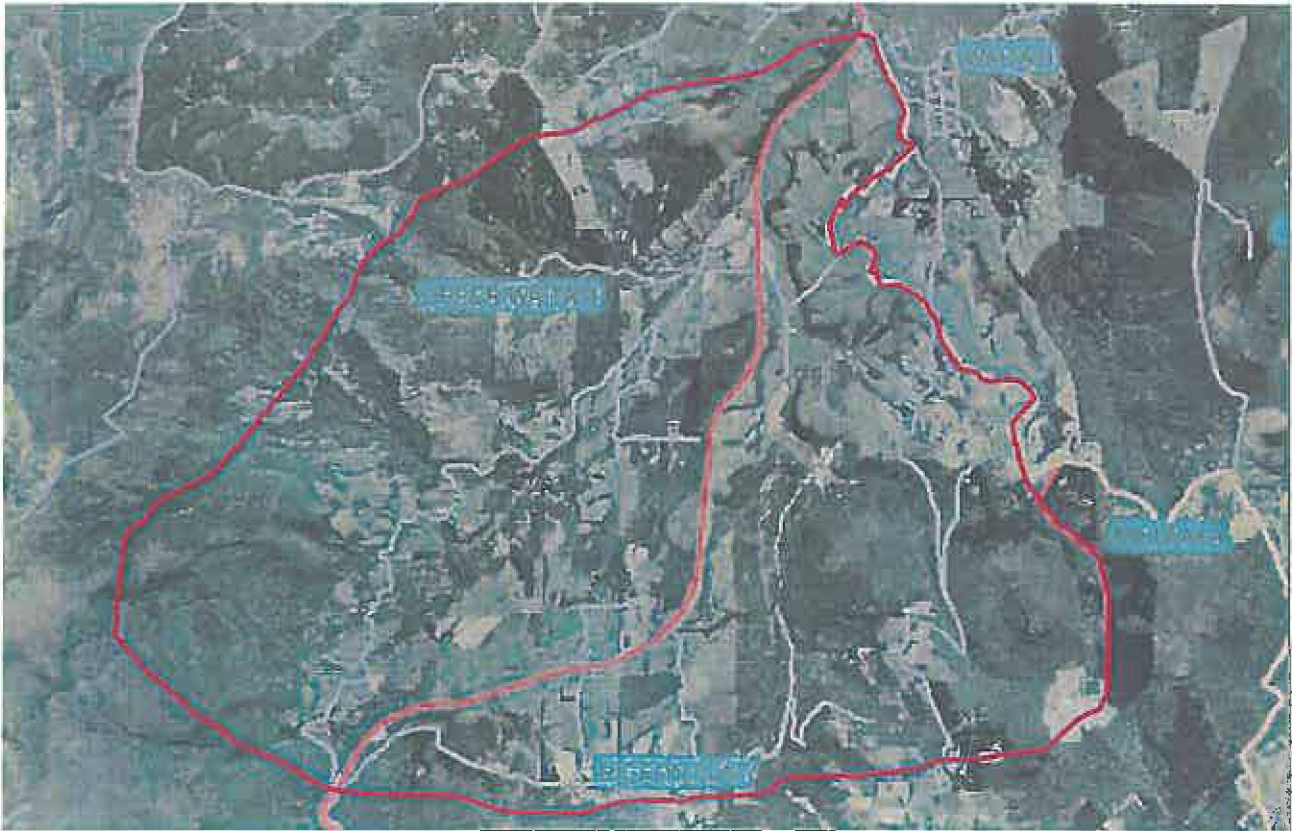
**Waitati Valley catchment Area**

The catchment area for the Waitati Valley was subjected to some of the heaviest rainfall of the whole of the storm period of the 25 and 26 April 2006. The catchment area is bounded to the south by the ridge through Leith Saddle between Mount Cargill and Swampy Summit.

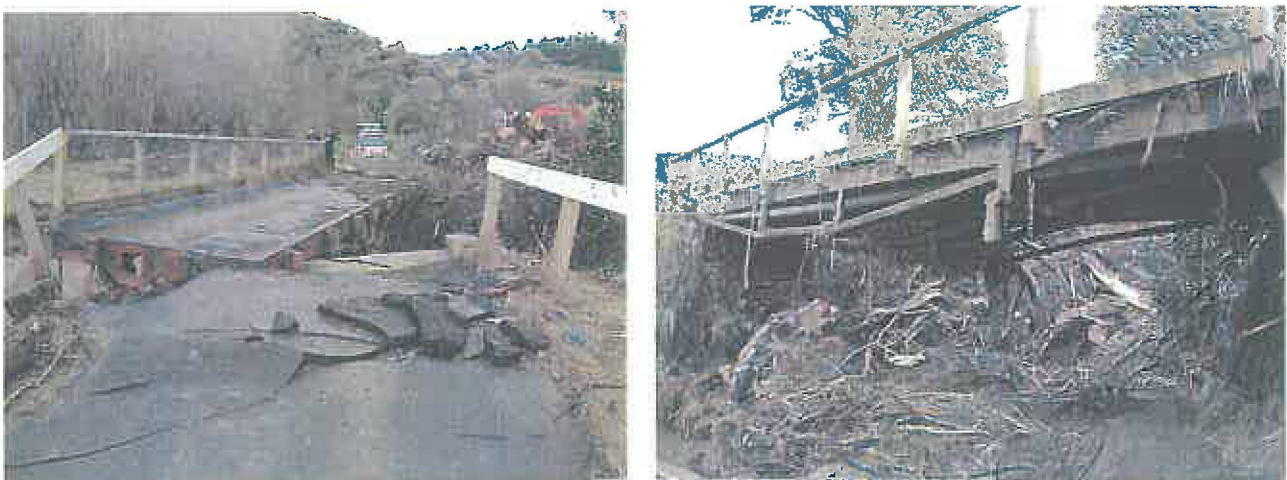
**McIntosh Road Bridge**

When the weight of water on the bridge reached a critical level, the bridge gave way releasing a surge wave down through the lower Waitati Valley.

The bridge settled back onto its abutments, possibly through being anchored in place by the service ducts passing across the bridge. The services themselves were severed.

The bridge at McIntosh Road has been reinstated.

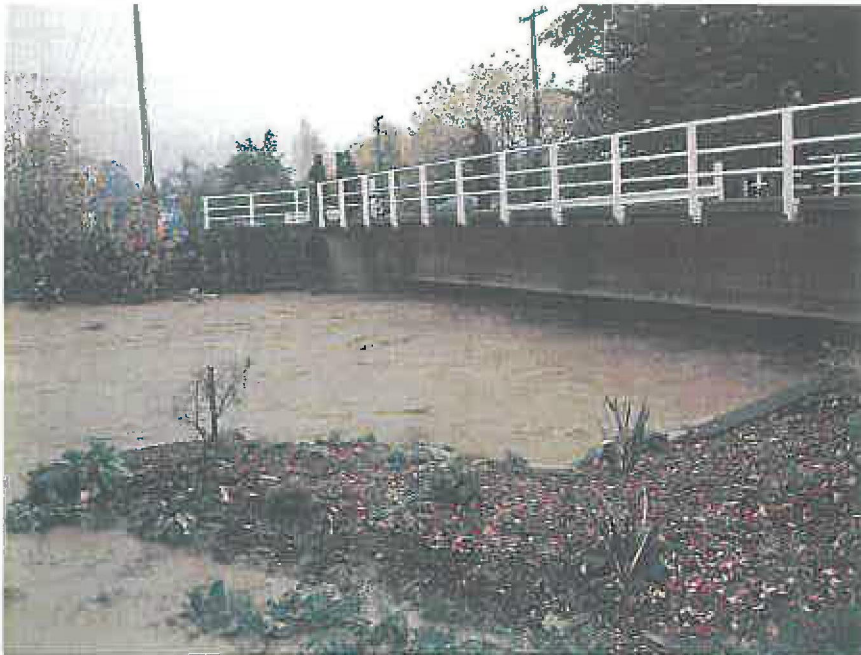
A dead tree, carried by the high river flows, became lodged under the main road bridge in Waitati on Harvey Street beside the Waitati Hall/Library/Community Centre. This obstruction caused the river to back up and burst the true right bank.

**Full river flow under the Harvey Street road bridge shortly before the tree became stuck**

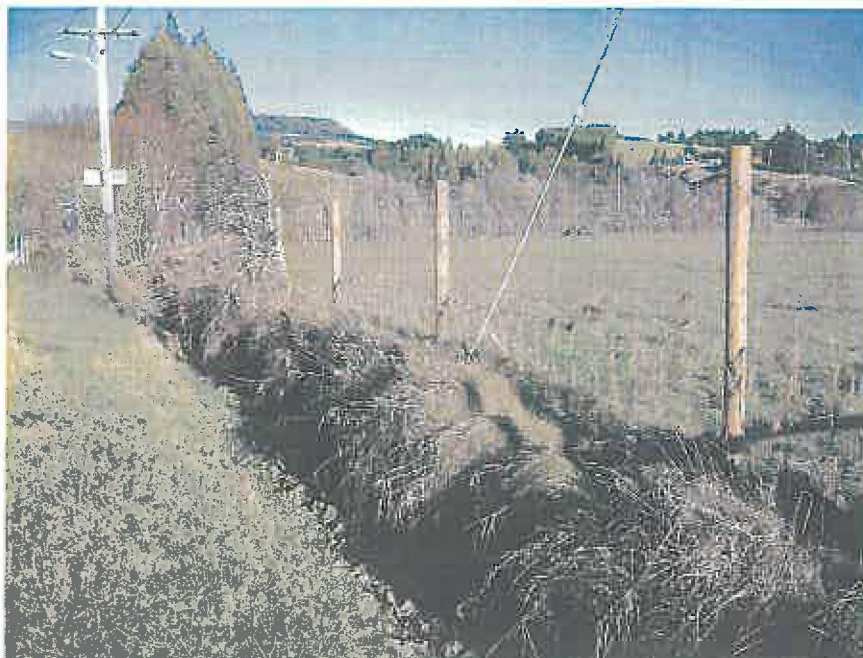
The paddocks identified as 42 and 44 Harvey Street were flooded to a maximum depth of approximately 3m. Parts of these paddocks had been set to grazing sheep, a number of which perished.

**Sheep were forced against this fence by the flood water. Debris can be seen indicating the depth of the flood**

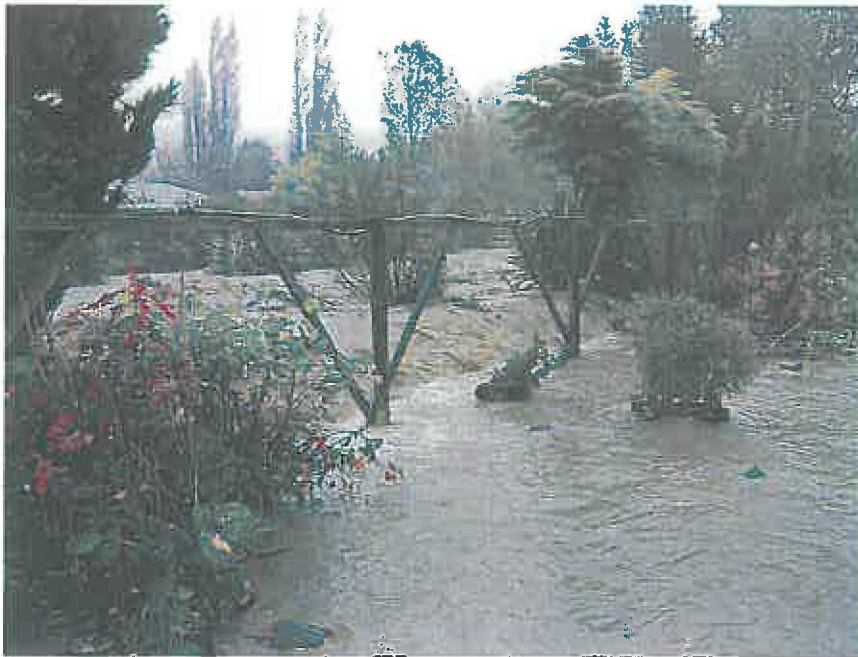
Two secondary flow paths developed. The principal secondary flow path draining the flooded area was across Harvey Street and along Orokonui Road (including passing through #57 Harvey Street and the section behind), rejoining the Waitati River approximately opposite Erne Street. The lesser secondary flow path took a north-westerly direction, almost following the old river alignment.

**Secondary Flow Path Developed through Blueskin Nursery**

6. The flood water flowed through Blueskin Nursery at a depth of approximately 100mm. This has been assumed to be a secondary flow path through the Nursery to the line of the old river.
7. Upstream of the Harvey Street bridge, the water level in the river has been assumed to be constant at around 8.0m adjacent to Quayle Street. This concurs with eye witness accounts of where the river burst its southern bank into the paddock behind #36 Harvey Street.
8. The wire fence along the west side of Harvey Street through #42 and #44 trapped an amount of debris as the flood water passed through it. From the 5.0m top water level at the Orokonui Road intersection described above, 0.3m head loss through the wire fence has been assumed, followed by a straight hydraulic grade up to 8.0m at Quayle Street.

Development on the line of the Waitati River's historical meanders is not recommended without suitable provision of flood protection measures. This area, through Blueskin Nursery and along the north side of Doctors Point Road is at risk of future floods.

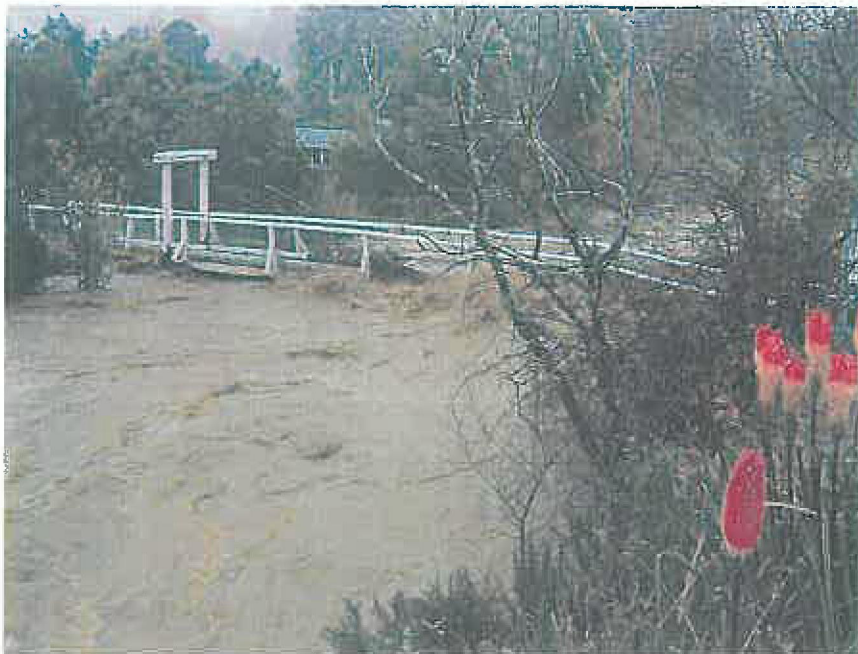
**Footbridge Connecting Erne Street to Orokonui Road**

2. Flood water in the Waitati River reached the soffit of the Harvey Street overbridge at approximately 8.0m.
3. The water level in the river reached the Erne Street/Orokonui Road footbridge as shown in the photograph above. Straight hydraulic grade has been assumed from 2.5m at the downstream end (1b) to the footbridge (3) where an allowance of 0.5m headloss has been assumed. Then straight hydraulic grade to 8.0m at the upstream end (2).

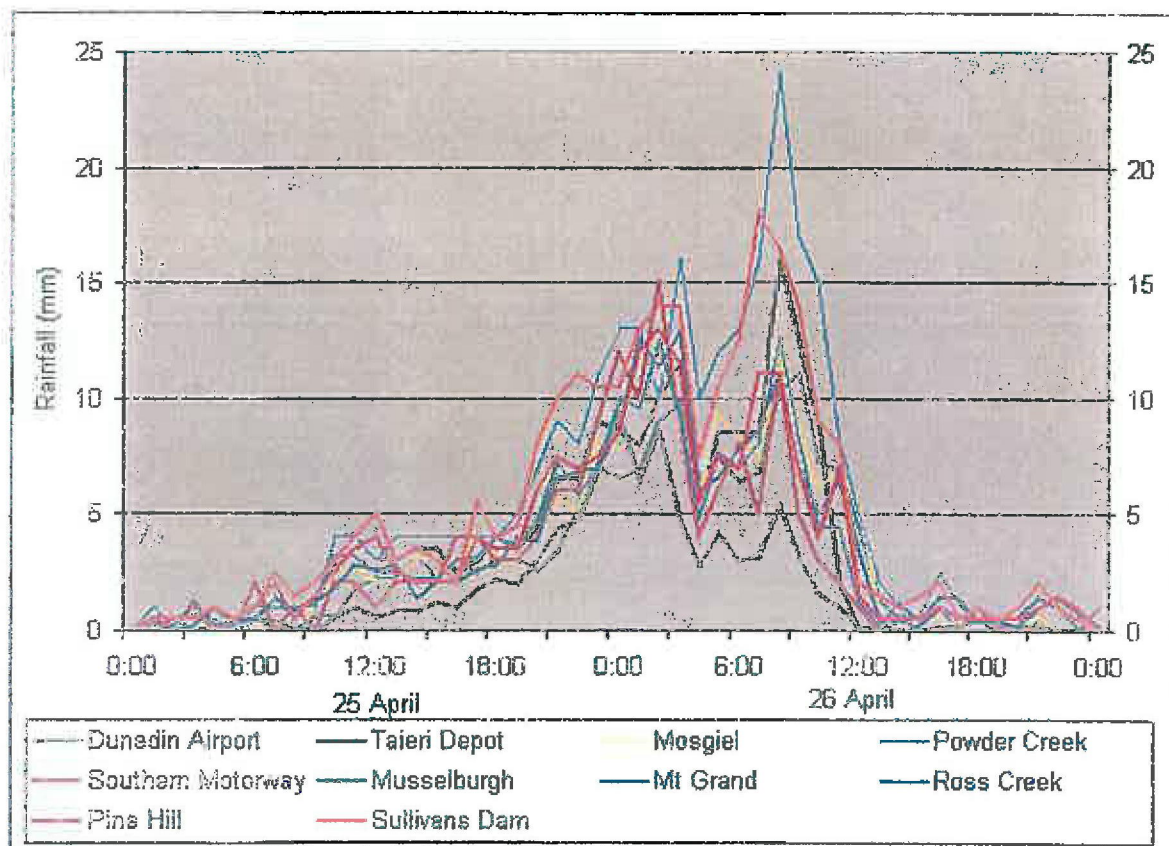
**Figure 7. Hourly rainfalls for Various Sites**

These sites were used in two ways. Firstly, they were used to analyse the distribution of rainfall over time. Figures 7 and 8 show the distributions. Figure 7 shows the hourly rainfalls for each site plotted against time and Figure 8 shows the cumulative total rainfall for each site.

Figure 7 shows that in general, the rainfall pattern through the storm was essentially the same at all sites. The rainfalls started quite lightly but gradually increased in intensity through to about 6pm (1800 hours) on 25 April. Rainfall intensities increased quite rapidly between 5pm on 25 April and 2am on 26 April. Over the next 2 hours intensities fell but by 4am they were increasing again to peak at around

8am. Intensities then fell quite rapidly after that and generally by midday, rainfall intensities had dropped to about 1mm/hour.

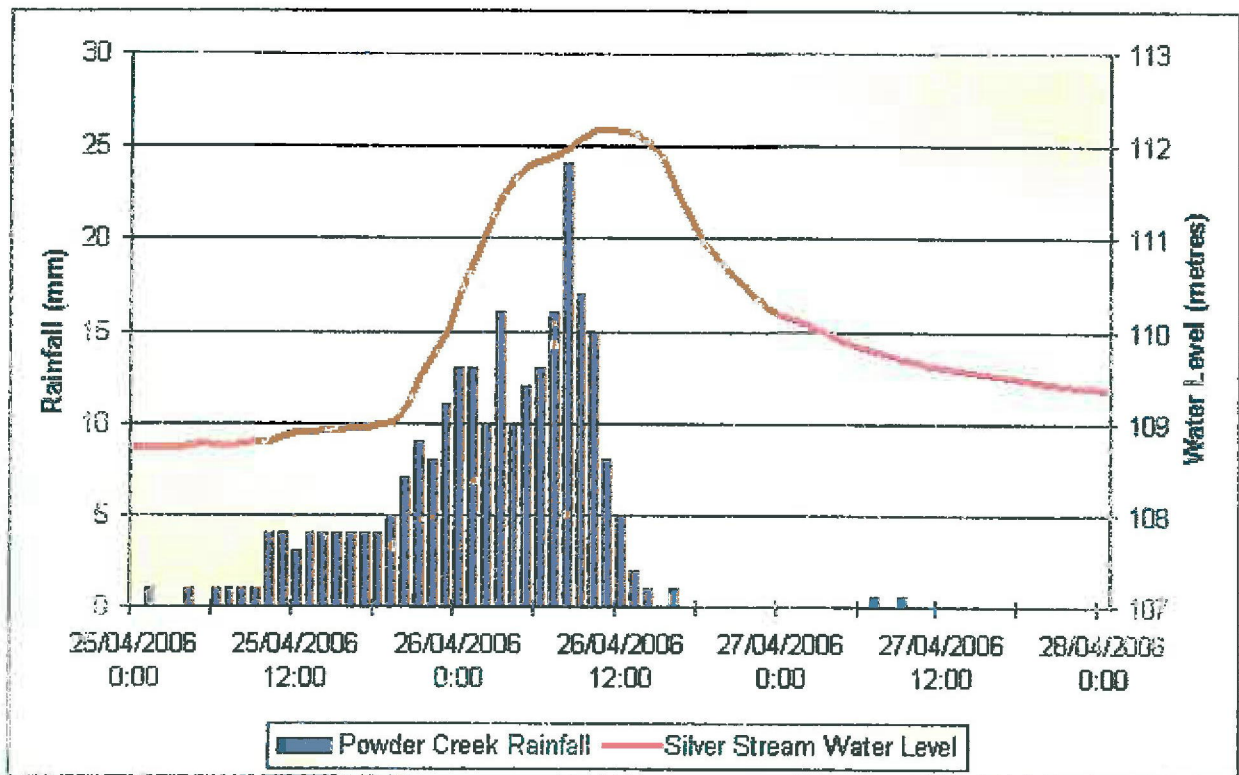
Figure 13. Silver Stream Water Level and Powder Creek Rainfall

Figure 13 is a graph showing hourly rainfall totals (vertical bars) at the Powder Creek raingauge plotted on the same time scale as the measured flood level (metres in Otago datum which is 100m below mean sea level) in the Silver Stream at Riccarton Road as measured by the ORC recorder. This graph shows that the river level

responded quickly to rainfall and that the peak water level occurred at Riccarton Road about 2 hours after the maximum rainfall was recorded at Powder Creek.

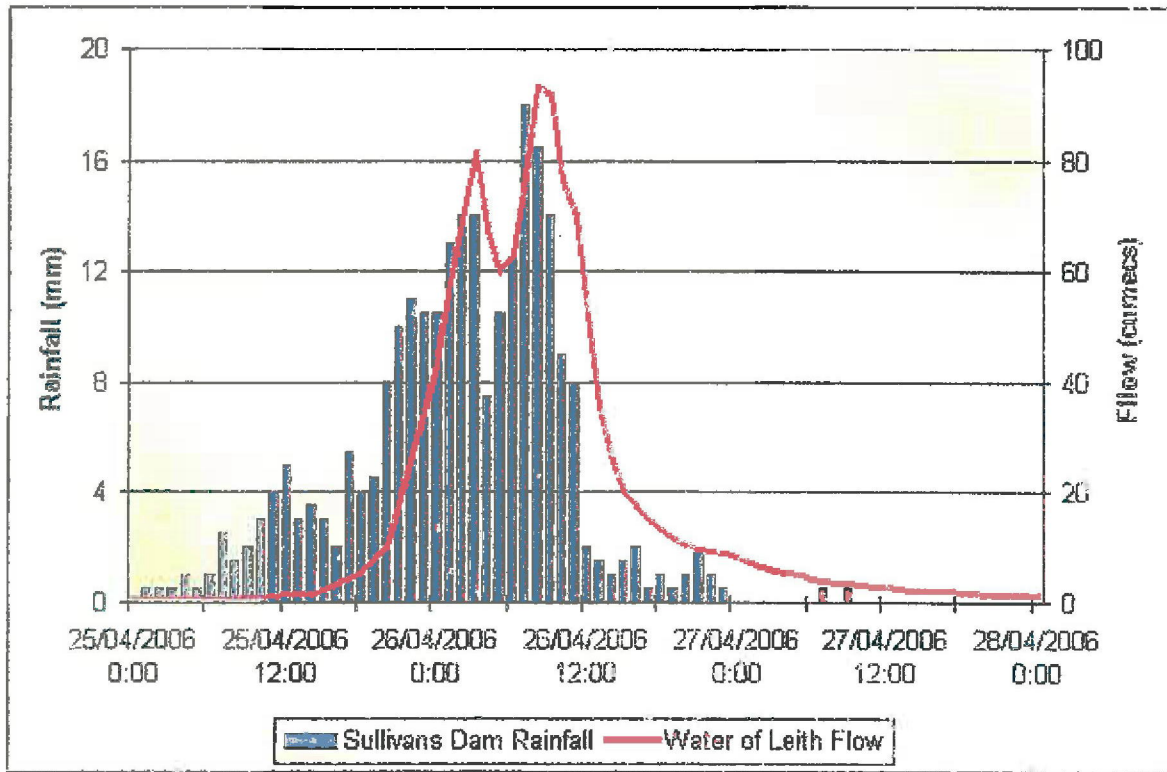
Figure 14. Water of Leith Flow and Sullivans Dam Rainfall

There are peak flow records available for the Water of Leith at University Footbridge for the period 1963 to 2006 and there are some historic floods that can be used in a peak flood return period analysis. Analysis of this entire record shows that the flood event in the Water of Leith at University Footbridge had a return period of about 10 years. A similar sized event is likely to have occurred in Waitati Stream.

It would be possible to derive a record of the flood flows in the Waitati Stream from the Water of Leith measured at the University Footbridge record if the Waitati Stream had not had the blockages caused by debris. These blockages will have caused the water level to rise much more rapidly at times and more slowly at other times at the Waitati township compared with the flood flow record for the Water of Leith. Figure 14 shows the Water of Leith flood flow at the University footbridge plotted with the Sullivans Dam hourly rainfalls. These two graphs are on the same time scale and they show that the Water of Leith is very responsive to rainfall in the catchment. The Waitati Stream would respond similarly if debris had not caused blockages from time to time.
