Ref: 22016

28 March 2022

## **RE: Preliminary Stormwater Management Options – 177 Tomahawk Road, Dunedin**

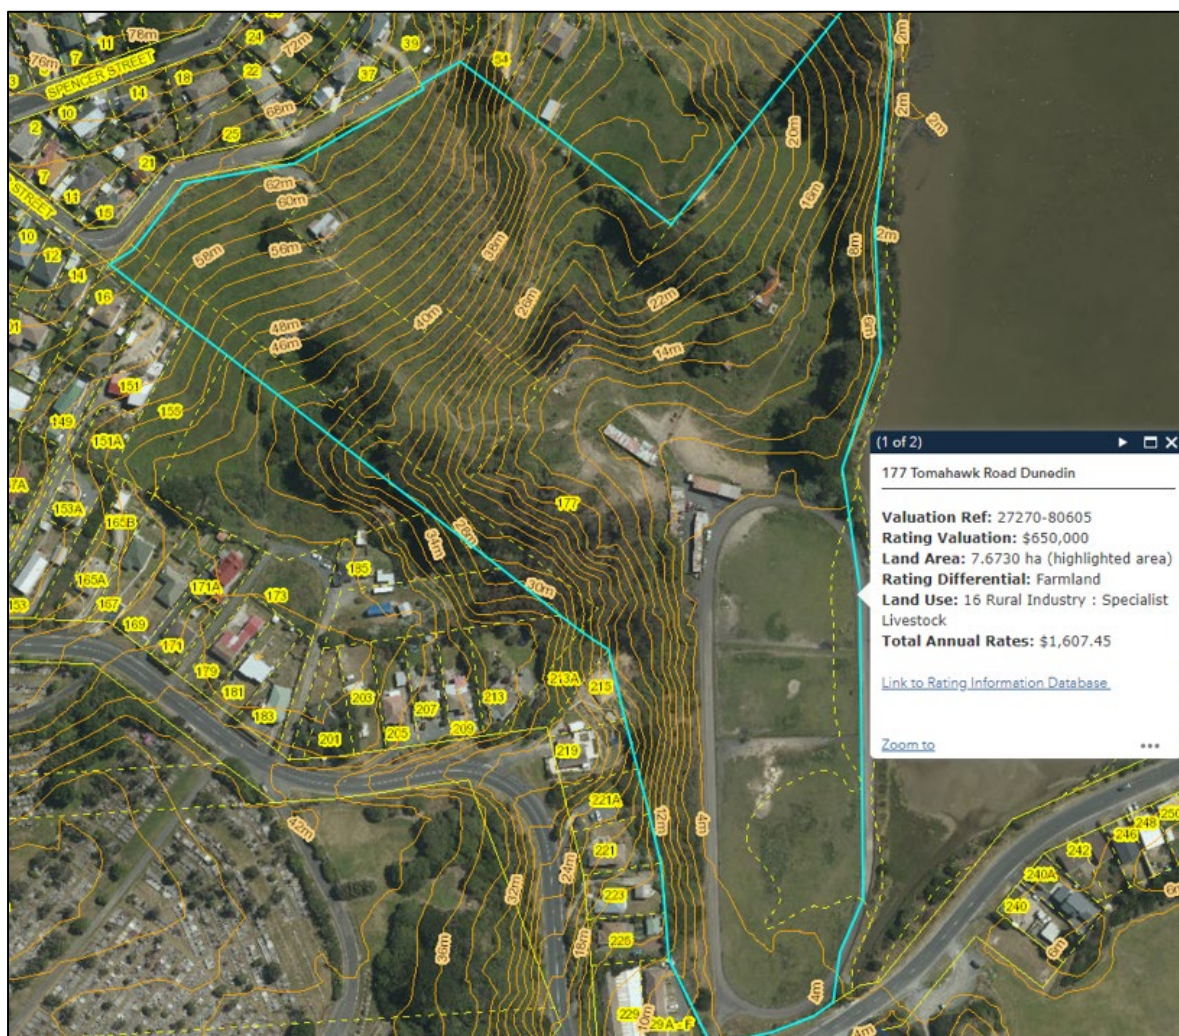
**Figure 2: Site topography (source: DCC webmaps)**

The upper section of the property is moderately sloping adjacent to Gloucester St however transitions to more steeply sloping land in the central area of the site before tapering to a gentle slope which runs out to the lower extent of the property (Figure 2). Two gullies in the central part of the site have associated steep localised slopes, they are well vegetated with broom. The lower section of the property is modified and flattened to form a horse training track.

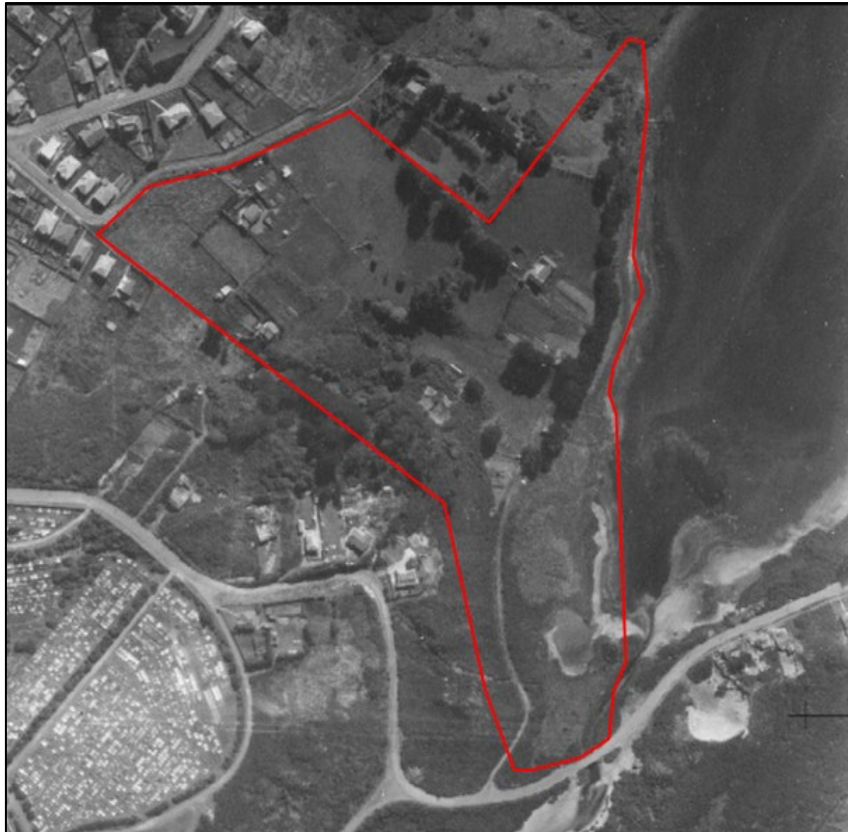
**Figure 3: Retrolens aerial imagery showing less modified margin of Tomahawk Lagoon circa 1947. 177 Tomahawk Road Property boundary indicated by red outline. Sourced from <http://retrolens.nz> and licensed by LINZ CC-BY 3.0**

Historical aerial imagery from 1947 indicate the land marginal to the lagoon margin has been filled to create the existing track infrastructure (Figure 3). Ponding water on the lower paddocks during the site visit (Figure 4) indicate this area may be suited to a constructed wetland.

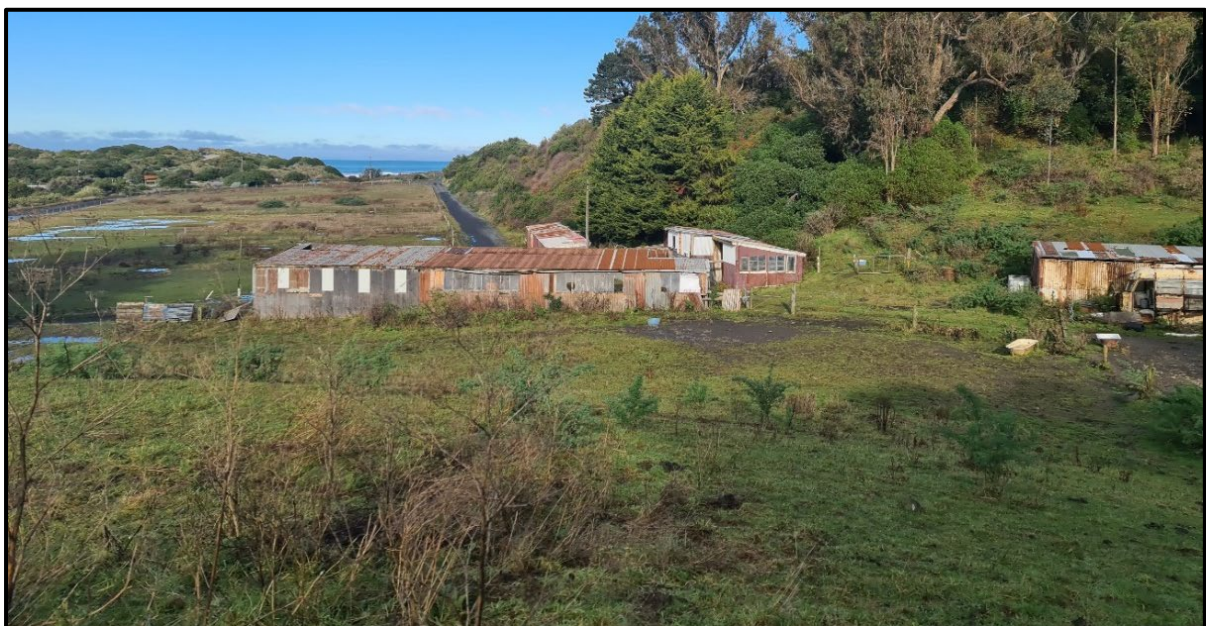
**Figure 4: Site photo of stables and training track. Ponding surface water visible in background.**

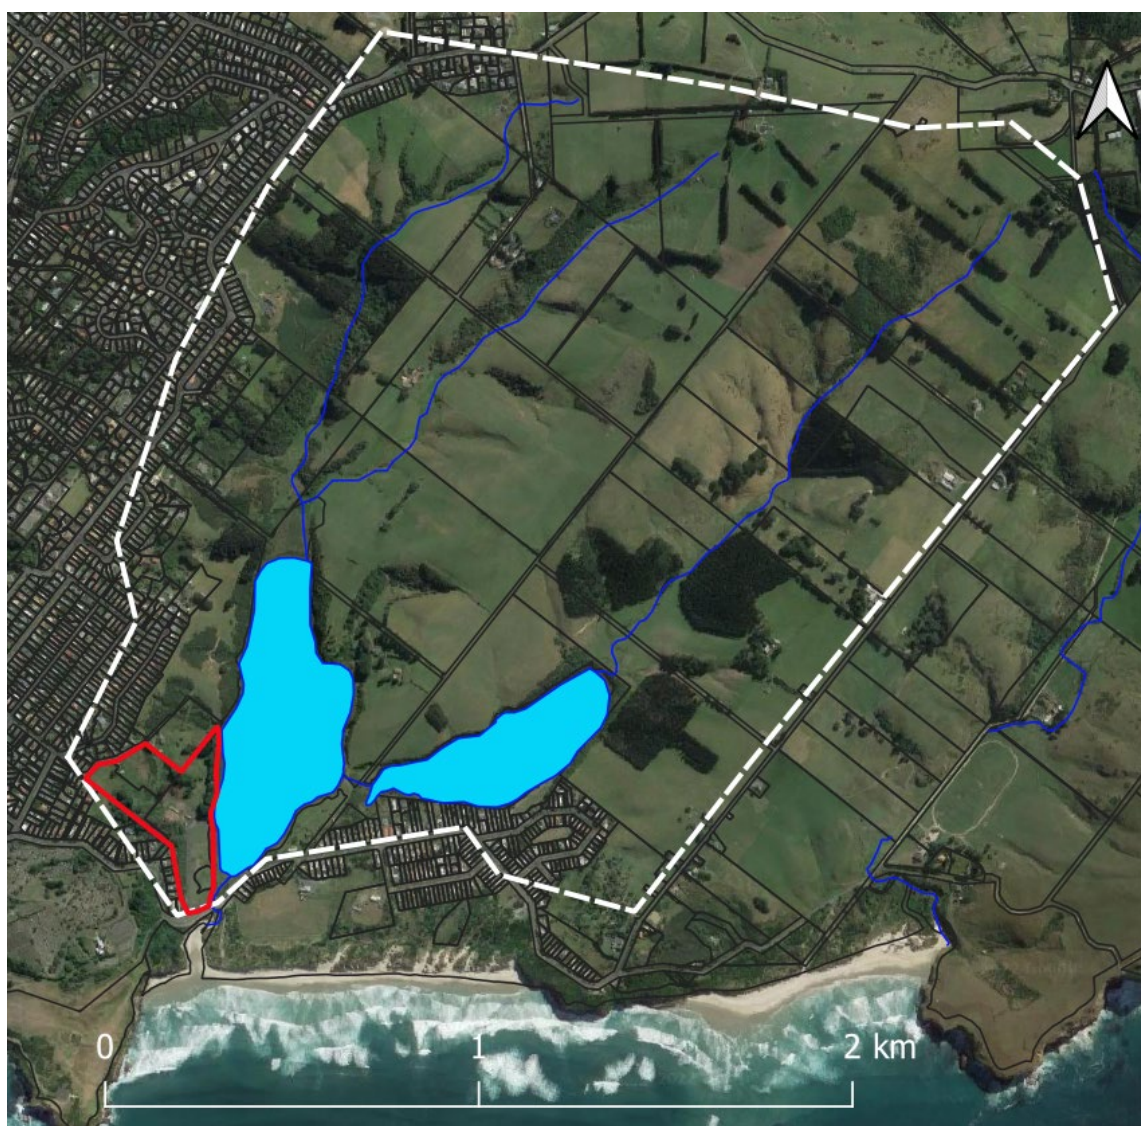
**Figure 5: Tomahawk Lagoon Catchment (white dashed), 177 Tomahawk Road (red), upper and lower lagoons (blue)**

The property is within the Tomahawk Lagoon Catchment. There are no direct discharges of stormwater from the property to the lagoon. Most of the site drains to the flat, low lying training track area where it ponds and soaks to ground (or evaporates). In very high rainfall events it is assumed that water would over flow from the ponding areas to the lagoon. The site is situated close to the lagoon outlet. Figure 5 below shows the proximity of the land to the Tomahawk Lagoon.

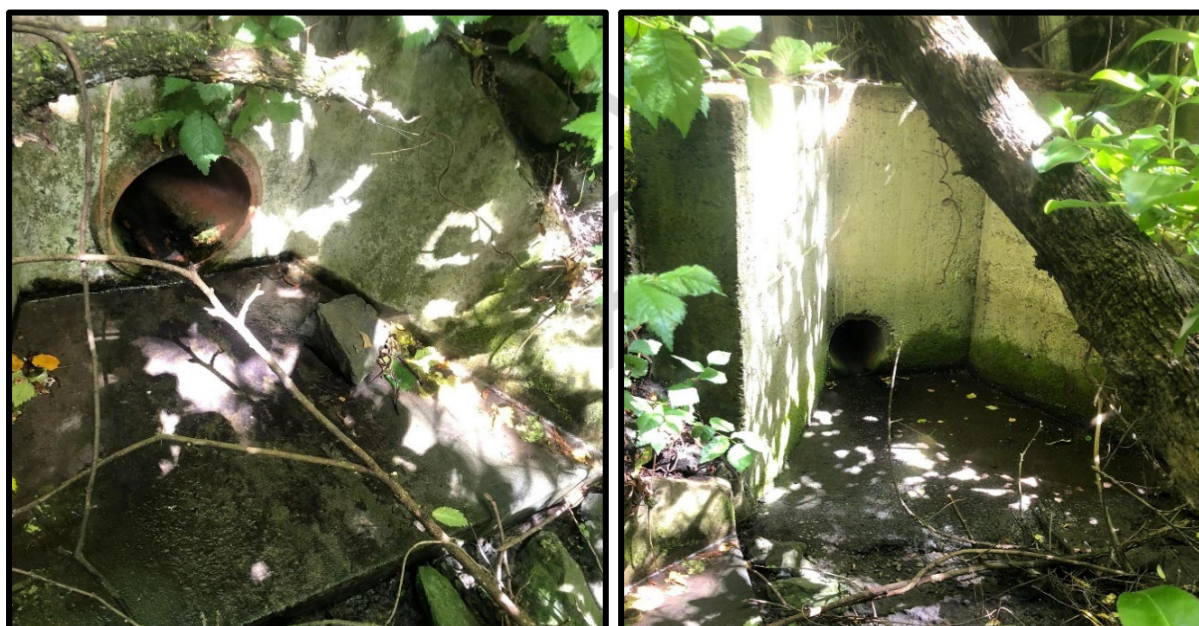
**Figure 7: Stormwater discharge pipes at boundary of 177 Tomahawk Road, with untreated stormwater flowing to a soak hole.**

Stormwater from development southwest of the property currently discharges via two outlets (Figure 7) into the same gully on 177 Tomahawk Road. The stormwater is untreated and causing scour of the hillside and is not retained within the soak hole (Figure 8).

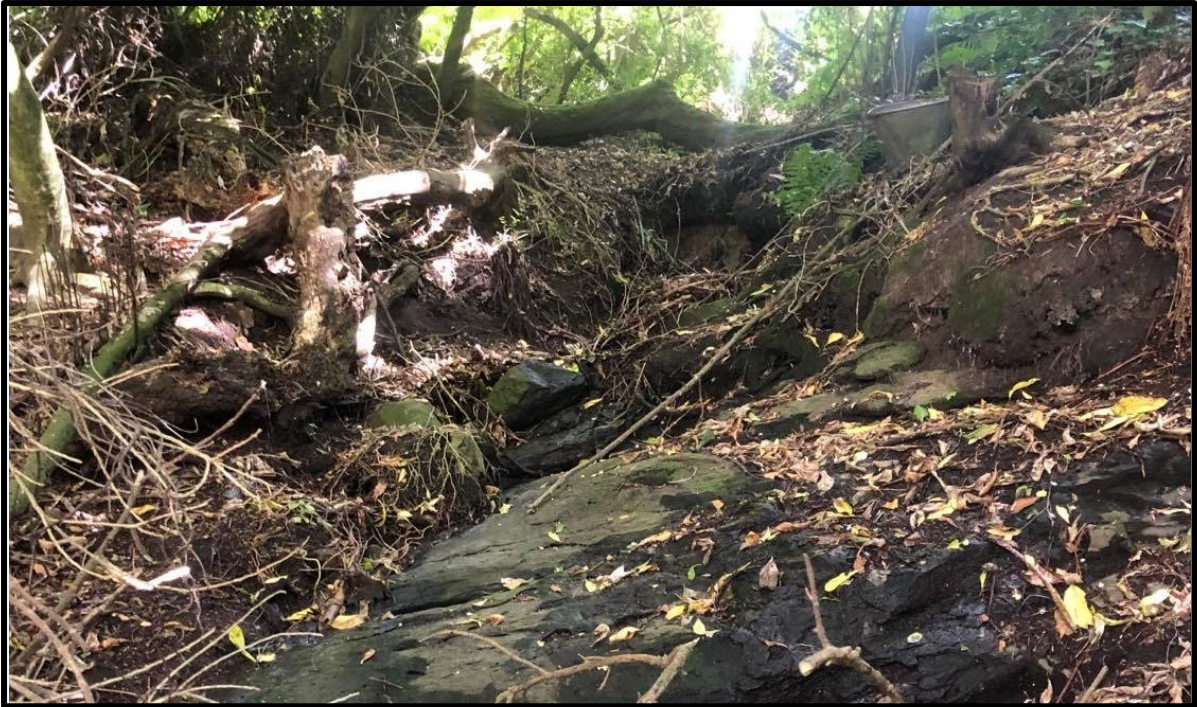
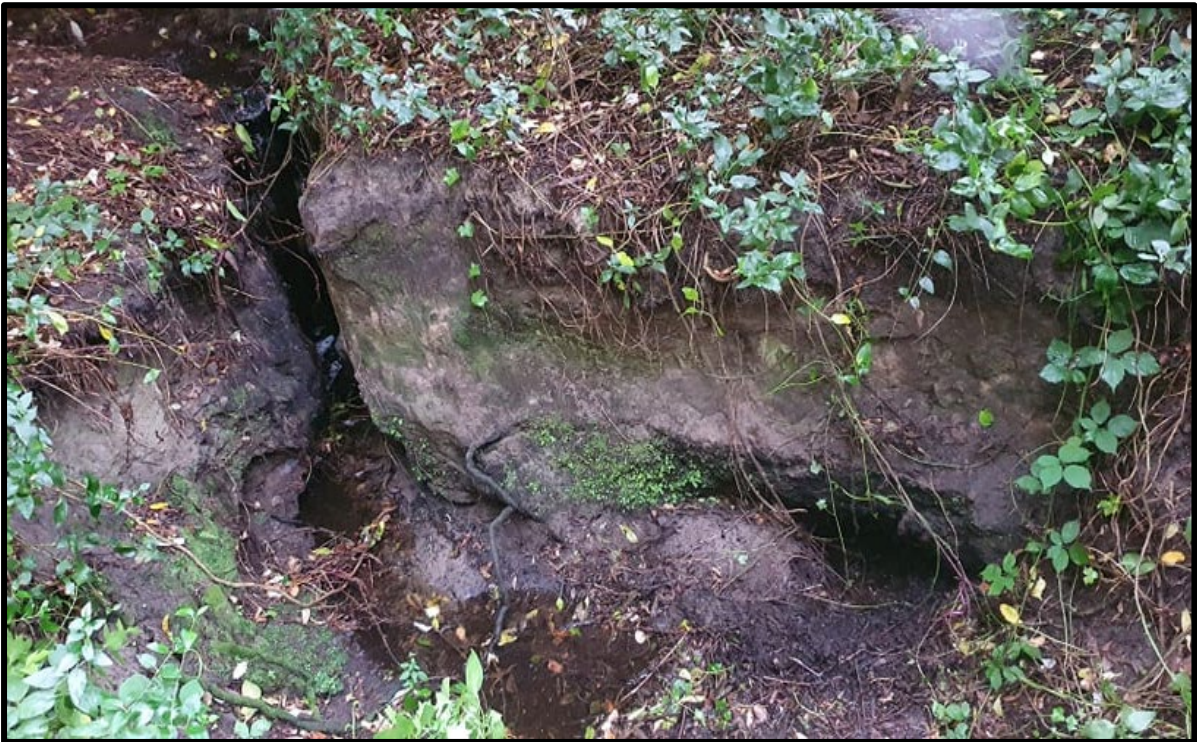
**Figure 8: Stormwater erodes the hillside and enters a deteriorated soak hole where it flows into a 30 cm wide hole within 177 Tomahawk Road.**

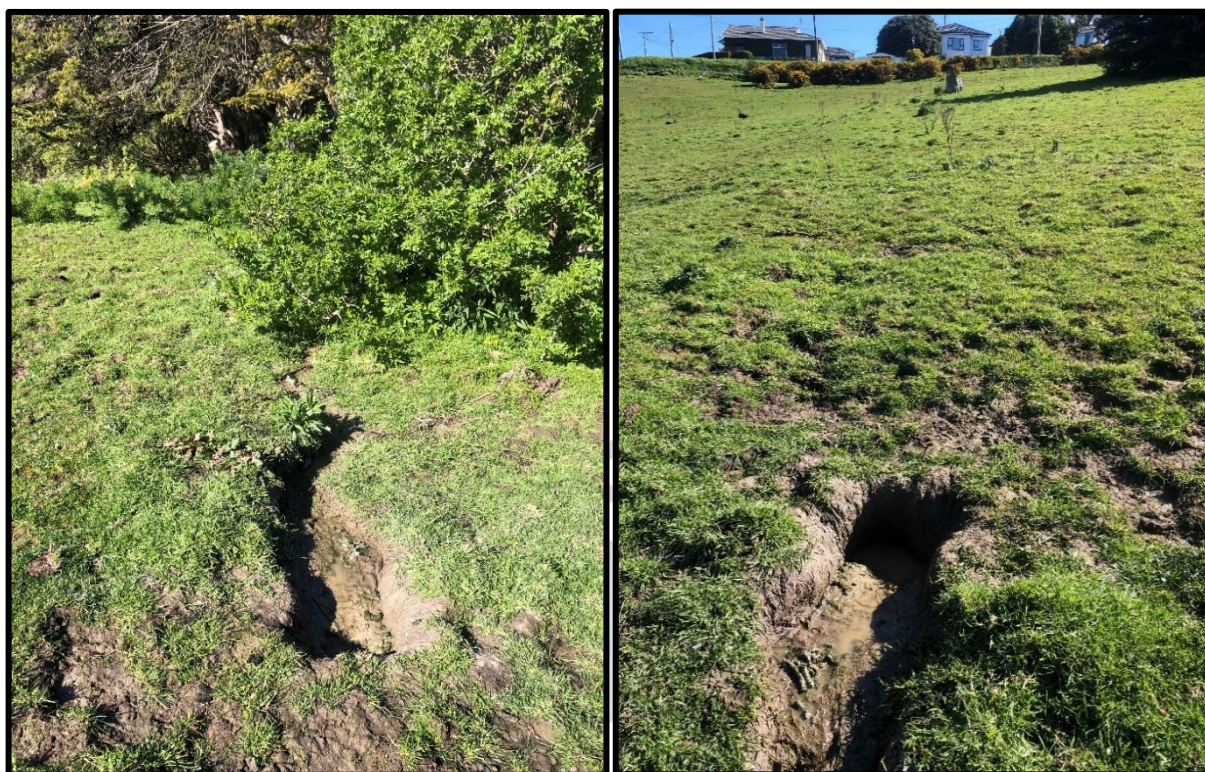
**Figure 9: A natural seep approximately 80 m from the Gloucester Street boundary downhill (left) and uphill (right).**

There is a natural seep present at the top of the property, approximately 80 m from the northwest boundary. The seep reportedly remains wet throughout summer months and flow may be observed during winter (*pers. comm.* Tim Lequeux, 3 December 2021). At the time of the site visit no flow was visible from the seep (Figure 9).

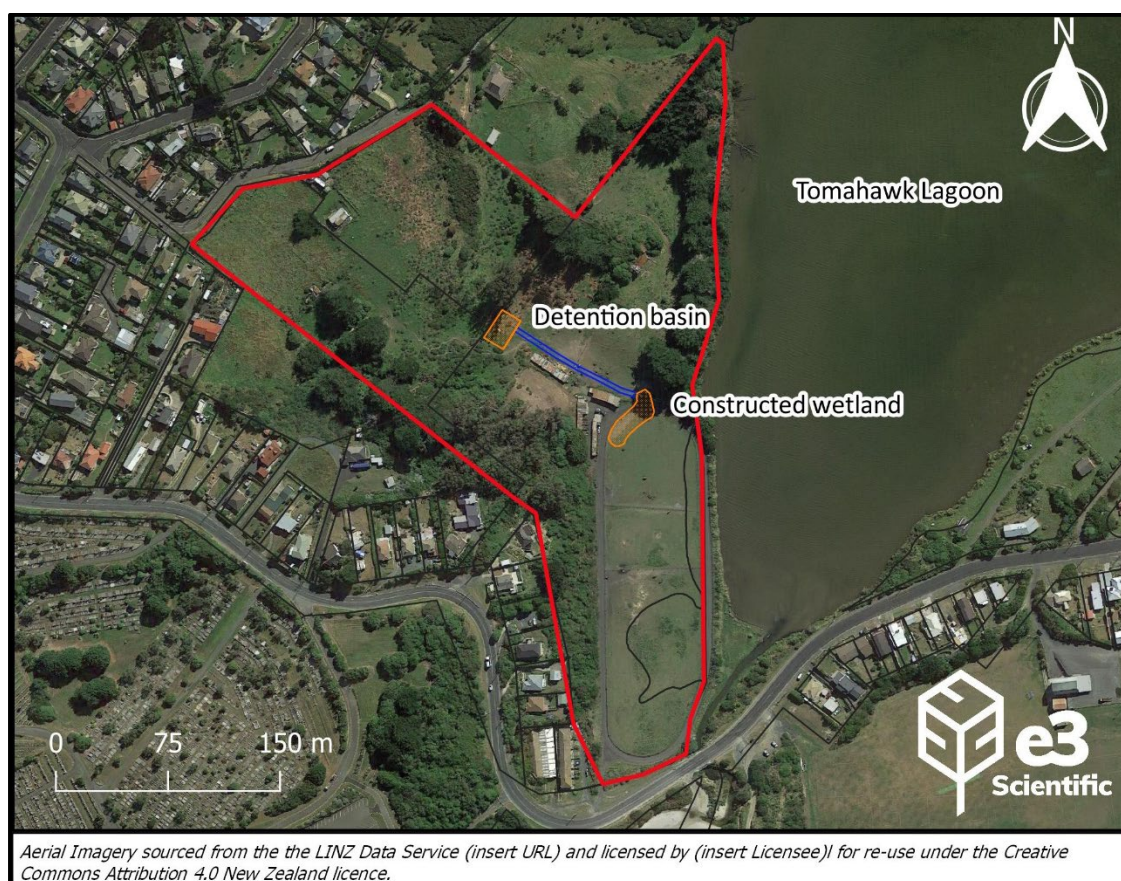
**Figure 11: Proposed stormwater management infrastructure for 177 Tomahawk Road, Dunedin. Blue area indicates swale placement allowing overland flow to enter constructed wetland.**

The proposed location of the stormwater pipe discharge to the detention basin is approximately 130 m west of Tomahawk Lagoon (Figure 11). This discharge point has been selected due to its location outside of the coastal hazards area and coastal character area (Figure 12). Constructing the detention basin at the 12 m contour allows for stormwater quality to be improved prior to reaching the groundwater table. This site is above the area predicted to have a low water table (Barrell, Glassey, Cox, & Smith, 2014). This location is also where the overland flow from the site naturally converges.

The stormwater pipe outlet will have baffles and rock protection to minimise scour and erosion. Stormwater will enter a dry detention basin planted with appropriate native vegetation to capture the 'first flush' of rainfall and allow for contaminants to settle. The stormwater infrastructure design will consider existing soil saturation to ensure small slips and slumps in the property do not occur below the outfall and detention pond. Prior to development progressing, the depth of the water table depth and soakage capacity of the detention basin area will be confirmed to further inform infrastructure design. The detention basin design and planting should have consideration for ecological and landscape values alongside meeting drainage and water quality goals.

Stormwater will drain from the detention pond via a planted 2 m wide swale to provide for additional water quality improvements before entering a constructed wetland. Bunding also planted with native vegetation may be used down slope of the swale to ensure overland flow from extreme rainfall events do not reach the lagoon.

The designated area for the detention basin shown in Figure 11 above is approximately 330 m<sup>2</sup>. This indicates that adequate land is available to treat the
