# Riccarton Road Upgrade Landscape Effects Assessment

22 October 2009

## **Introduction**

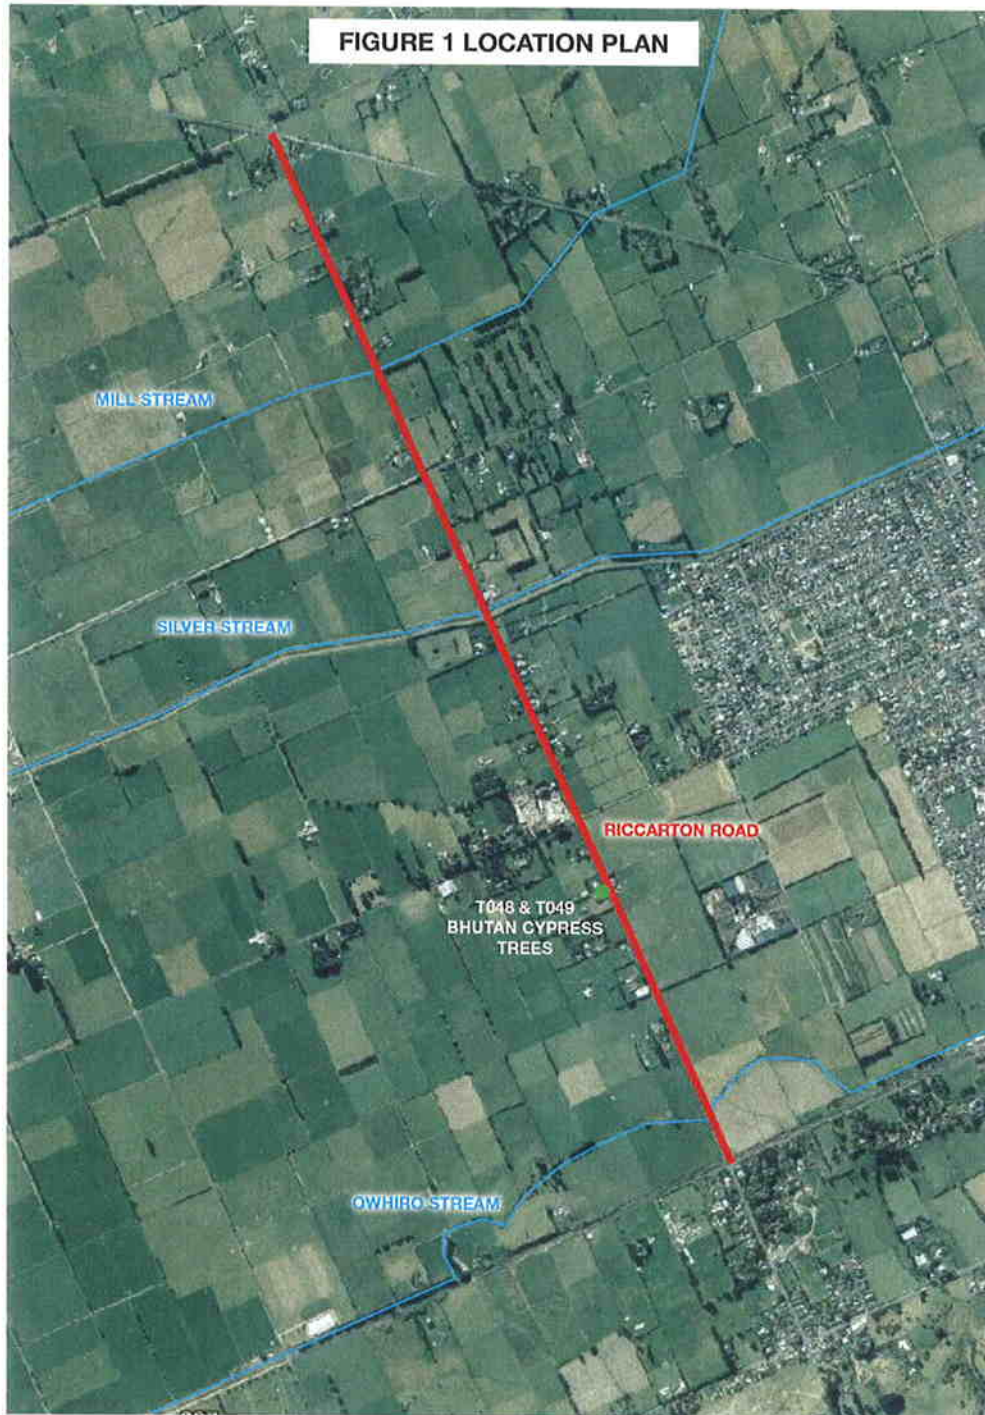
Riccarton Road runs more or less north – south in a straight alignment along the western side of Mosgiel. It intersects with State Highway 87 in the north and State Highway 1 in the south. Its landscape context is the northern Taieri plain and the topography is flat. Figure 1 illustrates its location.

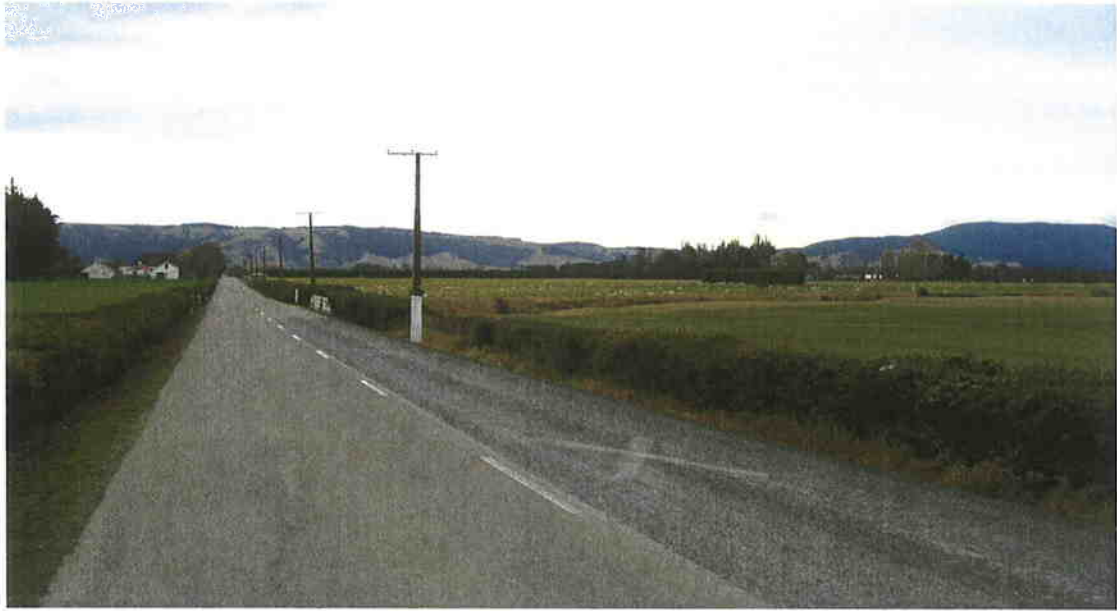
*Figure 2 : Riccarton Road crossing Owhiro Stream defined by gorse hedges.*

Riccarton Road crosses three streams along its route. These are Mill Stream, Silver Stream and Owhiro Stream. The natural character of all these waterways has been severely modified by channeling and the construction of stopbanks. The road rises to a crest at the Silver Stream bridge.

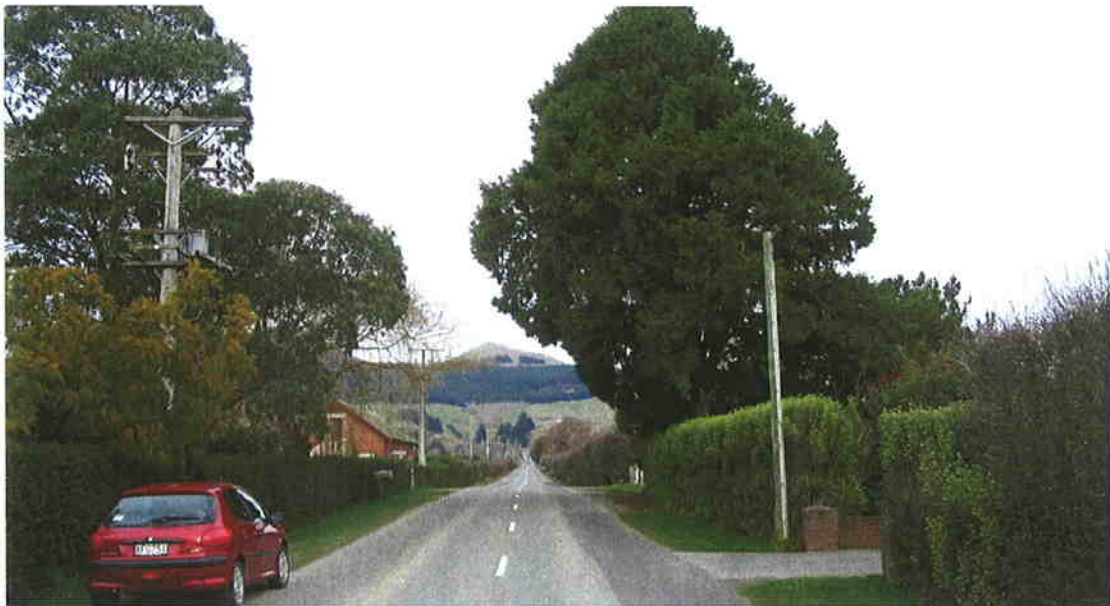
*Figure 3: The protected Bhutan Cypress trees at 119 Riccarton Road, the barn across the road and the well maintained hedges are elements that enhance the landscape*

Two significant Bhutan Cypress trees listed in Schedule 25.3 in the Dunedin City district Plan, located at 119 Riccarton Rd will be retained by weaving the shared path around their western side. This provides for two important landscape elements to remain whilst avoiding adversely affecting an attractive barn and associated plantings on the opposite side of the road. It does mean however that additional designated road width is required at this point with the associated impacts on the private properties at 119 and 117 Riccarton Rd.

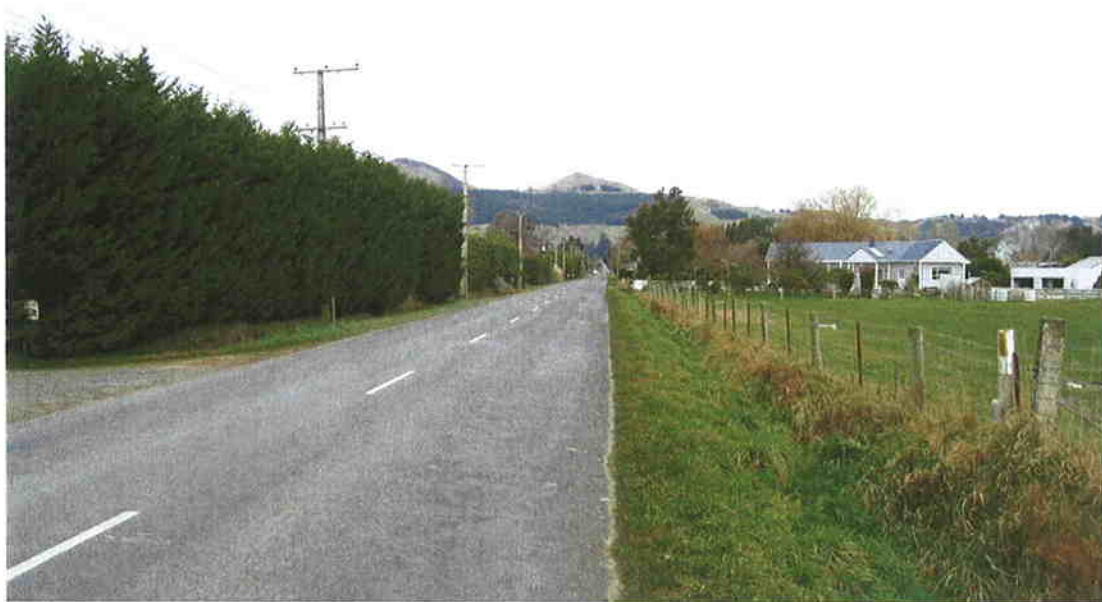
*Figure 4 : Riccarton Rd looking south-east. The plantings on the left side provide strong separation between the road and houses whilst those on the right provide a much weaker buffer.*
