Appendix 6: Building Assessments (external)

10.1 South Side of Road

10.3 Associated Features

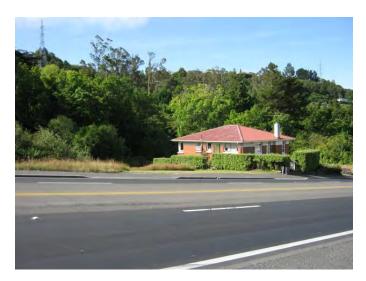
152 Caversham Valley Road

Brick dwelling with hipped roof and no heritage values. Dwelling indicative of design influences of the middle of the twentieth century.

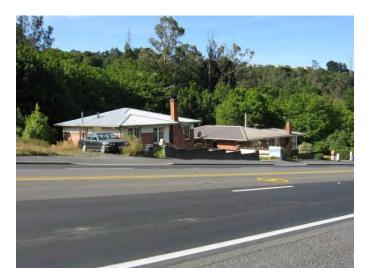
168 Caversham Valley Road

Brick dwelling with gabled hipped roof and no heritage values. Dwelling indicative of design influences of the middle of the twentieth century.

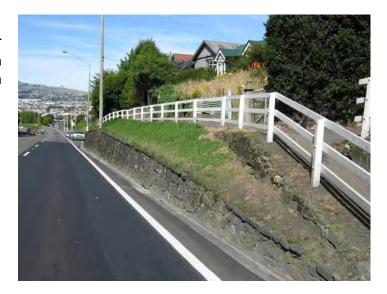
Rock Wall Section 1 (1931)

Blue stone retaining wall for roadway and provides footpath access to houses. Random rubble, cement mortar.

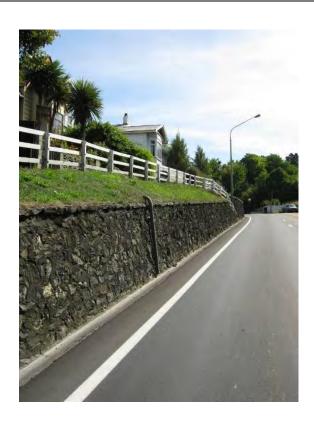
Rock Wall Section 2 (1931)
As with section 1. With some overlay Portland Cement repairs.

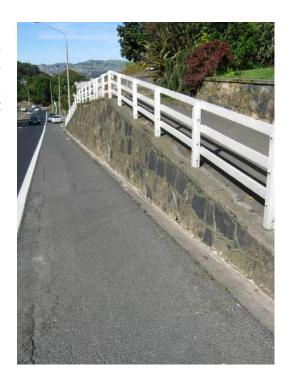
Rock Wall Section 3 (1933)

Regularly shaped blue stone retaining wall for road edge and footpath. Adjacent houses have similar retaining walls at the front boundaries. Square cut stone, regularly coursed with a 'tuck pointed' finish to the mortar.

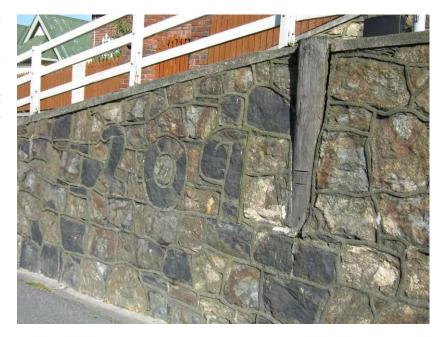
The most distinctive feature of this section is the clear '209' stone worked number. This is thought to refer to the road crew that built the wall as it bears no reference to the addresses around it.

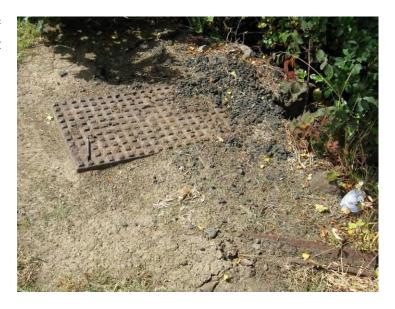
Laing Street on north side of railway overbridge abutment remains.

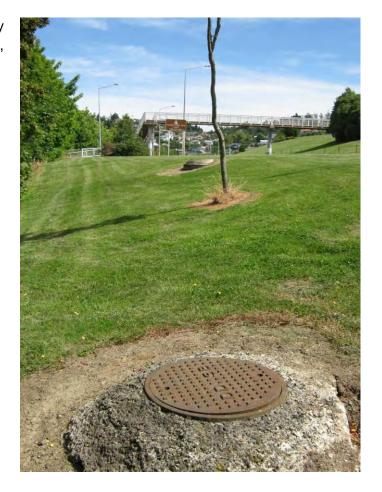
Water mains access by Goodall Street footbridge, south side of road

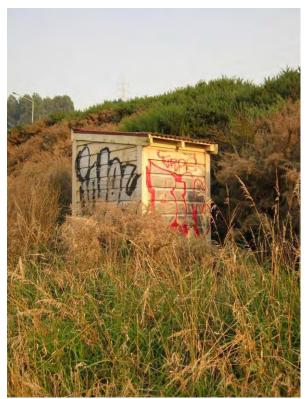
MOW shed opposite old Caversham Station

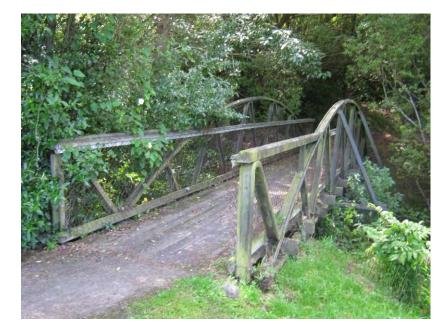
Relocated railway footbridge. Currently over Gas Works Creek and the current Goodall St footbridge will be placed downstream, by the existing road margin.

Close up of railway footbridge iron – NZ made 10 pound railway track..
