CARISBROOK STADIUM TRUST

**Preliminary Ground
Contamination Investigation
Spectator Events and Education
Zone - Dunedin: FINAL ISSUE**

December 2007

T&T Ref: 51219

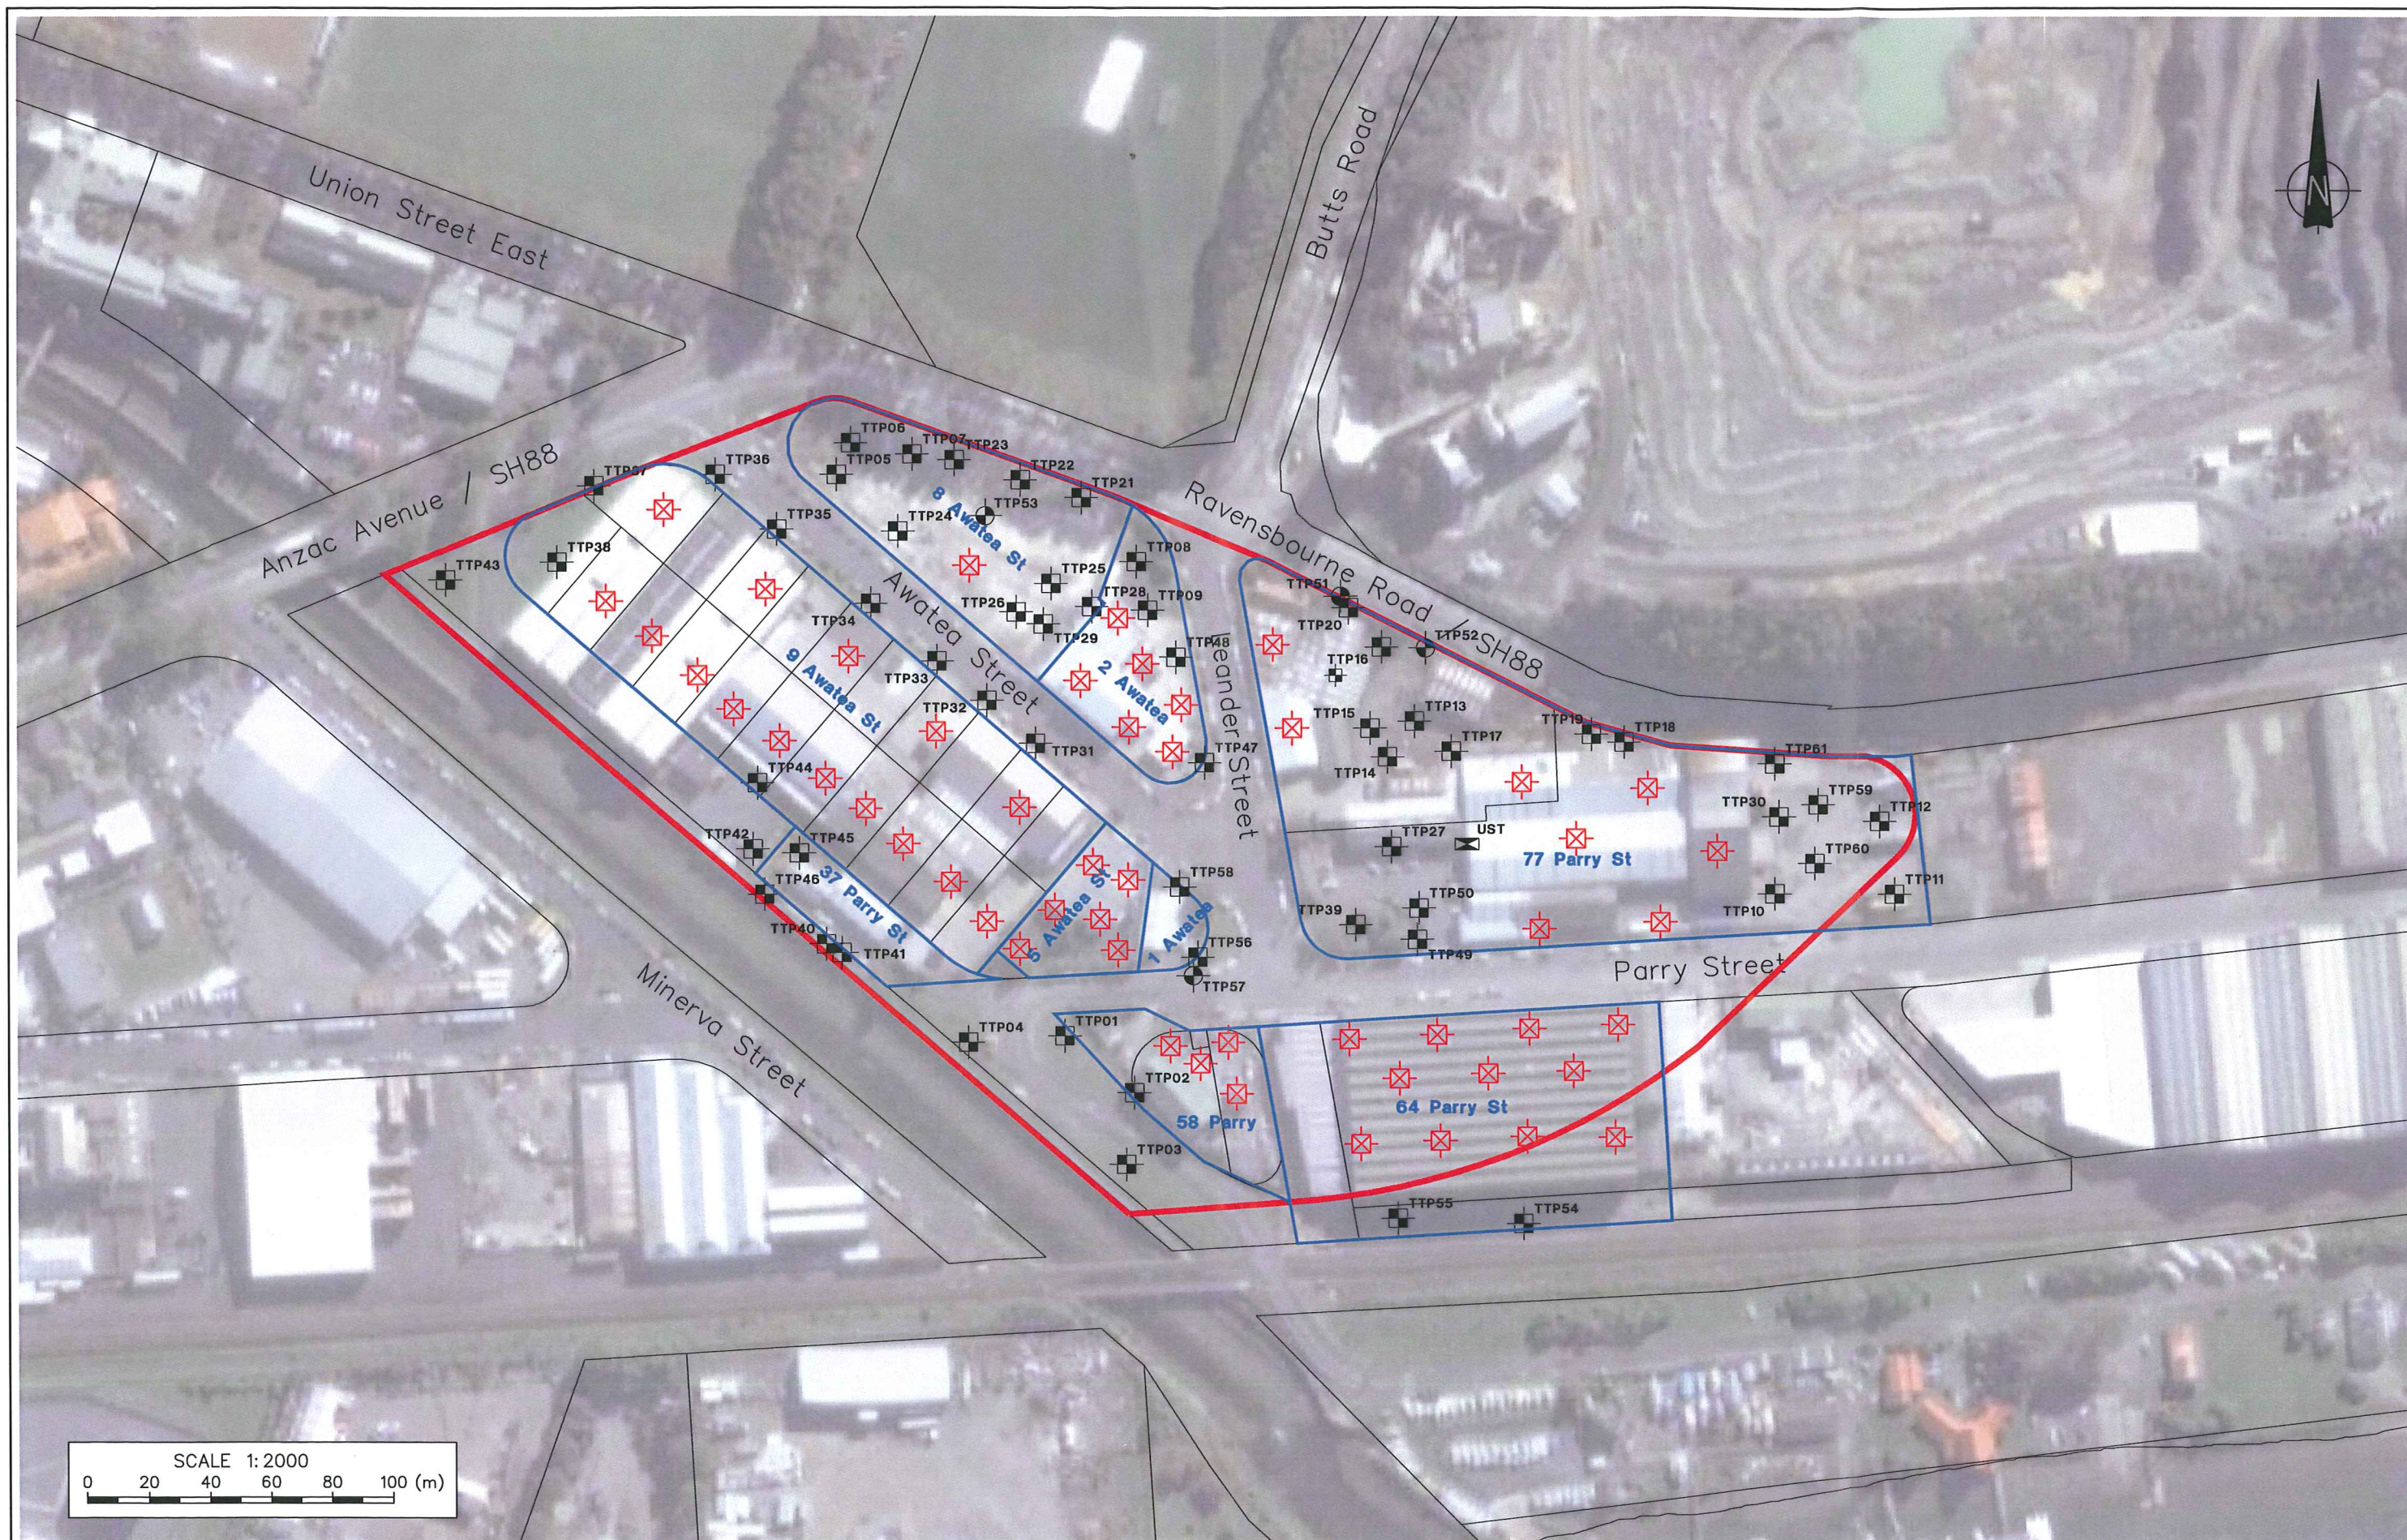
P:\51219\WorkingMaterial\CAD\Figure 2.dwg, Layout1, 30/11/2007 9:51:07 a.m., 1:1

An underground storage tank was noted at this location. It appears to have an inlet coming from the former wool scour building. It is possible this tank was used to store waste water from the wool scouring process. The UST location is shown on Figure 2, Appendix A.

To provide a 95% confidence that all hotspots with a diameter larger than 25m are detected across the site, the full set of sample locations should be undertaken. Targeted investigation of other potential sources of contamination, including a solvent-like odour and an Underground Storage Tank (UST) on 77 Parry Street are also recommended.
