OCEAN BEACH SURVEY

FINAL REPORT 2018 - 2020

A Report to the Dunedin City Council
Nguyen Minh Duc & Mike Hilton
School of Geography
University of Otago

11th March 2021

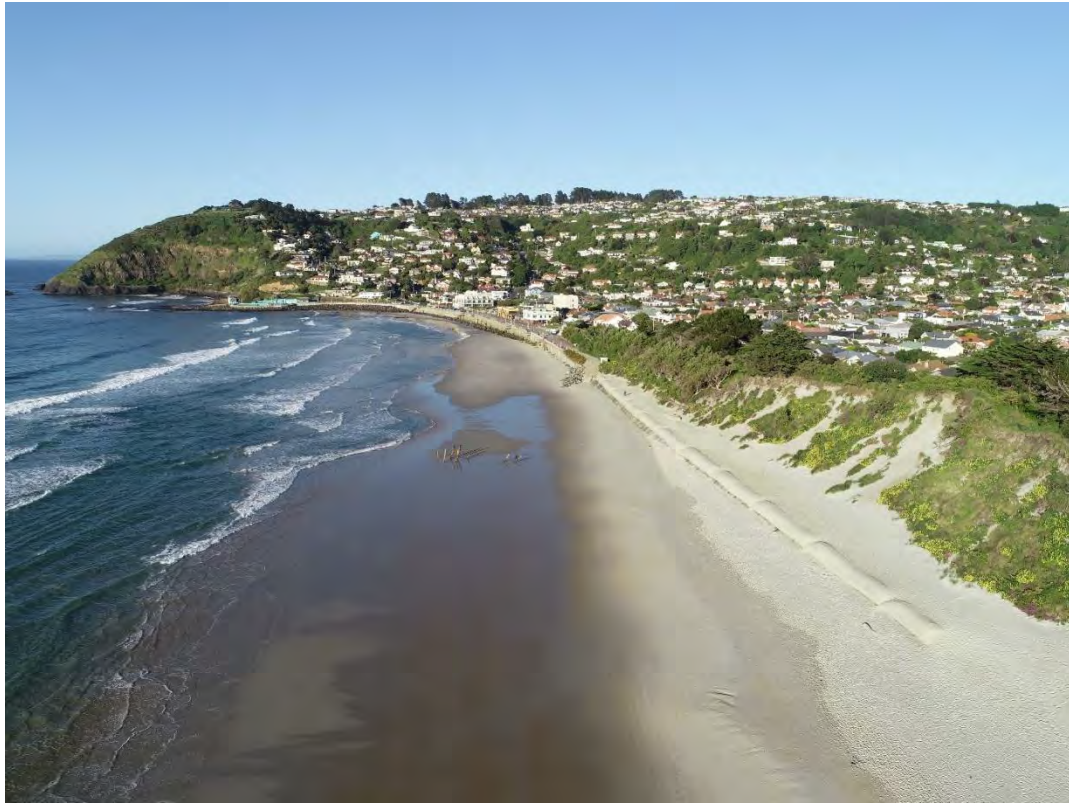
Figure 2.2: Oblique UAV photo of the Area 1 shoreline on the 25th November 2019.

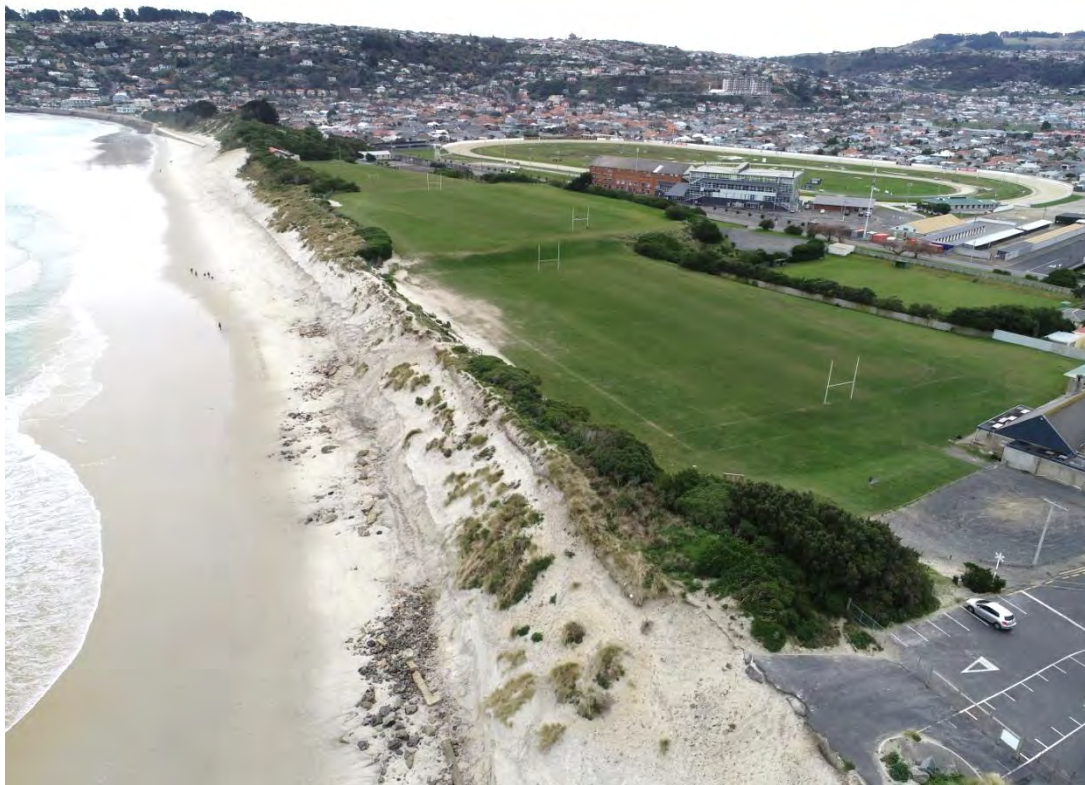
Figure 2.3: Oblique UAV photo of the Area 2 shoreline on the 8th August 2019.

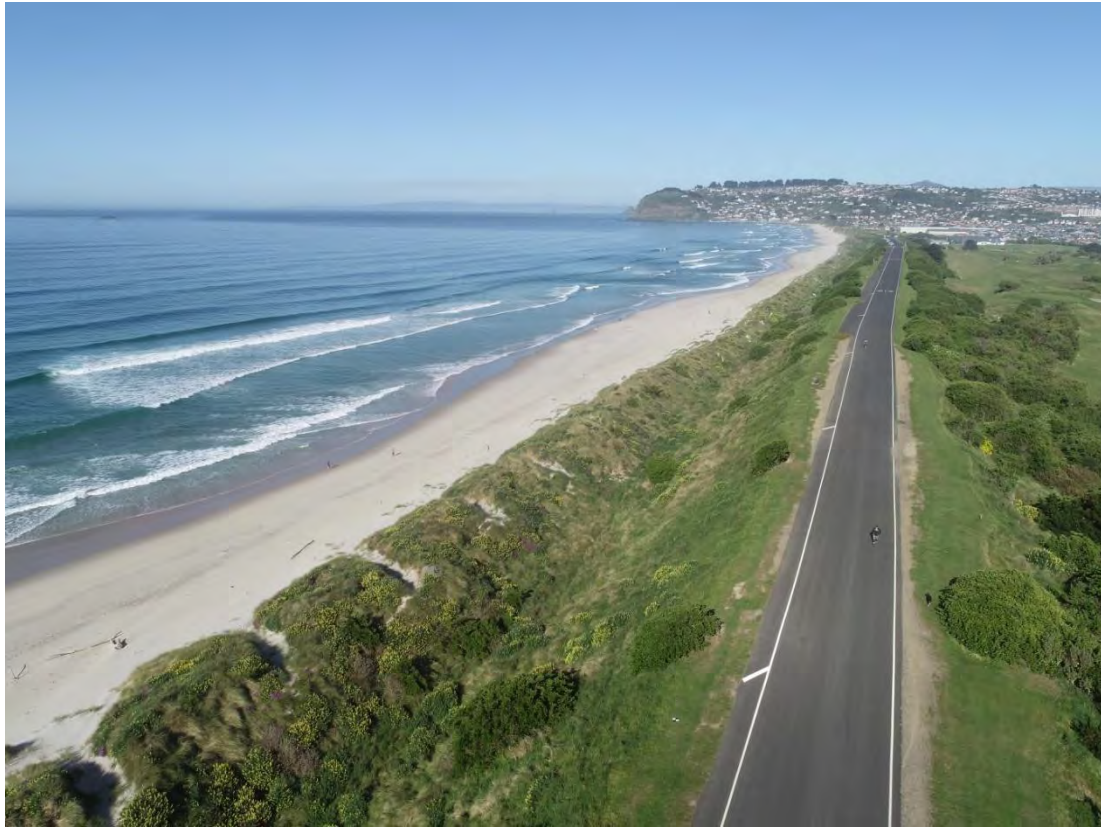
Figure 2.4: Oblique UAV photo of the Area 3&4 shoreline on the 4th November 2020.

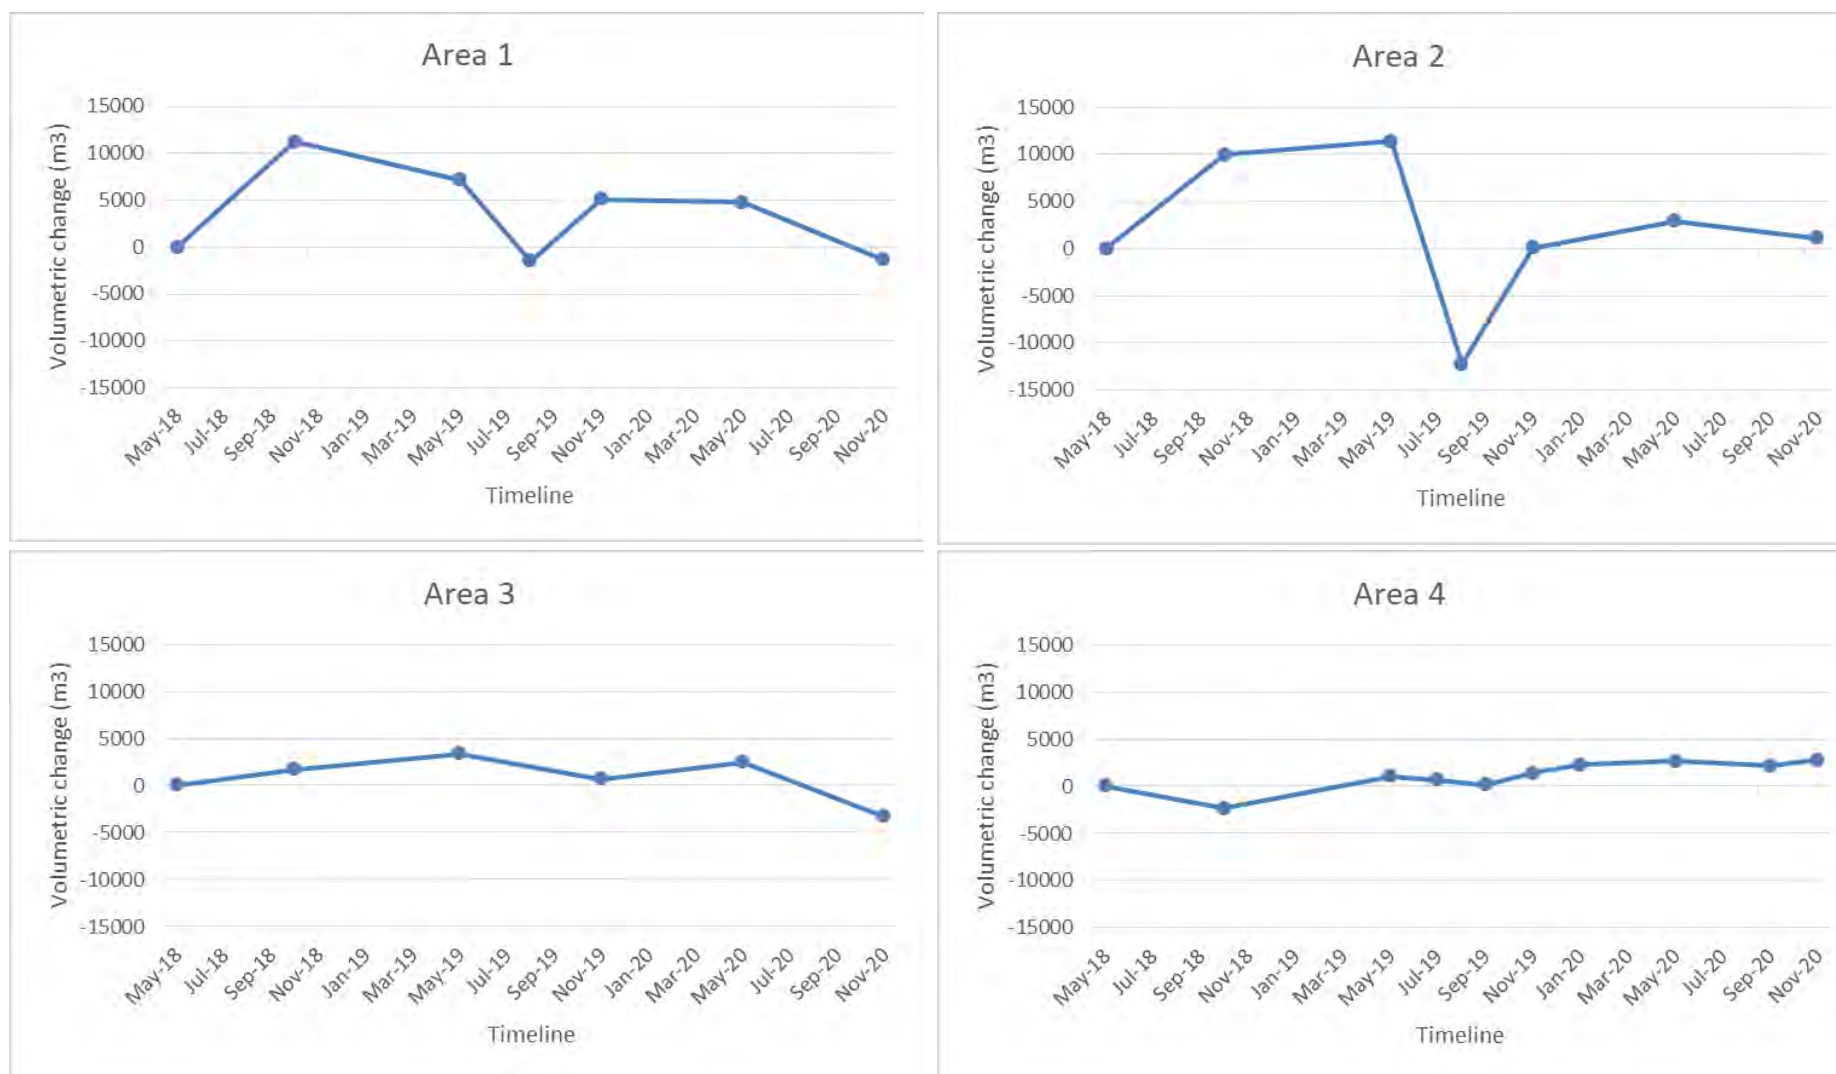
Figure 5.37: Time-series of volumetric sand change in 4 survey areas between the 29th May 2018 and the 11th November 2020.

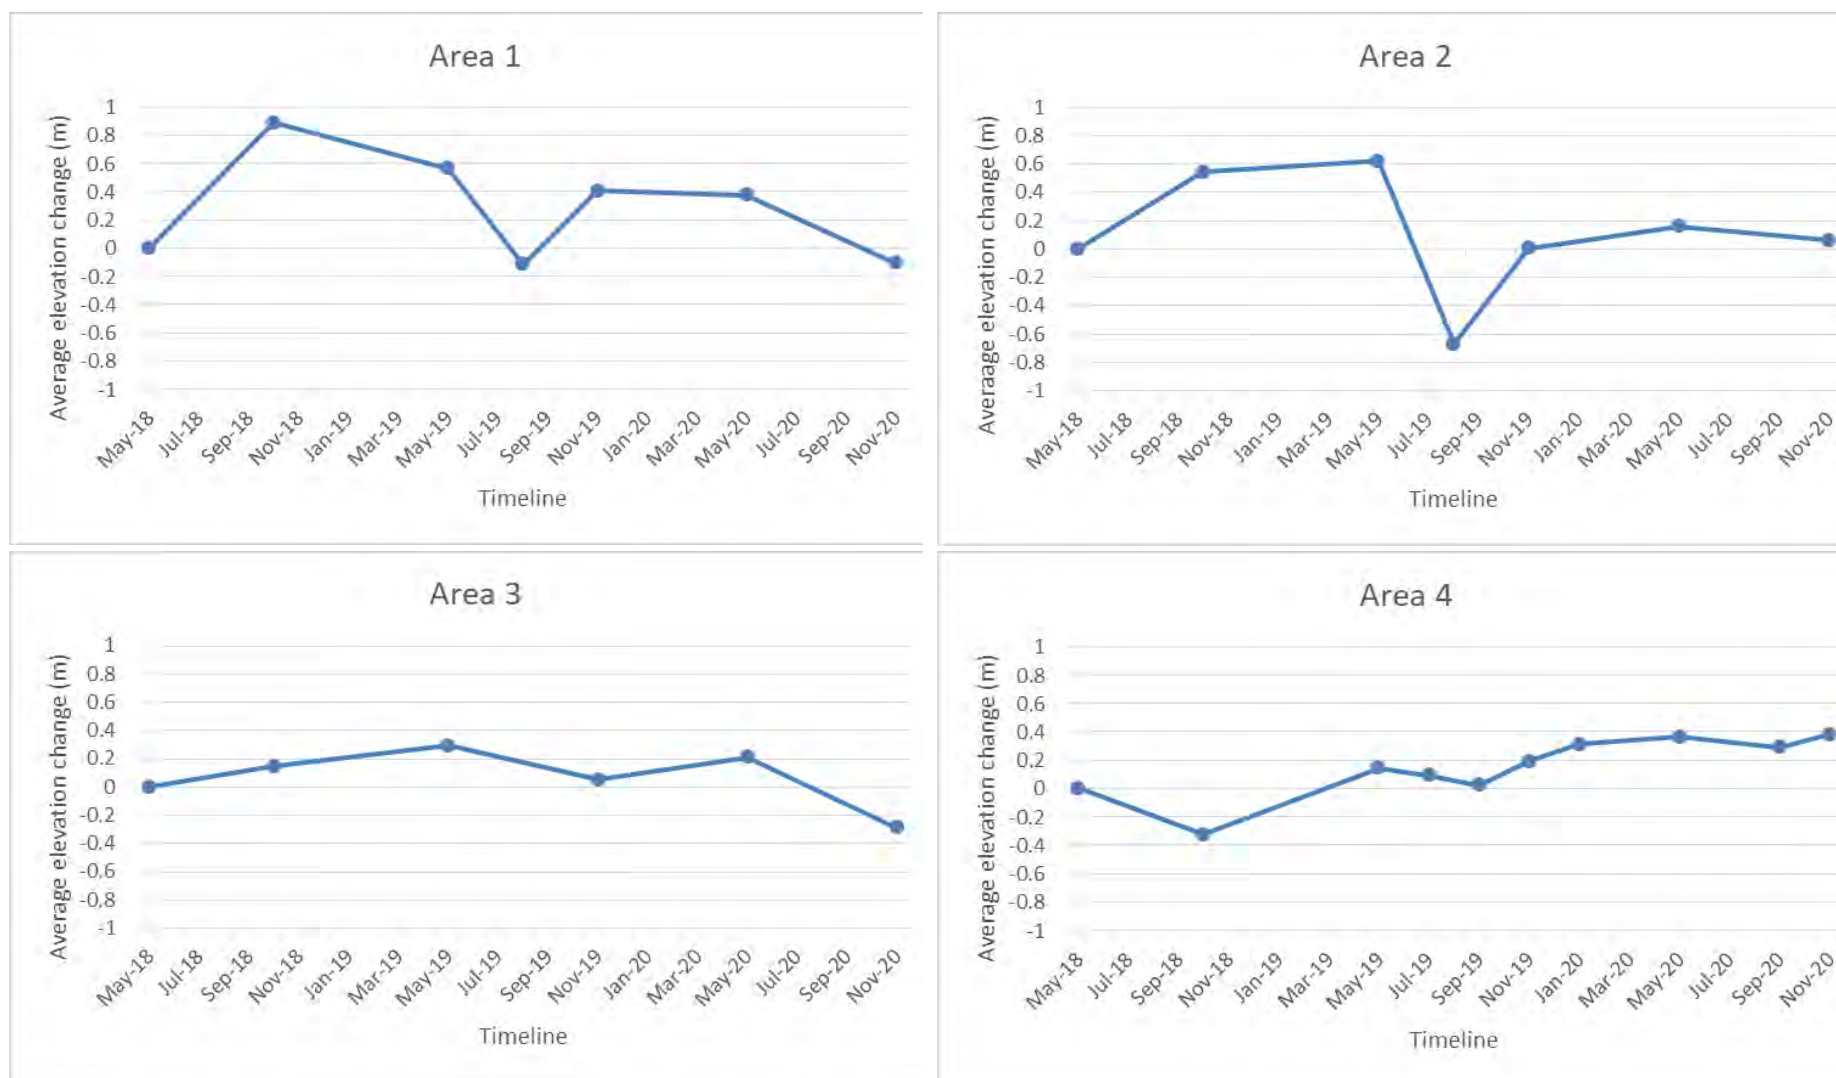
Figure 5.38: Time-series of beach elevation change in 4 survey areas between the 29th May 2018 and the 11th November 2020.

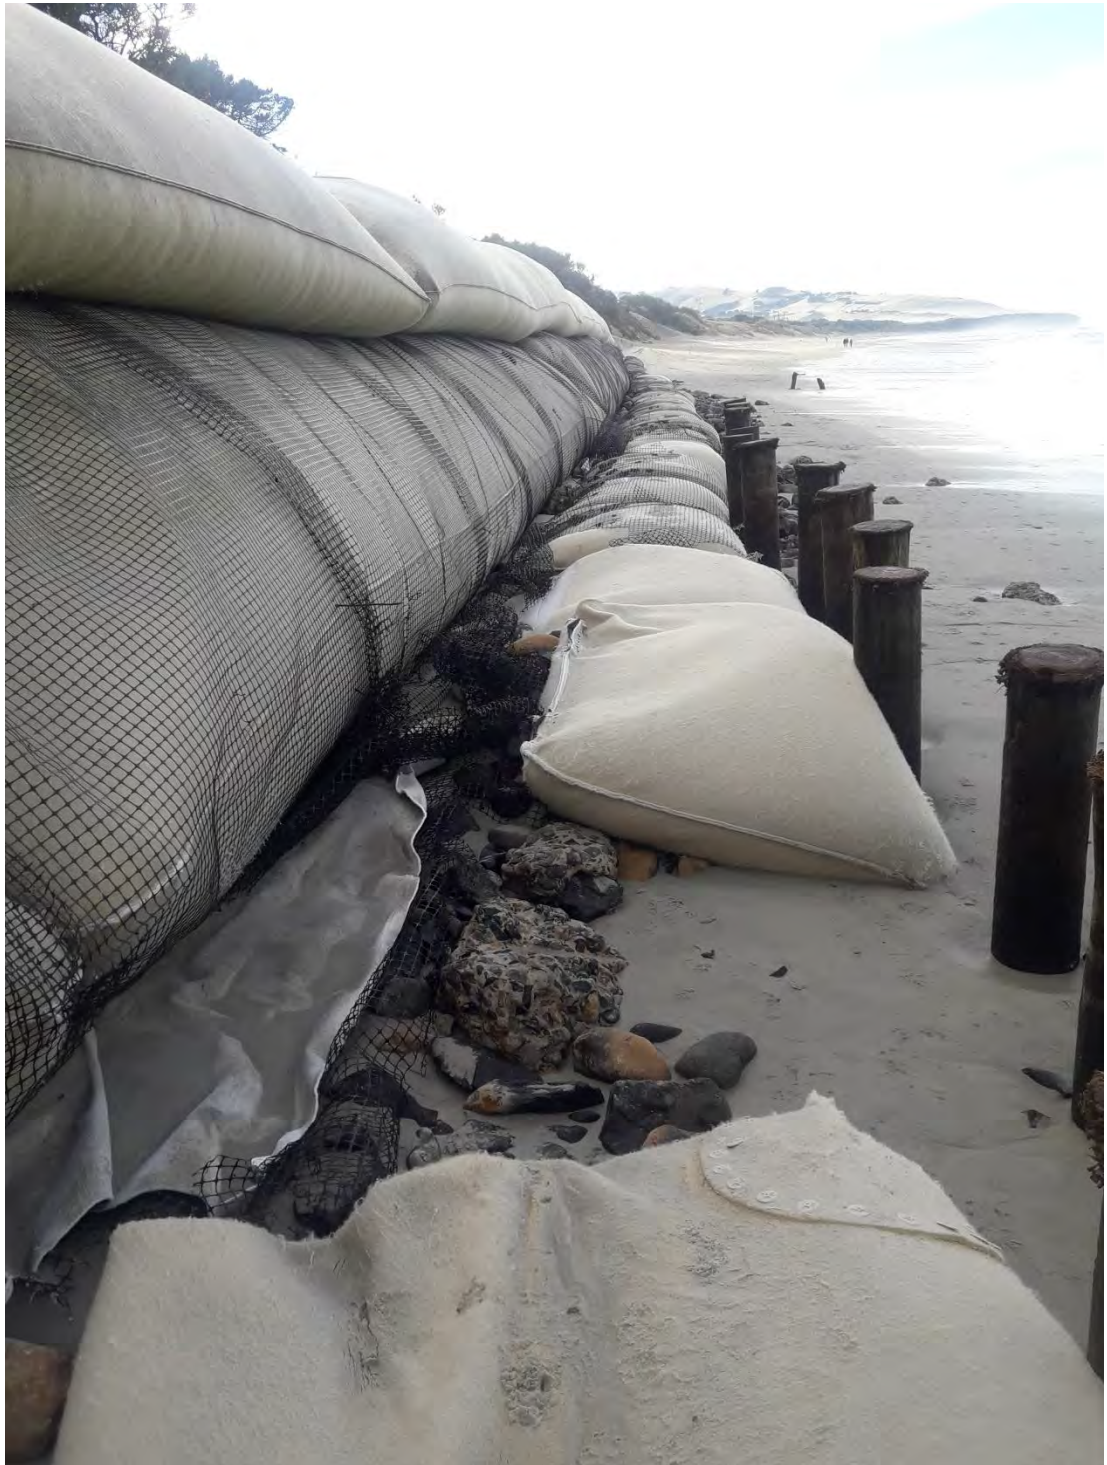
Overall in 2018 – 2020 periods, the beach in Area 1 appears to be vulnerable to erosion, especially during autumn - winter time. The geotextile tubes were broken after the autumn storm on early May 2019 (Figure 7.1). The beach generally is more stable during summer time.

Figure 7.1: Broken geotextile tube on early May 2019 after autumn storm. Photo: Tom Simons-Smith

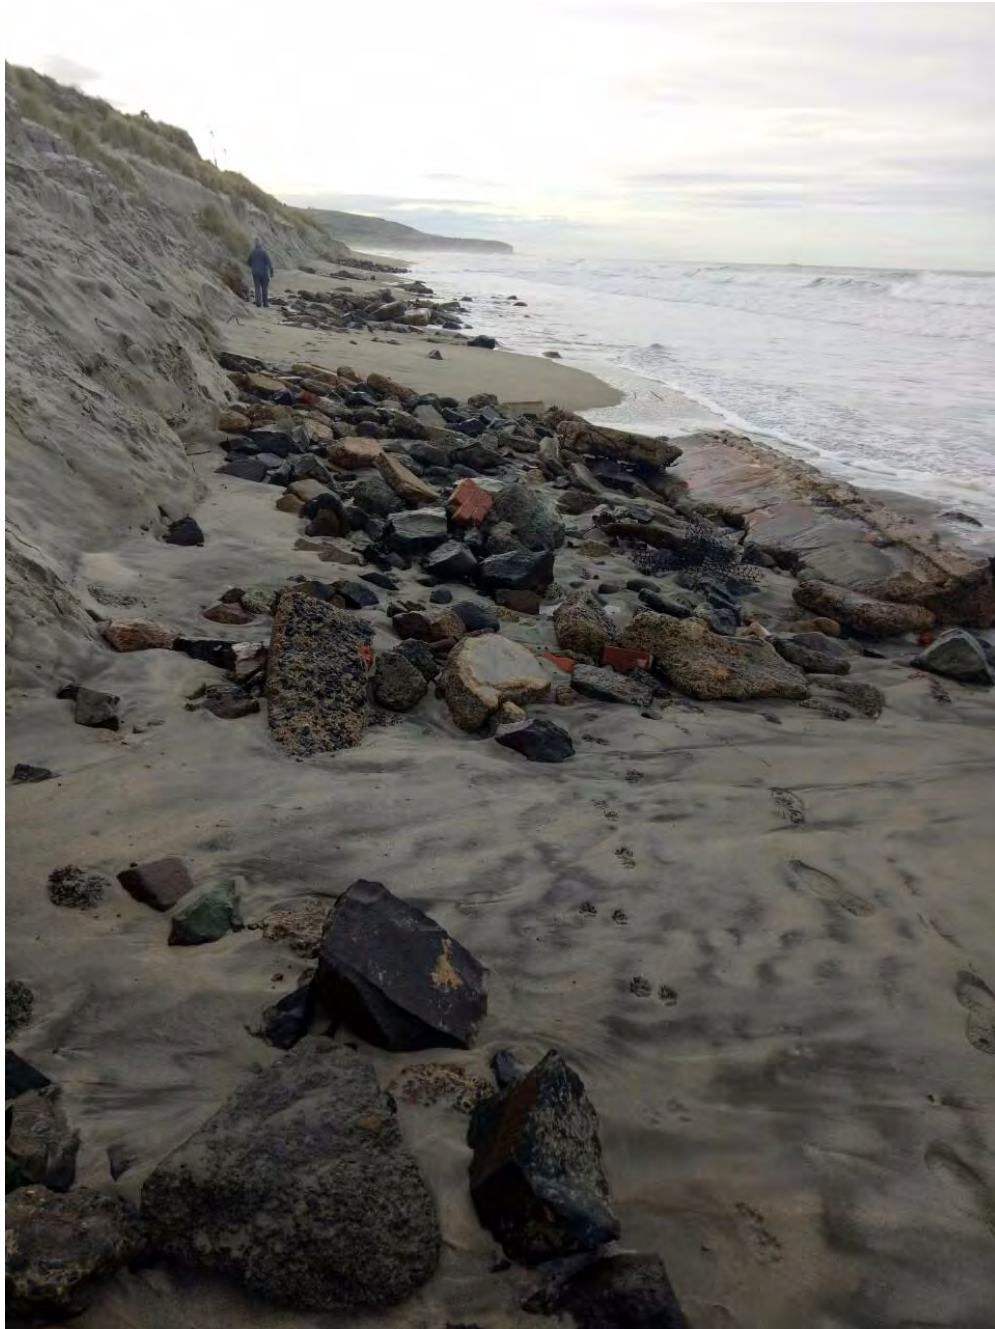
Figure 7.2: Rock and concrete were exposed in front of 4 m dune scarp on Profile 5 of Area 2, after winter storm on early August 2019.

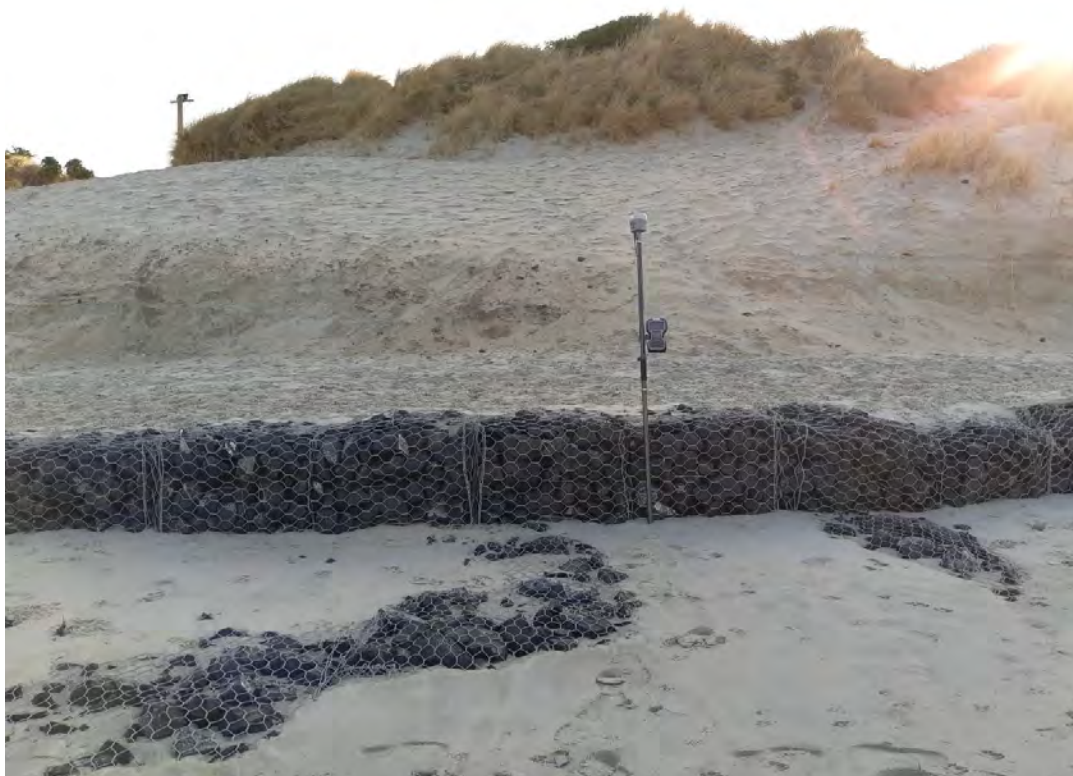
Winter storms lowered beach elevations on the west side of Moana Rua Road about 1 m between the 1st May and 26th July 2020 (Profile 5 – Figure 4.9; Figure 6.2). On the east side of the road (Profile 6), the beach experienced no significant change. However, at the east side end of Kettle Park (outside of surveyed areas), approximately 2 m beach scarp was found on the east side end of Kettle Park on 26th July 2020 (Figure 7.3 and Figure 7.4)

Figure 7.3: Beach erosion of 1 m in Area 2 on the 26th July 2020.

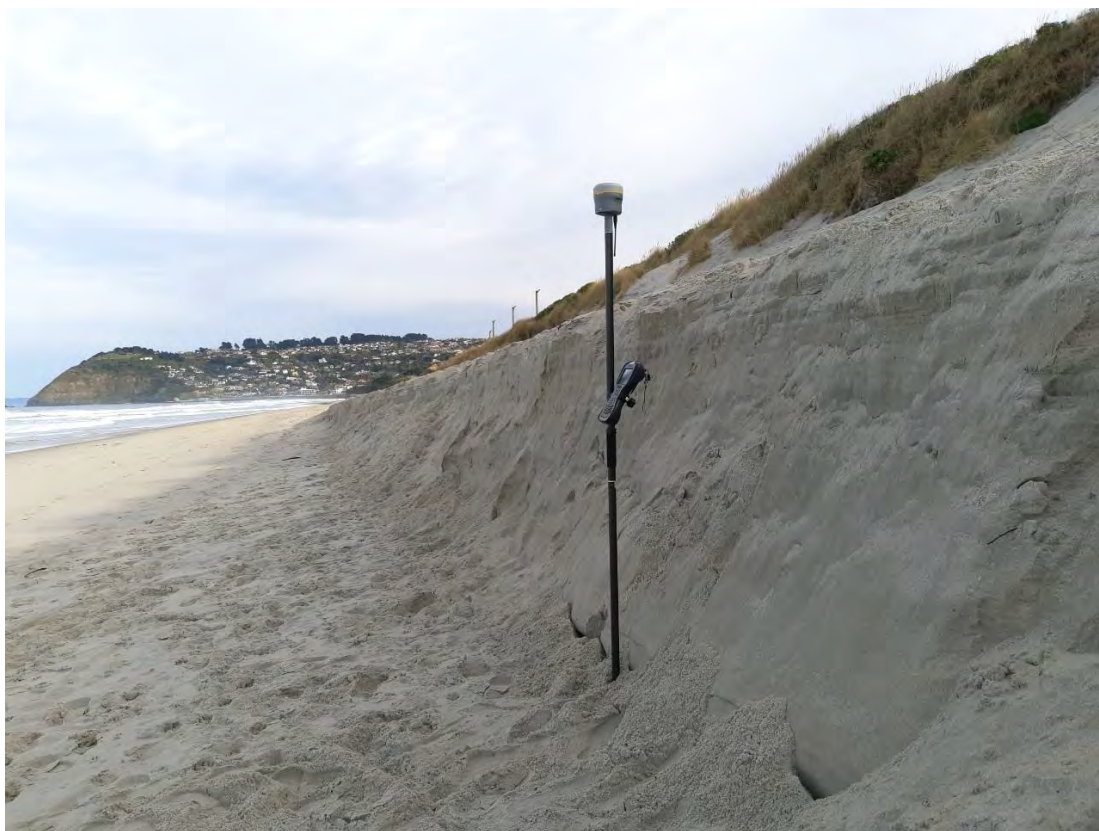
Figure 7.4: Upper beach erosion of approximately 2 m in Area 2 on the 26th July 2020.
