# Dunedin City Council

## Waste Futures - Smooth Hill Landfill

### Geotechnical Factual Report

August 2020

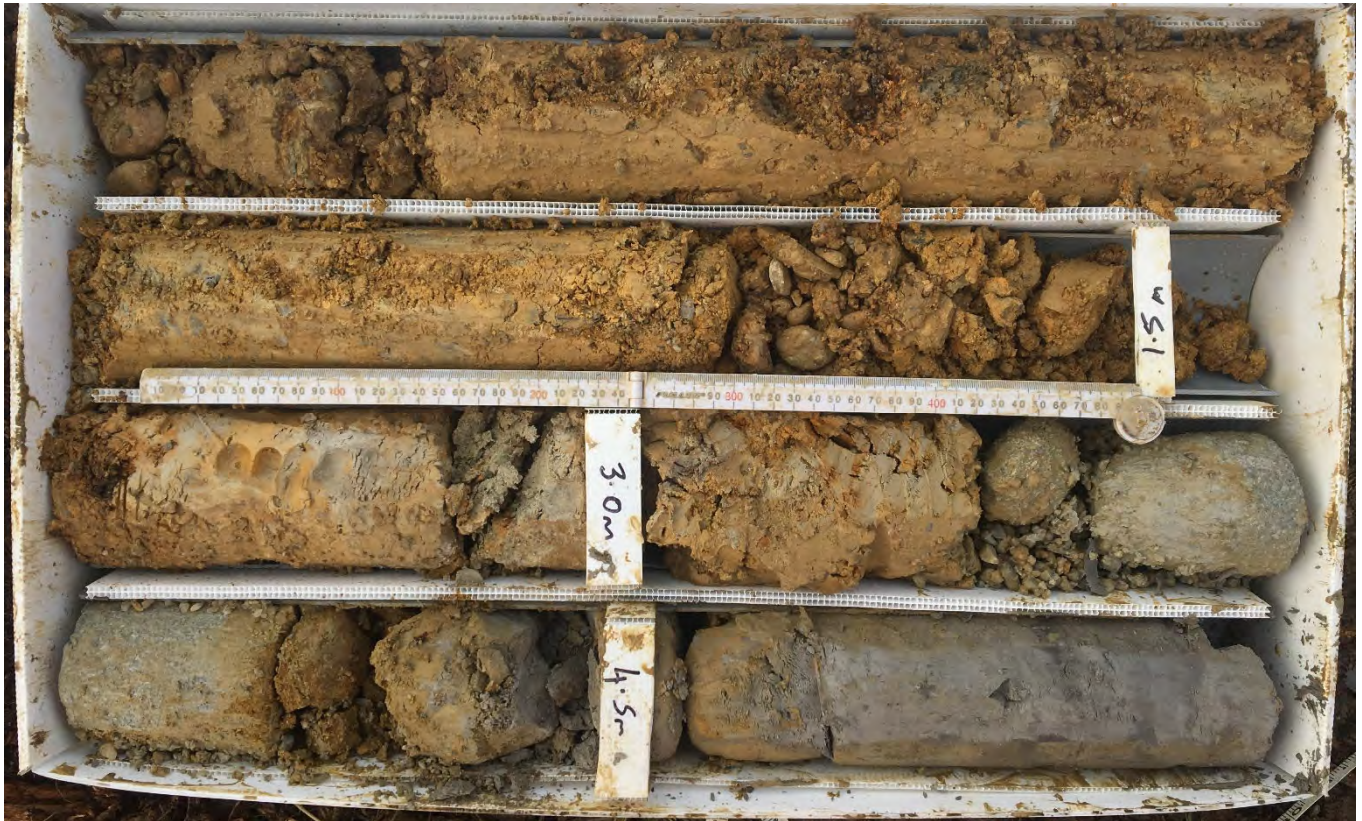
Box 1 of 5: 0.00 m to 4.80 m

Project	Smooth Hill Landfill Consenting	
Client	Dunedin City Council	
Job number	12506381	Page 1 of 3
Borehole ID	BH01

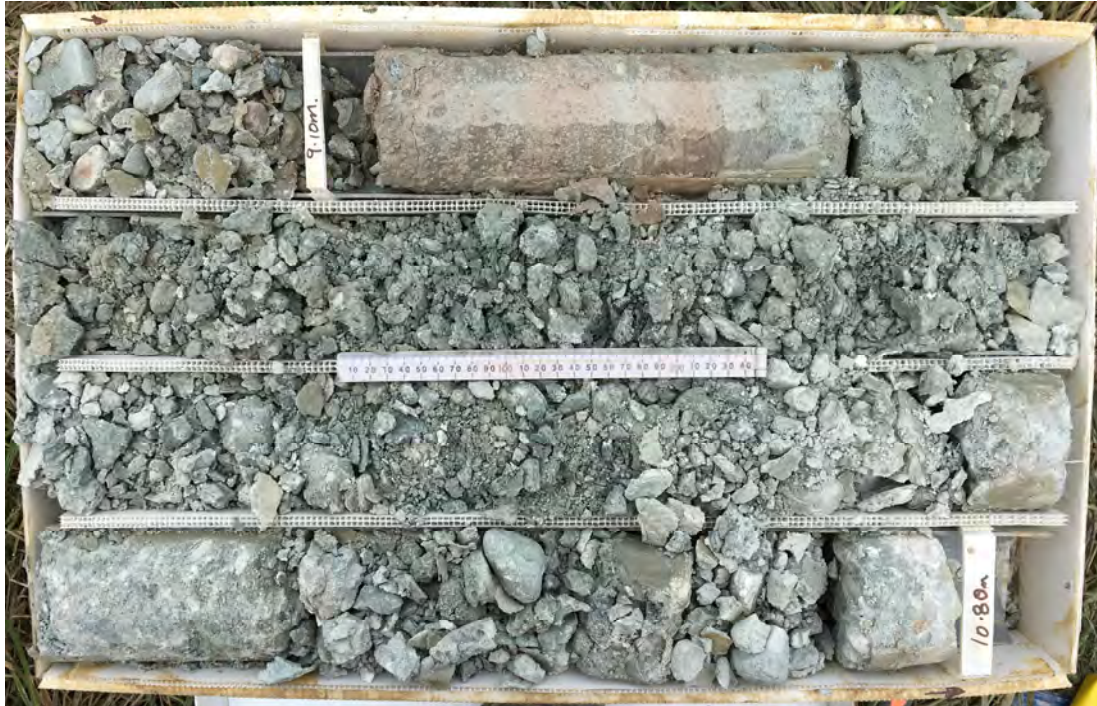
Box 5 of 5: 9.00 m to 10.80 m

10.80 m to 61.00 m (EOH) – Wash drilled, no core recovered

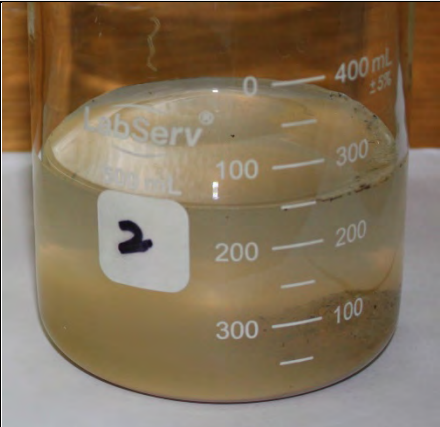
2 min	≈ 20 %	No colloidal cloud	
1 hr	≈ 100%	Dense colloidal cloud over	
6 hr	≈ 100 %	Dense colloidal cloud over	
Crumb Test Classification:		Grade 4 (Highly Dispersive)	
<b>Note:</b> <ul style="list-style-type: none"><li>Distilled water was used in the pinhole dispersion and crumb test. Both tests were carried out on remoulded samples.</li><li>The pinhole dispersion sample was compacted to 95% NZ standard compaction.</li><li>Photograph at completion of the crumb test.</li><li>The sample tested was the fraction passing the 2.00mm sieve.</li></ul>

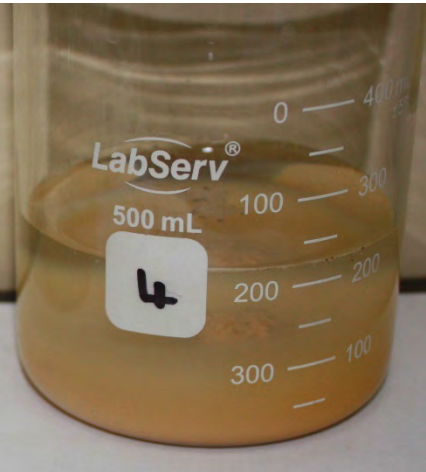
CRUMB TEST: ASTM D6572-13e2 (Method B)		
Elapsed Time	Estimated Slaking	Observations Recorded
2 min	< 2%	Colloidal cloud evident around cube
1 hr	≈ 55%	Heavy colloidal cloud ≈ 20mm deep covering entire bottom
6 hr	≈ 80%	Heavy colloidal cloud ≈ 20mm deep covering entire bottom
Crumb Test Classification: (1 Day Curing)		Grade 4 (Dispersive)

- Distilled water was used in the pinhole dispersion and crumb test. Both tests were carried out on remoulded samples.
- The pinhole dispersion sample was compacted to 95% NZ standard compaction.
- Photograph at completion of the crumb test.
- The sample tested was the fraction passing the 2.00mm sieve.
