Dunedin City Council

Waste Futures - Smooth Hill Landfill

Assessment of Effects to Groundwater

August 2020

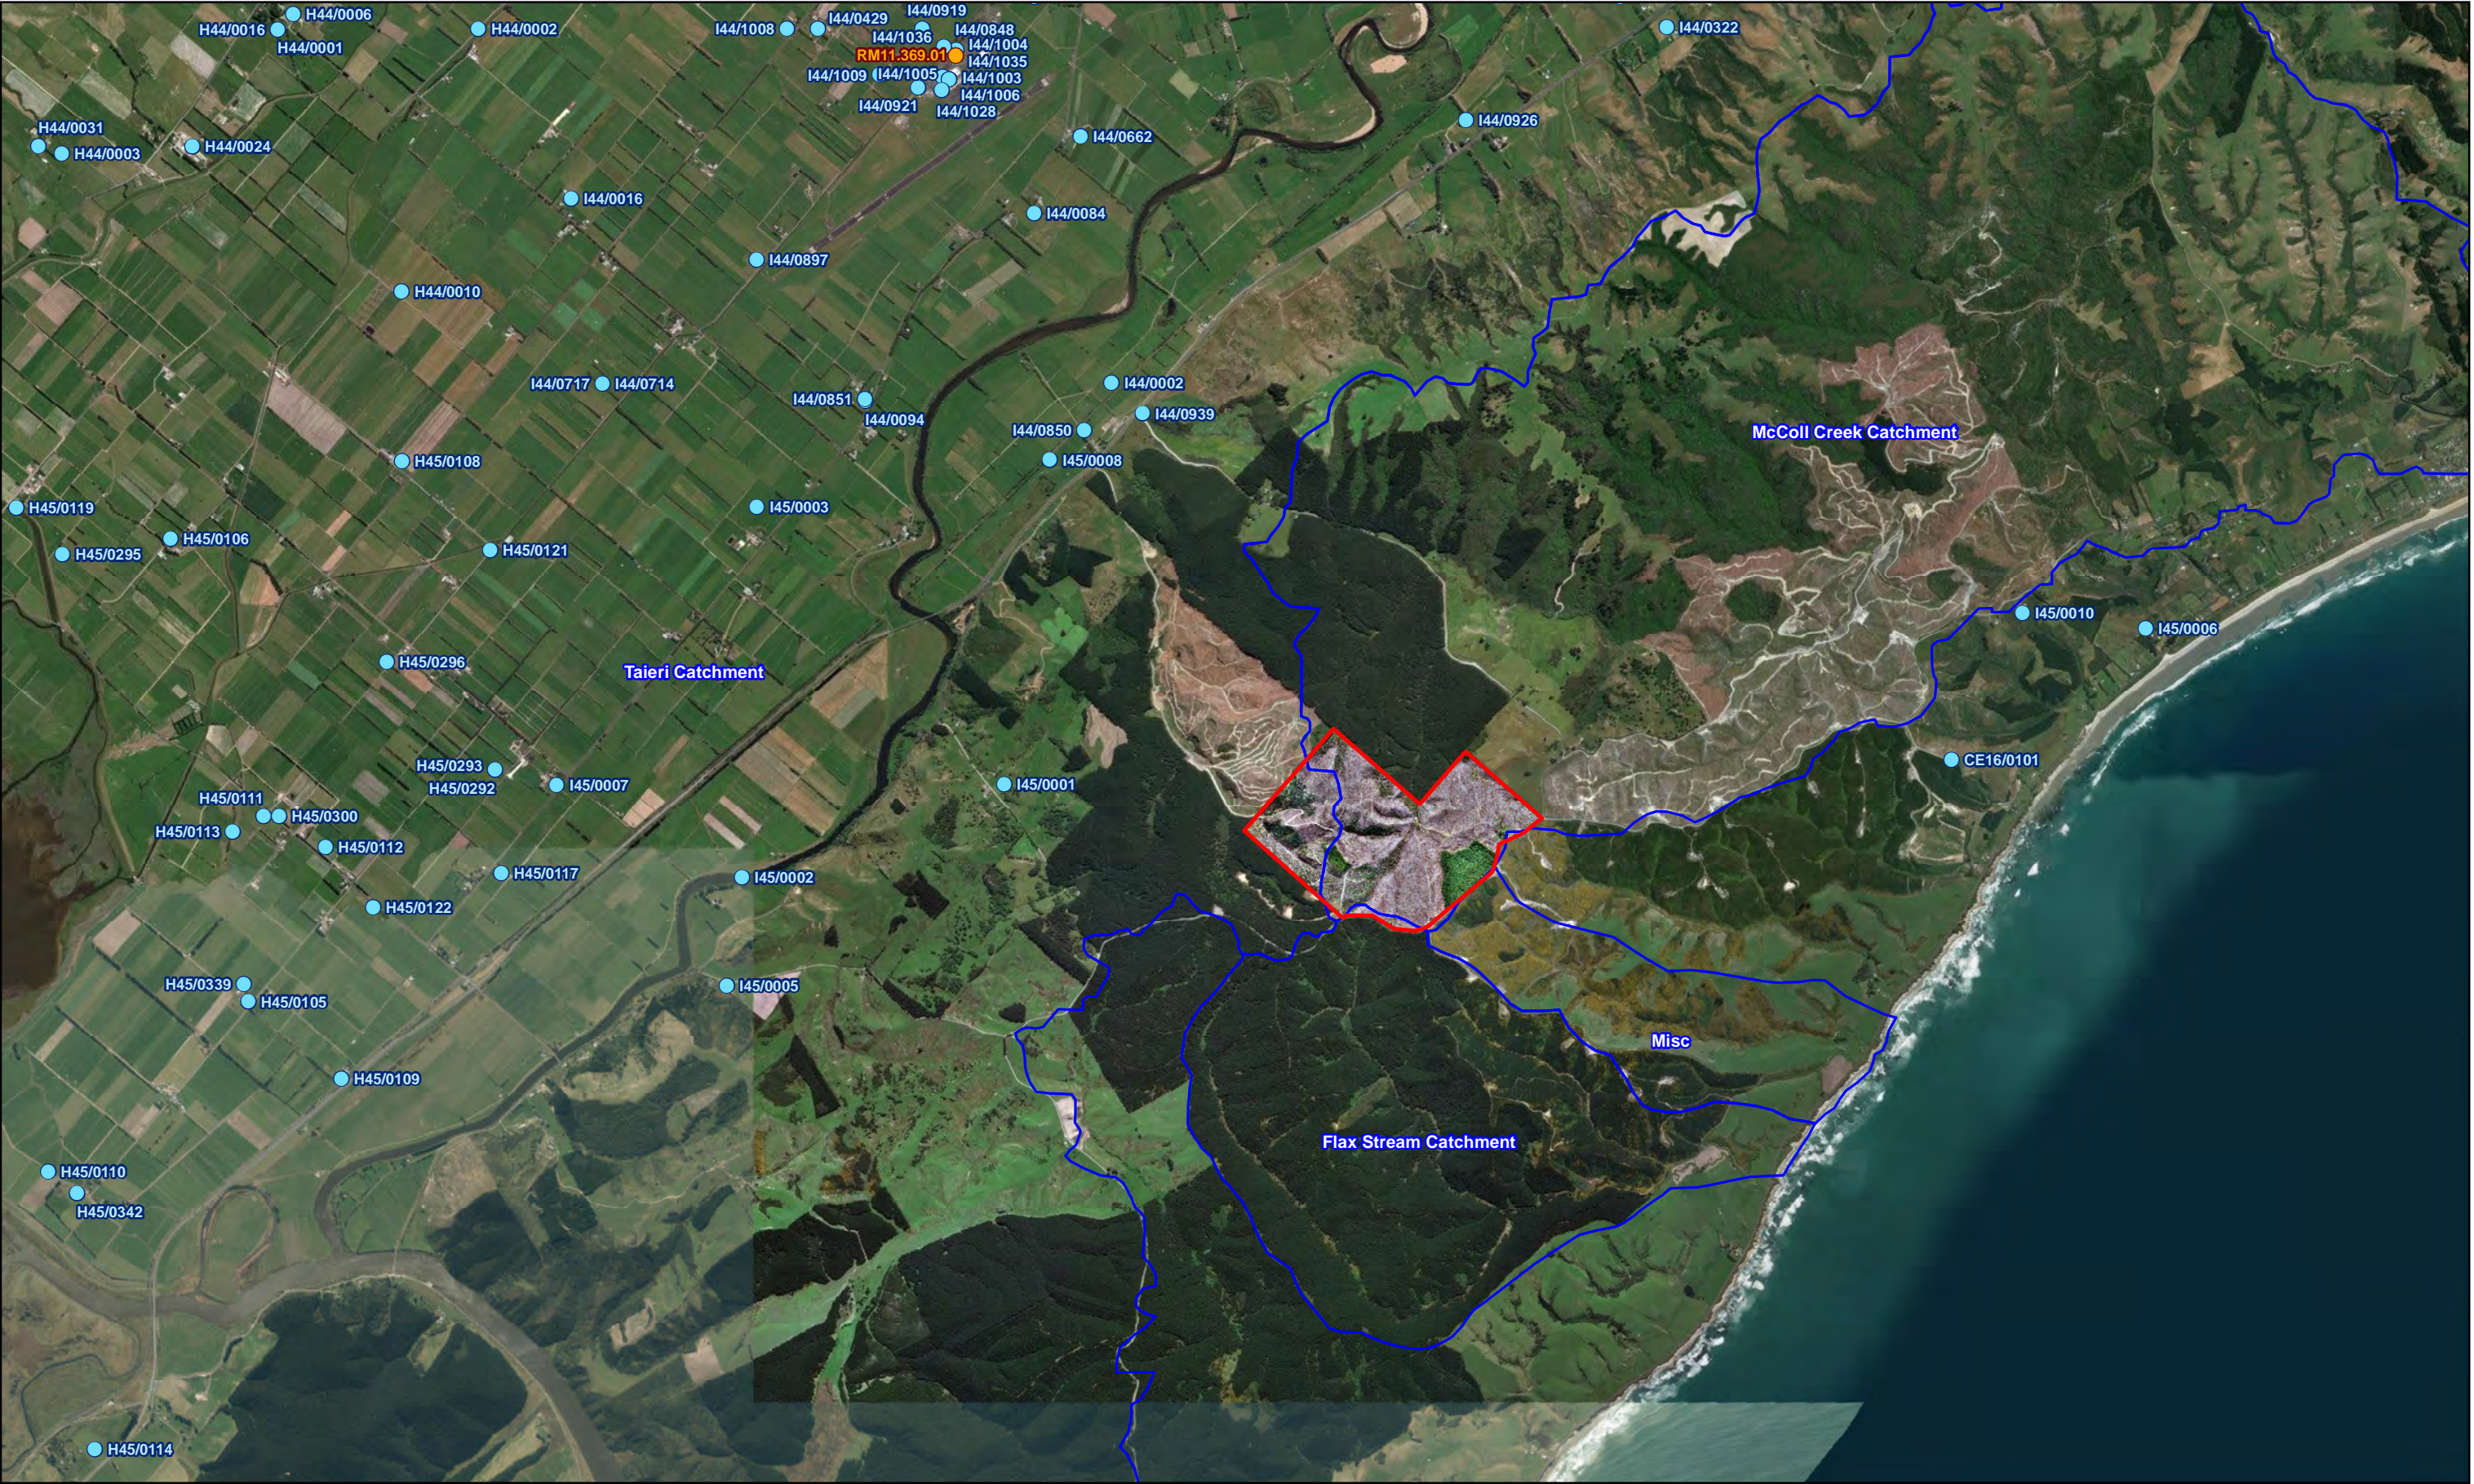
Figure 4 - Surface Water Catchments

Otago Regional Council (ORC) designate water allocation regions by surface water catchment and/or aquifer. Due to the limited groundwater resource at the location of the Smooth Hill site, the proposed landfill footprint forms part of the “McColl Creek” surface water allocation catchment (Figure 1 and Figure 4) rather than a defined aquifer system. The catchment has an available allocation of 0.93 L/s and has no recorded active consents (including surface water or groundwater takes) (ORC, 2019). Bounded by Big Stone Road to the south east and by the elevated ridge on the north west, the catchment is approximately 2700 hectares (ha) in area. McColl Creek discharges to the Pacific Ocean at Brighton, with Otokia Creek comprising the main tributary. The proposed Smooth Hill Landfill footprint is located within the upper reaches of the Otokia Creek (Figure 1 and Figure 4). The catchment area for the Otokia Creek at the site is approximately 69 ha, which encompasses the catchments of the two first order streams whose confluence is located approximately 100 m south of where the stream crosses the northern site boundary (Figure 1 and Figure 4).

While almost all of the landfill footprint and related structures/activities will be located within the Otokia Catchment, a small area (approximately 9,000 m²) of landfill embankment on the southern edge of the landfill is part of the Open Stream surface water catchment located to the south of the site (see Drawing 51-12506381-C303). The Open Stream catchment forms part of the “Flax Stream” surface water allocation catchment (Figure 1 and Figure 4) which is approximately 612 ha in area, and discharges to the Pacific Ocean south east of the Site. The Flax Stream surface water catchment has an available allocation of 0.22 L/s and has no recorded active consents (including surface water or groundwater takes) (ORC, 2019). The embankment proposed to be constructed within the Open Stream catchment will comprise clean engineered fill. Waste is not proposed to be placed in this area.

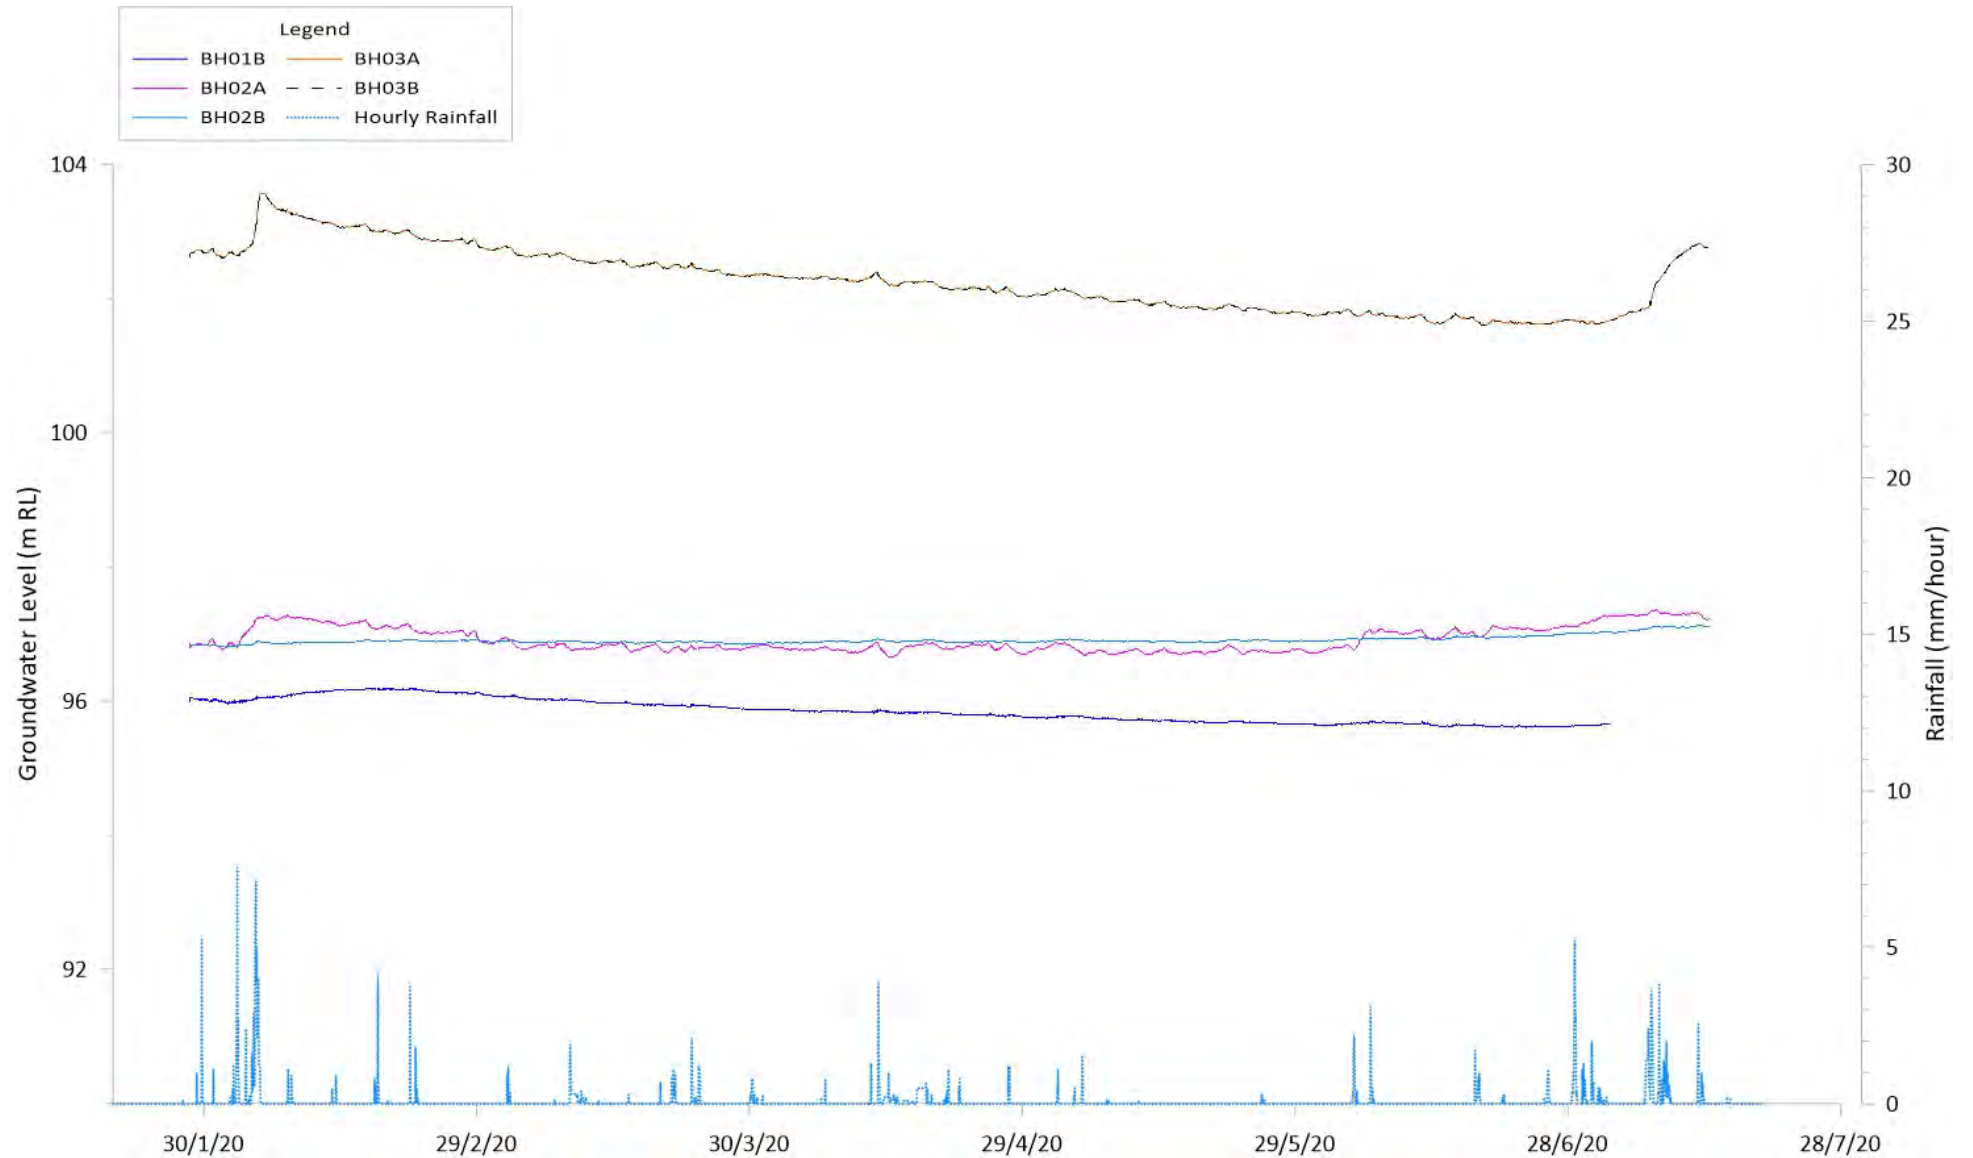
Figure A 3: 2020 groundwater levels
