Appendix 5: Geotechnical Interpretive Report

Dunedin City Council

Waste Futures - Smooth Hill Landfill Consenting Geotechnical Interpretive Report

August 2020 ([updated May 2021](#))

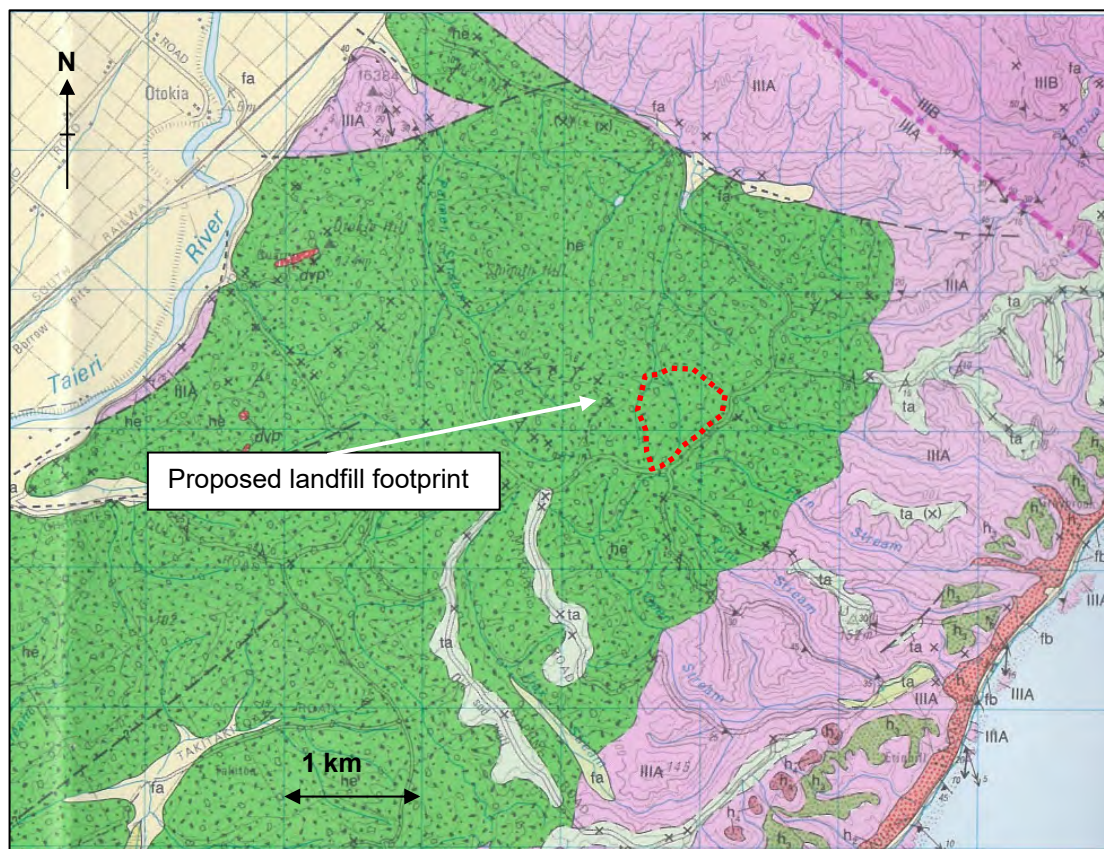
Figure 4 Excerpt from 1:50,000 Geology of the Milton Area (Bishop, 1994)

Figure 4 presents an excerpt from the Bishop (1994) geological map.

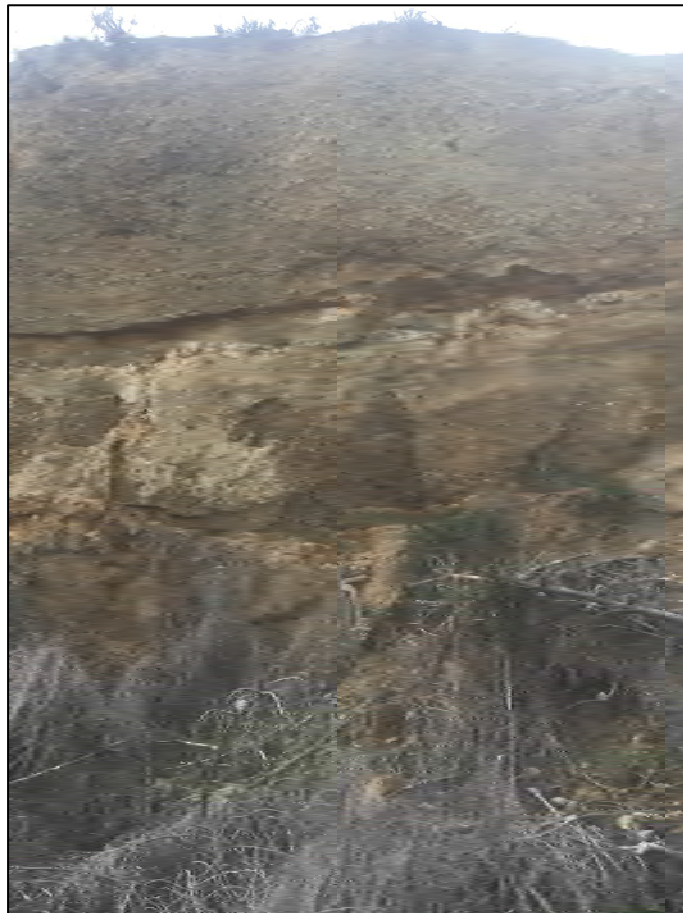
Figure 5 RockTaratu Formation outcrop near the northwest extent of the site

A single rock outcrop was mapped adjacent to the northwest boundary of the site. A photograph of the outcrop is presented in Figure 5 below. Bedding is most evident in the interface between the sandstone and conglomerate beds and appears to display cross-bedding in the sandstone beds. The bedding observed in the outcrop is consistent with that indicated in the published geological map for the Henley Breccia.

As discussed in Section 1.4 of this report, this outcrop has now been mapped as Henley Breccia rather than Taratu Formation. Similar material was logged in boreholes (BH09, BH209 & BH10). Although not indicated by published geology as outcropping on the site, the Taratu Formation was mapped on-site in a single outcrop (adjacent to the northwest boundary of the site). A photograph of the outcrop is presented in Figure 5 below. Bedding is most evident in the interface between the sandstone and conglomerate beds, and appears to display cross-bedding in the sandstone beds. The bedding observed in the outcrop is consistent with that indicated in the published geological map

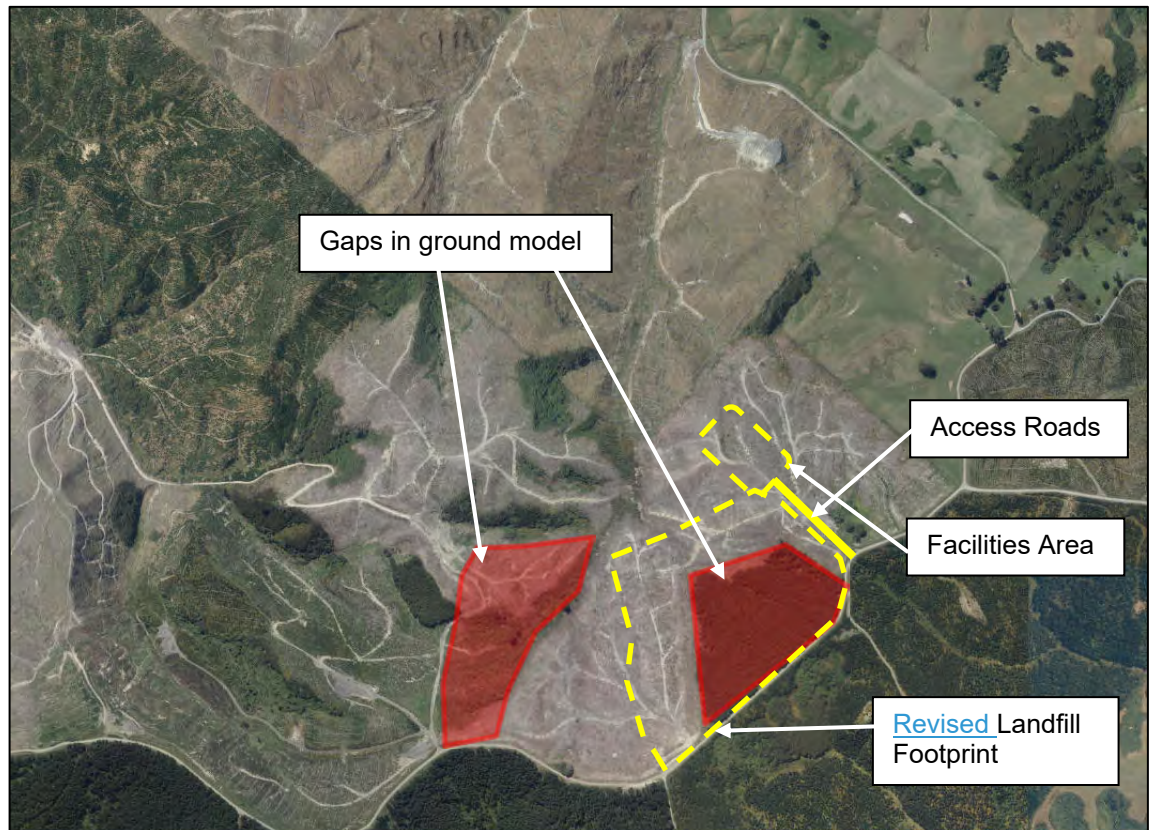
Figure 6 Identified gaps in the ground model (image sourced from DCC Webmap)

Due to these factors, some gaps in the ground model remain where limited information on the underlying geology is available. These are highlighted on Figure 6 below.

However, the investigations [to date](#) have generally encountered consistent geological conditions across the site and reasonable and confident assumptions can be made regarding the likely ground conditions within the highlighted area [remain within the revised landfill footprint](#) Figure 6.

[The footprint of the revised design no longer coincides with the western “gap”, thus reducing our gap in site specific knowledge.](#)

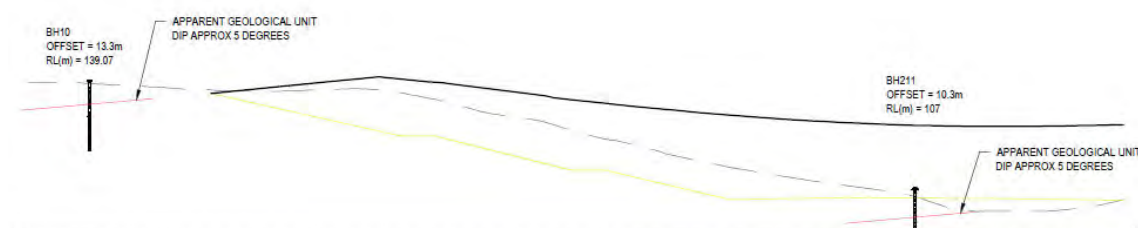
Figure 7 CH120 (excerpt from Drawing 12506381-01-Q003)

The cross sections at CH120 and CH240 are looking to the south east along the cut slope of Stage 1. The “apparent” dip of the bedding is very shallow and demonstrates favourable bedding (Figure 7). Bedding controlled failure is assessed as low.

As a temporary slope, CH240 will not be altered. Engineered fill will be ultimately placed across it during Stage 2.

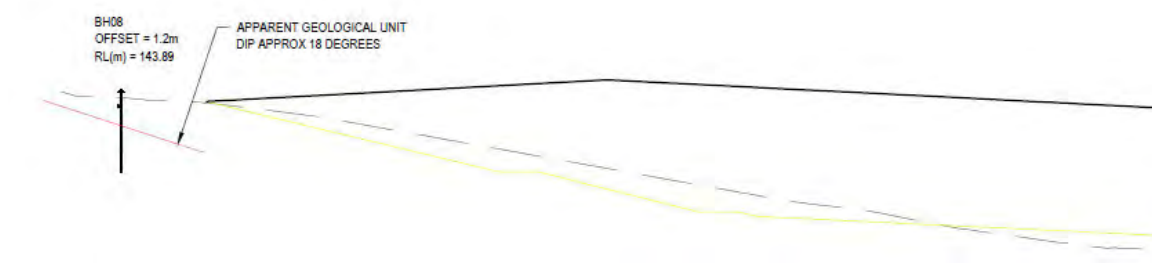
Figure 8 CH400 (excerpt from Drawing 12506381-01-Q003)

These cross sections are looking to the southwest. This face of the landfill is in the least structurally favourable orientation for bedding controlled failure. The cut of the temporary slopes has been chosen to minimise exposure of bedding planes in the face of the cut face.

The risk of bedding controlled failure is considered low.

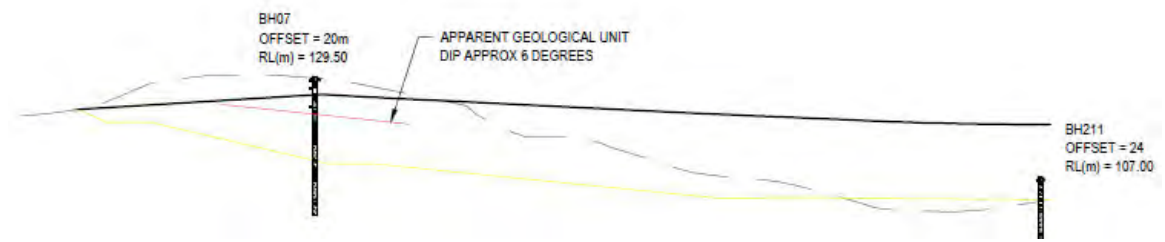
Figure 9 CH700 (excerpt from Drawing 12506381-01-Q003)

The cross sections at CH560 and CH700 are looking to the north west along the cut slope of the later stages of Stage 1. The apparent dip of bedding is very shallow and favourable

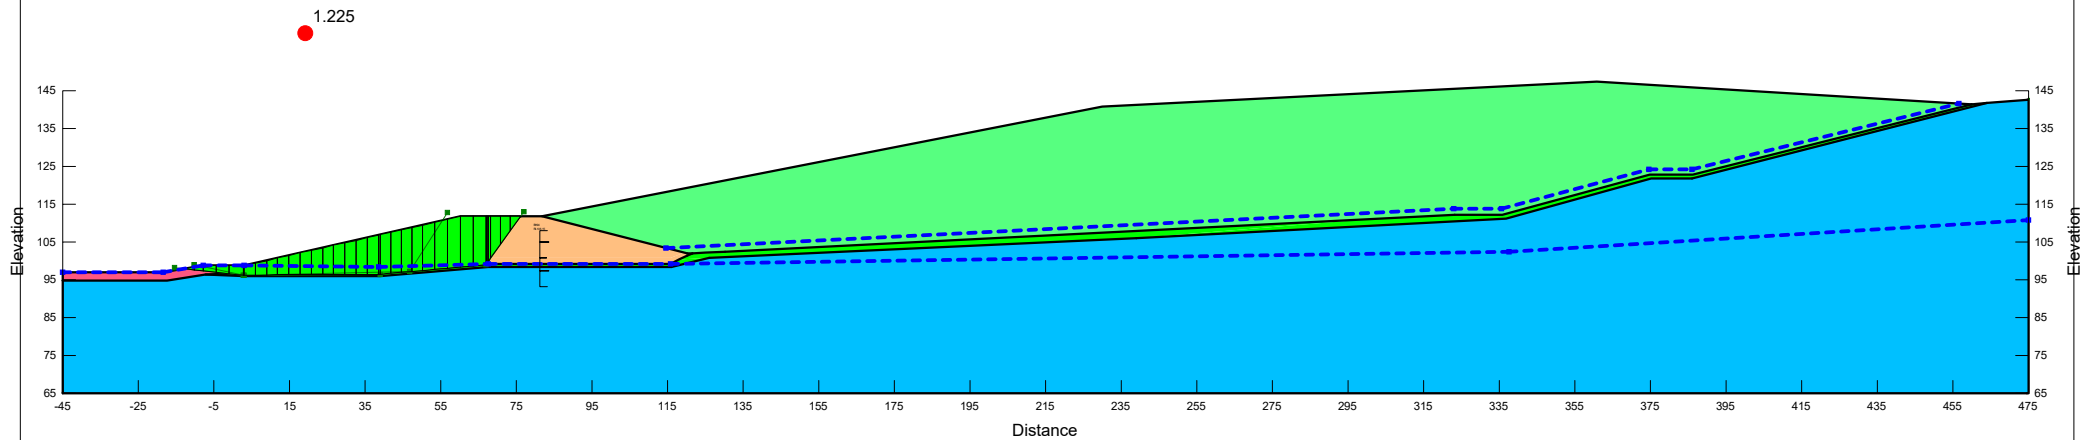
Color	Name	Model	Unit Weight (kN/m³)	Cohesion' (kPa)	Phi' (°)	Phi-B (°)	Piezometric Line
	03 Residual Soil (SILT)	Mohr-Coulomb	18	2	30	0	1
	10 Bulk/Eng Fill	Mohr-Coulomb	18	0	30	0	1
	11 MSW Long term	Mohr-Coulomb	12	9	22	0	2
	13 SW Siltstone (VW-W)	Mohr-Coulomb	18	50	30	0	1
	14 Residual Soil	Mohr-Coulomb	18	2	30	0	1

Horz Seismic Coef.: 0.31

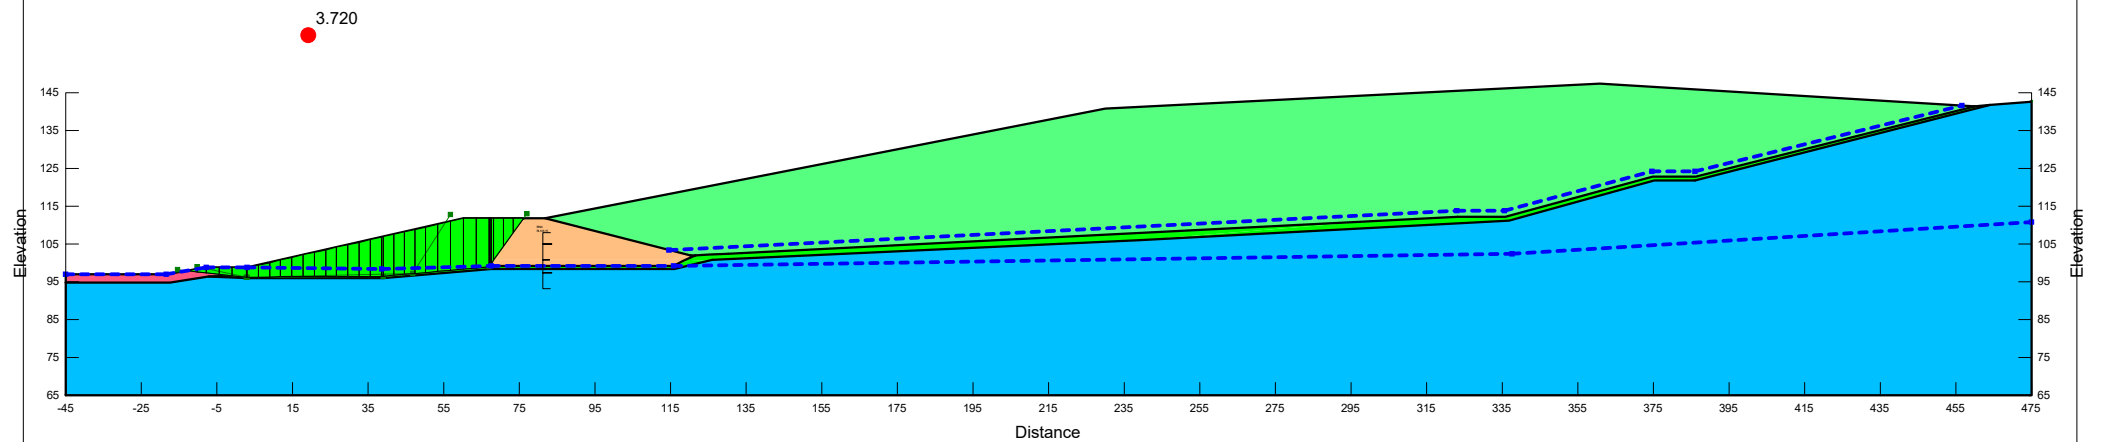
Color	Name	Model	Unit Weight (kN/m³)	Cohesion' (kPa)	Phi' (°)	Phi-B (°)	Piezometric Line
	03 Residual Soil (SILT)	Mohr-Coulomb	18	2	30	0	1
	10 Bulk/Eng Fill	Mohr-Coulomb	18	0	30	0	1
	11 MSW Long term	Mohr-Coulomb	12	9	22	0	2
	13 SW Siltstone (VW-W)	Mohr-Coulomb	18	50	30	0	1
	14 Residual Soil	Mohr-Coulomb	18	2	30	0	1

Horz Seismic Coef.:

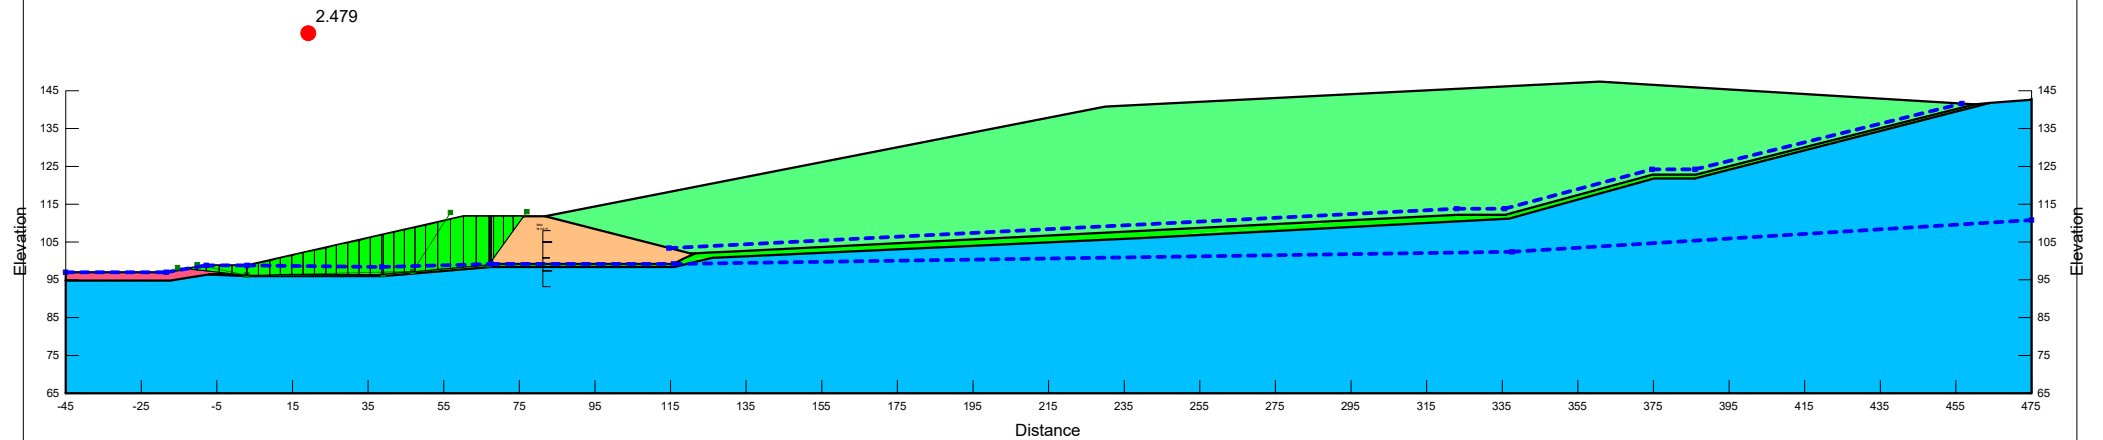
Color	Name	Model	Unit Weight (kN/m³)	Cohesion' (kPa)	Phi' (°)	Phi-B (°)	Piezometric Line
■	03 Residual Soil (SILT)	Mohr-Coulomb	18	2	30	0	1
■	10 Bulk/Eng Fill	Mohr-Coulomb	18	0	30	0	1
■	11 MSW Long term	Mohr-Coulomb	12	9	22	0	2
■	13 SW Siltstone (VW-W)	Mohr-Coulomb	18	50	30	0	1
■	14 Residual Soil	Mohr-Coulomb	18	2	30	0	1

Horz Seismic Coef.: 0.08
