Appendix 6: Geotechnical Factual Report

Waste Futures Phase 2, Workstream 3 Smooth Hill Landfill Smooth Hill Consenting - Geotechnical Factual Report

August 2020 [\(updated May 2021\)](#)

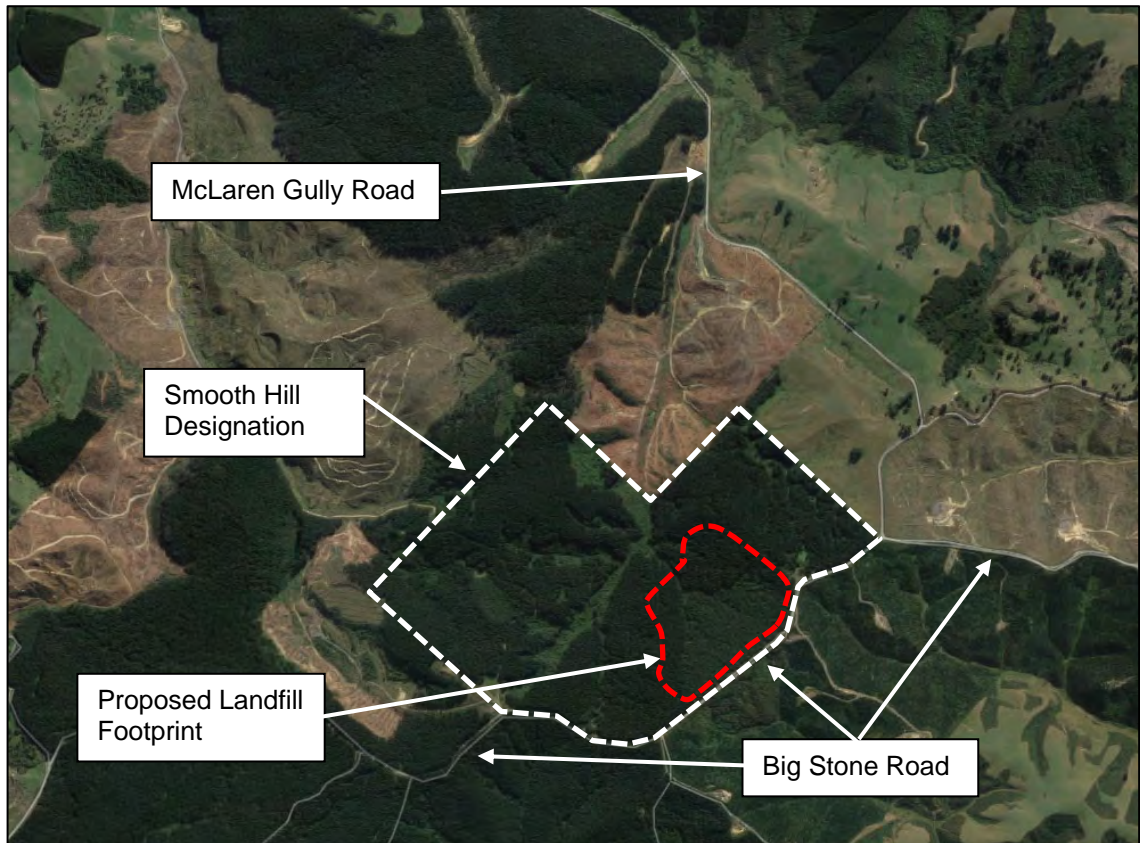
Figure 3 Proposed landfill site (base image sourced from Google Maps)
(Updated May 2021)

The proposed site is bordered by Big Stone Road along its southern boundary. Access from State Highway 1 (SH1) is currently via McLaren Gully Road. The proposed site is bounded to the north and west by forestry land, and to the northeast by farmland. Figure 3 provides a closer view of the proposed site.

The proposed site is located in a south to north trending gully, which is fed by smaller gullies from the east, west and south. The flow direction for water exiting the gully is from the south to the north. The slopes around the southern half of the site form a natural “amphitheatre” shape, which is bisected by a larger central ridge, and a smaller ridge in the south-western corner – both trending south to north.

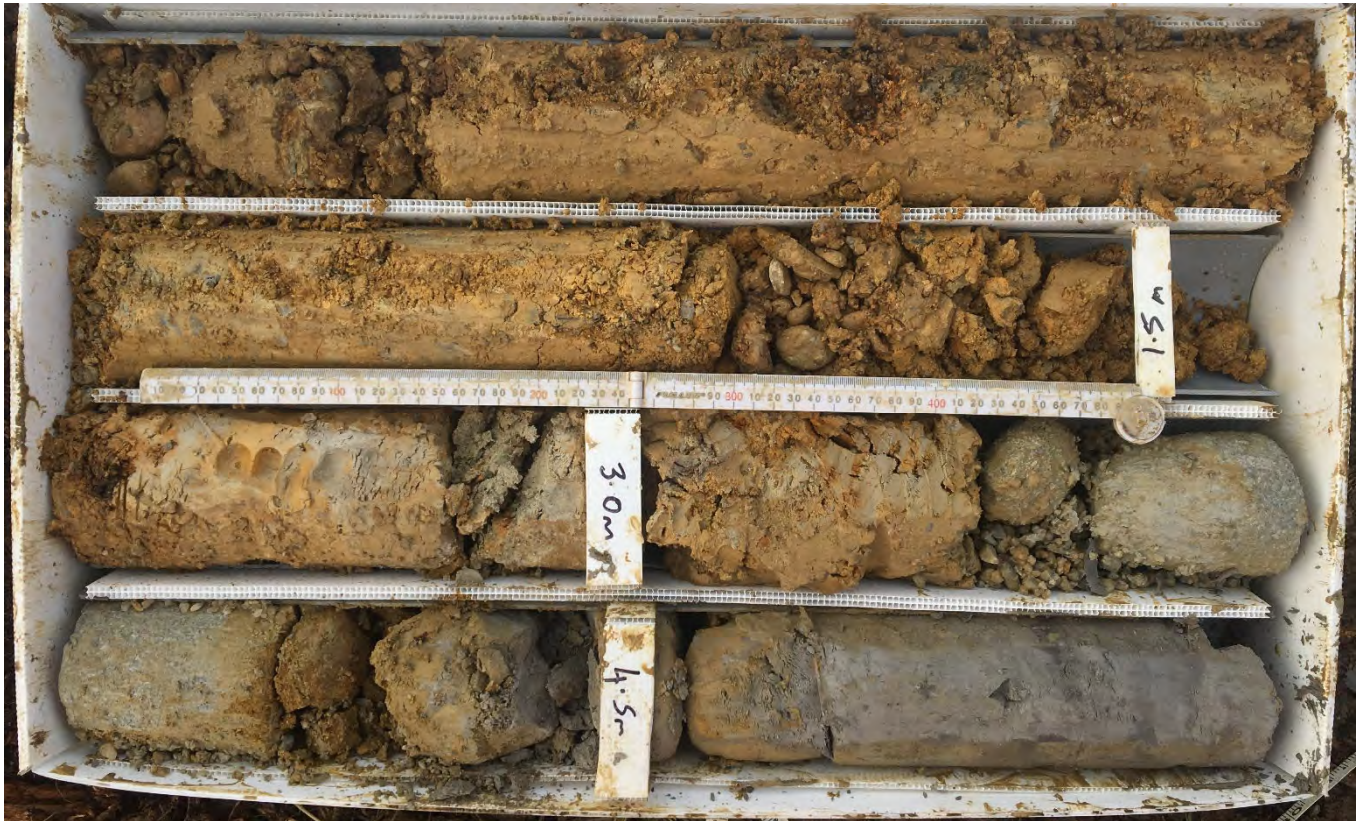
Box 1 of 5: 0.00 m to 4.80 m

Project	Smooth Hill Landfill Consenting	
Client	Dunedin City Council	
Job number	12506381	Page 1 of 3
Borehole ID	BH01

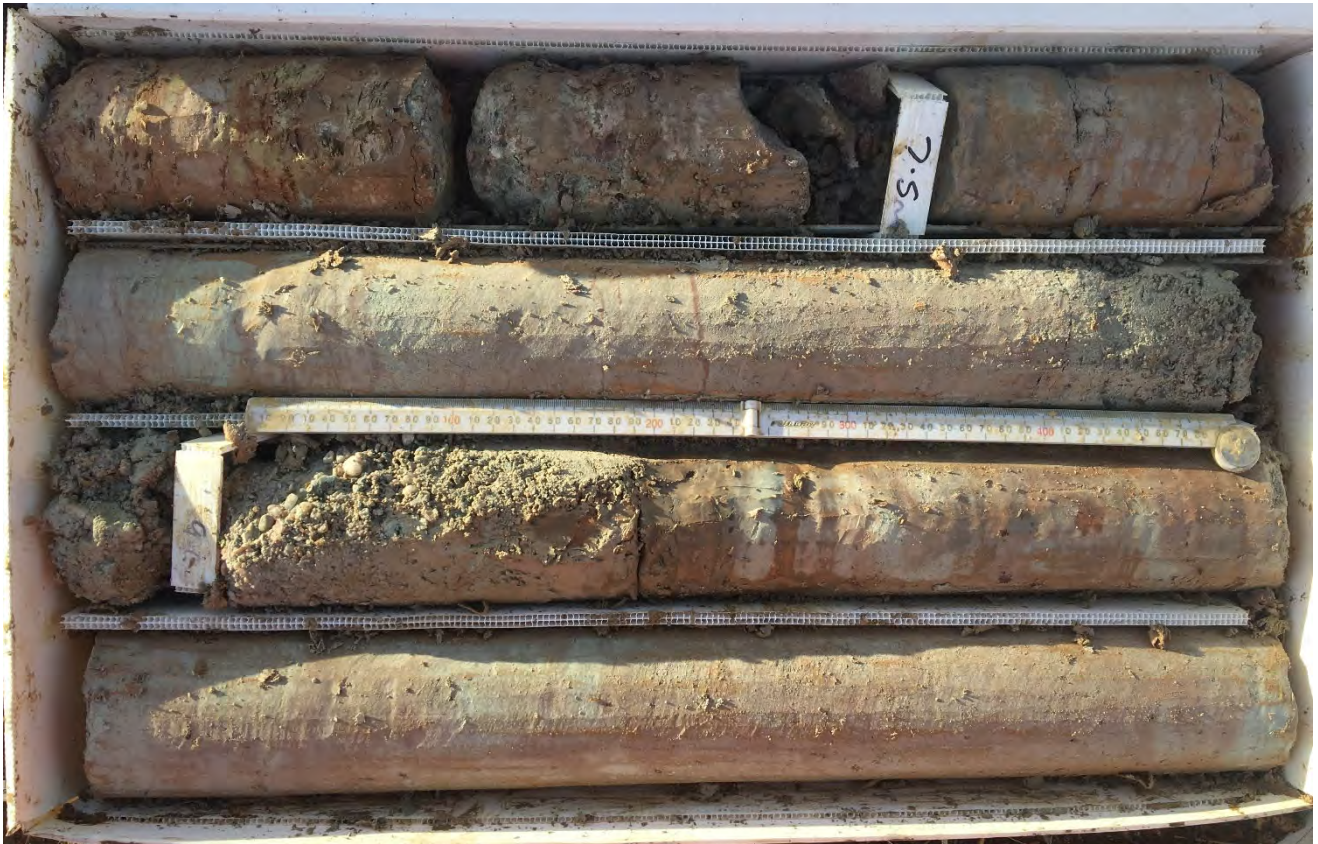
Box 3 of 5: 8.20 m to 10.20 m

Project	Smooth Hill Landfill Consenting	
Client	Dunedin City Council	
Job number	12506381	Page 2 of 3
Borehole ID	BH01

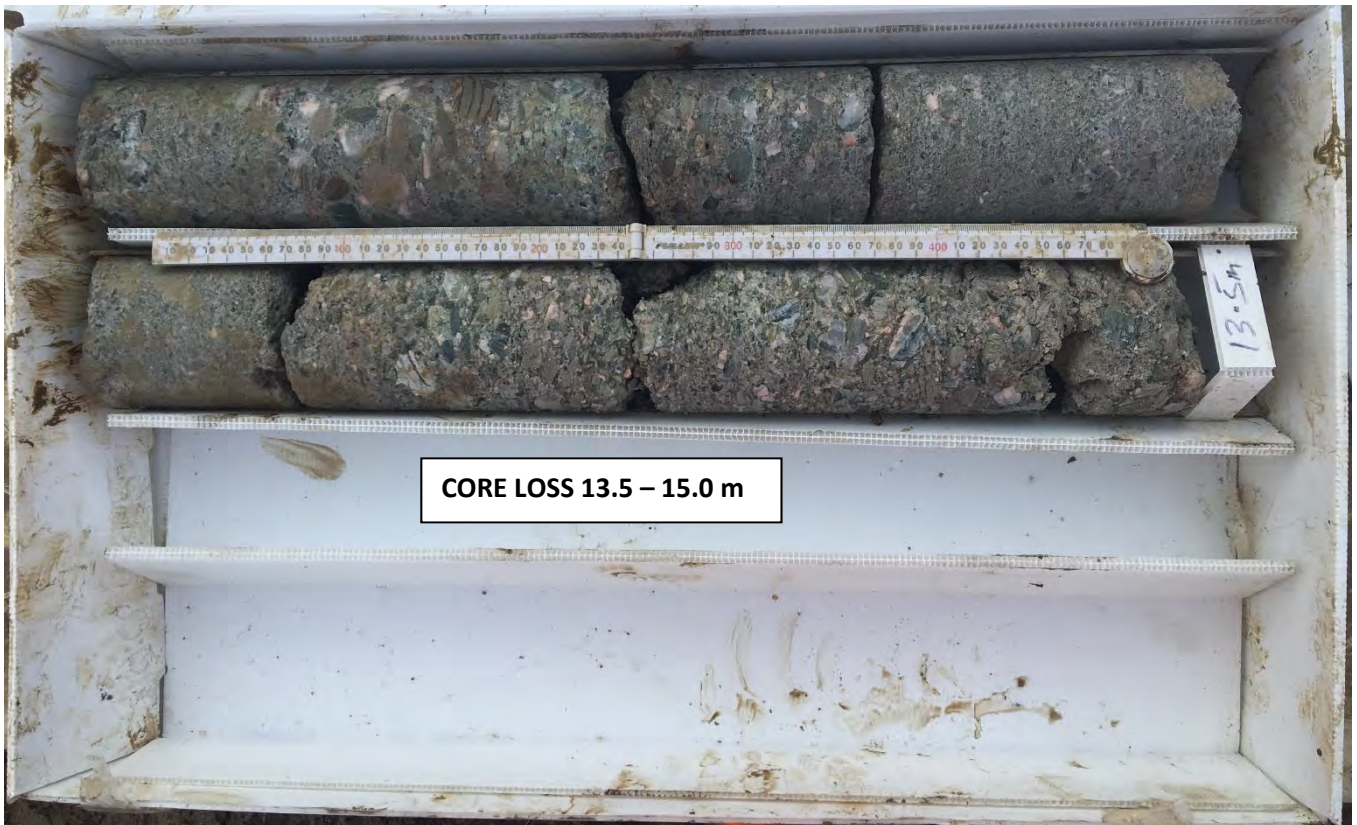
Box 5 of 5: 12.40 m to 15.00 m (EOH)

Project	Smooth Hill Landfill Consenting	
Client	Dunedin City Council	
Job number	12506381	Page 3 of 3
Borehole ID	BH01

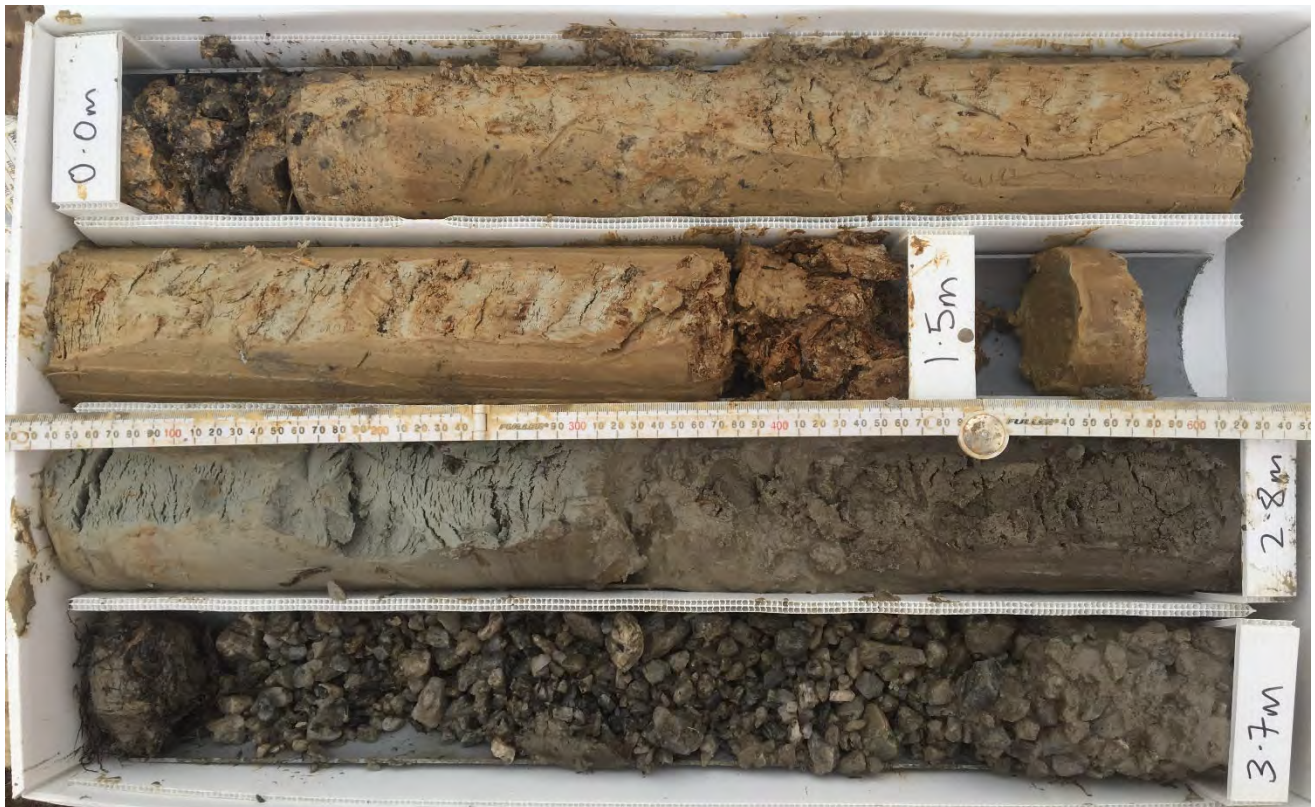
Box 1 of 6: 0.0 m to 3.7 m

Project	Smooth Hill Landfill Consenting	
Client	Dunedin City Council	
Job number	12506381	Page 1 of 3
Borehole ID	BH02

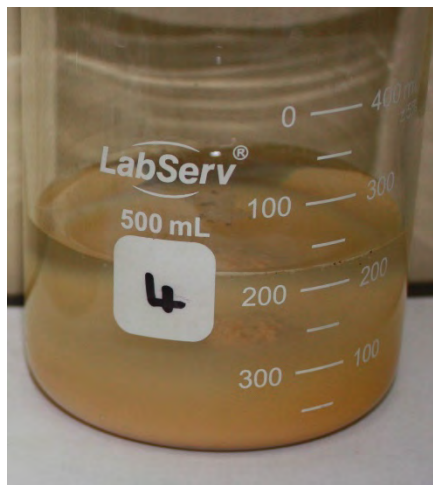
CRUMB TEST: ASTM D6572-13e2 (Method B)

Elapsed Time	Estimated Slaking	Observations Recorded	
2 min	< 2%	Colloidal cloud evident around cube	
1 hr	≈ 55%	Heavy colloidal cloud ≈ 20mm deep covering entire bottom	
6 hr	≈ 80%	Heavy colloidal cloud ≈ 20mm deep covering entire bottom	
Crumb Test Classification: (1 Day Curing)		Grade 4 (Dispersive)
