Appendix 8: Groundwater Report

Dunedin City Council

Waste Futures Phase 2 - Work Stream 3. Smooth Hill Landfill Assessment of Effects to Groundwater

August 2020 ([Updated May 2021](#))

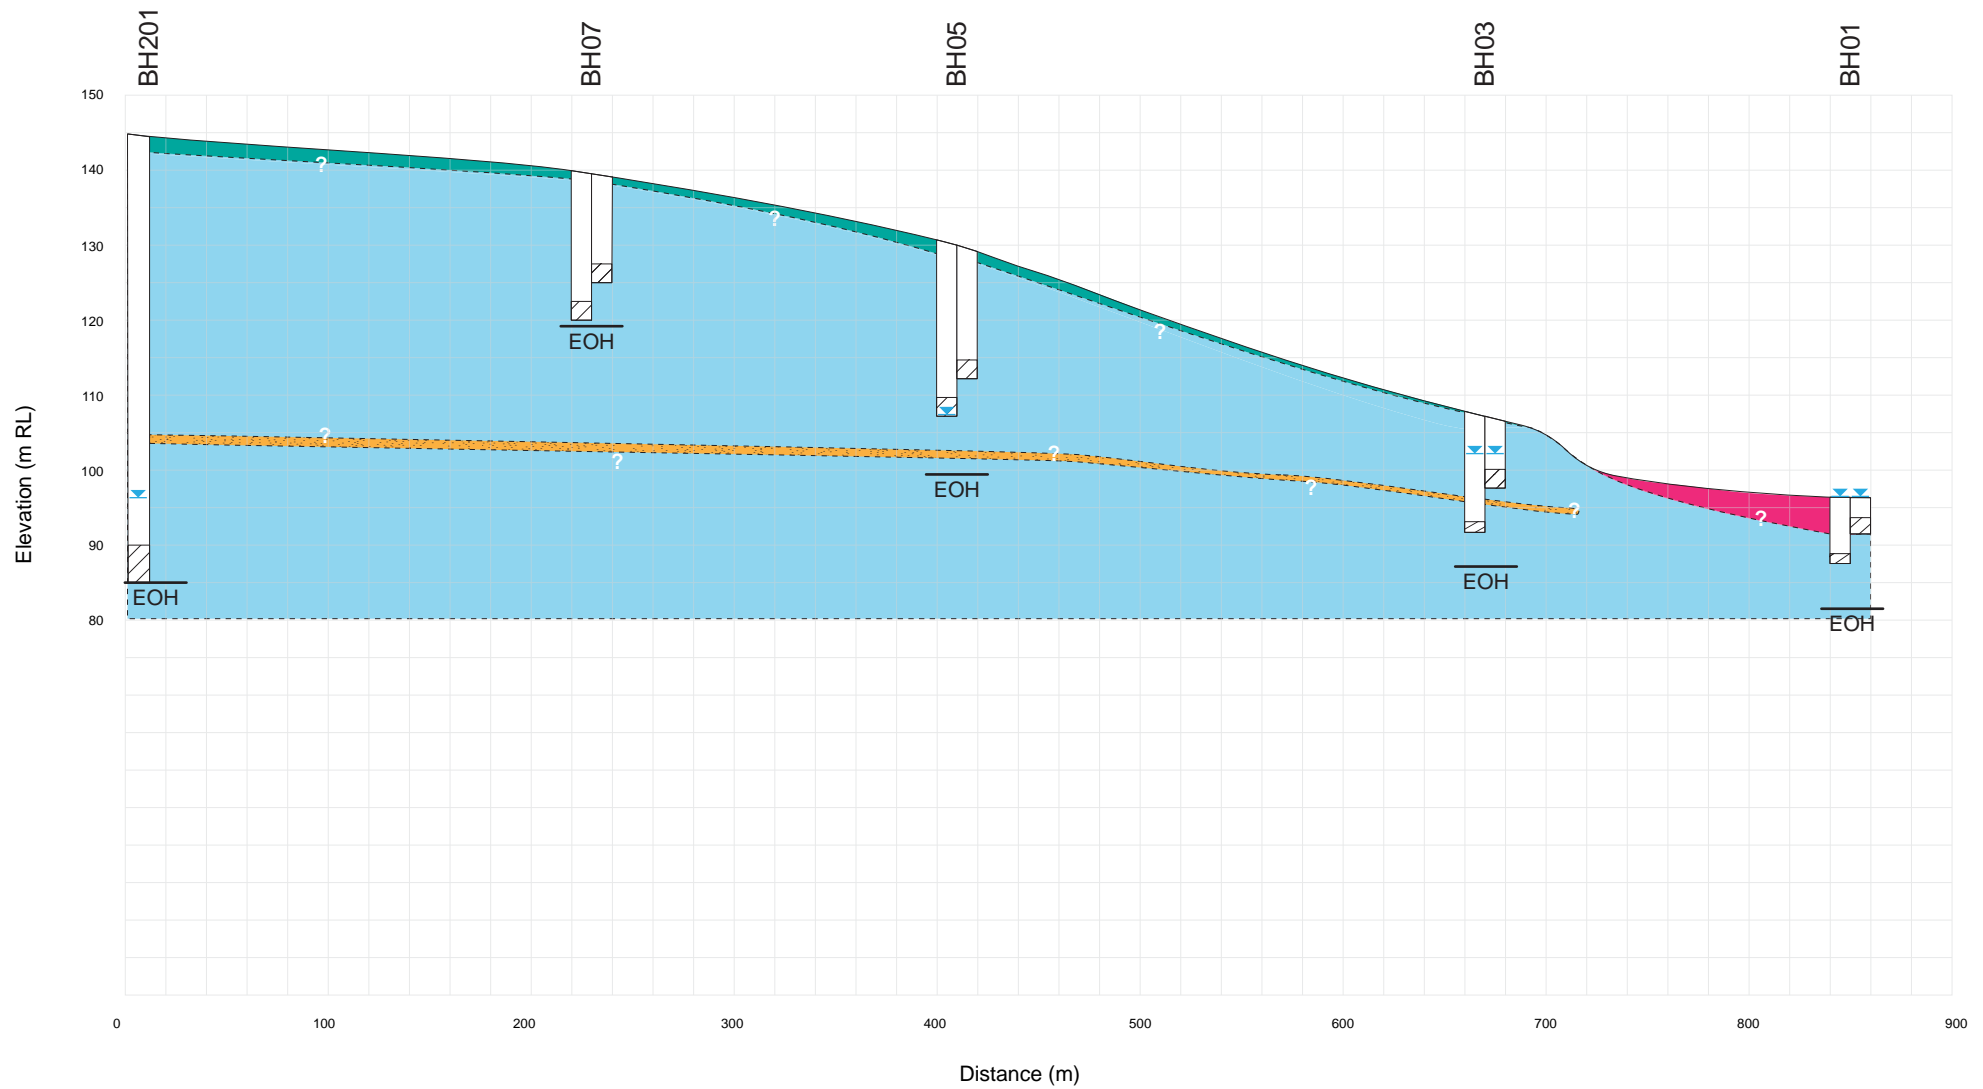
Figure 7

A ~~layer of fine-grained, low permeability material noted for its~~ distinctive reddish brown and brown ~~coloration siltstone layer, possibly a historic lake deposit,~~ was also recorded intermittently across the site in a number of bores within the Henley Breccia, at elevations between approximately 95 m RL and 103 m RL (BH03, BH04, BH05 and BH211). A reddish-brown layer was also observed during wash drilling of BH201, however no approximate depth for this layer was recorded. The elevation of ~~the siltstone this low permeability~~ layer indicates that it is likely to have been eroded away at BH01 and BH02 and is therefore not anticipated to be consistent across the whole site.

Cross Section A-A'

The reddish brown low permeability layer brown siltstone layer, and decreasing permeability of Henley Breccia with depth, is interpreted as retarding percolation of groundwater. This has resulted in the formation of a localised shallow groundwater system within the alluvium (BH01A and evidenced in the moist to saturated conditions in a number of the test pits included on Figure 9 and the surrounding shallow Henley Breccia above the brown siltstone low permeability layer (BH02A, BH02B, BH03A, BH04A and BH211A).

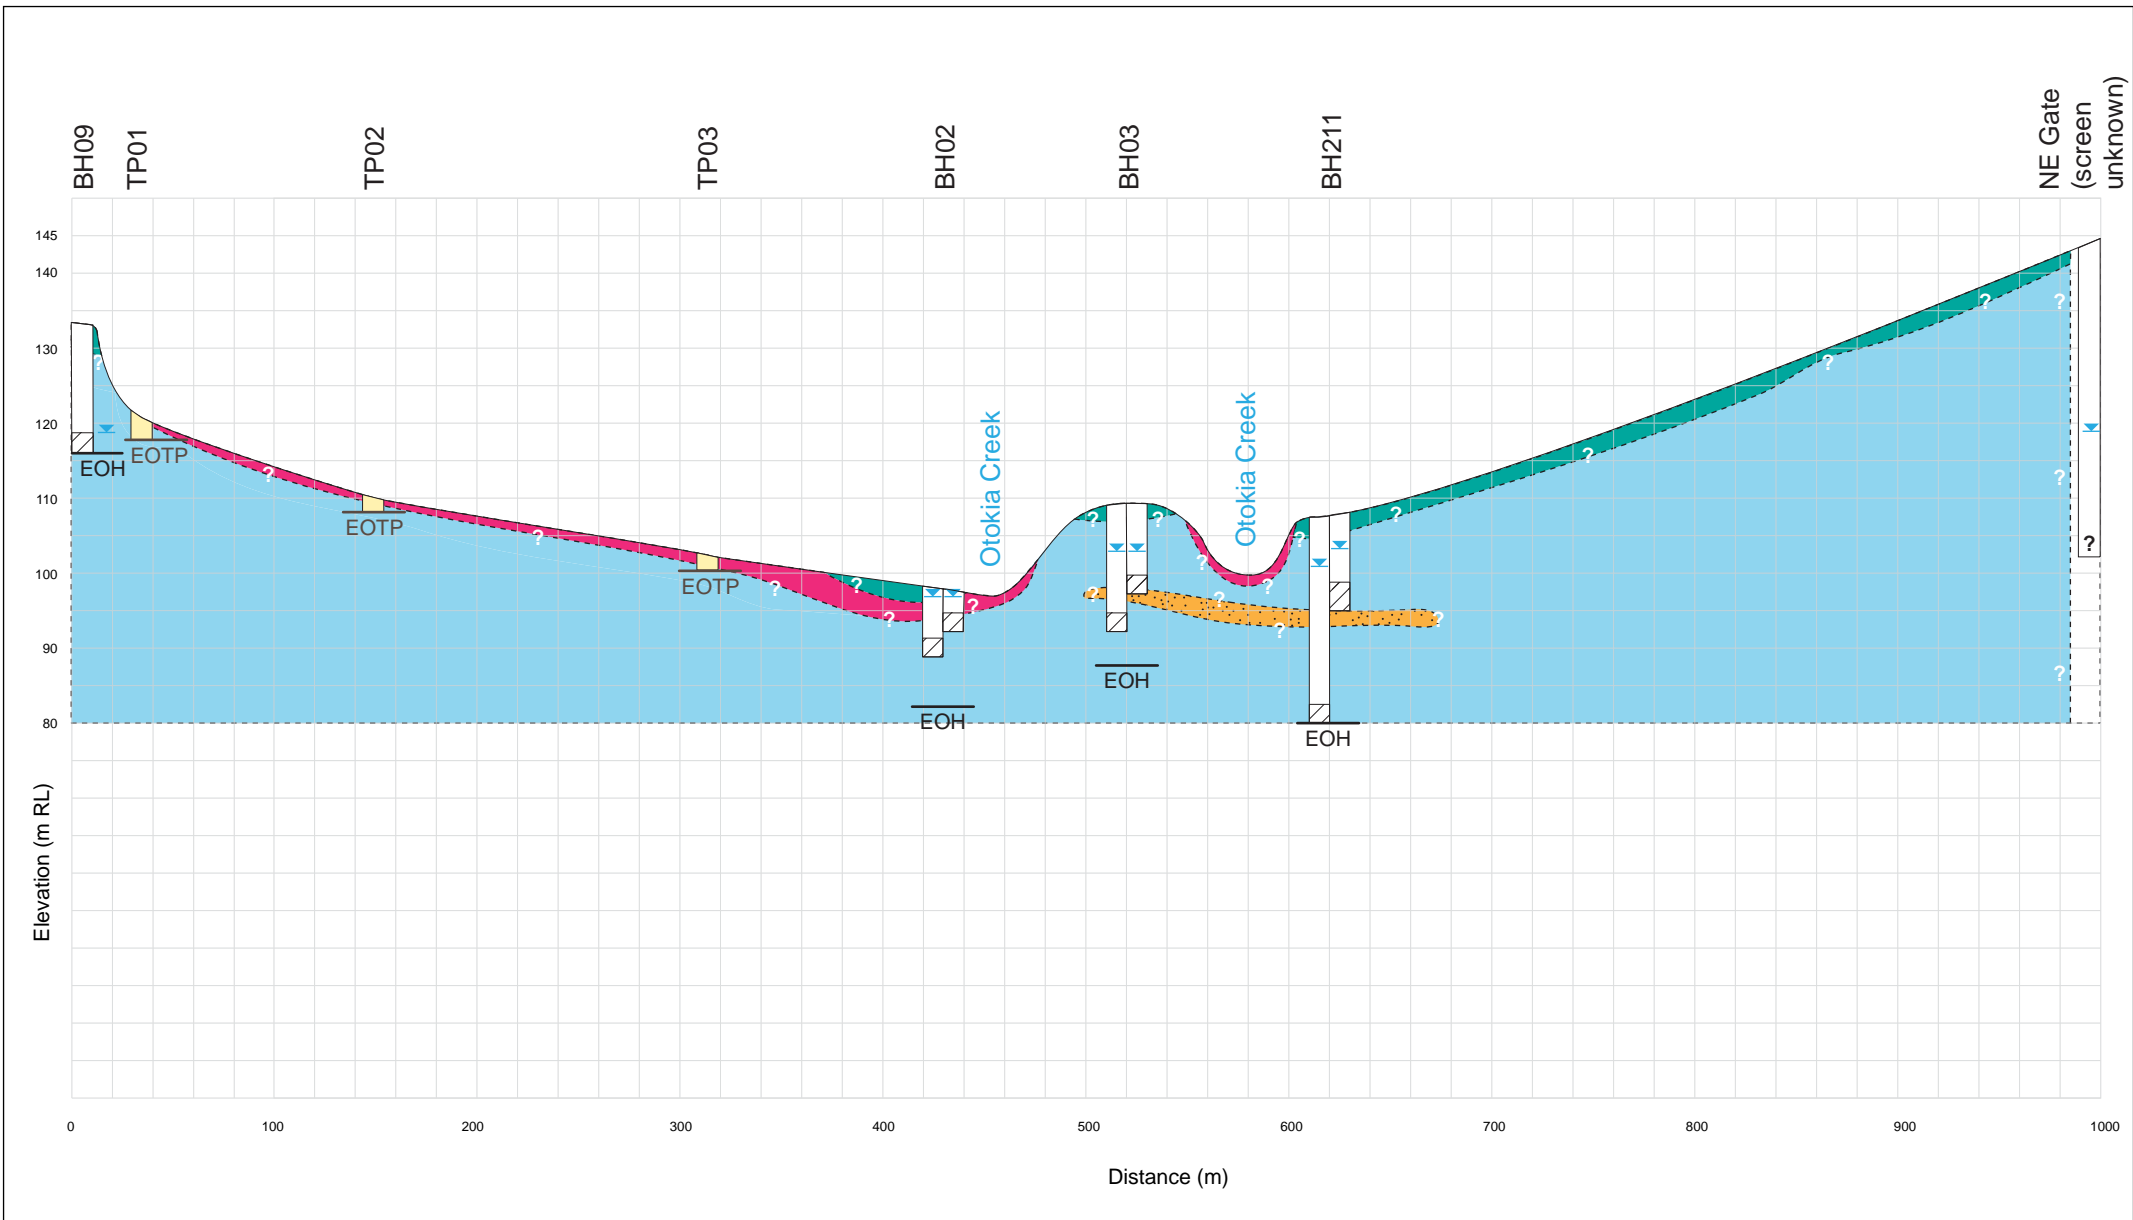
Figure 8

Cross Section B-B'

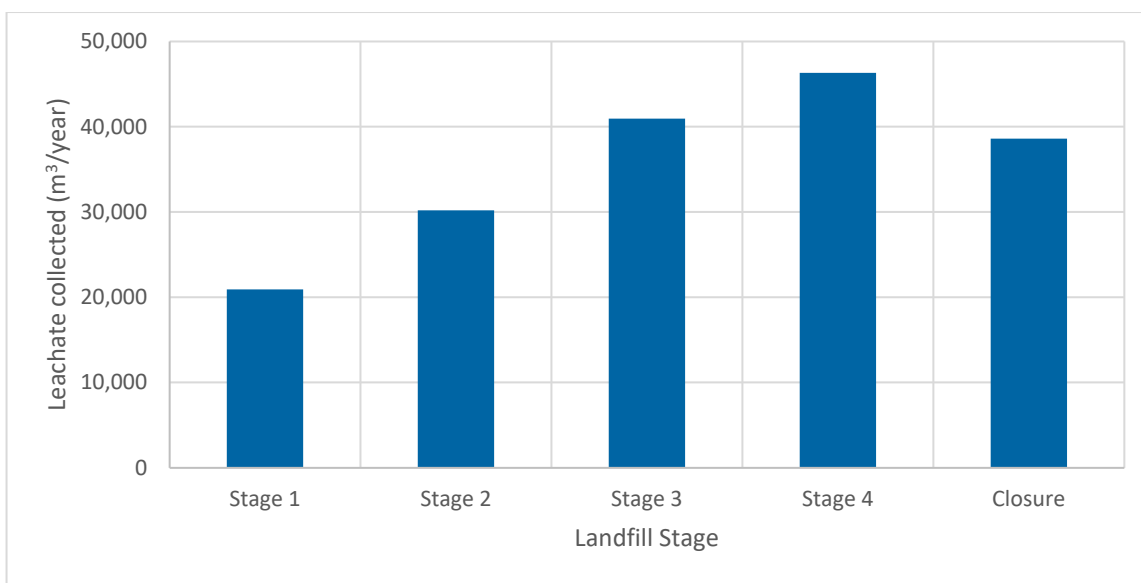
Figure 10: HELP Model landfill leachate to collection system (Updated May 2021)

Figure 10 presents a summary of the landfill leachate predicted to be collected in the leachate collection systems during operation and after stage closure. ~~There are two drainage collection systems for the proposed landfill, which separate the leachate collection in Stages 1 and 2 from leachate collection in Stages 3, 4 and 5. The predicted leachate volumes reported to the collection systems during operation will not occur concurrently as each landfill stage will be closed before the next one is opened. The largest leachate volumes are collection volumes are~~ likely to occur during operation of stage ~~4~~5, with a total predicted leachate volume of approximately ~~99,000~~46,310 m³/year ~~for the whole landfill (worst case for stages 3, 4 and 5 combined with closed stages 1 and 2).~~ After complete landfill closure, the total leachate predicted ~~to be collected from all five stages~~ is approximately ~~38,584~~90,000 m³/year.

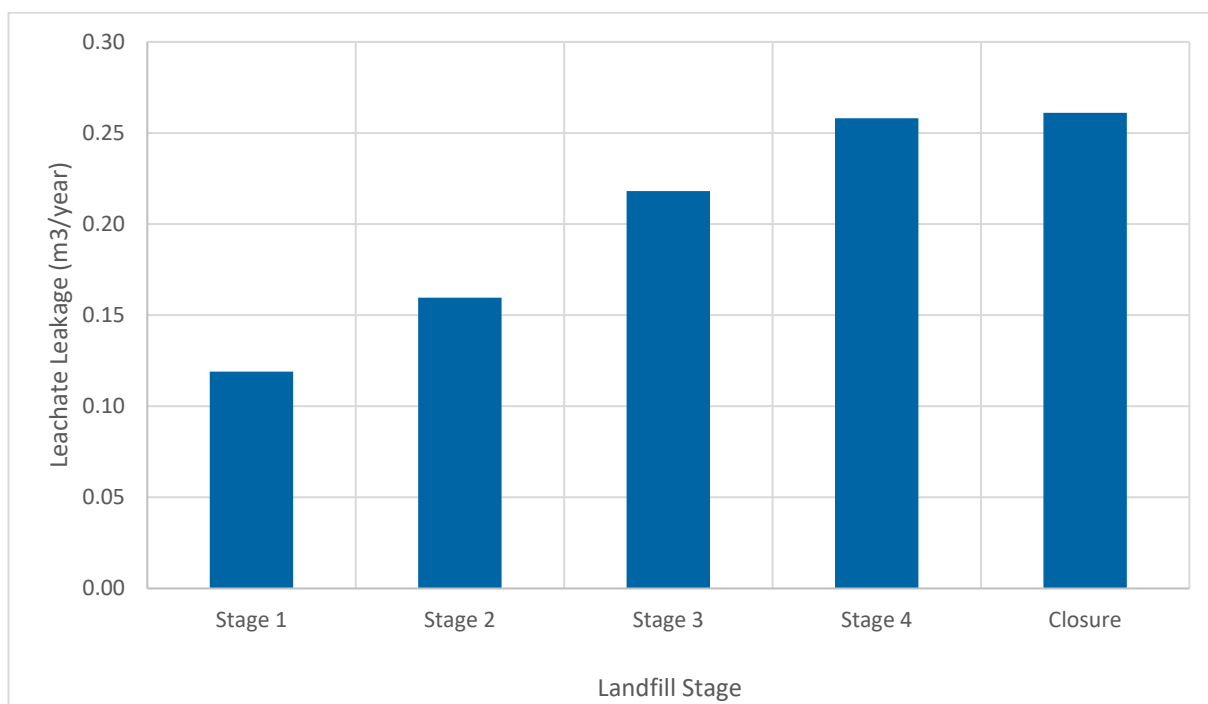
Figure 11: HELP Model leachate leakage through the landfill liner ([Updated May 2021](#))

A summary of the predicted leachate leakage through the landfill liner during operation and after stage closure is presented in Figure 11. ~~As with leachate generation, the leachate leakage during landfill operation will not occur concurrently due to sequential stage construction. The maximum leachate leakage is likely to occur during operation of stage 4 and after landfill closure5, with a predicted leakage rate of 0.263-0 m³/year. (generated from operational stage 5 and closed stages 1, 2, 3 and 4). The predicted total leachate leakage from all stages after landfill closure is approximately 1.9 m³/year.~~
