Project Number: 6-CD109.55

Landslide Monitoring Report – Howard Street

PROJECT
DUNEDIN CITY COUNCIL
HOWARD STREET
LONG-TERM LANDSLIDE MONITORING

TITLE
CUMULATIVE LANDSLIDE DISPLACEMENTS
HOWARD STREET

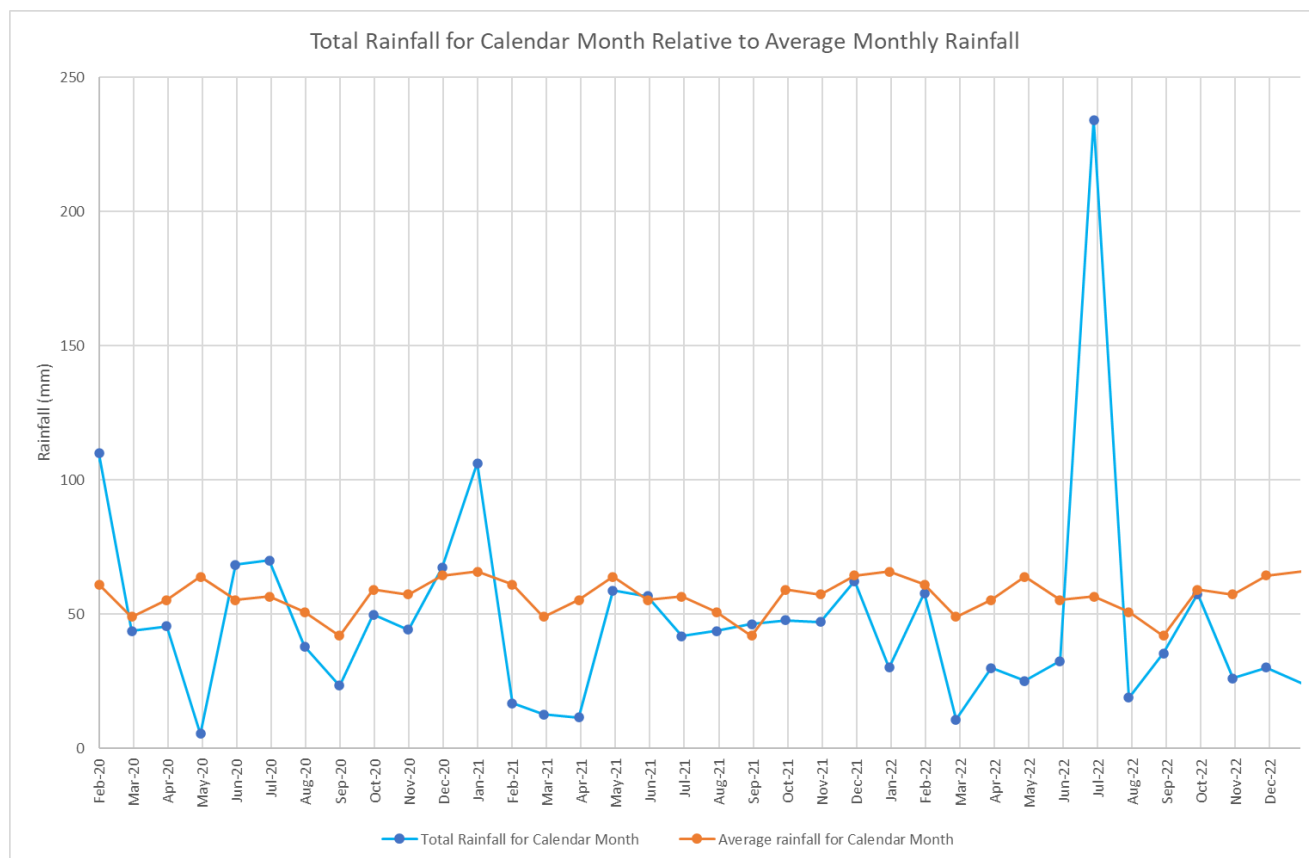
Figure 1: Measured monthly rainfall compared with average monthly rainfall (CliFlo.niwa.co.nz).

A summary of the rainfall data since the previous survey is presented in Figure 1. The rainfall data was retrieved from the NIWA (National Institute of Water and Atmospheric Research) National Climate Database website ([CliFlo.niwa.co.nz](https://cliFlo.niwa.co.nz)) using the Musselburgh Station (Agent ID #15752). Mean monthly rainfall was calculated for the Musselburgh Station using data between 1997 and 2022.

A significant rainfall event during July 2022 is evident in Figure 5, whereby 234 mm was recorded in the calendar month, including 98 mm on 13 – 14 July and 95 mm on 26 – 28 July 2022.

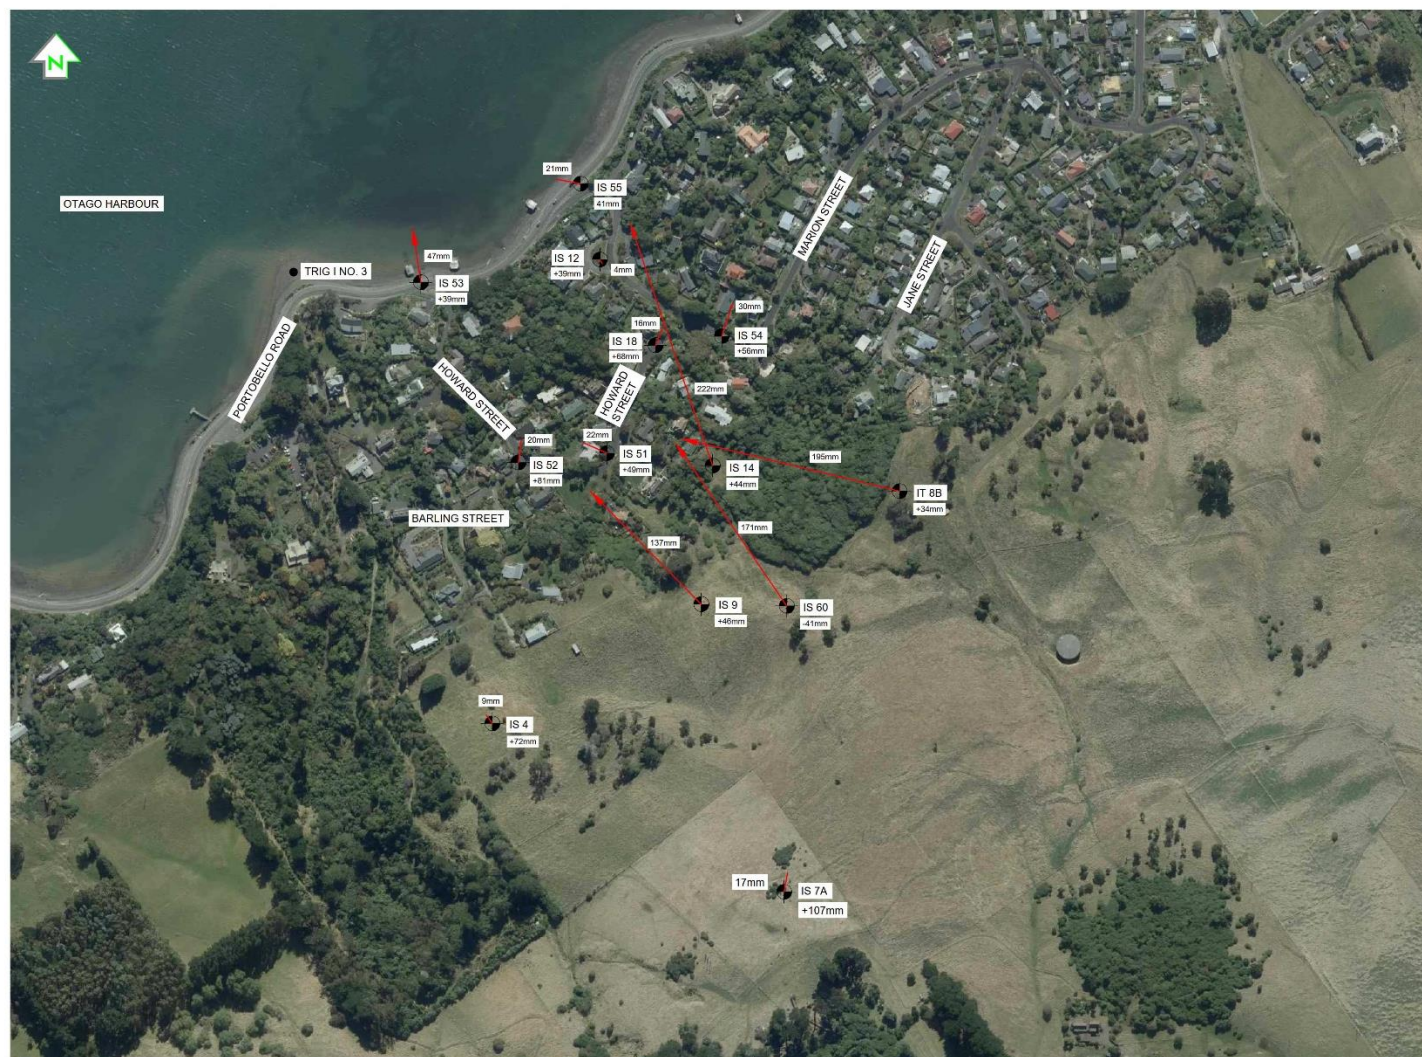
SHEET NO.
C01

When analysing survey data back to the base survey from 1998, there is clear indication that all the points are moving in the direction of the harbour. Maximum horizontal deformations recorded since the base survey have almost all exceeded the accuracy of the survey. However, positive vertical deformation has been reported across all but one of the survey marks, which is atypical of landslides. The current survey methodology has been developed to address the anomaly observed in the vertical deformations. It is expected that subsequent surveys will provide an improved observation of the vertical deformation trend.

+/- Xmm = CUMULATIVE VERTICAL DISPLACEMENT
SINCE THE BASE SURVEY

— CUMULATIVE HORIZONTAL DISPLACEMENT SINCE THE BASE SURVEY (1:1000 SCALE)

It is recommended that the survey frequency is to continue on a yearly or two-yearly interval, using the same survey method described in Section 2. This will help establish a more reliable history of survey data. At present, deformations are still relatively minor but the last two surveys have indicated most of the deformations between surveys have exceeded the accuracy of the survey which may indicate an increase to the deformation rate.

If subsequent surveys indicate that the deformation rate is increasing, then it would be recommended to reduce the intervals between surveys. Increasing the survey frequency will provide a better understanding of the nature and conditions in which these deformations are occurring which will help to inform the risk posed to affected dwellings and strategies for long-term risk management.
