Project Number: 6-CD109.55

Landslide Monitoring Report – Motu Street

29 June 2023

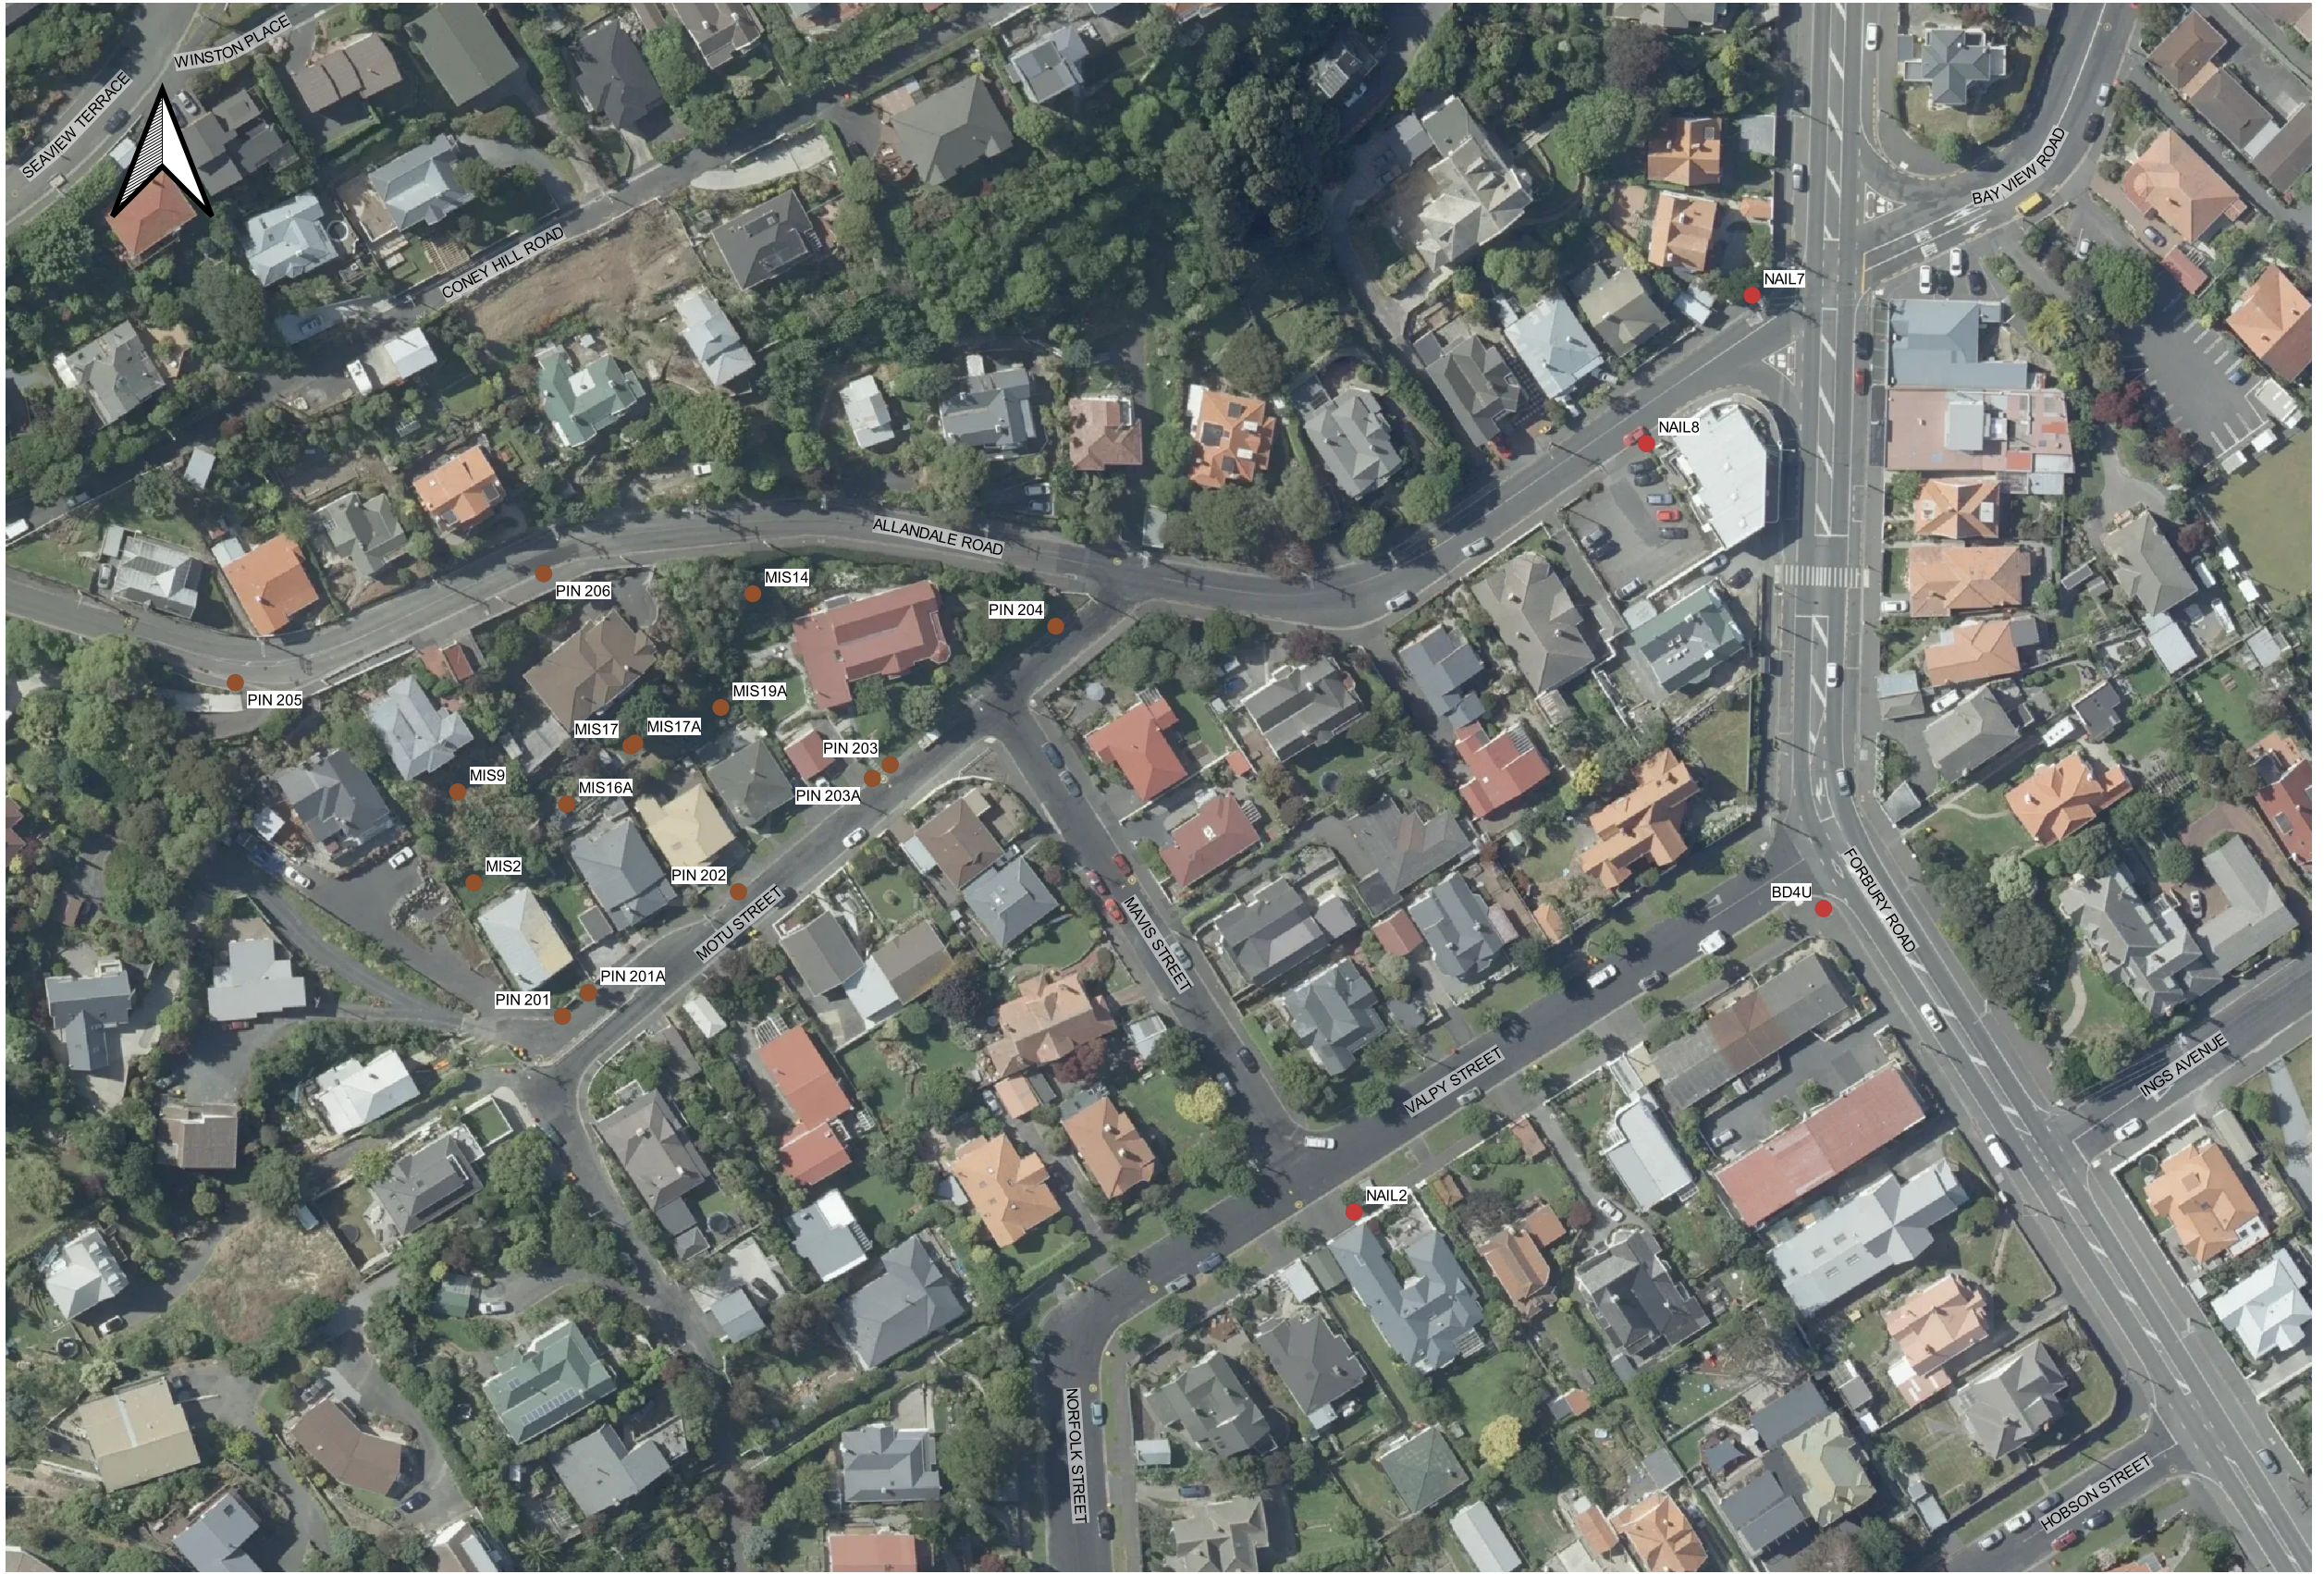
2022 SURVEY PLAN

This report presents a summary of the factual survey monitoring results for the Motu Street site, as well as monitoring recommendations. A mark displacement diagram is provided in Appendix A.

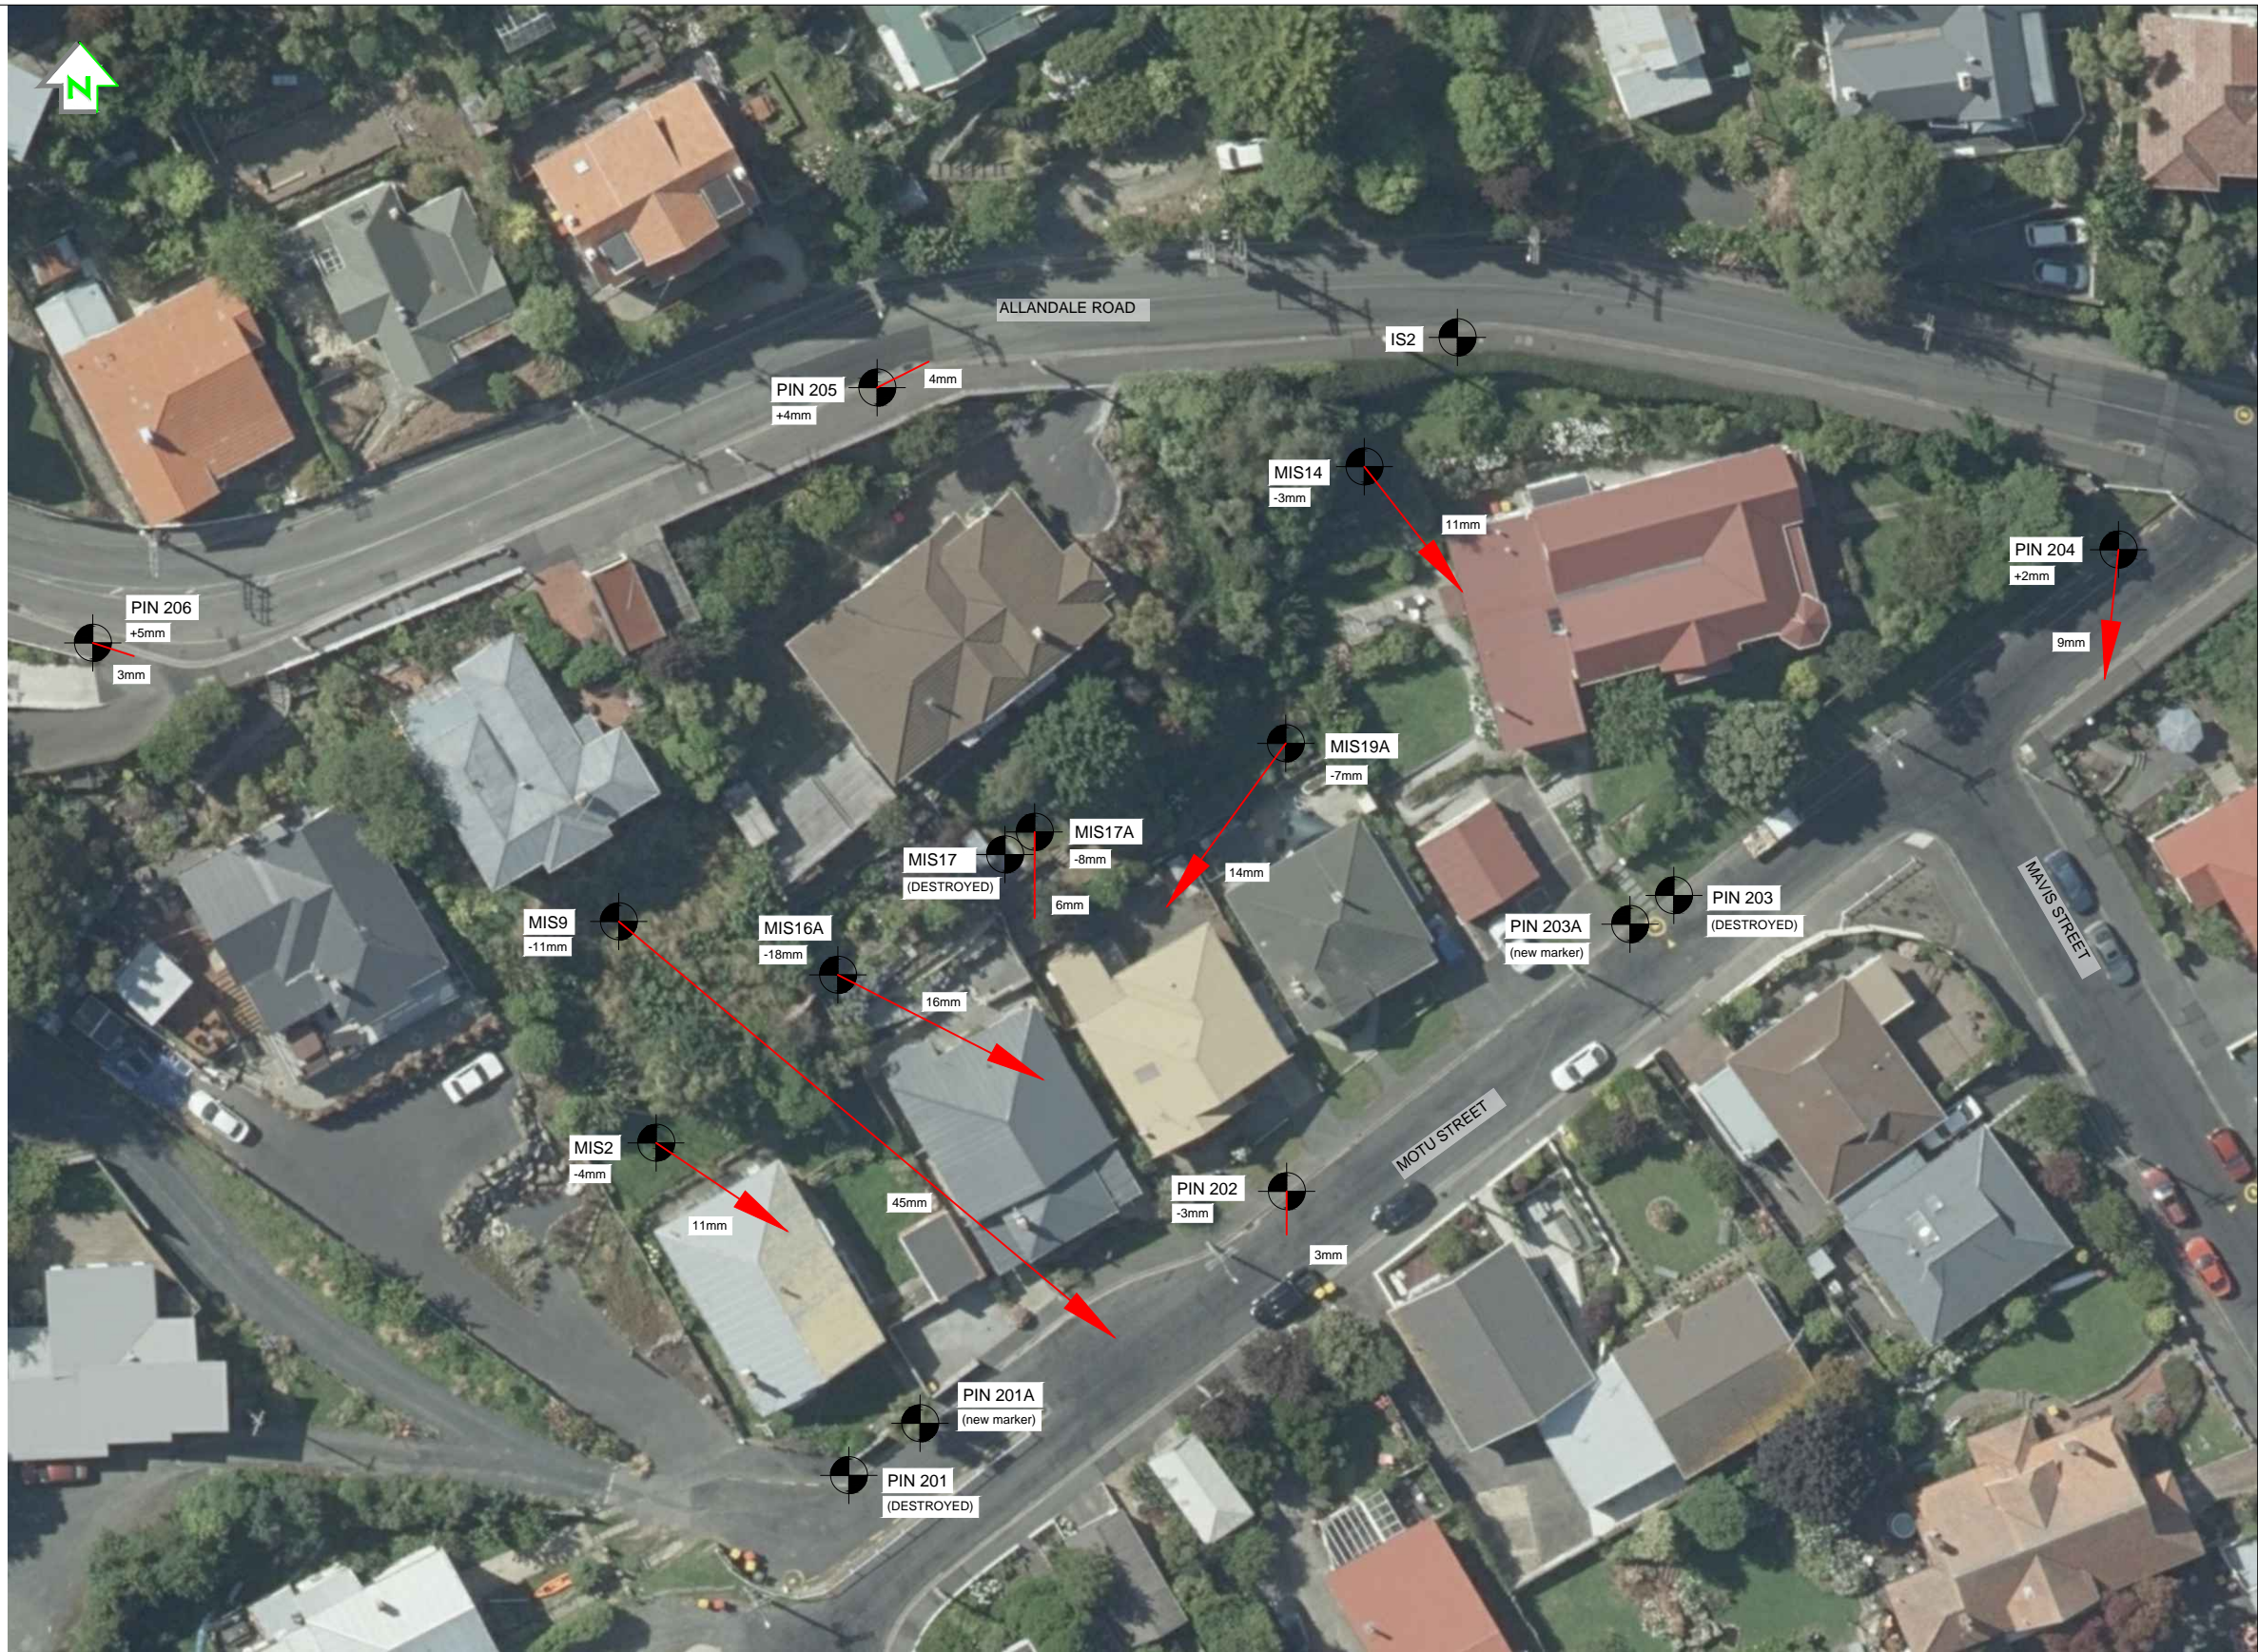
2022 SURVEY RESULTS

The current survey iteration has indicated horizontal deformation from the base survey in four separate locations (MIS9, MIS14, MIS16A, MIS19A) that exceed the accuracy of the survey. The direction of this movement is towards multiple residential dwellings along the northern side of Motu Street, so monitoring should continue to provide insight to the long-term risk to this area. At present, there is insufficient monitoring history to establish if there is a deformation trend establishing or if these movements have occurred as a result of discrete events. It is recommended surveys continue at yearly or 2-yearly intervals, using the same survey method described in Section 2.

| TITLE CUMULATIVE LANDSLIDE DISPLACEMENTS MOTU STREET | | | |
