Project Number: 6-CD109.55

Landslide Monitoring Report – Sidey Street

6 April 2023

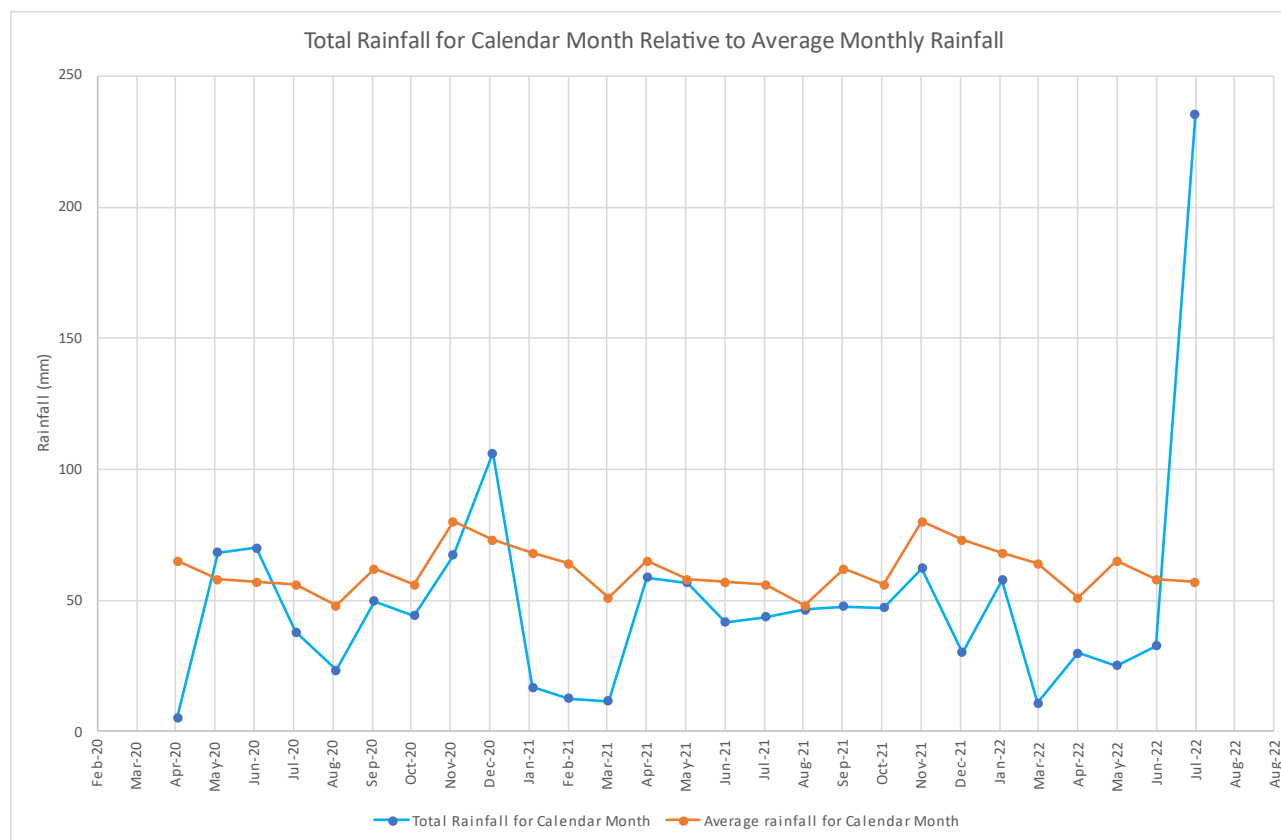
Figure 1: Measured monthly rainfall compared with average monthly rainfall (Climo.niwa.co.nz).

A summary of the rainfall data since the previous survey is presented in Figure 1. The rainfall data was retrieved from the NIWA (National Institute of Water and Atmospheric Research) National Climate Database website ([CliFlo.niwa.co.nz](https://cliFlo.niwa.co.nz)) using the Musselburgh Station (Agent ID #15752).

Significant rainfall during July 2022 is evident in Figure 1, whereby 235 mm was recorded in the calendar month, including 97.6 mm on 12 – 13 July and 94.6 mm on 26 – 28 July 2022.

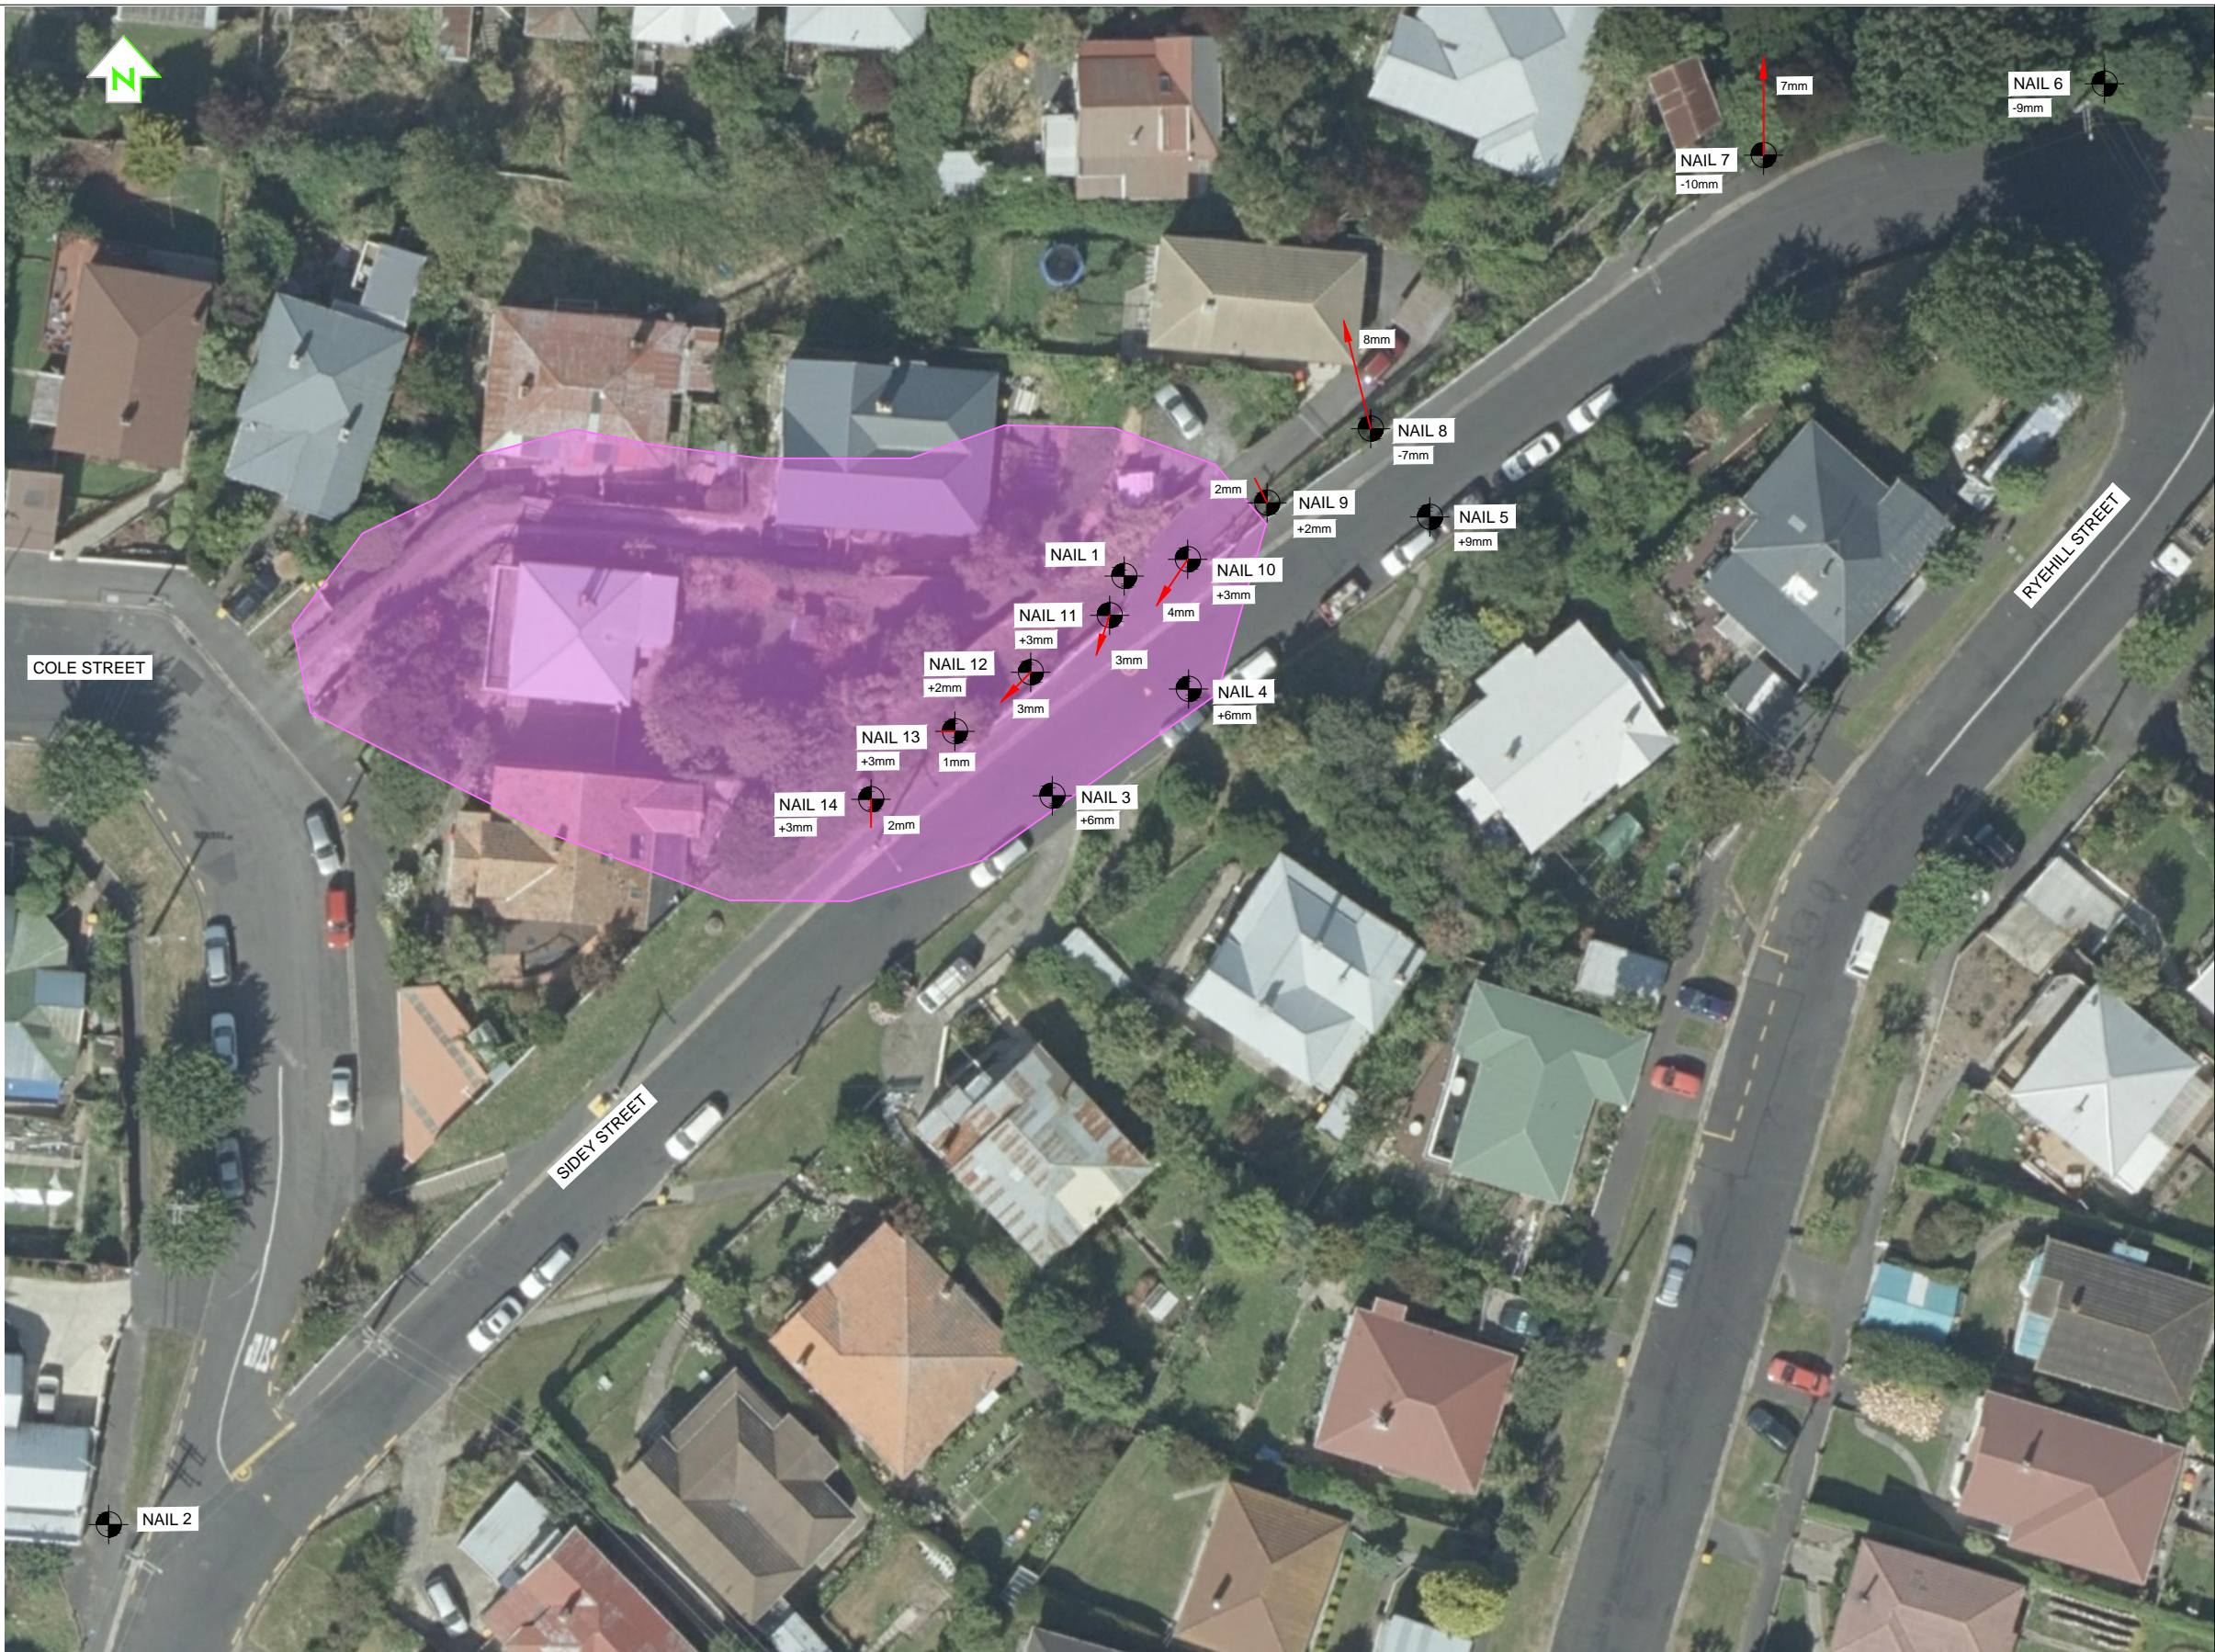
2022 SURVEY RESULTS

The review of survey data back to the base survey conducted in 2010 shows no conclusive trend of movement. The deformations recorded between surveys have so far not exceeding the accuracy of the survey. Additional surveys will be required to establish if there is movement actively occurring.

Furthermore, positive vertical deformations have been recorded across multiple survey marks, which is atypical of landslides. This is possibly attributable to some of the control points residing within the zone of movement. On this basis it is recommended that additional control points are established outside of the observed zone of movement. Surveys are recommended to continue on one- or two-yearly intervals, using the same survey method described in Section 2.

PROJECT DUNEDIN CITY COUNCIL SIDEY STREET LONG TERM LANDSLIDE MONITORING			
TITLE CUMULATIVE LANDSLIDE DISPLACEMENTS SIDEY STREET			
WSP PROJECT NO. 6-CD109.55	PROJ-ORIG-VOL-LOC-TYPE 6-CD109.55	SHEET NO. C01	REVISION A
