# Application for Resource Consent in accordance with Schedule 4 of the Resource Management Act 1991

# Re: Subdivision Application - 195 & 245 Wakari Road, Dunedin

On behalf of JKS Paddock Limited, we submit for consideration by your Council an application for subdivision for Stage 1 of a staged development at 195 & 245 Wakari Road, Dunedin.

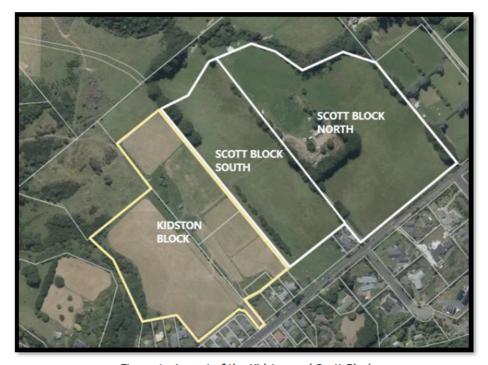
Figure 1 : Layout of the Kidston and Scott Blocks

245 Wakari Road was recently the subject of subdivision SUB-2023-73 approved by Council on 16 August 2023. The subdivision created two lots, separating 3.71ha in proposed Lot 1 (the 'Scott Block South') from the remainder of the site in proposed Lot 2 (being the 'Scott Block North') as shown in Fig. 1 below. Access to both lots will continue to be from the existing vehicle crossing, which sits within proposed Lot 1. A proposed ROW will be created in proposed Lot 1, serving proposed Lot 2 which will potentially enable access to the Kidston Block in subsequent stages. This ROW will also provide the opportunity for construction access for Stage 1 of the Kidston Block.

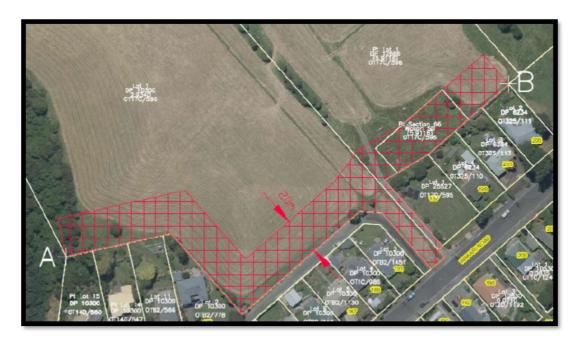
Figure 2 : Area Subject to Encumbrance 5114600.2

Encumbrance 5114600.2 provides for a 20m wide strip within which "no building may be built or erected" against the existing ribbon of residential properties fronting Wakari Road. The extent of the encumbrance is shown in Fig.2 below. Other than the no-build requirement, there is no stipulation or restriction in the instrument as to ownership of the area or other use. For clarity, the encumbrance does not prohibit residential sites being located or partially located within the area.

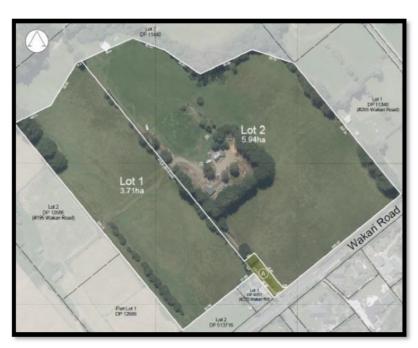
Figure 3 : Subdivision SUB-2023-73 on the Scott Blocks

Subdivision SUB-2023-73 approved the subdivision of the Scott Block to create Lot 1 which would be immediately carried into the overall development as a subsequent stage.

Lot 1 comprised the 3.71ha of land adjoining the Kidston block and included a 16m wide access strip over the current formed driveway from Wakari Road. A Right of Way easement burdened against proposed Lot 1 for the benefit of proposed Lot 2 will provide both current access and allow for construction access as well as potential future residential access from Wakari Road.

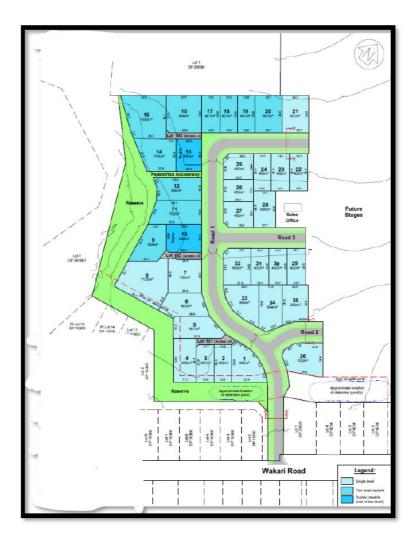
Figure 4: Stage 1 Development Plan

Terramark Plan 230195/12 shown below as Fig.4 sets out Stage 1 of the development comprising the land within the Kidston Block being the southern portion of the site proper.

Stage 1 will contain 36 new residential lots ranging from 404m<sup>2</sup> to 1,032m<sup>2</sup> in area. Lots on the upper slopes and southwestern boundary where the site falls toward the creek are proposed to contain two-level dwellings. The balance of the lots will be restricted by private covenant to single level dwellings with a maximum height of no more than 5.5m. Proposed Lots 10 and 13 are earmarked for duplex development – that is two dwellings sharing a common wall.

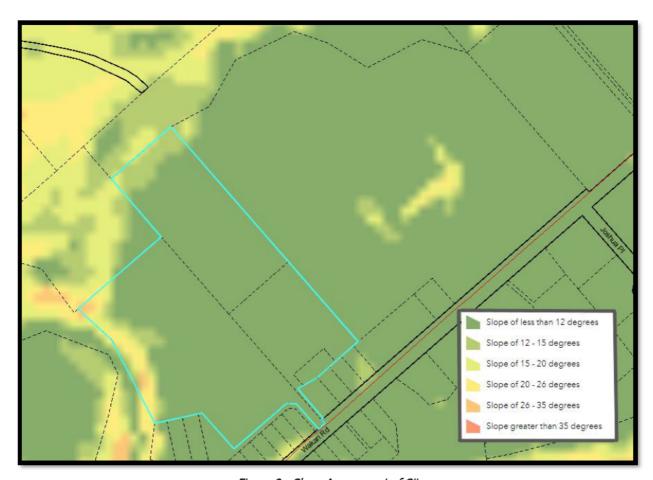
Figure 9 : Slope Assessment of Site

With respect to earthworks, the DCC datamap shows the site has a slope of less than 12 degrees which informs the earthworks assumptions for compliance against the standards. The activity status table in Rule 8A.3.2 shows the activity status of earthworks activities across all zones, provided any performance standards are met. The activities in the earthworks category are listed in the Nested Table in Section 1.3.

The table below summarises the small-scale threshold and the proposed scale of works. The site is assessed as <12 degrees slope as shown in Fig. 9. The proposed earthworks do not comply with Rule 8A.5.1.2.a, and therefore are considered a large-scale earthworks activity, which is a restricted discretionary activity.

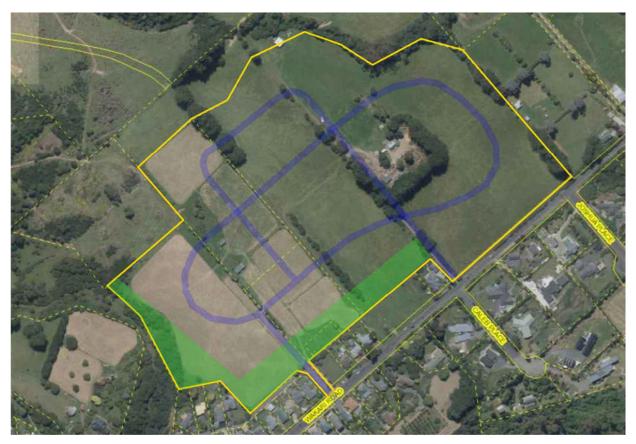
A preliminary sketch layout (Figure 2.1) shows a likely future reserve of approximately 1 ha along the southern and eastern margins (partly adjoining the creek).

Preliminary road alignments are shown on Figure 2.1, but detailed design is yet to be completed.

Figure 2.1 – Development area bounded by yellow, with potential roads (blue) and reserve (green)

We understand that a series of new access roads will be constructed off Wakari Road to serve the subdivision. Conceptual roads are indicated in Figure 2.1.

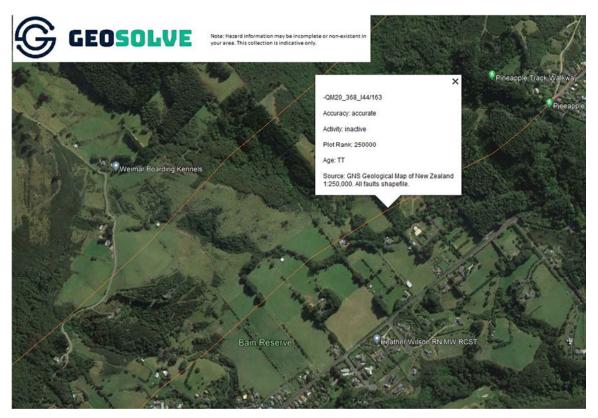
Figure 5.2 – Inactive faults on or near the subject site (GNS Science Ltd)

Inactive faults are also mapped on and near to the site as shown in Figure 5.2 according to GNS Science Ltd. This could mean that differing rock types are possible under the site if fault offsets are significant. The recent Canterbury earthquakes have highlighted the issue that previously unidentified faults or presumed activity status may be very significant factors in the actual future risk applying to any particular site.

It should be noted the fault terminations shown on fault trace maps are often approximations (owing to lack of data) and the presence of other active faults may be unknown because they may be obscured by overburden soils.

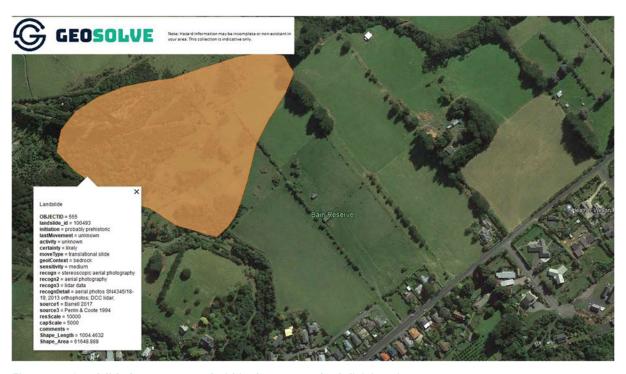
Figure 5.1: Landslide feature mapped within the proposed subdivision site.

The land stability hazard only affects a minute corner of the proposed area and is not considered a hazard for the site. There are no other hazards on adjacent land that may affect this site.

Engineering geological mapping of the site (and in particular the area of the site within the above landslide feature) revealed no indicative scarps or hummocky terrain characteristic of recent land movement.

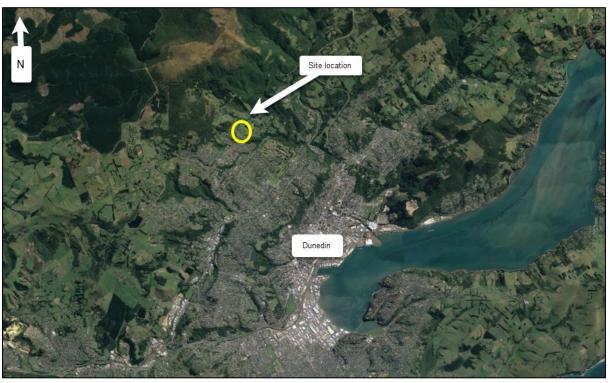
Figure 2.1: Site Location

The site is located to the north of Dunedin City, on the northern side of Wakari Road, presented in Figure 2.1 below.

The 9.6 hectare sloping site sits above established residential lots on the northwest side of Wakari Road. A description of the existing site characteristics and photographs of predeveloped site are presented in Section 4 below.

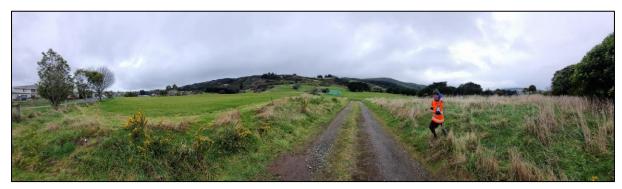
Figure 4.2: Development Site Looking Northwest from Access Road

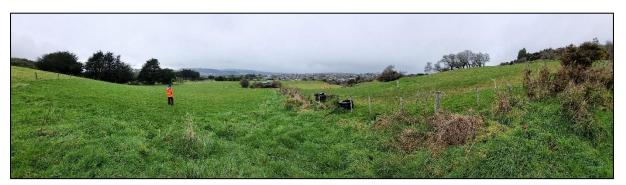
Figure 4.3: Development Site Looking Southeast towards Access Road

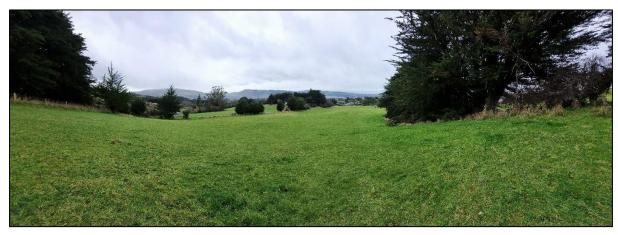
Figure 4.6: View Looking Down Ephemeral Watercourse Located in Stage 2 Land

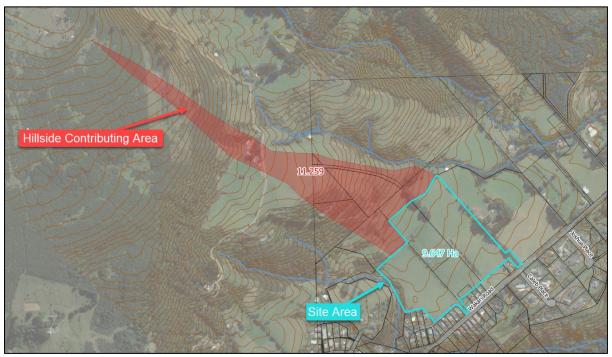
Figure 5.1: Stormwater Catchment Area

The contributing upper catchment area for this ICMP associated with both Stages 1 and 2 of the proposed development is approximately 11.26 hectares as shown in Figure 5.2. The catchment consists of grass and scrubby bushes, including land grazed by cattle and sheep.

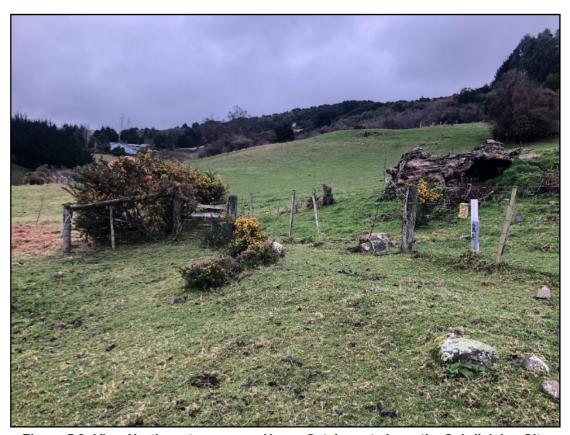
A view of the lower reaches of this upper catchment area is presented in Figure 5.3 below.

Figure 5.3: View Northwest up across Upper Catchment above the Subdivision Site

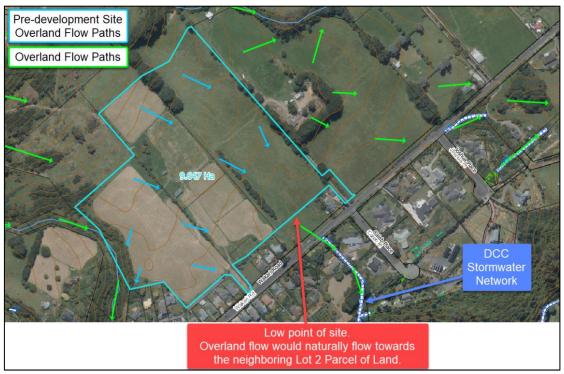
Figure 5.4: Overland Flow Directions within and around the Site

As noted earlier, stormwater runoff flowing from upper hillside contributing area and predevelopment flows from the majority of Stages 1 and 2 of the development area flow towards an existing ephemeral watercourse feeding into an existing culvert running under Wakari Road on the southeastern boundary of the adjacent Lot 2 DP513716 located between 205 and 225 Wakari Road as shown in Figure 5.4 below.

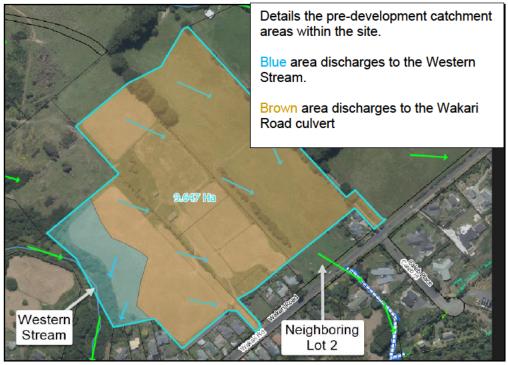
There is no existing DCC Stormwater infrastructure located within the proposed development site. Any existing infrastructure is located under Wakari Road and to the southeast of Wakari Road. The DCC stormwater networks which consist of open channels and associated culverts which convey the overland flows to either the western stream or the channel running through 210 Wakari Road (opposite Lot 2 DP513716) as shown in Figure 5.5 below. Both channels eventually end up discharging into Ross Creek.

Pre-development catchment areas within the proposed subdivision site are also presented in Figure 5.5 below. There are two catchments, a portion of the western side of the site slopes to the west towards a significant gully that drains towards a large culvert at the intersection of Helensburgh Road and Wakari Road, and the remainder of the site which flows towards the ephemeral watercourse and culvert in adjacent Lot 2 DP513716 as noted above.

Figure 5.5: Predevelopment Catchment Areas within the Site

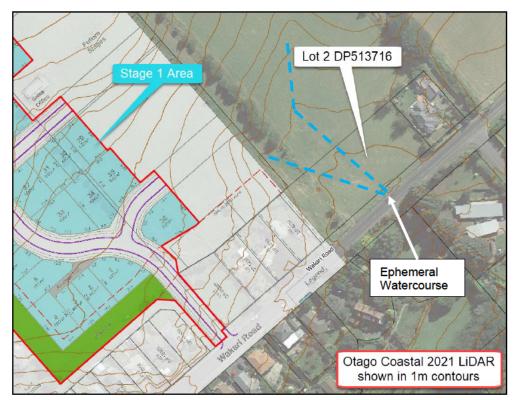
Figure 5.6: Ephemeral Watercourse and Lot 2 DP513716

Figure 5.6 shows the location of Lot 2 DP513716 in relation to Stage 1 of the proposed development and the existing ground contours in the area of the ephemeral watercourse.

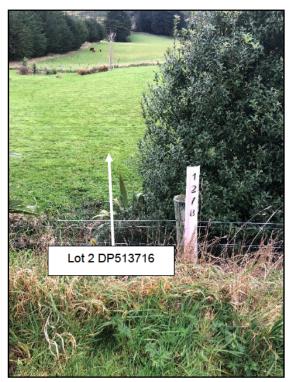
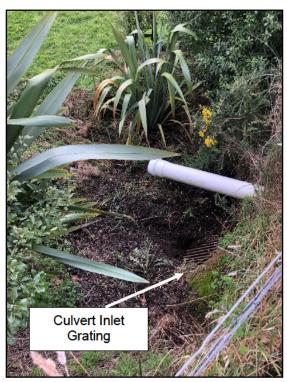
Figures 5.8 and 5.9: Grated Drain Culvert Lot 2 DP513716

Figures 5.7 to 5.9 show the ephemeral watercourse passing through Lot 2 DP513716 and the culvert inlet grating at the low point leading under Wakari Road.

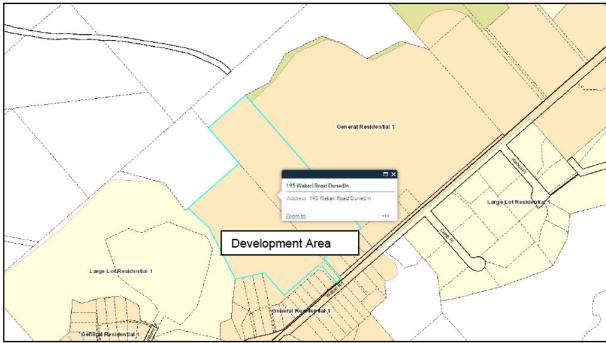
The development site - both Stages 1 and 2 (highlighted by the light blue boundary in Figure 6.1 below) is zoned as General Residential 1 in the Dunedin City Council 2GP.

Figure 6.1: Site Location and Planning Map extracted from DCC 2GP

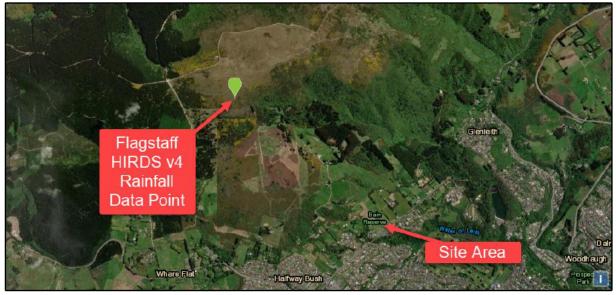
Data was sourced from NIWA in HIRDS Version 4 at the point shown in Figure 7.2 which is representative of the rainfall falling on the contributing hillside catchment.

Figure 7.2: HIRDSv4 Rainfall Data Point and Site Location
