# Dunedin City Wastewater Overflows

**An assessment of receiving  
water environments**

Prepared by  
Ryder Consulting  
November 2015

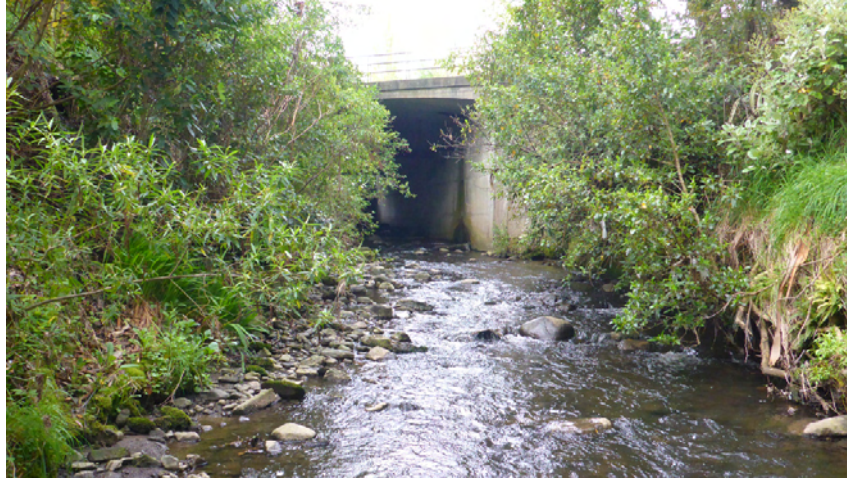
**Figure 3.** Kaikorai Stream downstream of the Kaikorai Valley wastewater overflow. The overflow pipe is located underneath the Kaikorai Valley Road bridge on the true right of the stream.

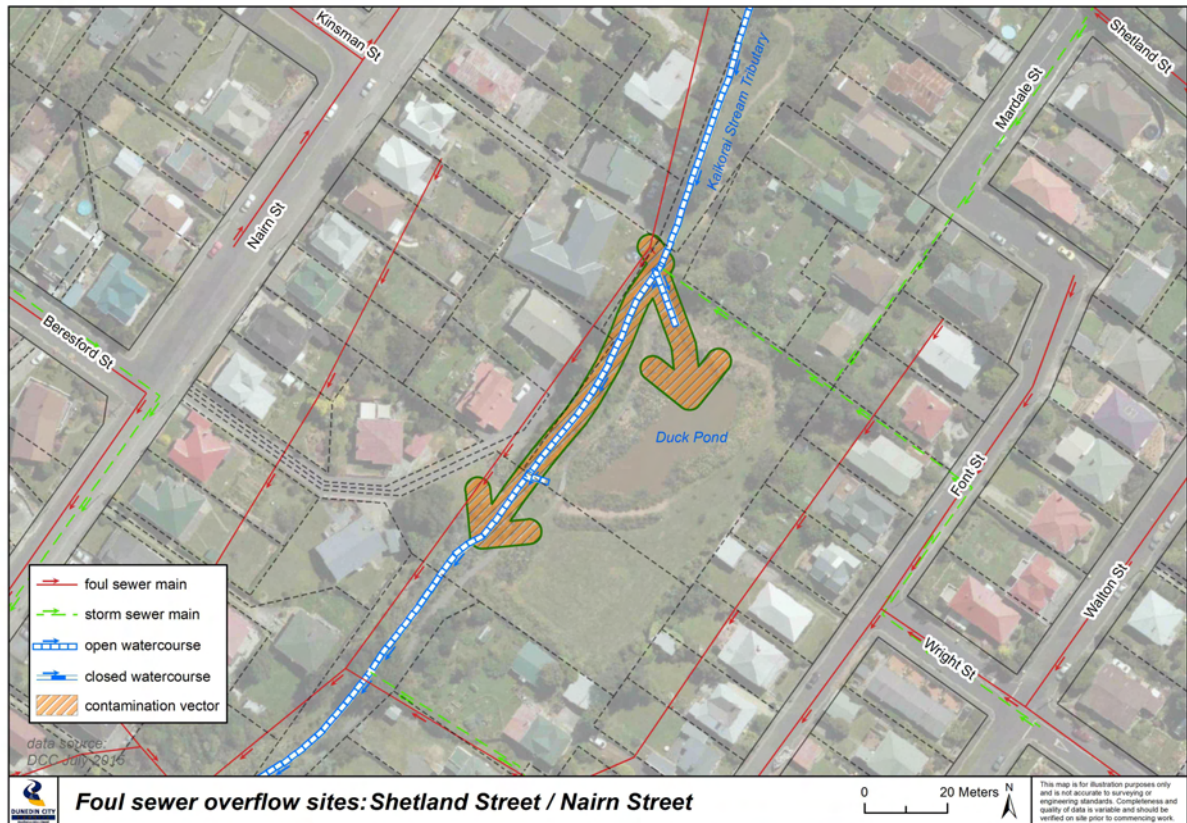
**Figure 4.** Aerial photograph detailing Kaikorai Valley wastewater network pipes (red lines) and the location of the Shetland Street / Nairn Street wastewater overflow (orange arrow) which discharges to a tributary of Kaikorai Stream (blue and white line).

The Shetland Street / Nairn Street overflow is located in a residential block further upstream in the Kaikorai Stream catchment (Figures 1 and 4). It is regarded as a high level overflow that directly enters an unnamed tributary of Kaikorai Stream via a pipe (Figure 5). The tributary connects to a small duck pond adjacent to the tributary immediately downstream of the overflow pipe. Like the Kaikorai Valley overflow, it has a high overflow frequency and volume (Figure 1, Appendix 1) caused by a low in-line pipe capacity.

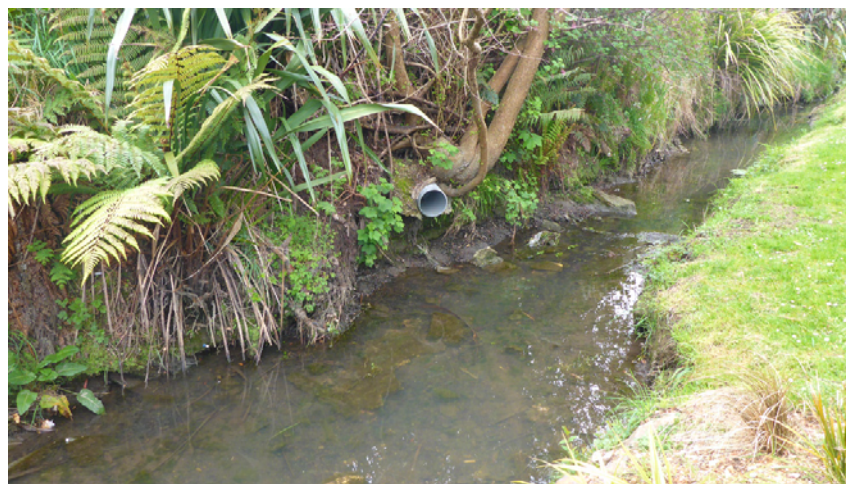
**Figure 5.** Shetland Street / Nairn Street wastewater overflow and a small tributary of Kaikorai Stream.

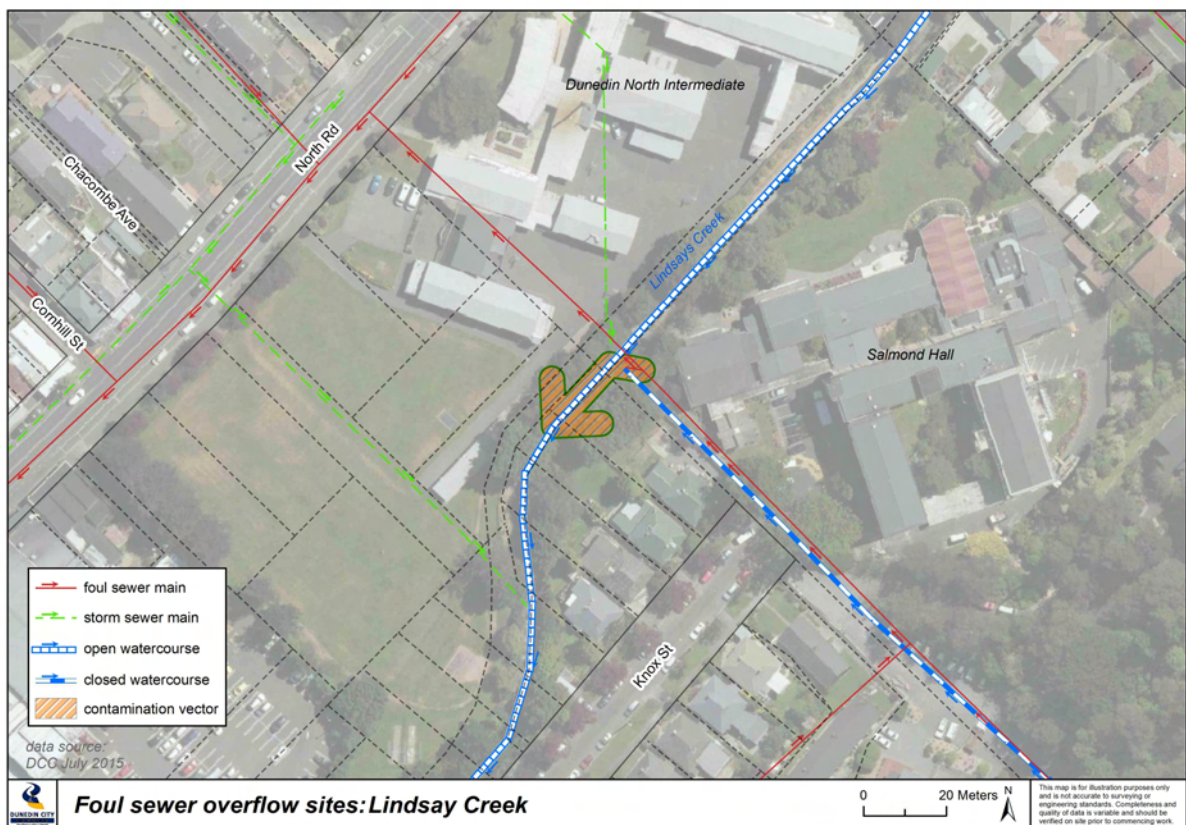
**Figure 6.** Aerial photograph detailing North East Valley wastewater network pipes (red lines) and the location of the Lindsay Creek wastewater overflow (orange arrow) which discharges to Lindsay Creek (curved blue and white line).

The Lindsay Creek overflow is located within North East Valley near Knox Street (Figures 1 and 6). The pipe has a relatively low in-line design capacity causing high volume overflows at a high frequency (Figure 2, Appendix 1) directly into Lindsay Creek. The Lindsay Creek overflow poses a potential risk to the water quality of Lindsay Creek (Figure 7) and the Water of Leith to which Lindsay Creek drains.

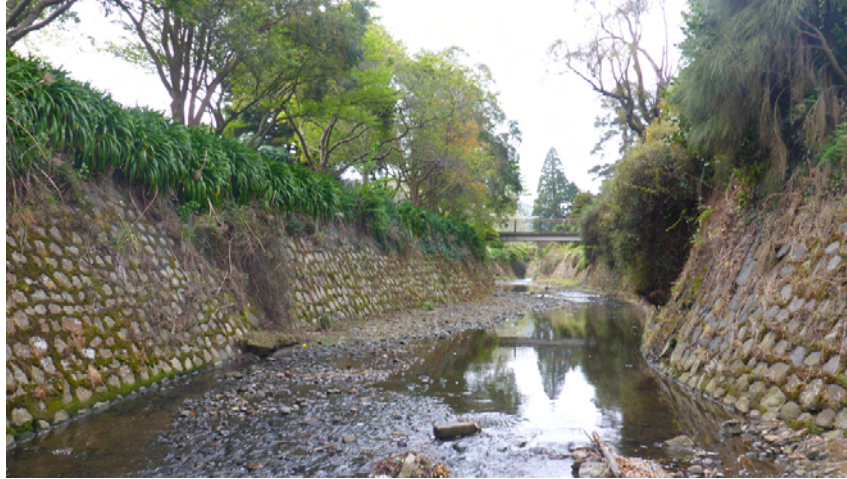
**Figure 7. Lindsay Creek 400 m downstream of the Lindsay Creek wastewater overflow located near Knox Street.**

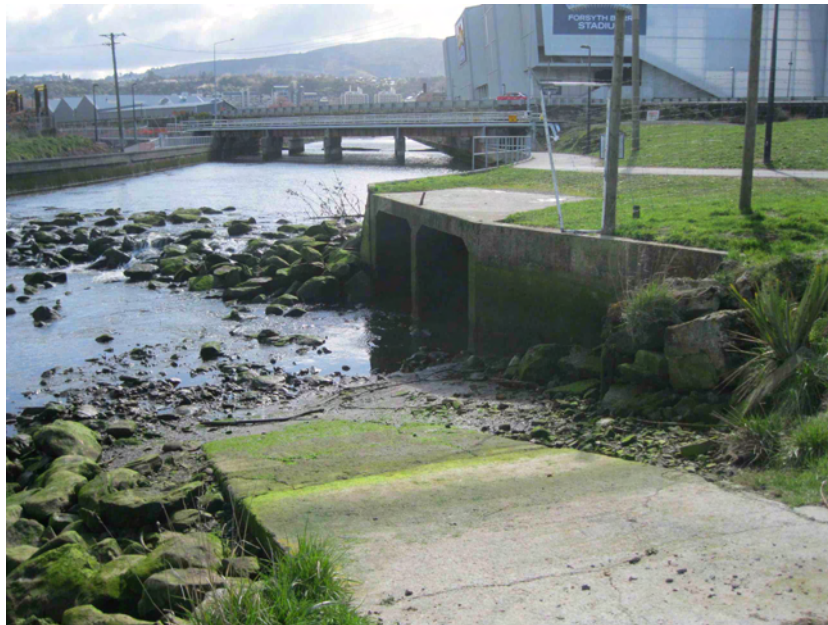
**Figure 9.** Photo of lower Water of Leith showing the conduit that discharges Butts Creek and stormwater that may carry wastewater from the Harbour Terrace / Union Street East overflow site.

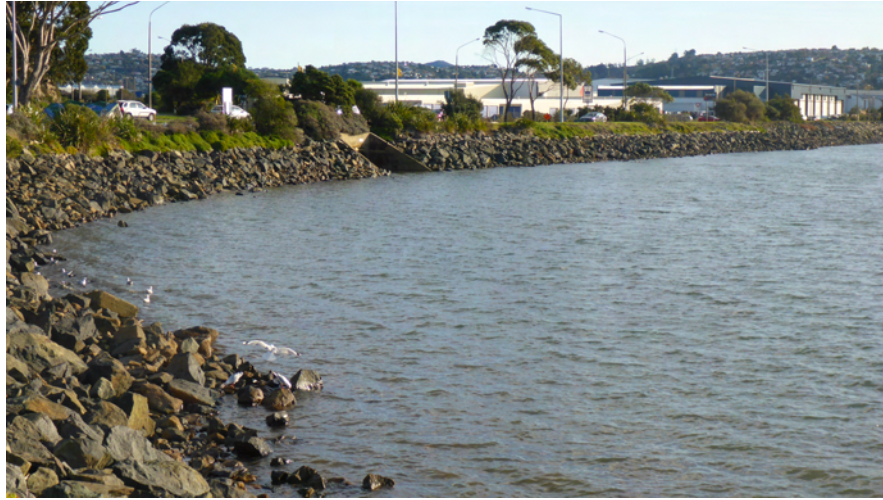
**Figure 11. Portobello Road stormwater outfall (centre of photo) that conveys overflow wastewater from the Hillside Road / Surrey Street site.**

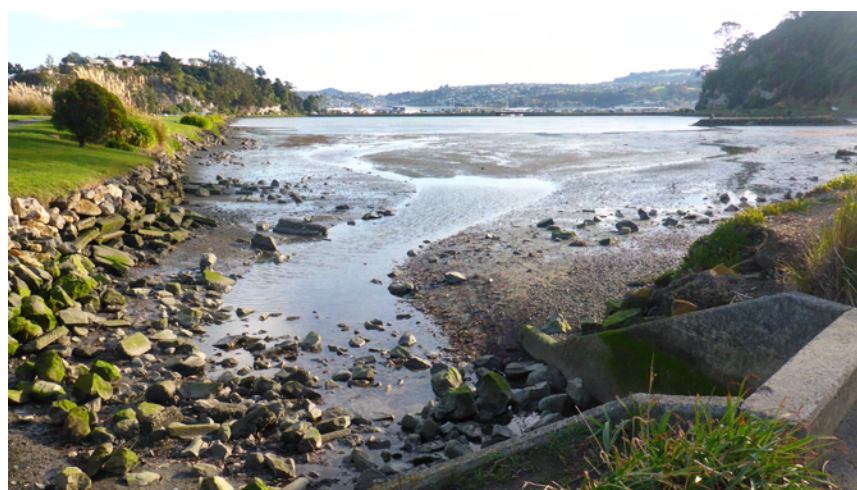
**Figure 13. Upper north-east corner of Andersons Bay inlet at the Marne Street road bridge.**

The discharge is into the top end of Anderson's Bay Inlet (Figure 13) via a large opening under the road bridge (Figure 14).

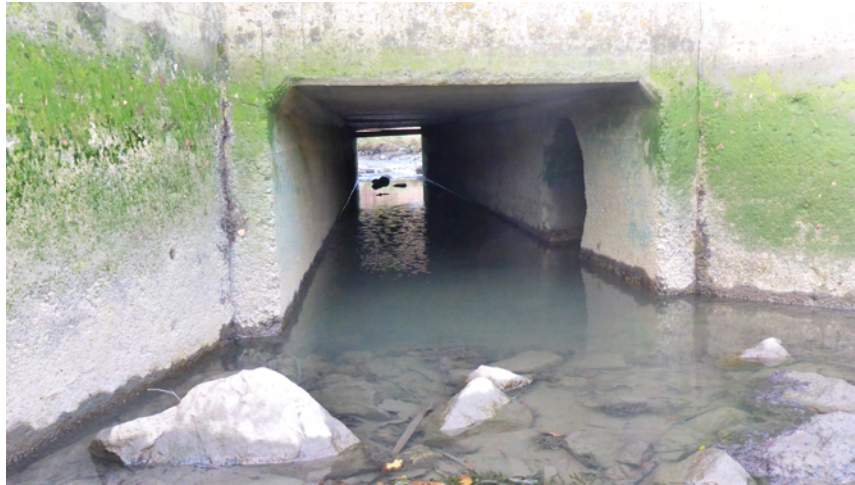
**Figure 14. Overflow Marne Street road bridge showing pumping station discharge outlet on right.**

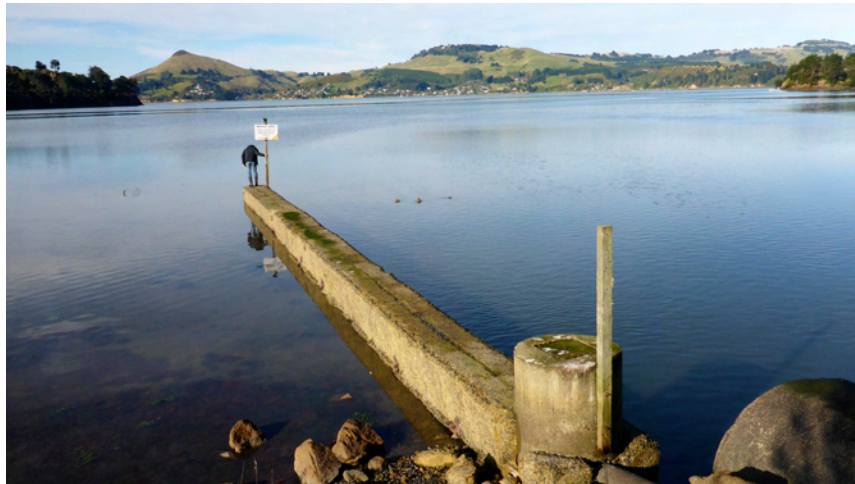
**Figure 16.** The extended pipe that conveys overflow wastewater and stormwater into Sawyers Bay.

Sawyers Bay Pumping Station overflows from the pumping station wet-well through a pipe into the harbour at Sawyers Bay (Figures 1, 15 and 16).

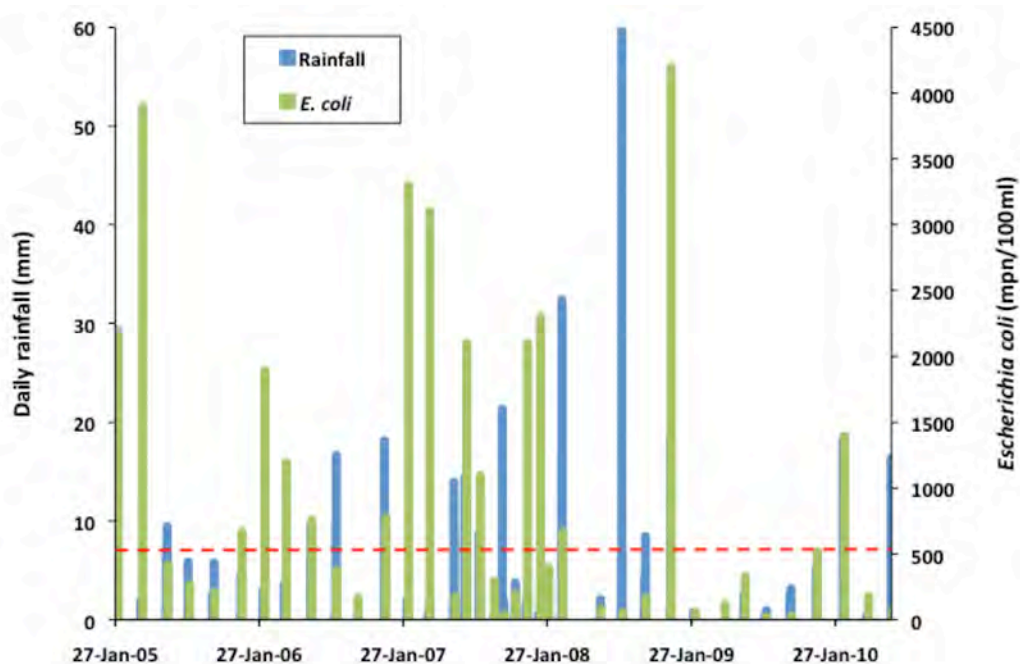
**Figure 18.** *Escherichia coli* levels (green bars) and rainfall for five days prior to water sampling (blue bars) between January 2005 and June 2010 for Kaikorai Stream at Townleys Road. Water quality data from ORC, rainfall data from NIWA CliFlo (National Climate Database). Red dashed line indicates Ministry for the Environment action/red mode level, above which there could be a health-risk for swimming.

Comparing rainfall for five days prior to the date of water sampling occasions with levels of faecal contaminants in the stream reveals that high *E. coli* and faecal coliform (both faecal indicator bacteria) levels are generally found at both sites following low rainfall events (i.e. under low river flows) (see Figure 18 for the Townsleys Road site). Faecal indicator bacteria levels tended to be lower following high rainfall events (i.e. high river flows), likely due to increased dilution due to higher water volumes in the stream. These results indicate that the water quality of Kaikorai Stream is generally poor, and the poor quality is more pronounced under lower river flow conditions.

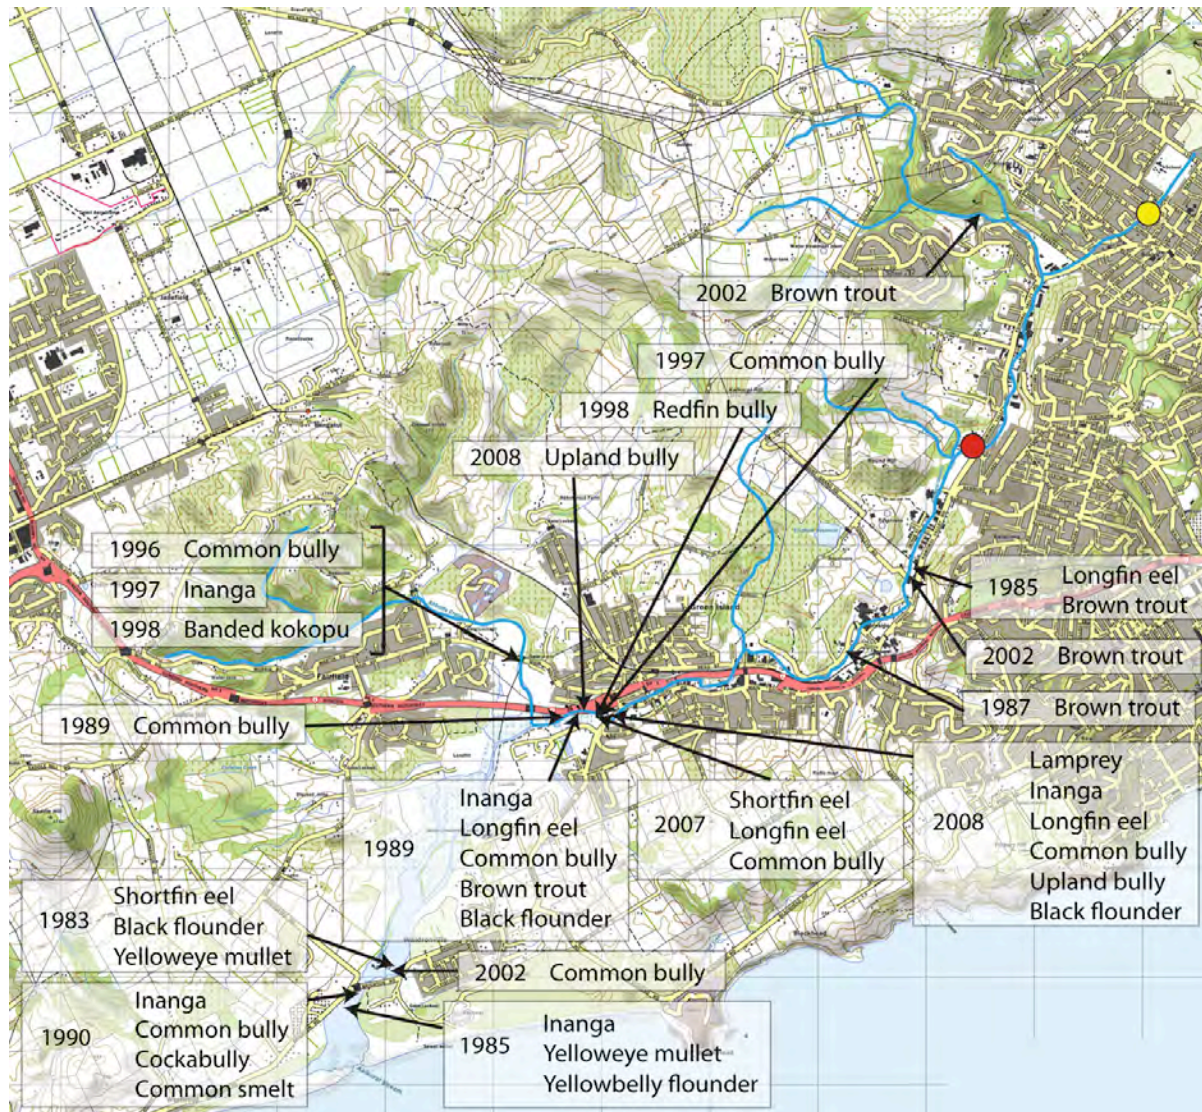
Figure 19. Known fish distribution in the Kaikorai Stream catchment (blue line) as obtained from the New Zealand Freshwater Fish Database (NIWA). The red (Kaikorai Valley) and yellow (Shetland Street / Nairn Street) circles indicate the points of discharge for DCC wastewater overflows.

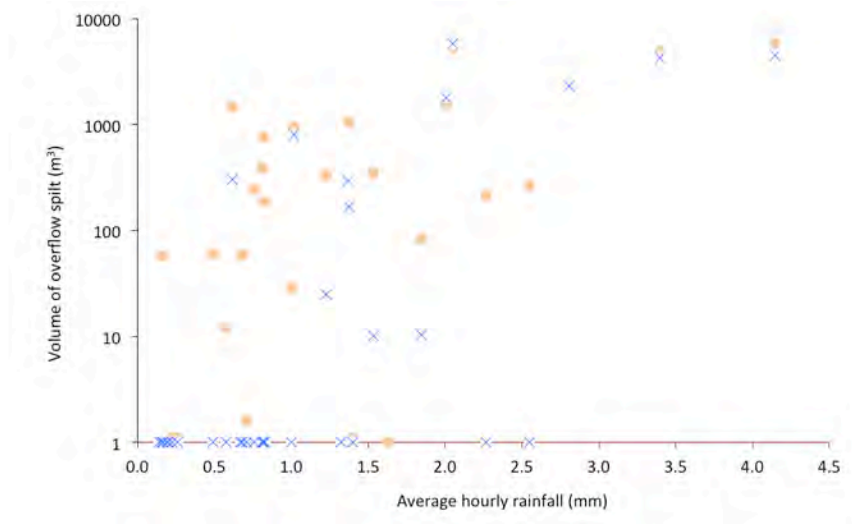
**Figure 1.** Scatter graph of Kaikorai Valley (•) and Shetland Street / Nairn Street (x) overflow volumes during rainfall events. Monitoring data obtained from DCC records between October 2011 and December 2013.
