Stormwater Compliance Monitoring 2015

Stormwater Discharges from Dunedin City

(ORC Discharge Permits RM11.313.01 – RM11.313.10)

Ryder Consulting Ltd.

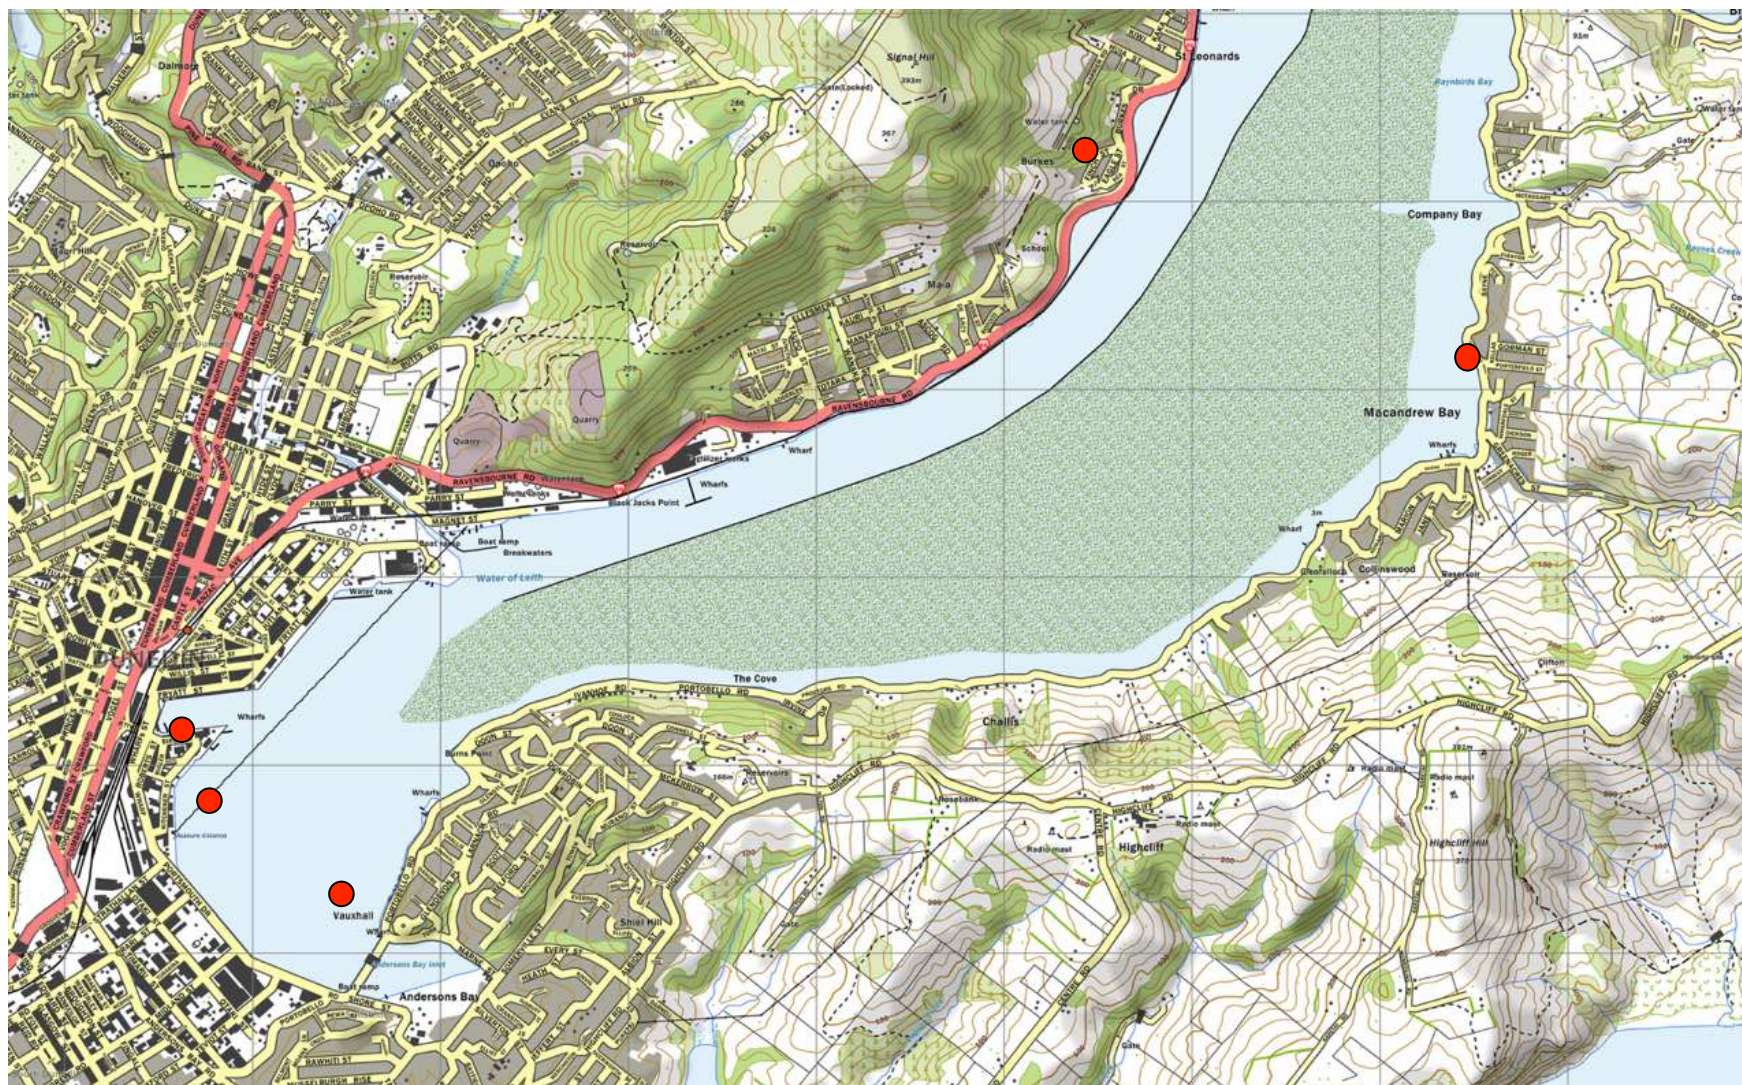
Figure 2.2 Upper Harbour Basin biological sampling sites. Anticlockwise from centre top: Burkes, Kitchener St, Orari St, Portobello Rd, Macandrew Bay.

Biological monitoring was carried out at five sites (Figure 2.2). At Kitchener Street, Orari Street and Portobello Road epifauna and flora were assessed at the waters edge at low tide at three sites (0-5 m distant from the outfall, 15-20m from the outfall and 45-50m from the outfall). Assessment was made using 3 x 1 m² quadrats at each site for flora and 5 x 0.25 m² quadrats at each site for epifauna. Infauna were assessed from three 200 mm deep 85 mm
