Dunedin City Council

## Stormwater Monitoring

July 2018 – June 2019

*Prepared for Dunedin City Council*

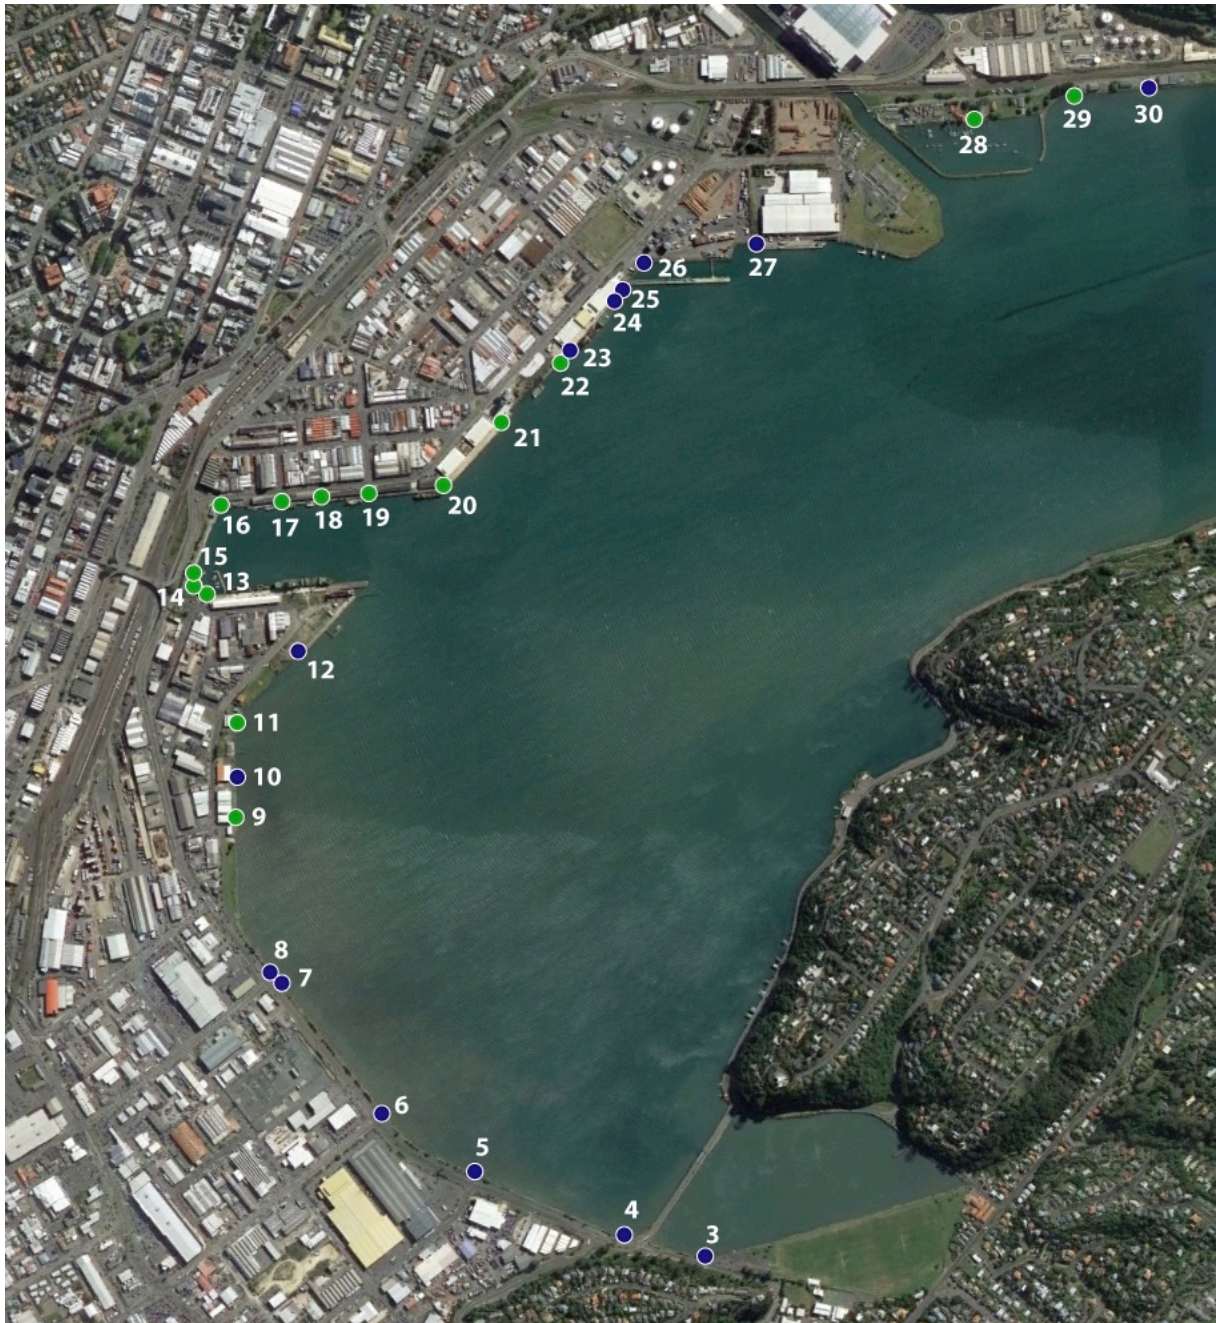
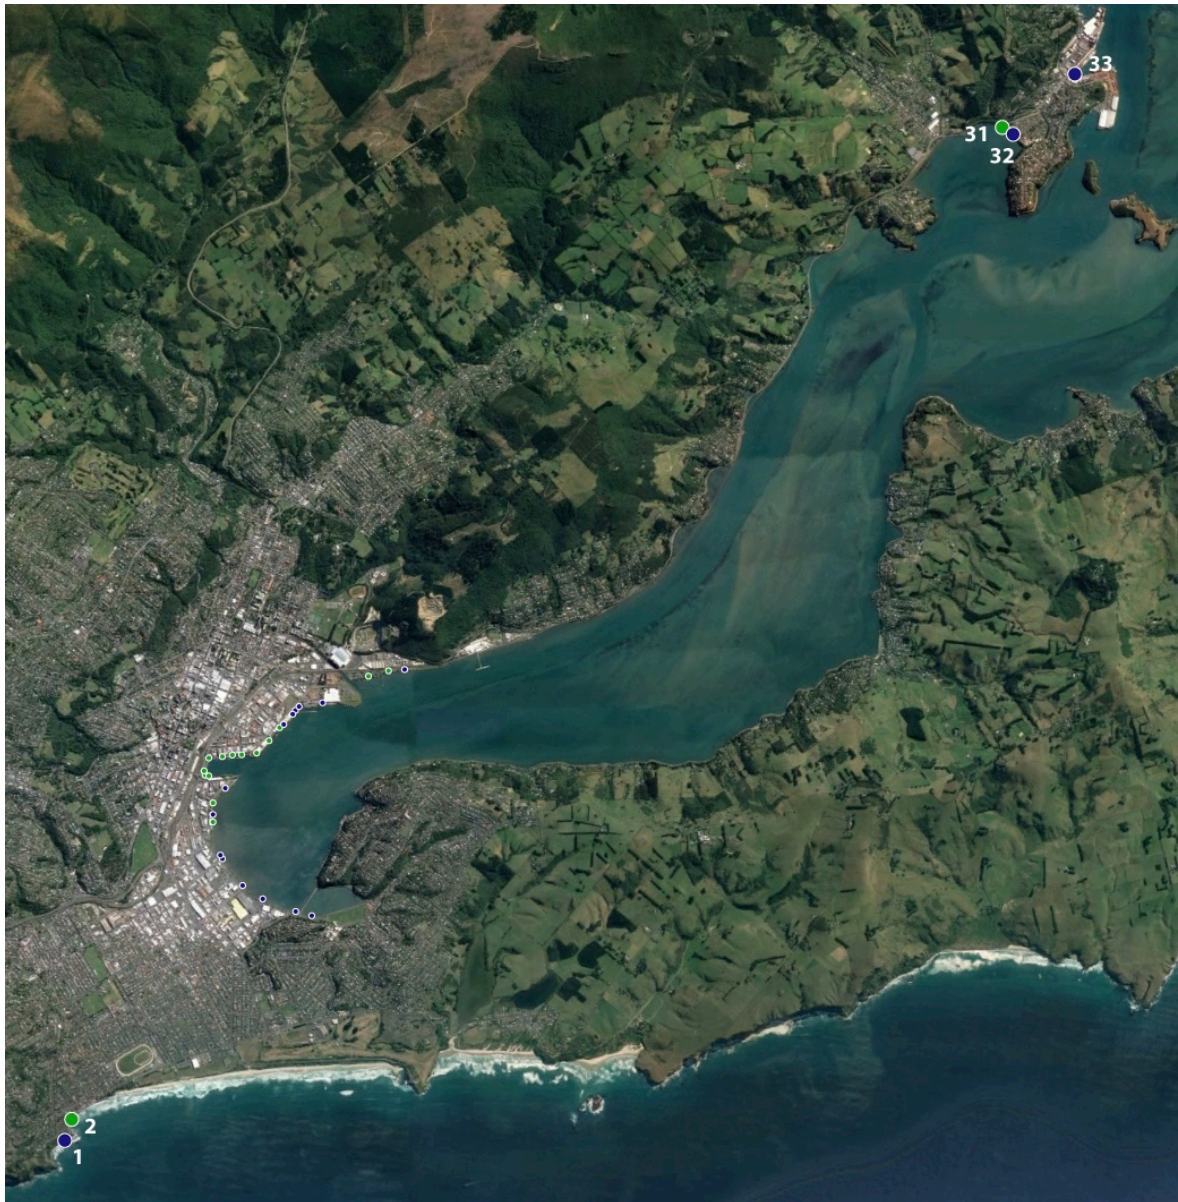
**Figure 2. Dunedin stormwater outfalls. Monthly dry weather sampling sites (blue circles) and six-monthly dry weather sites (green circles). See Appendix One for outfall information. Aerial photo from Google Earth.**

**Figure 2 continued. Dunedin stormwater outfalls. Monthly dry weather sampling sites (blue circles) and six-monthly dry weather sites (green circles). See Appendix One for outfall information. Aerial photo from Google Earth.**

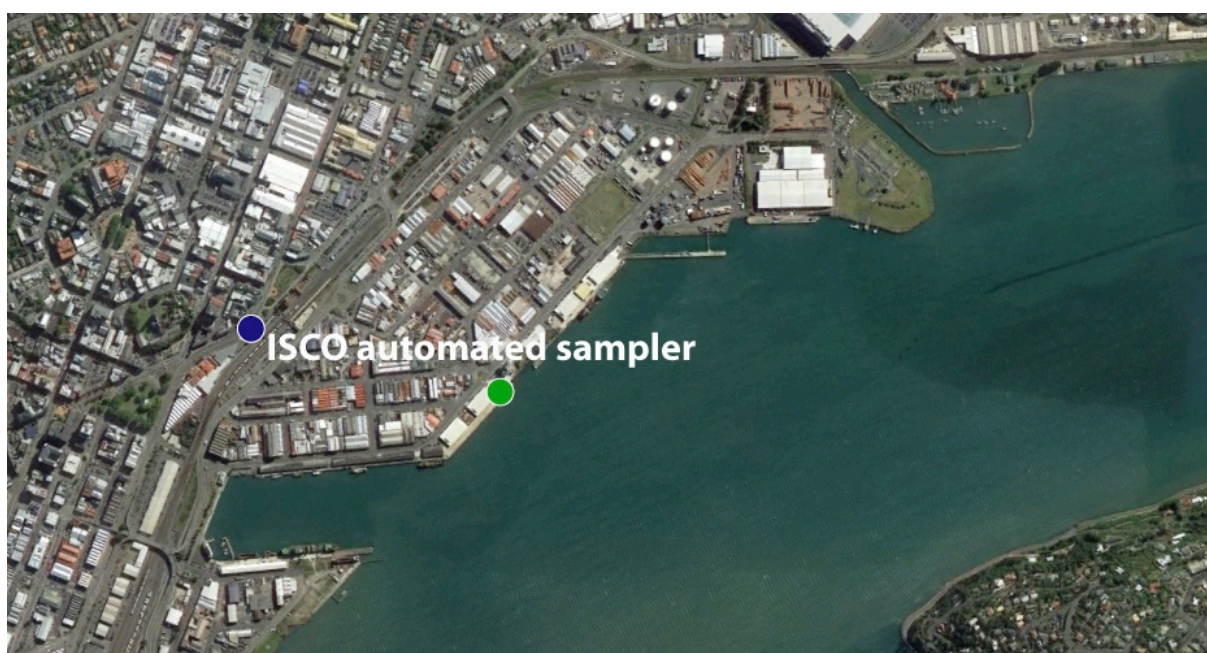
**Figure 3.** The location of the ISCO automated sampler, near Toitu, sampling the Mason Street catchment. Mason Street stormwater outfall indicated by green circle. Aerial photo from Google Earth.

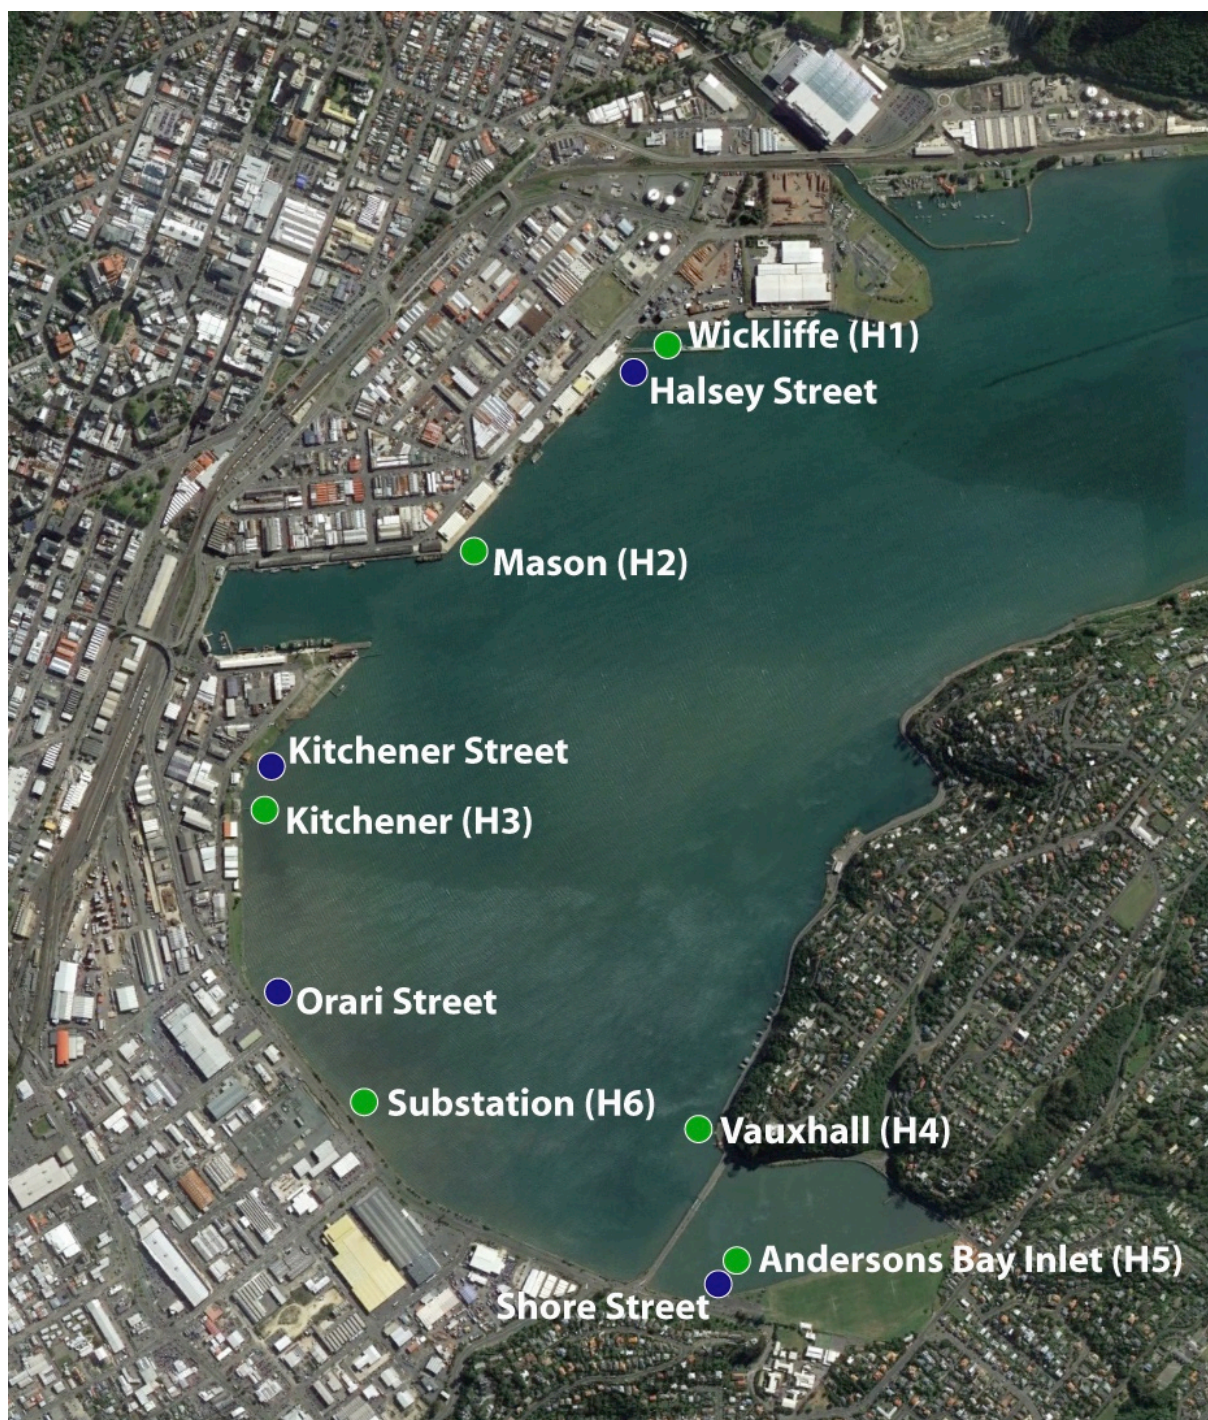
**Figure 4. Otago Harbour water quality sampling sites (green circles) and sediment sampling sites (blue circles). Aerial photo from Google Earth.**

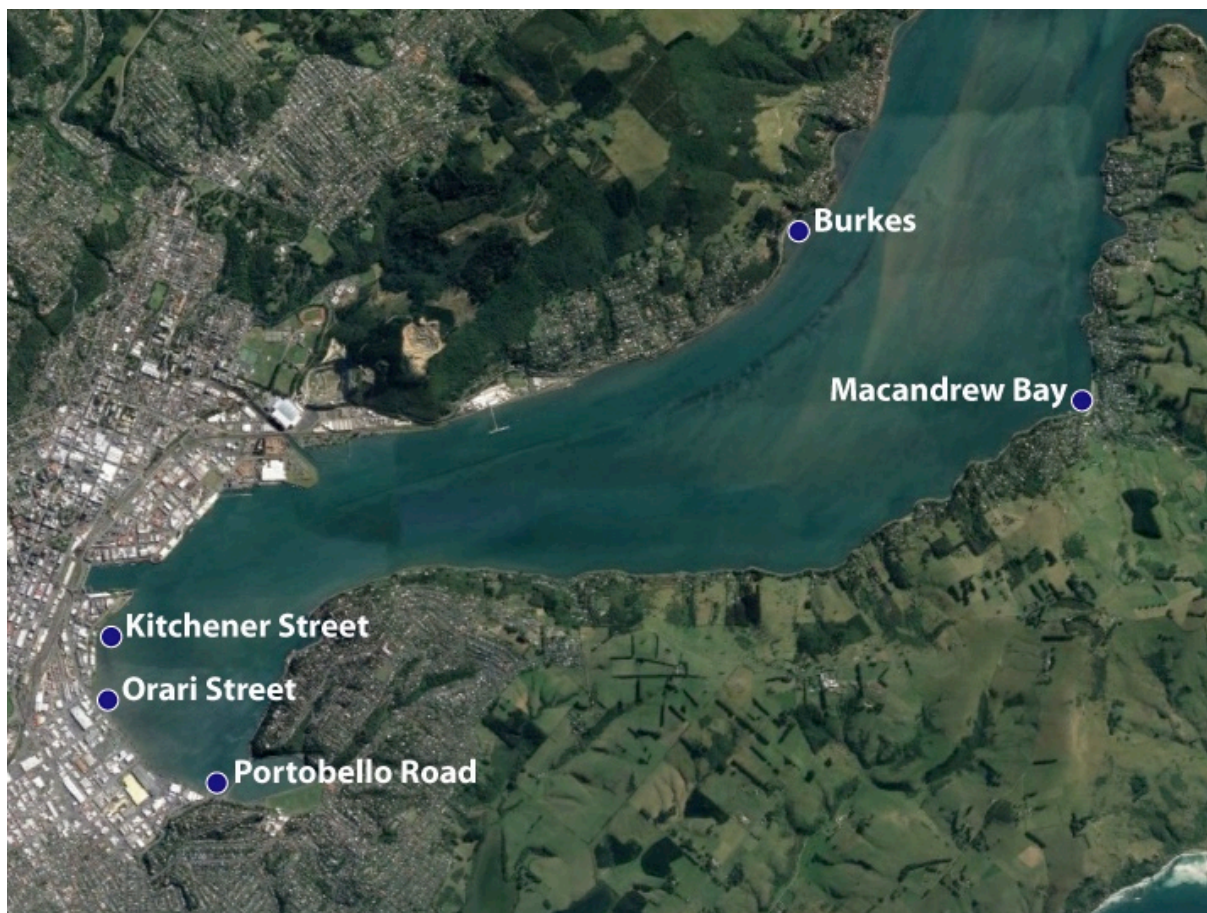
**Figure 5. Otago Harbour biological sampling sites. Aerial photo from Google Earth.**

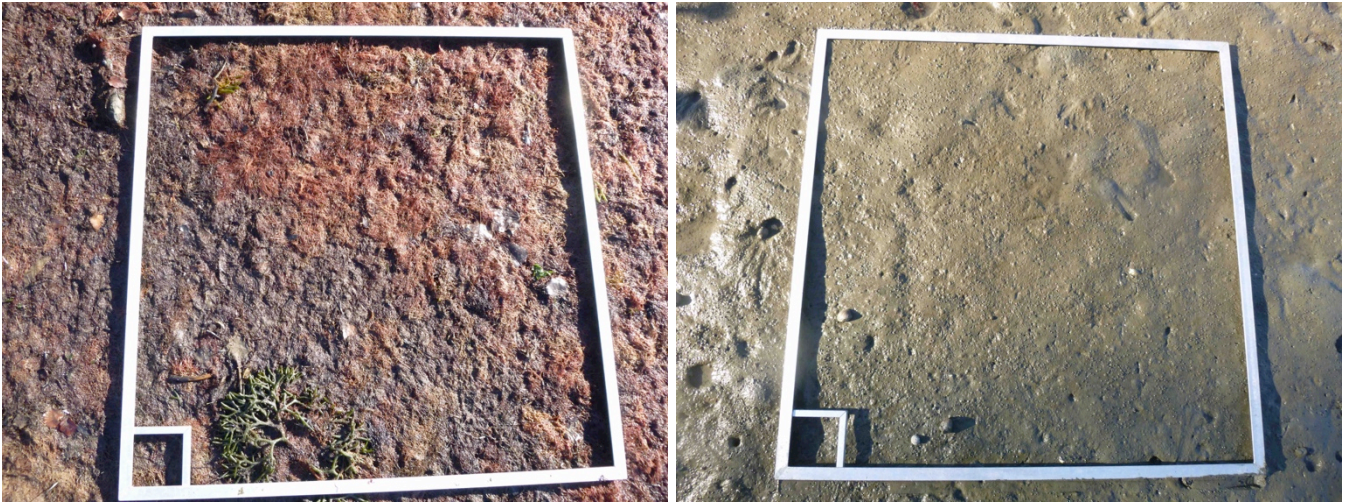
**Figure 8. Examples of macroflora at Otago Harbour sites, April 2019. Codium (green algae) on top of extensive beds of Ceramium (red algae) at Orari Street site (left) and no macroflora at Burkes (right).**

conditions prevailing at the time. In July 2019, cover of the algae was observed to be decreasing, possibly due to colder weather. Should extensive beds persist at this site, further investigations into nutrient concentrations in the surrounding water may be useful.

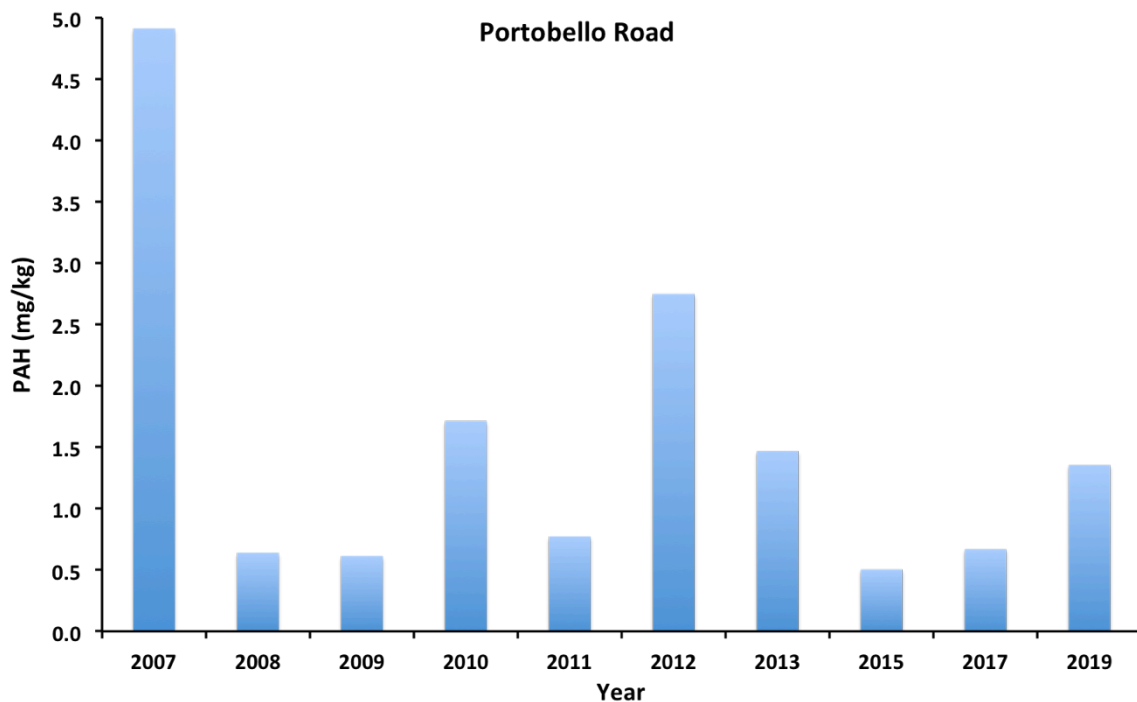
Cockles collected from the Portobello Road site have previously had much higher PAH concentrations than at the other sites, likely as a result of historic contamination of that site. PAH concentrations in cockle flesh have fluctuated over time but concentrations in 2019 fell within the range of concentrations seen from previous monitoring (Figure 11).

**Figure 11. Concentrations of PAHs in cockle flesh at the Portobello Road site, 2007 to 2019.**
