5 CONDITION ASSESSMENT

5.1 Exterior

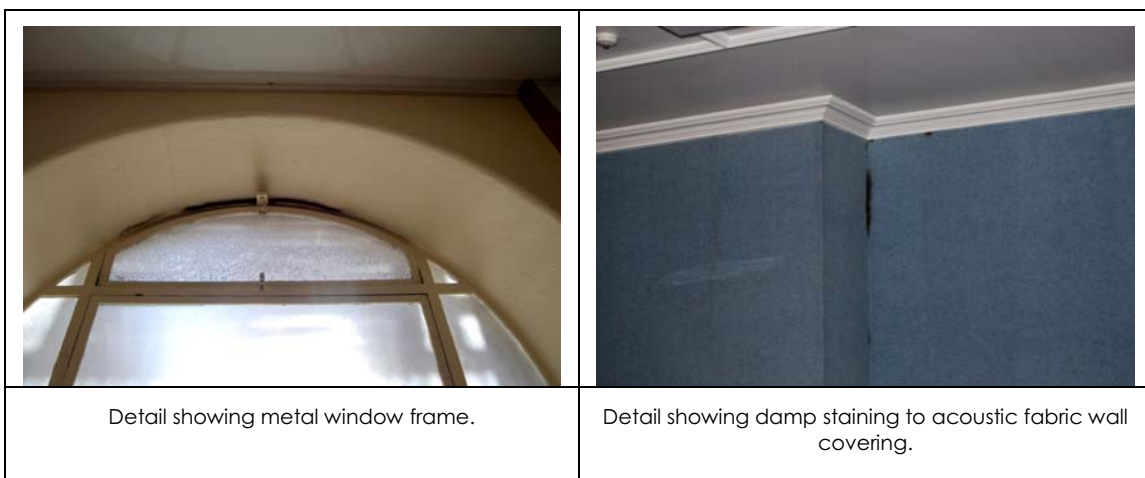
Original metal windows survive to most spaces and appear to be in good condition, although they tend to be heavily overpainted. No signs of major corrosion were noted however. In general all windows need regular maintenance and should be closely inspected for signs of corrosion. Repairs to cracked panes should be carried out where these occur.

Original flooring in the Glenroy auditorium is also in good condition, apart from scratches and pitting caused by general wear and tear, impact and footfall.
