**PRESENTATION MATERIAL FOR PLAN CHANGE 1 SUBMISSION**  
**Patersons on behalf of Blue Sky Property 45 Beach Limited**

The DCC Heritage Assessment for the building at 45 Beach Street recommended that the entire external building envelope, excluding the carport and garage on Albert Street, was recommended for protection.

Patersons, on behalf of BlueSky, requests that the Scheduled Heritage Building BX046 feature, referring to the main building at 45 Beach Street be removed from PC1. This includes from the planning maps.

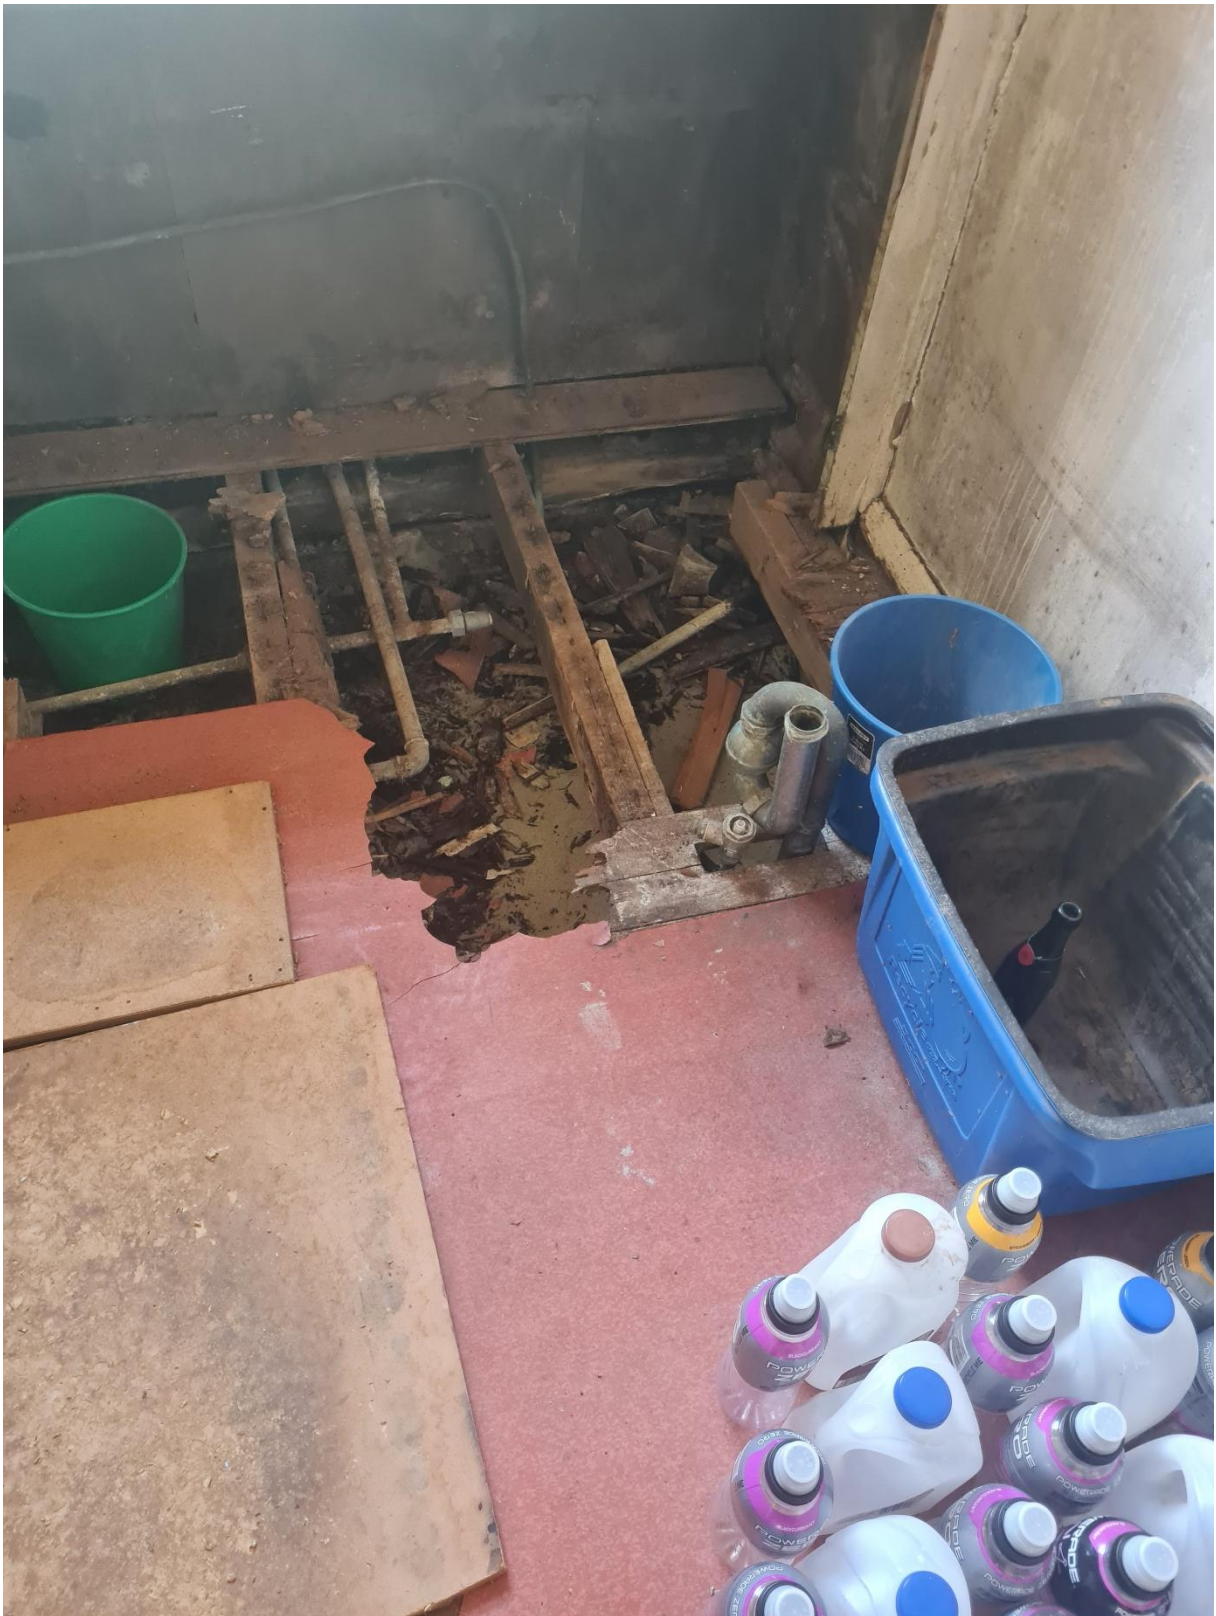
*Photo 1 - Rotted floor framing bearing directly on soil*

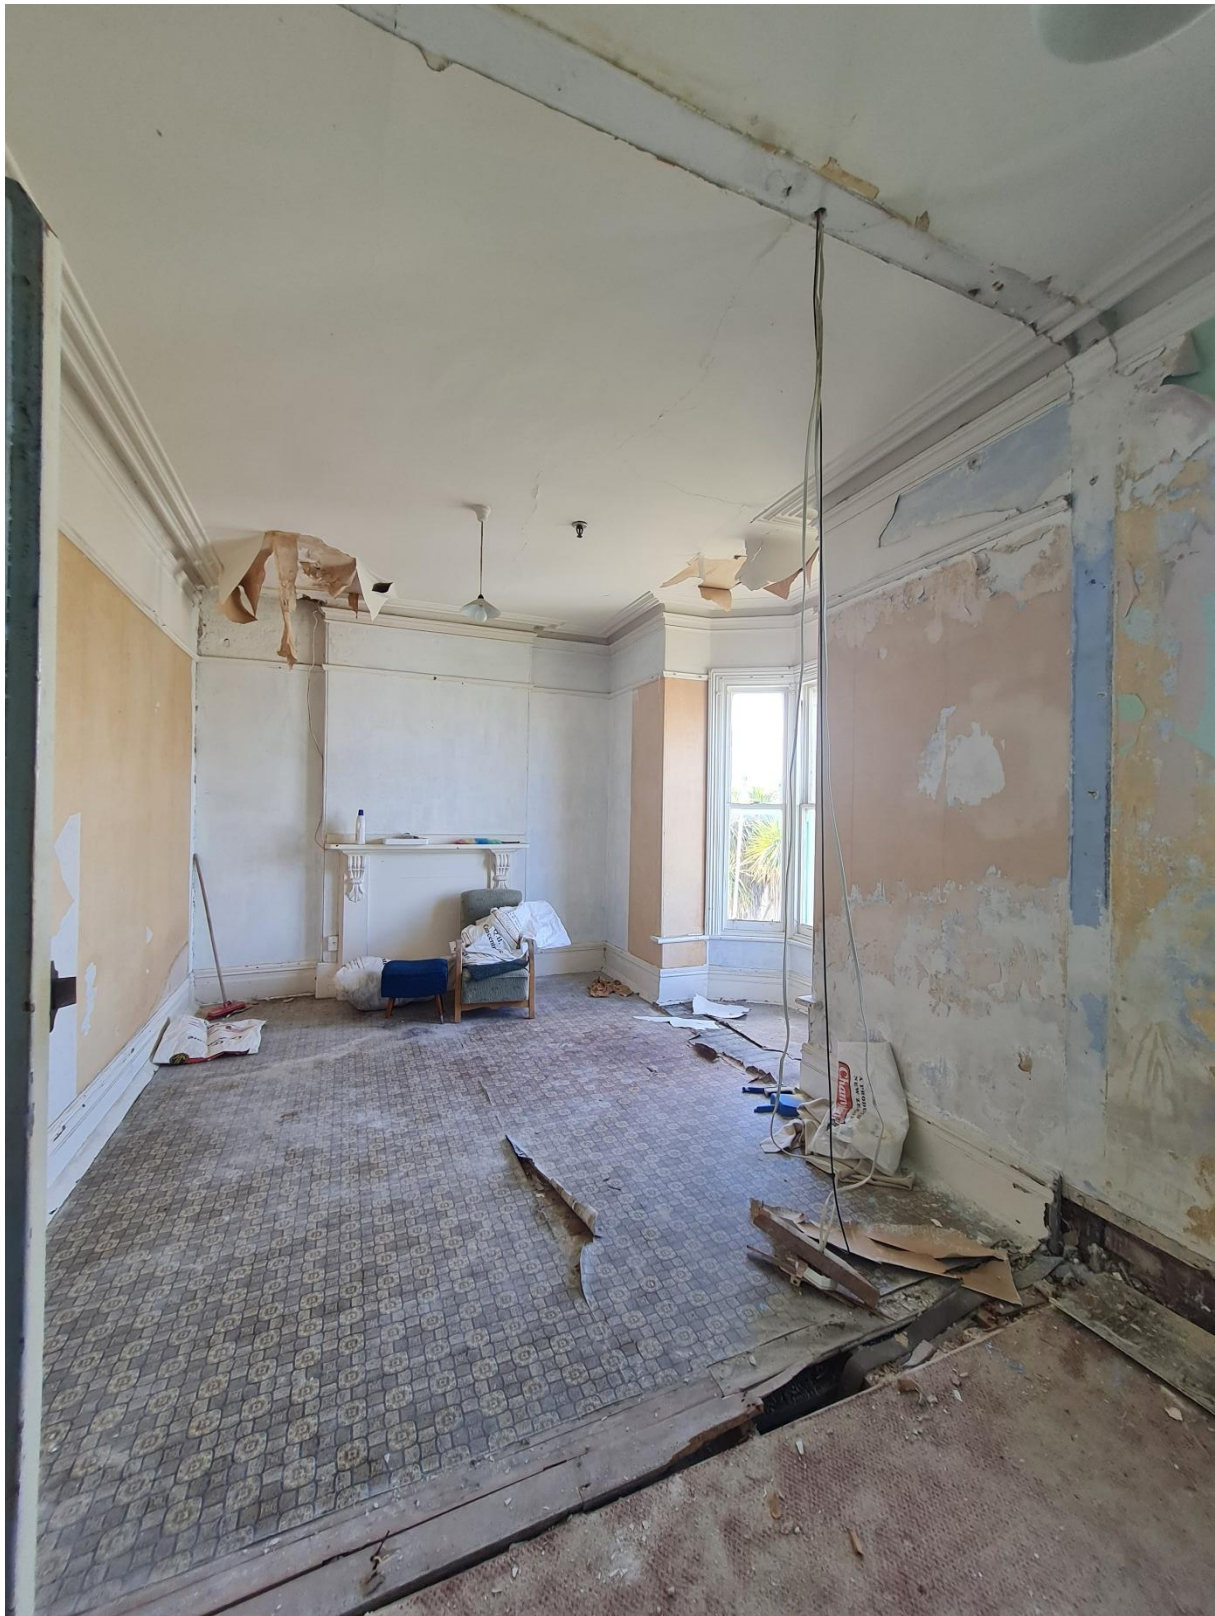
*Photo 4 - Removed wall with no additional bracing or support & exposed electrical wiring, upper level*
