RE: LUC-2018-367 Application to remove significant tree T442

As per your July 10, email request, I have conducted a site visit to number 27 Falkland Street Dunedin, to inspect significant tree T442 listed on Schedule 25.3 as a Cedar (*Cedrus sp.*). The purpose of the visit was to assess the condition of the tree, specifically in relation Application LUC-2018-367 [to remove a significant tree T442 - Cedar].

Site Address: 27 Falkland Street Dunedin 9010 [Property No: 5016576]
Client: Lucy Collins, City Planning. Dunedin City Council
The Proposal: Assess tree T442 in relation Application LUC-2018-367
Assessment date: July 13, 2018

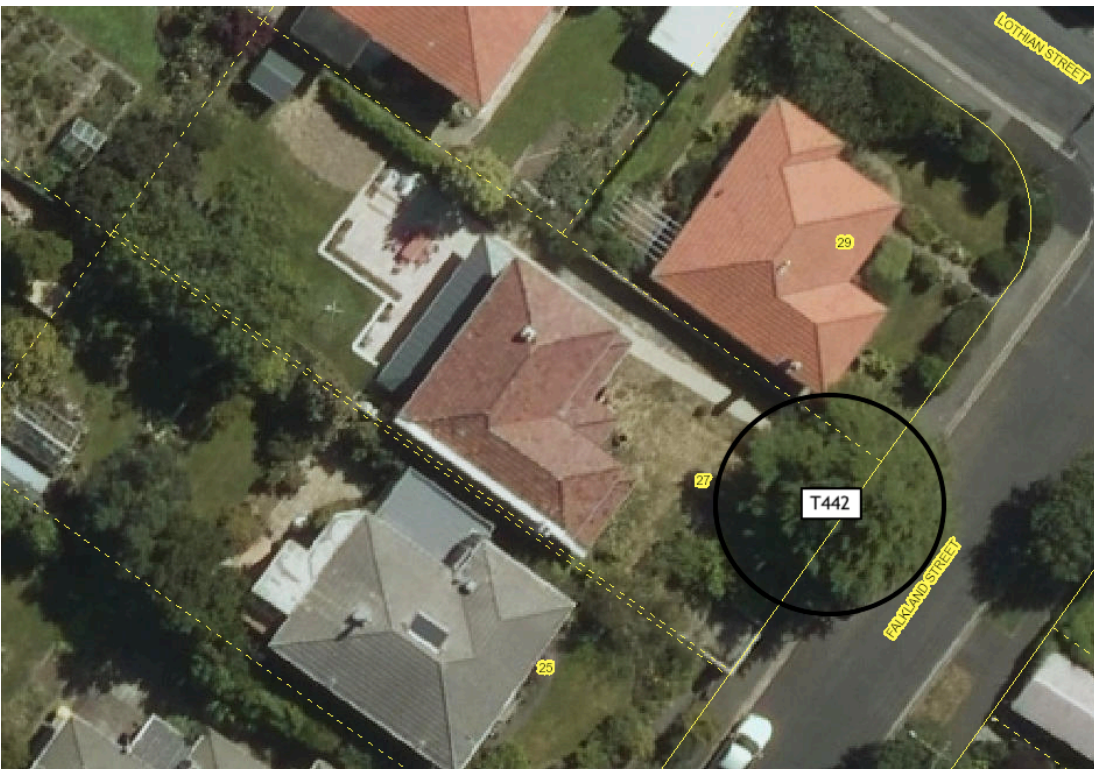
Image two: Google Maps image showing approximate location of T442 in relation to the front boundary of number 27 Falkland Street
